CALIFORNIA DEPARTMENT OF FISH AND WILDLIFE

STREAM INVENTORY REPORT

Unnamed Tributary to the Van Duzen River

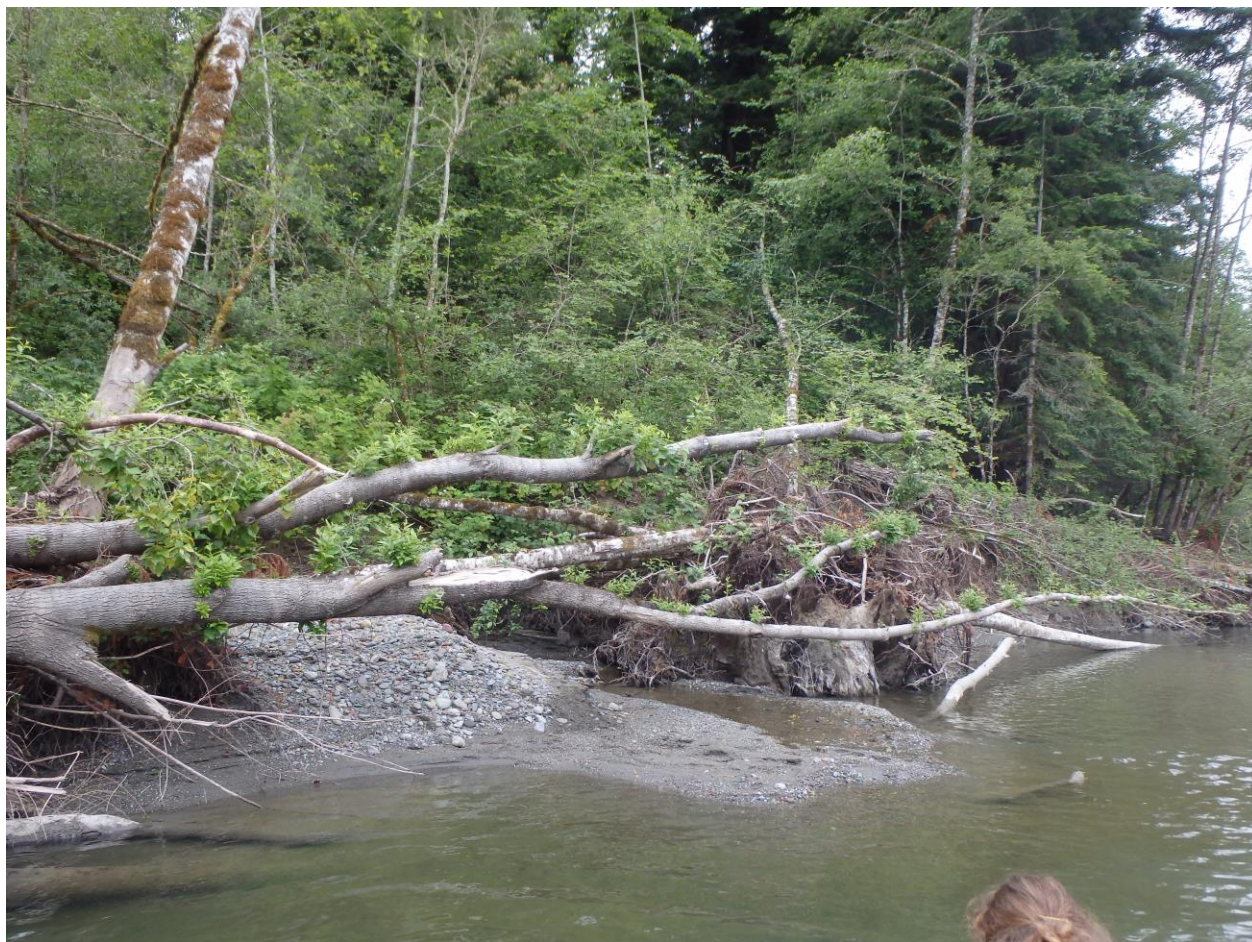
Photo 1: Start of survey at the confluence of the Van Duzen River. (Photo taken 5/30/2017)

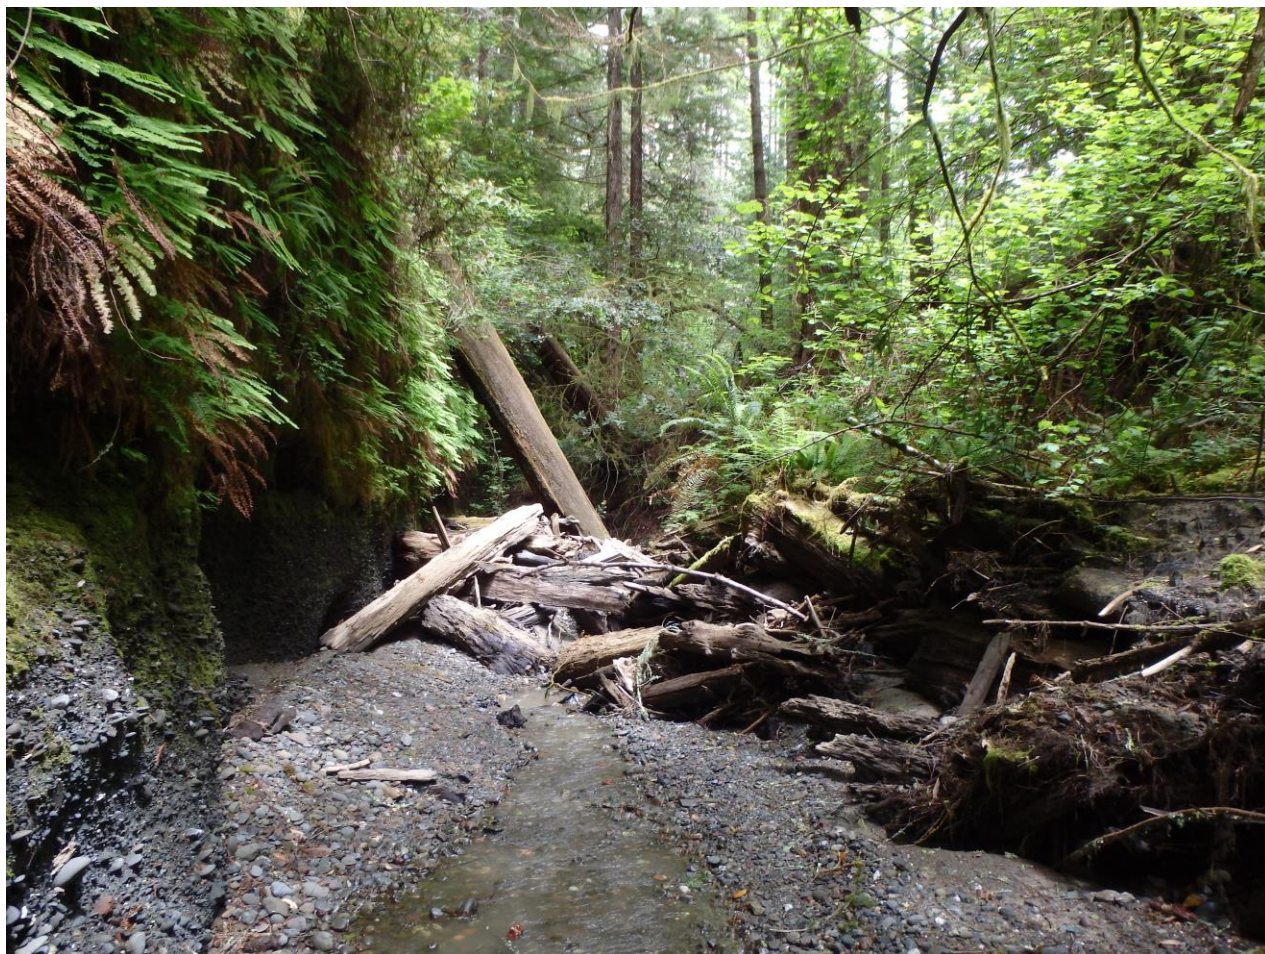
4' deep. The sediment ranges in size from sand to small cobble. The LDA is not a barrier to salmonids. Fish were not observed above the LDA.
1135	0034.00	There is a 1' plunge over a LWD into the pool.
1402	0044.00	LDA #3 is 9' high x 18' wide x 68' long and contains 35 pieces of LWD. Water flows through the LDA and there are visible gaps in it. Sediment is being retained in the approximate dimensions of 20' wide x 50' long x 6' deep. The LDA is not a barrier to salmonids. Fish were not observed above the LDA.
1547	0050.00	LDA #4 is 3.5' high x 18' wide x 15.5' long and contains 6 pieces of LWD. Water flows through the LDA and there are visible gaps in it. Sediment is being retained in the approximate dimensions of 20' wide x 30' long x 3.5' deep. The sediment ranges in size from silt to small cobble. The LDA is not a barrier to salmonids. Fish were not observed above the LDA.
1568	0052.00	LDA # 5 is 5.5' high x 18' wide x 16' long and contains 13 pieces of LWD. Water flows through the LDA and there are visible gaps in it. Sediment is being retained in the approximate dimensions of 25' wide x 35' long x 4' deep. The sediment ranges in size from silt to small cobble. The LDA is not a barrier to salmonids. Fish were not observed above the LDA.

Photo 2: Large debris accumulation #3 in habitat unit # 44, 1,402' upstream of start of survey.
(Photo taken 5/30/2017)

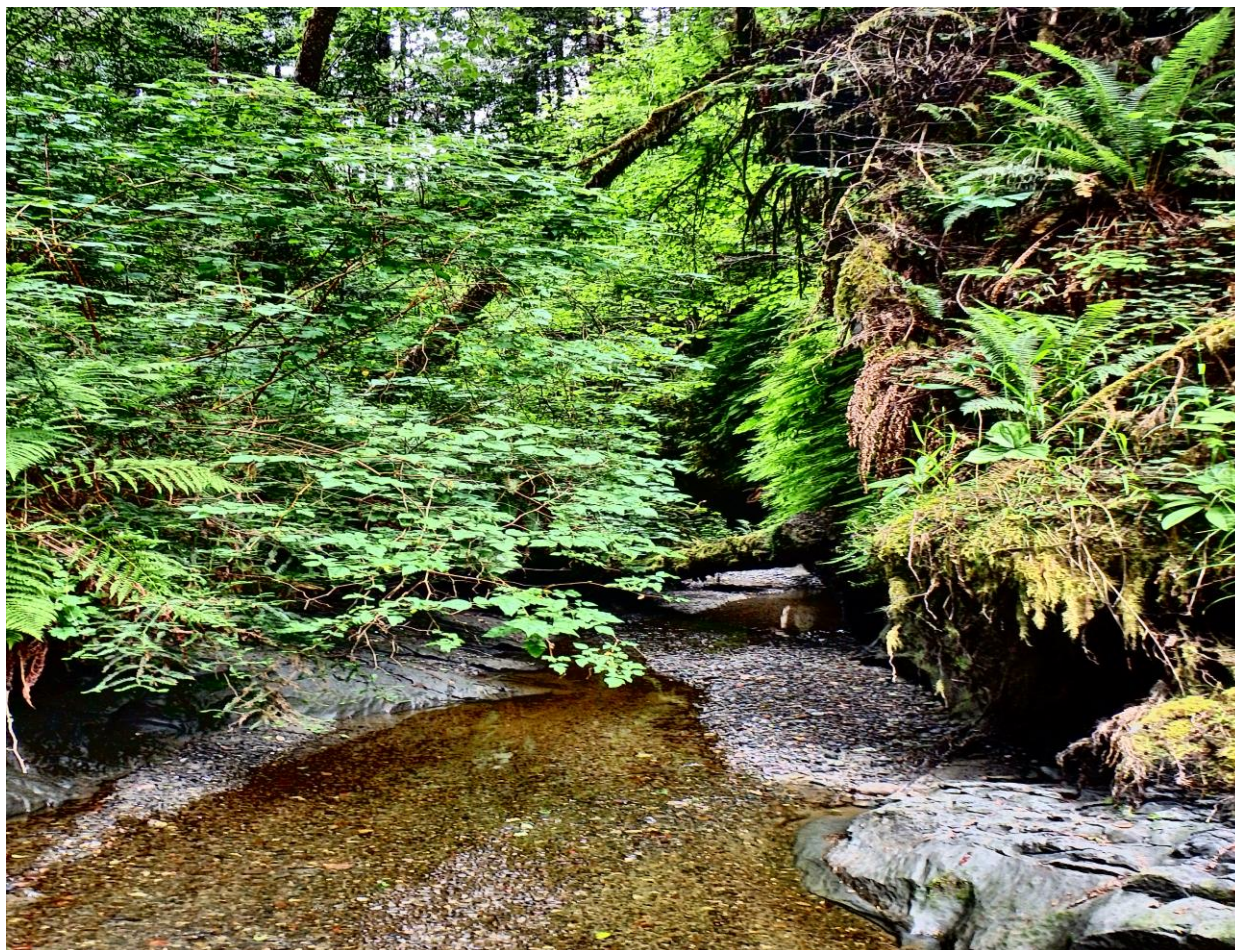
Photo #3: Run at unknown distance from start of survey. (Photo taken 5/31/2017)

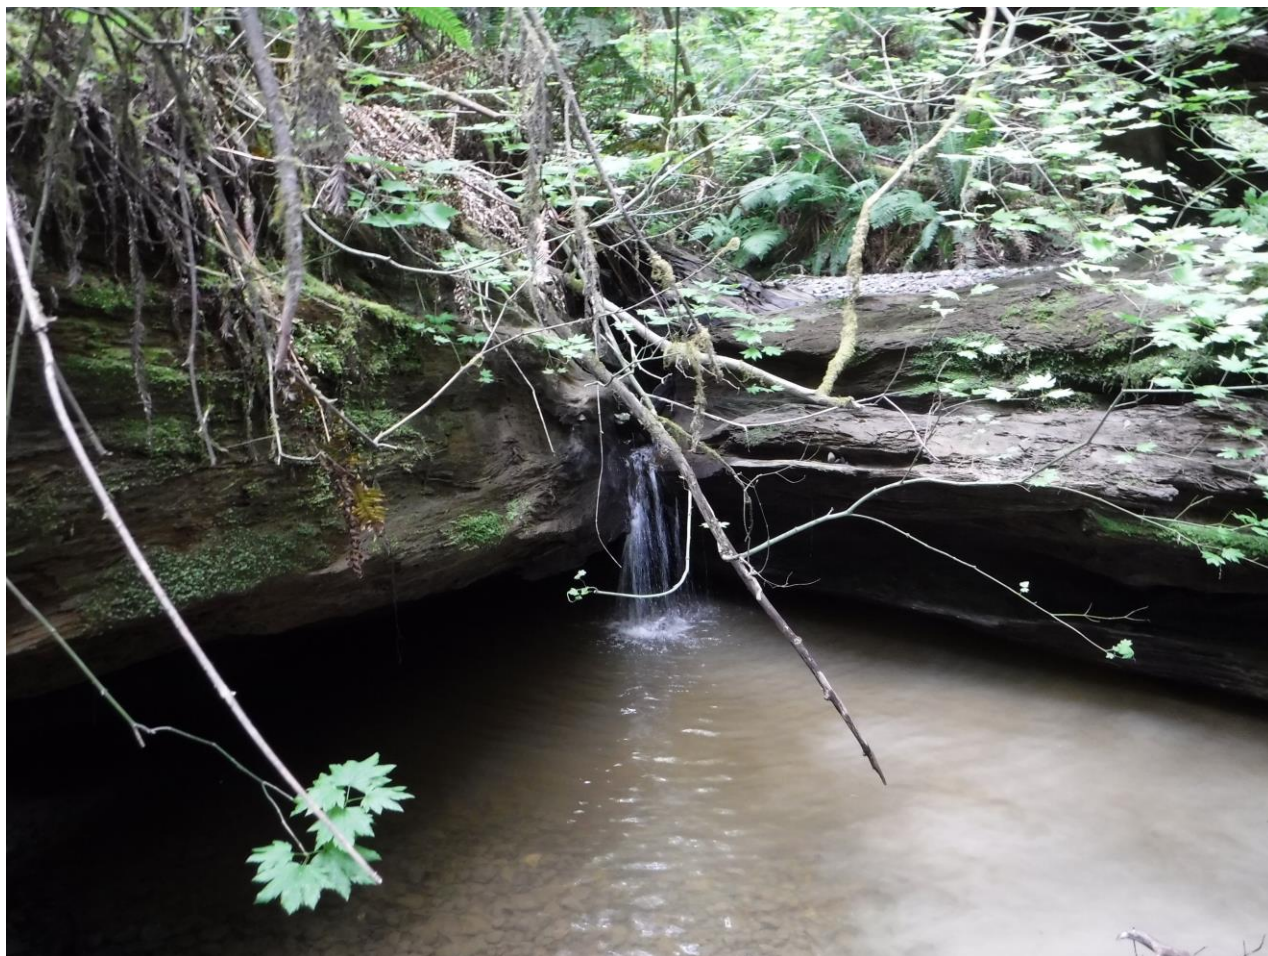
- 3644 0125.00 There is a 2' plunge over wood into the pool. There is a right bank landslide.
- 3698 0127.00 There is a 3' plunge over wood into a 1.4' deep pool. End of survey due to diminished habitat. The creek becomes more entrenched with an increasing slope. There are less pools and suitable spawning areas. There are a series of 10 LDA's in approximately 1,000', some having greater than a 4' plunge with shallow pools. Water periodical flows subsurface. LDA # 15 in habitat unit 109 is most likely a barrier to salmonids. It consists of a very large rootwad that blocks the entire channel where even in high winter flows would block access to salmonids. There were no fish observed in the entire reach. Access becomes increasingly difficult.

Photo 4: End of survey at habitat unit # 127, 3,711' upstream of start of survey. (Photo taken 6/6/2017)
