# STREAM INVENTORY REPORT

## Julias Creek

A stream inventory was conducted June 6, 2006 to July 12, 2006 on Julias Creek. The survey began at the confluence with South Fork Usal Creek and extended upstream 1.4 miles.

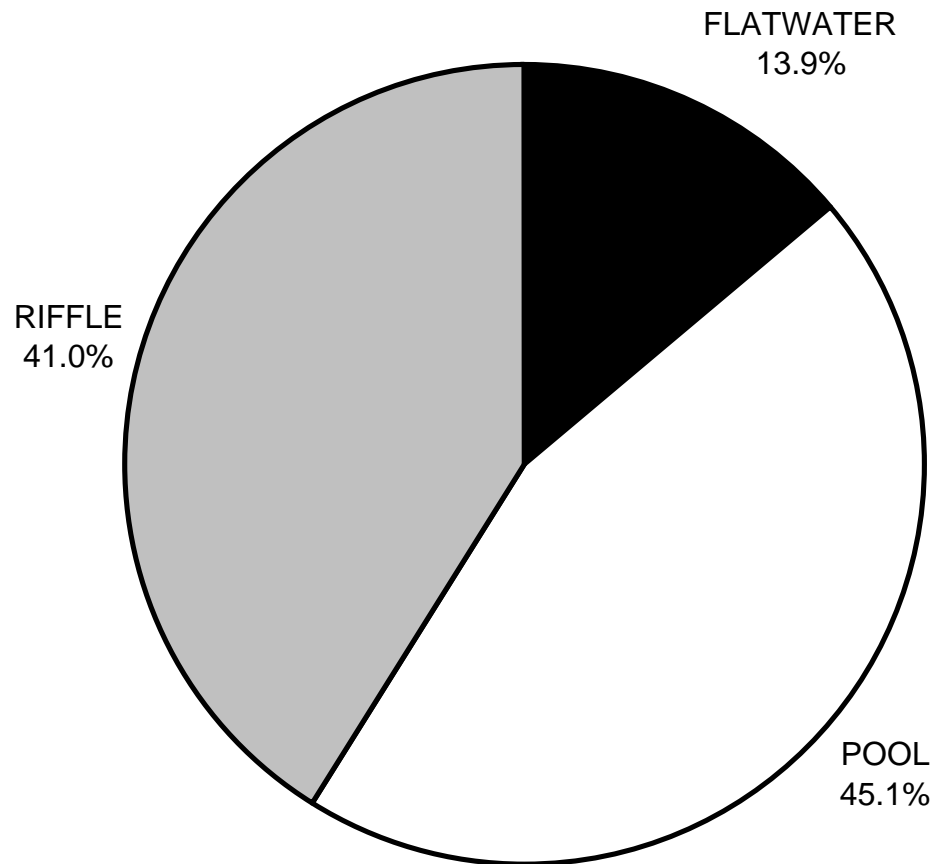
GRAPH 1

Table 1 summarizes the Level II riffle, flatwater, and pool habitat types. Based on frequency of occurrence there were 45% pool units, 41% riffle units, and 14% flatwater units (Graph 1). Based on total length of Level II habitat types there were 65% riffle units, 18% flatwater units, and 17% pool units (Graph 2).

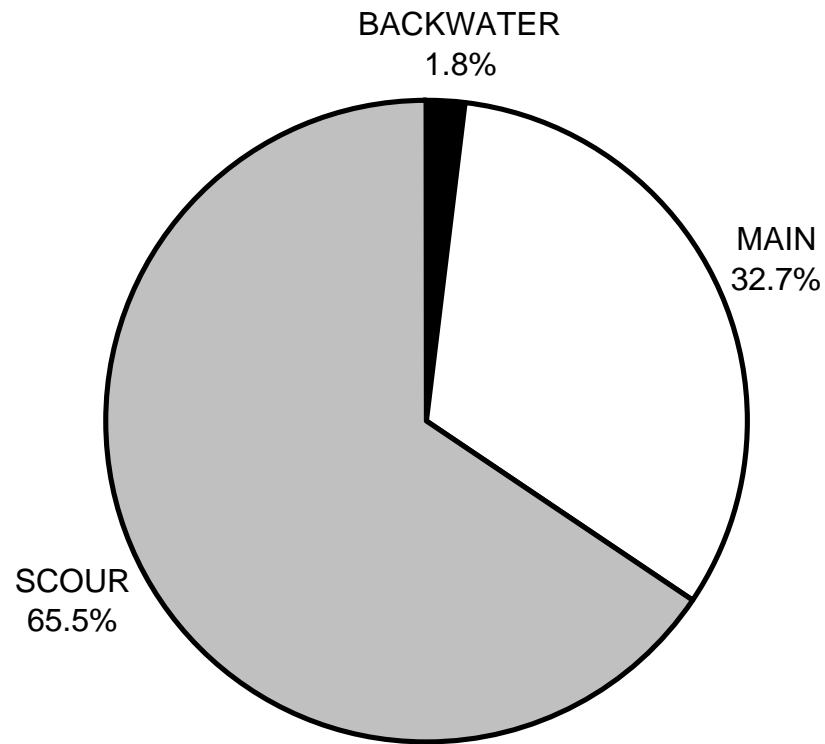
GRAPH 4

A total of 55 pools were identified (Table 3). Scour pools were the most frequently encountered at 65% (Graph 4), and comprised 62% of the total length of all pools (Table 3).

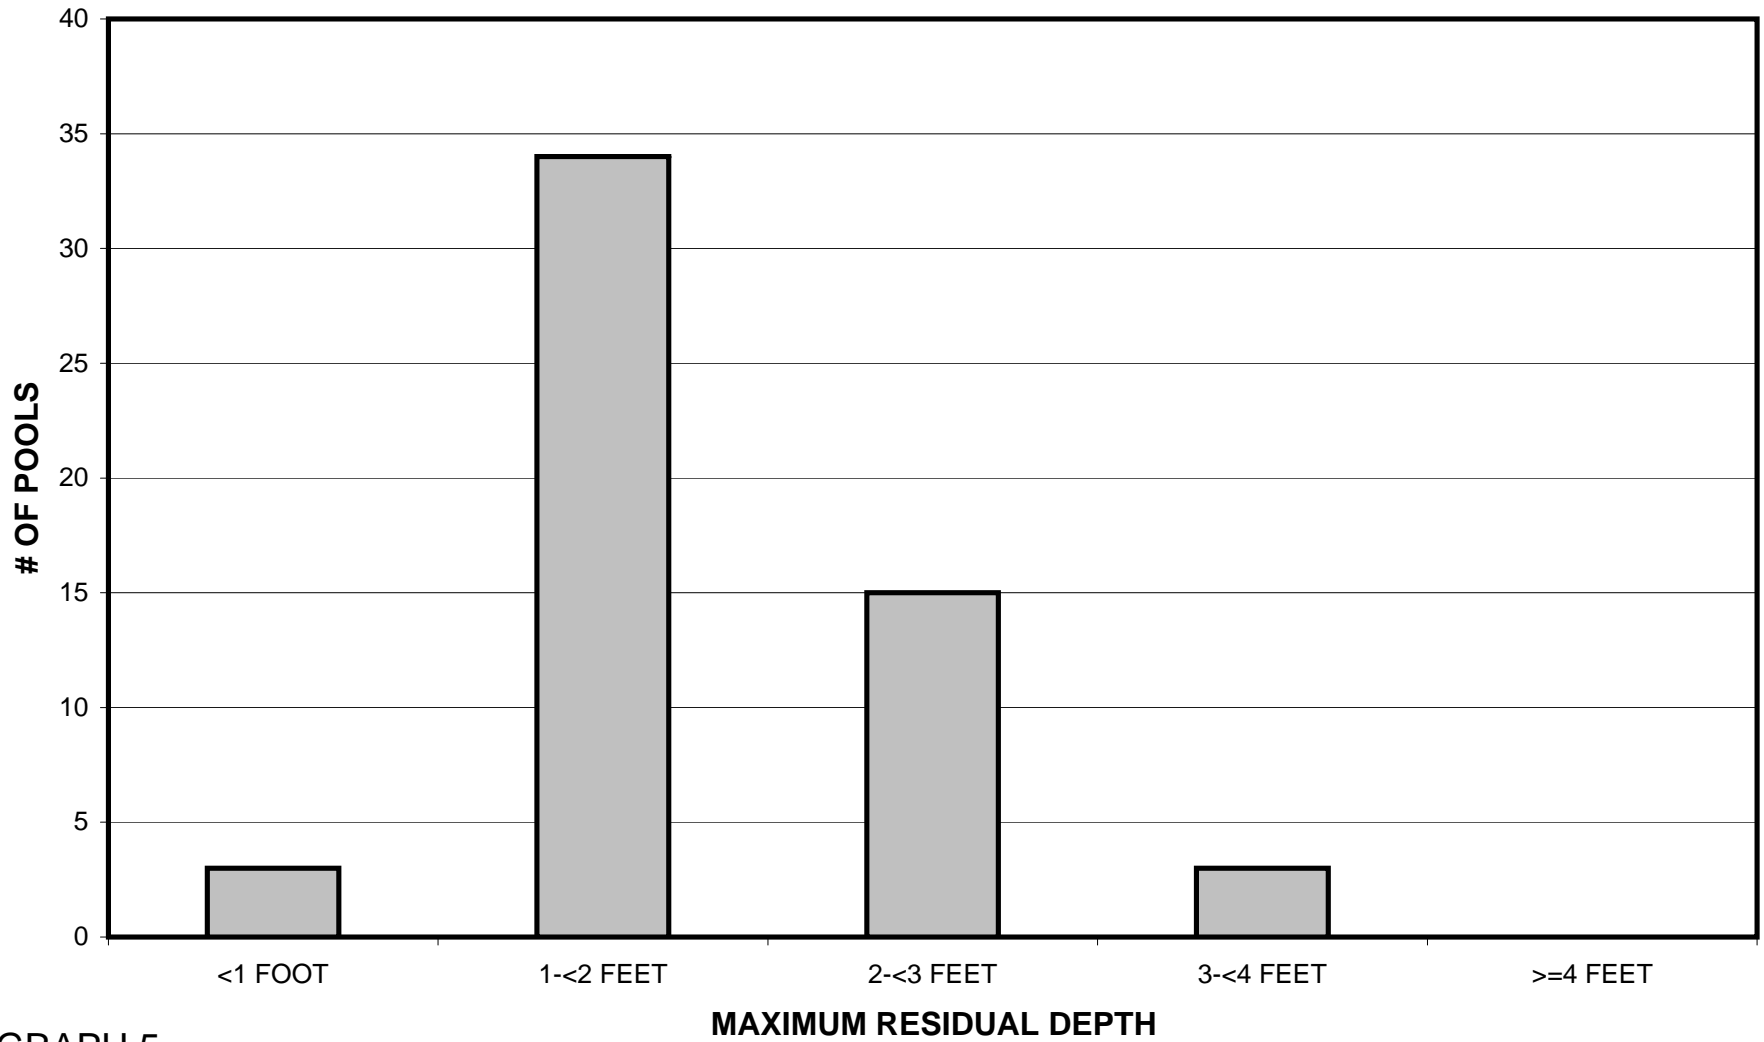
GRAPH 5

Table 4 is a summary of maximum residual pool depths by pool habitat types. Pool quality for salmonids increases with depth. Eighteen of the 55 pools (33%) had a residual depth of two feet or greater (Graph 5).

Flatwater habitat types comprised 18% of the total length of this survey, riffles 65%, and pools 17%. Eighteen of the 55 (33%) pools had a maximum residual depth greater than 2 feet. In

general, pool enhancement projects are considered when primary pools comprise less than 40% of the length of total stream habitat. In first and second order streams, a primary pool is defined to have a maximum residual depth of at least two feet, occupy at least half the width of the low flow channel, and be as long as the low flow channel width. Installing structure that will increase or deepen pool habitat is recommended.

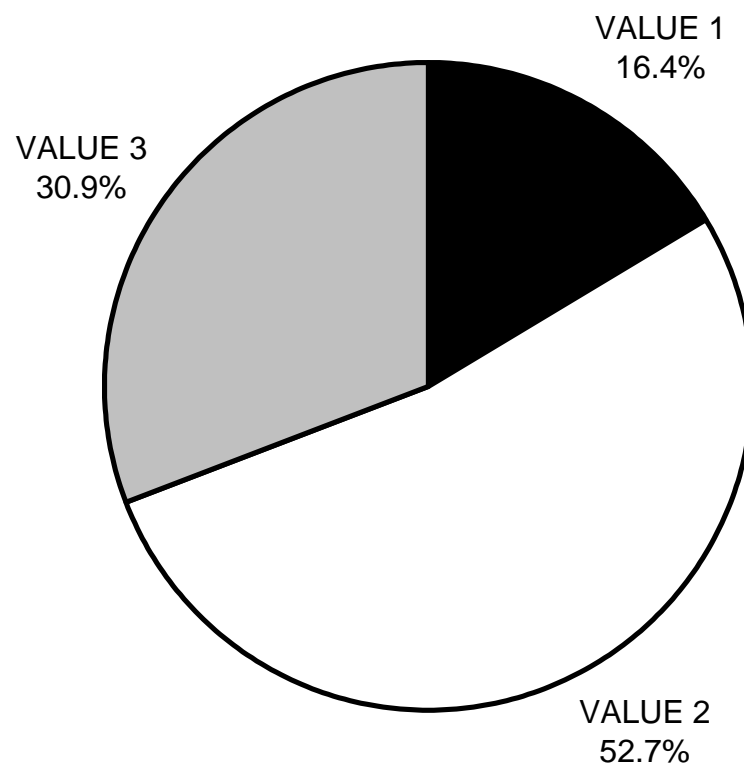
GRAPH 6

The depth of cobble embeddedness was estimated at pool tail-outs. Of the 55 pool tail-outs measured, 9 had a value of 1 (16.4%); 29 had a value of 2 (52.7%); 17 had a value of 3 (30.9%) (Graph 6). On this scale, a value of 1 indicates the best spawning conditions and a value of 4 the worst. Additionally, a value of 5 was assigned to tail-outs deemed unsuited for spawning due to inappropriate substrate such as bedrock, log sills, boulders, or other considerations.

Thirty-eight of the 55 pool tail-outs measured had embeddedness ratings of 1 or 2. Seventeen of the pool tail-outs had embeddedness ratings of 3 or 4. Cobble embeddedness measured to be 25% or less, a rating of 1, is considered to indicate good quality spawning substrate for salmon and steelhead. Sediment sources in Julias Creek should be mapped and rated according to their potential sediment yields, and control measures should be taken.

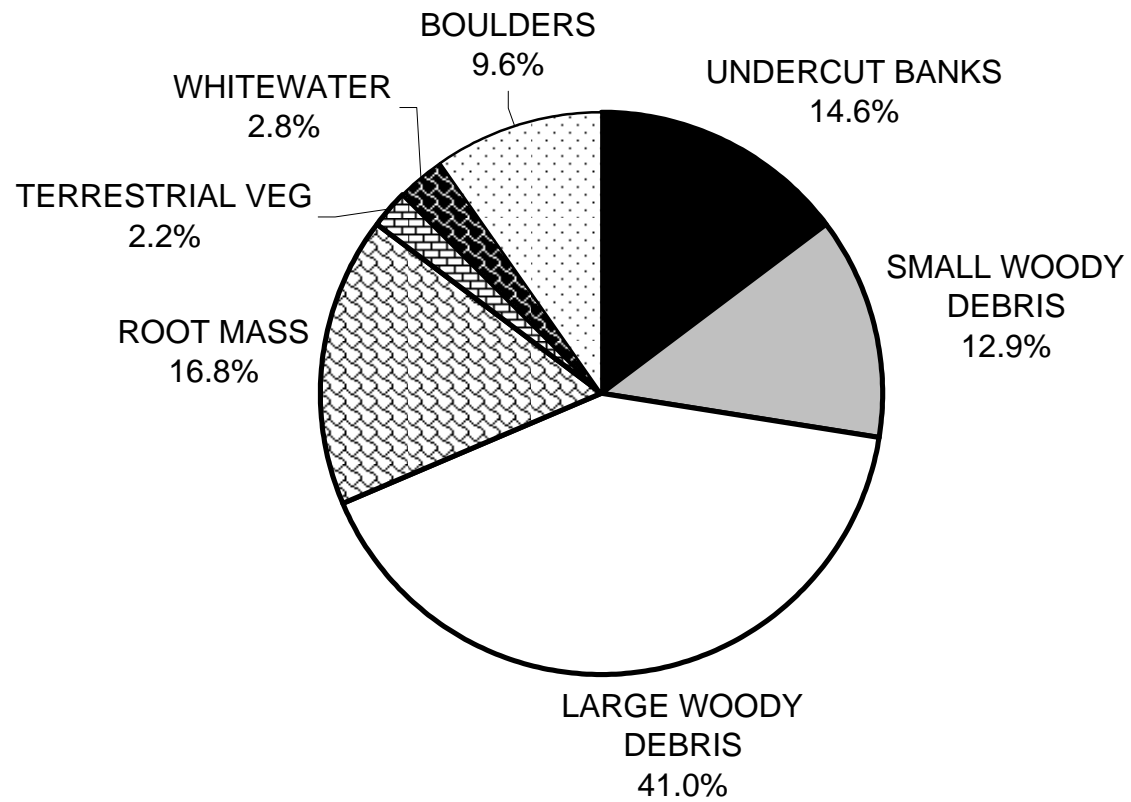
GRAPH 7

Table 5 summarizes mean percent cover by habitat type. Large woody debris is the dominant cover type in Julias Creek. Graph 7 describes the pool cover in Julias Creek. Large woody debris is the dominant pool cover type followed by root mass.

The mean shelter rating for pools was 51. The shelter rating in the flatwater habitats was 8. A pool shelter rating of approximately 100 is desirable. The amount of cover that now exists is being provided primarily by large woody debris in Julias Creek. Large woody debris is the dominant cover type in pools followed by root mass. Log and root wad cover structures in the pool and flatwater habitats would enhance both summer and winter salmonid habitat. Log cover structure provides rearing fry with protection from predation, rest from water velocity, and also divides territorial units to reduce density related competition.

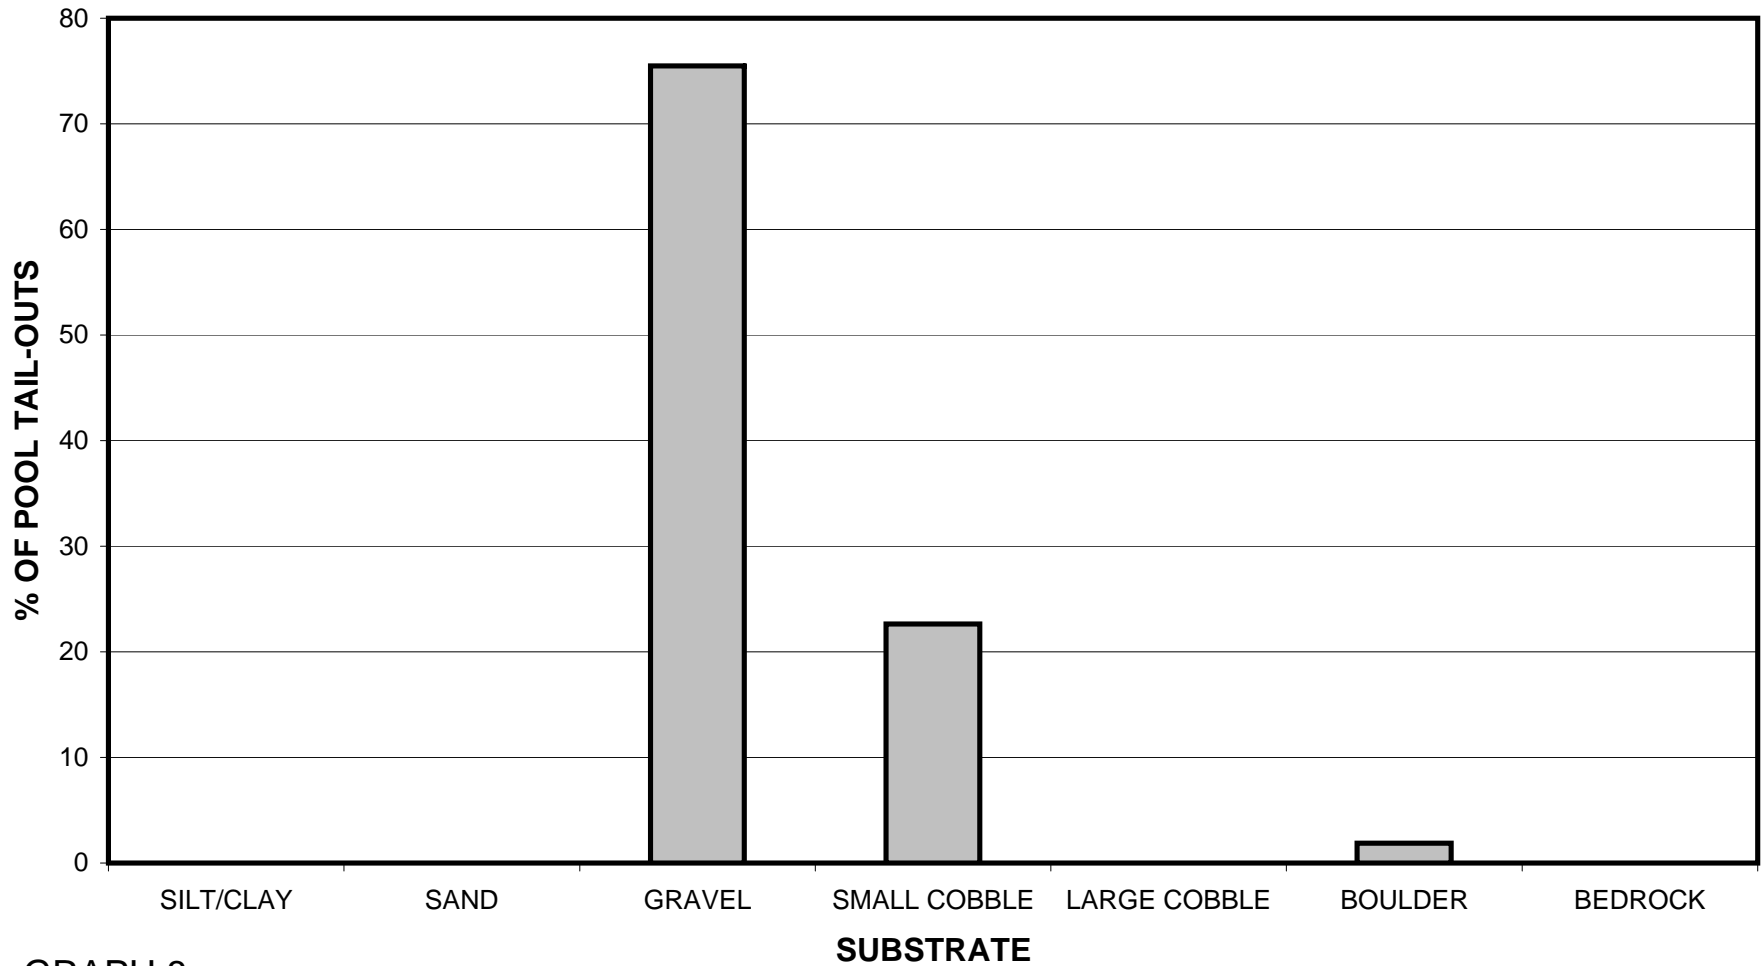
GRAPH 8

Table 6 summarizes the dominant substrate by habitat type. Graph 8 depicts the dominant substrate observed in pool tail-outs. Gravel was the dominant substrate observed in 75% of the pool tail-outs. Small cobble was the next most frequently observed dominant substrate type and occurred in 23% of the pool tail-outs

Fifty-two of the 53 pool tail-outs measured had gravel or small cobble as the dominant substrate. This is generally considered good for spawning salmonids.

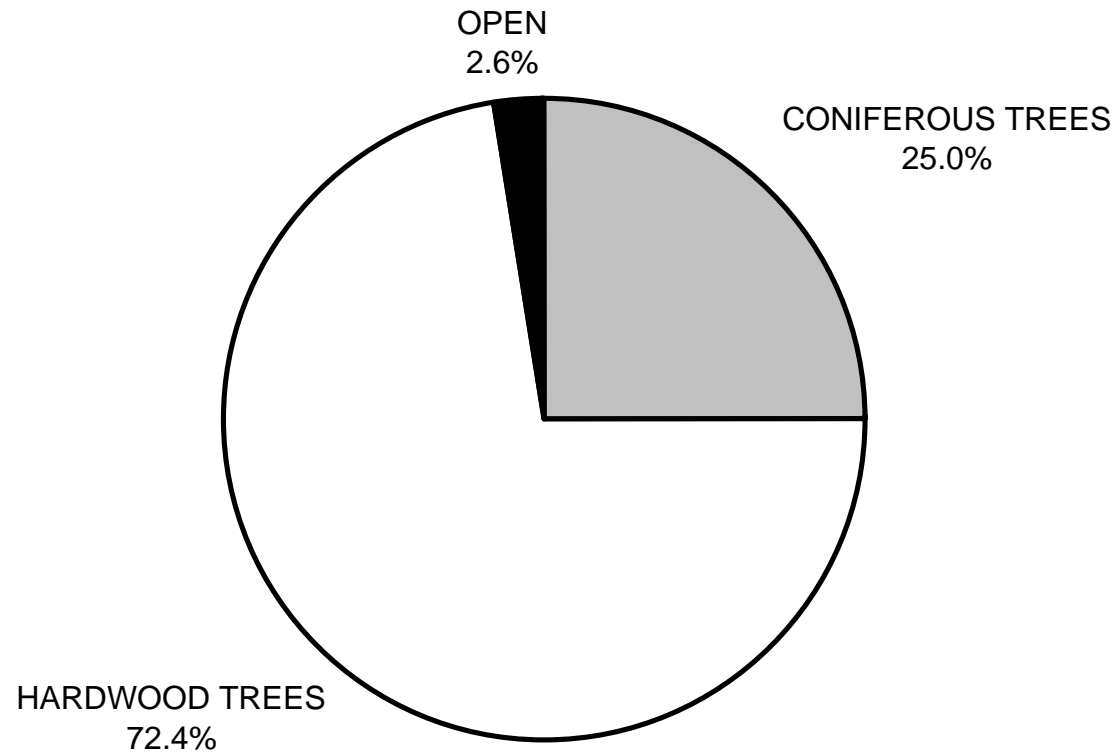
GRAPH 9

The mean percent canopy density for the surveyed length of Julias Creek was 97%. Three percent of the canopy was open. Of the canopy present, the mean percentages of hardwood and coniferous trees were 74% and 26%, respectively. Graph 9 describes the mean percent canopy in Julias Creek.

The mean percent canopy density for the stream was 97%. In general, revegetation projects are considered when canopy density is less than 80%.

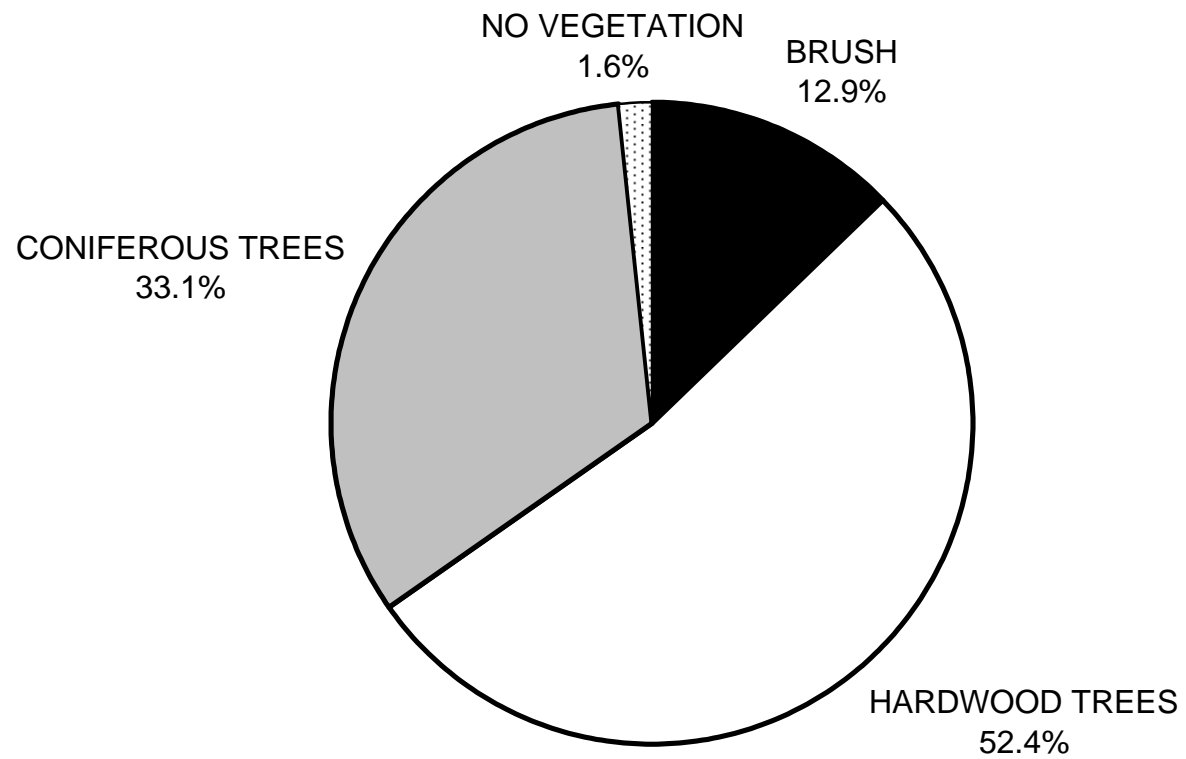
GRAPH 11

For the stream reach surveyed, the mean percent right bank vegetated was 95%. The mean percent left bank vegetated was 90%. The dominant elements composing the structure of the stream banks consisted of 89% sand/silt/clay, 6% cobble/gravel, and 5% bedrock (Graph 10). Hardwood trees were the dominant vegetation type observed in 52.4% of the units surveyed. Additionally, 33.1% of the units surveyed had coniferous trees as the dominant vegetation type (Graph 11). Hardwood trees were the dominant vegetation type observed in 52.4% of the units surveyed. Additionally, 33.1% of the units surveyed had coniferous trees as the dominant vegetation type (Graph 11).

The percentage of right and left bank covered with vegetation was 95% and 90%, respectively. In areas of stream bank erosion or where bank vegetation is sparse, planting endemic species of coniferous and hardwood trees, in conjunction with bank stabilization, is recommended.
