Stream Name: Sacramento River

Structure Owner: U.S. Bureau of Reclamation

Site Type: Dam

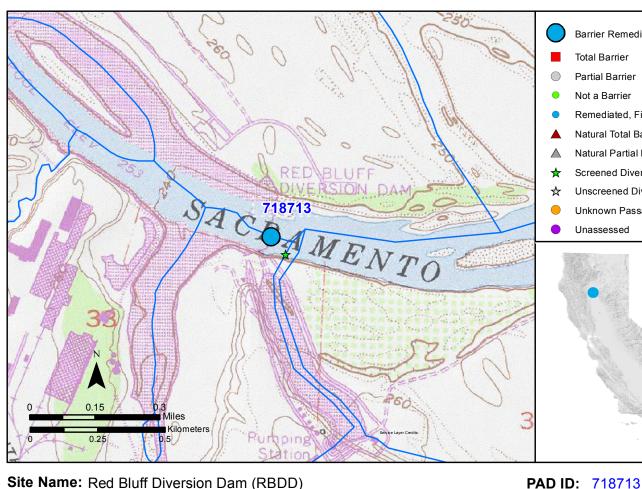
Notes: concrete structure 52 ft high, 740 ft long, with 11 gates and permanent fish ladders located in each abutment of the dam. Fish Passage Improvement Project approved, 2010-2012, to improve reliability to safely pass anadromous fish. Http://www.sacriver.org/aboutwatershed/roadmap/projects/red-bluff-diversion-damfish-passage-improvement. Gates are now raised year round since the summer of 2012. Passage status changed from 'partial' barrier to 'not a barrier'. The Tehama Colusa Canal Authority (TCCA) and the Bureau of Reclamation worked together to improve fish passage at RBDD. TCCA received American Recovery and Reinvestment Act funds to construct a positive barrier fish screen and a pumping plant, improving fish passage while maintaining delivery of irrigation water to the farmers.
