STREAM INVENTORY REPORT

Rail Creek

A stream inventory was conducted during May 6 to May 8, 2008 on Rail Creek. The survey began 349' upstream of the confluence with the Rail Creek reservoir and extended upstream 1.8 miles.

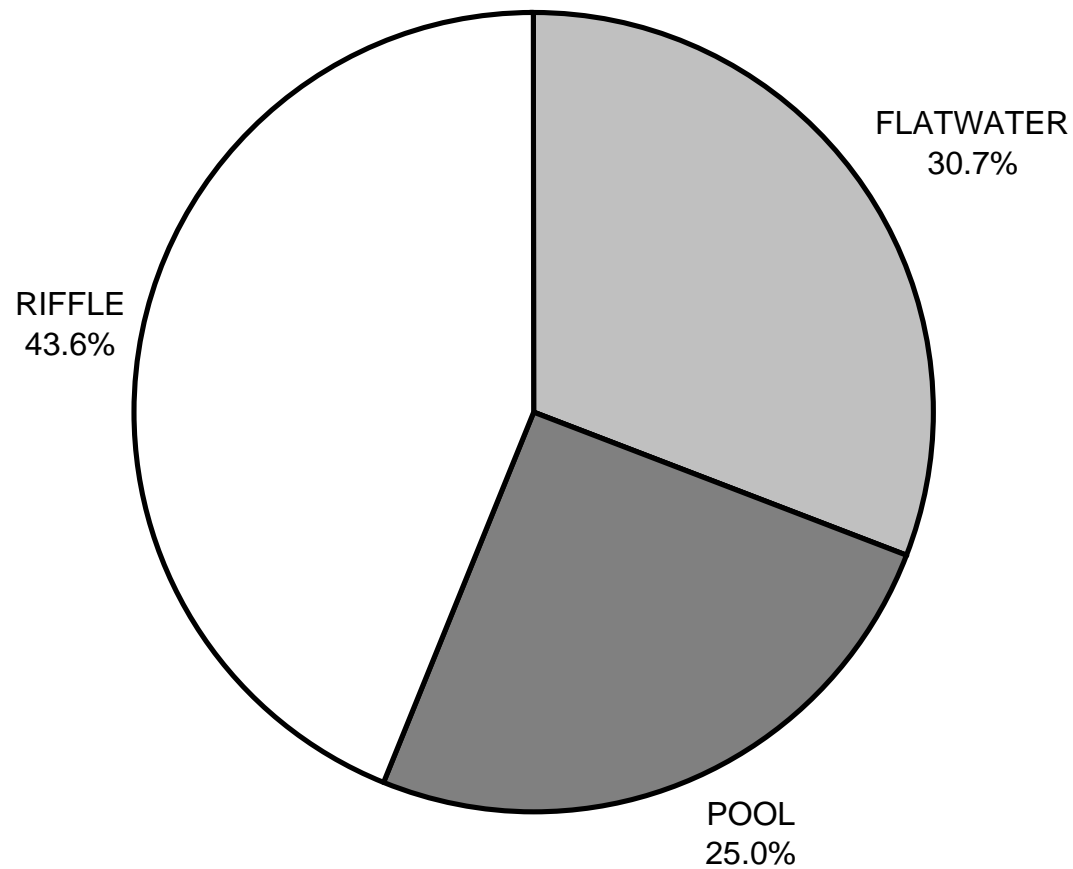
GRAPH 1

Table 1 summarizes the Level II riffle, flatwater, and pool habitat types. Based on frequency of occurrence there were 44% riffle units, 31% flatwater units and 25% pool units (Graph 1). Based on total length of Level II habitat types there were 55% riffle units, 33% flatwater units and 12% pool units (Graph 2).

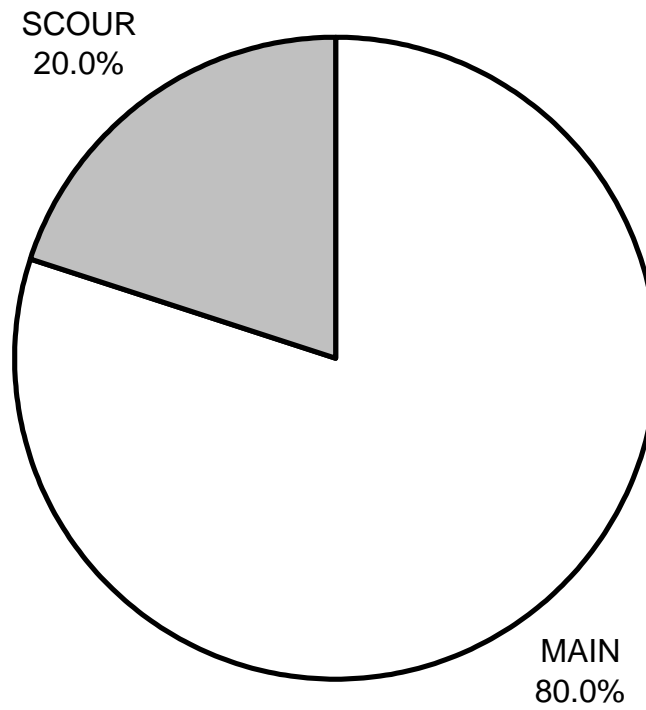
GRAPH 4

A total of 35 pools were identified (Table 3). Main channel pools were the most frequently encountered, at 80% (Graph 4), and comprised 78% of the total length of all pools (Table 3).

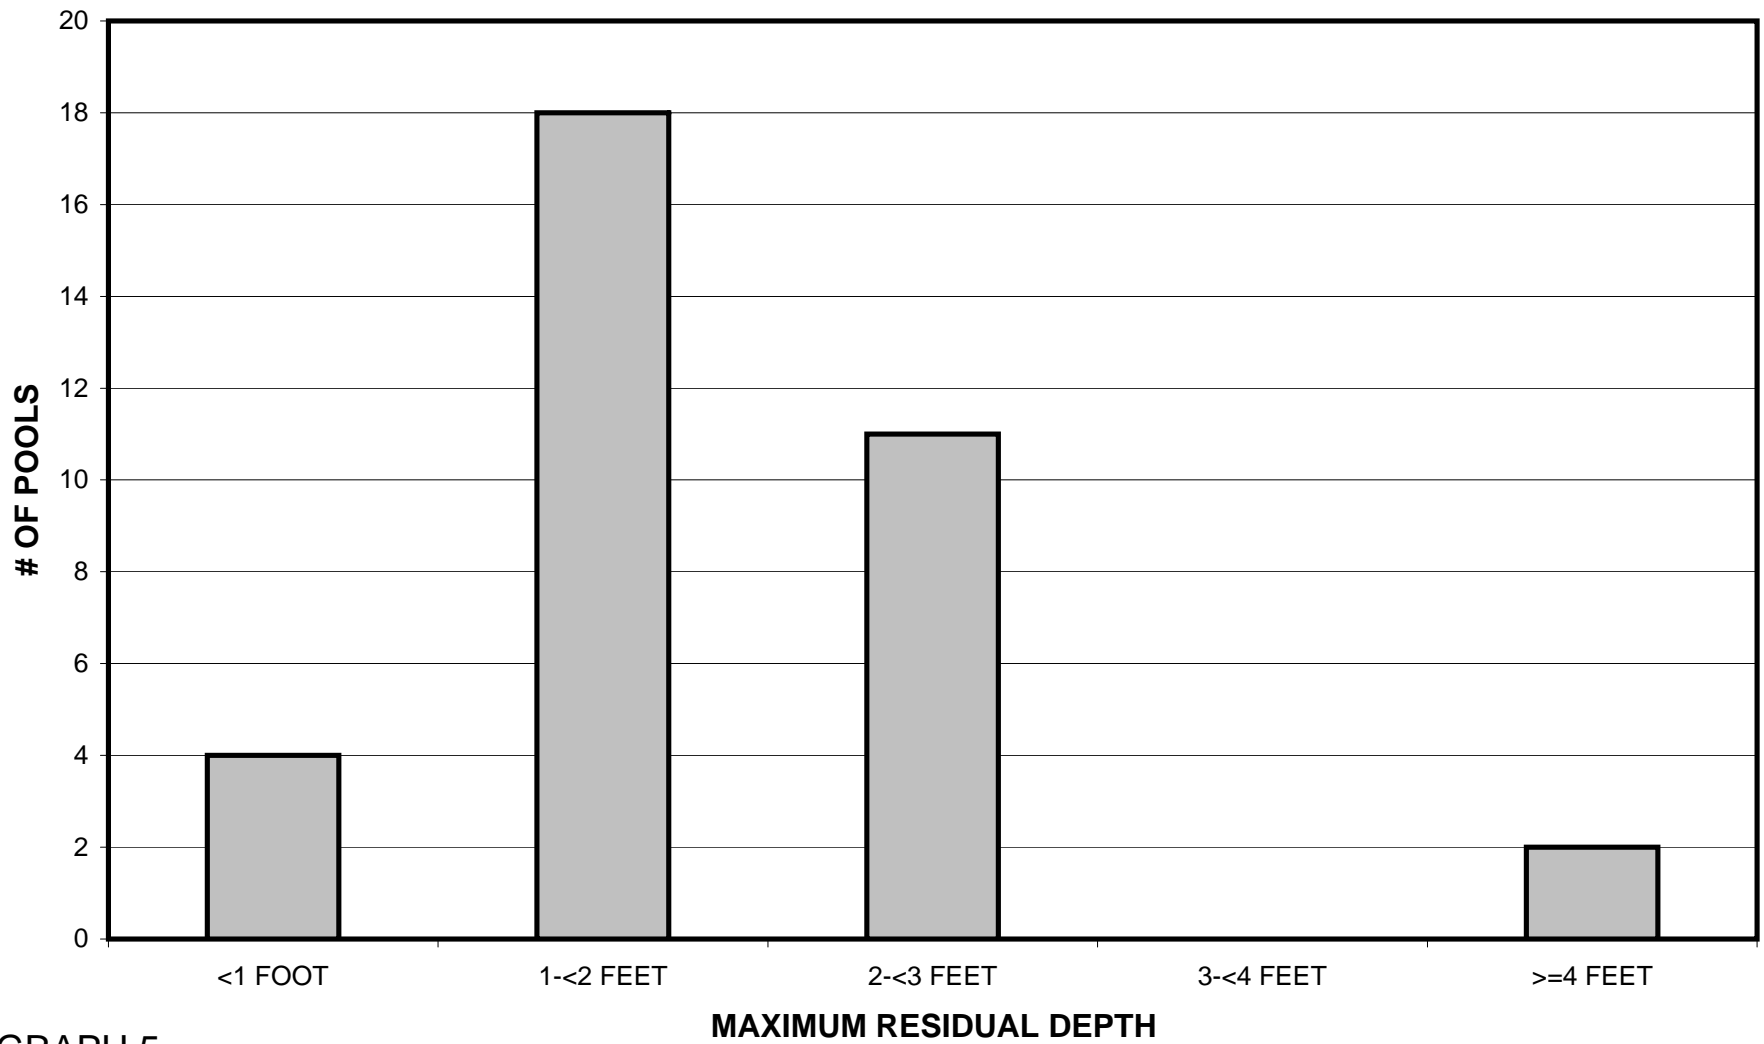
GRAPH 5

Table 4 is a summary of maximum residual pool depths by pool habitat types. Pool quality for salmonids increases with depth. Two of the 35 pools (6%) had a residual depth of three feet or greater (Graph 5).

Flatwater habitat types comprised 33% of the total length of this survey, riffles 55%, and pools 12%. The pools are relatively shallow, with only two of the 35 (6%) pools having a maximum residual depth greater than three feet. In general, pool enhancement projects are considered when primary pools comprise less than 40% of the length of total stream habitat. In third and fourth order streams, a primary pool is defined to have a maximum residual depth of at least three feet, occupy at least half the width of the low flow channel, and be as long as the low flow channel width. Installing structures that will increase or deepen pool habitat is recommended for locations where their installation will not be threatened by high stream energy, or where their installation will not conflict with the modification of the numerous log debris accumulations (LDA's) in the stream.

- 3) Where feasible, design and engineer pool enhancement structures to increase the number of pools. This must be done where the banks are stable or in conjunction with stream bank armor to prevent erosion.

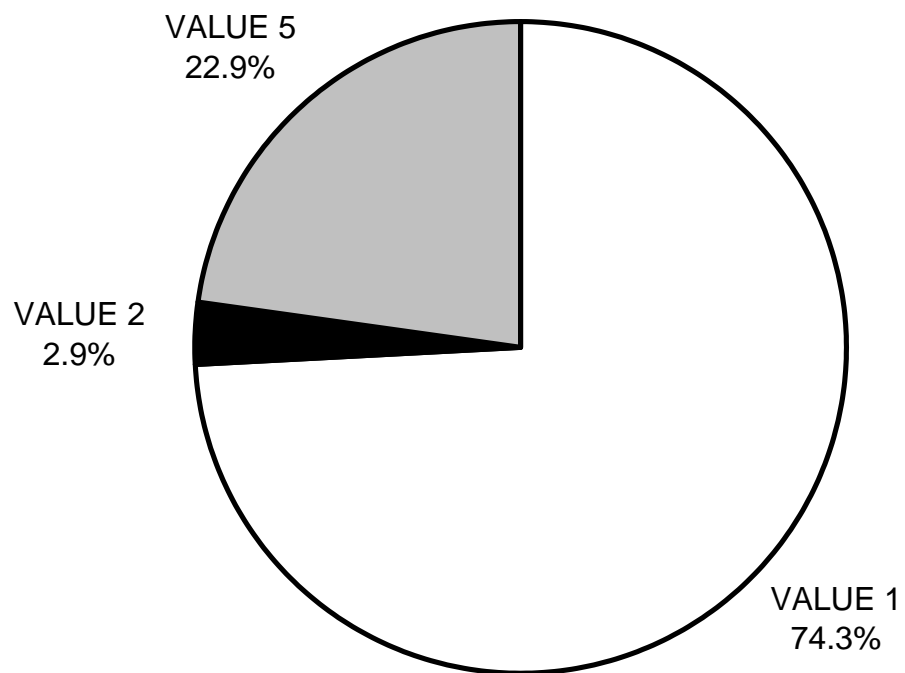
GRAPH 6

The depth of cobble embeddedness was estimated at pool tail-outs. Of the 35 pool tail-outs measured, 26 had a value of 1 (74.3%); one had a value of 2 (2.9%); eight had a value of 5 (22.9%) (Graph 6). On this scale, a value of 1 indicates the best spawning conditions and a value of 4 the worst. Additionally, a value of 5 was assigned to tail-outs deemed unsuited for spawning due to inappropriate substrate such as bedrock, log sills, boulders, or other considerations.

Twenty seven of the 35 pool tail-outs measured had embeddedness ratings of 1 or 2. None of the pool tail-outs had embeddedness ratings of 3 or 4. Eight of the pool tail-outs had a rating of 5, which is considered unsuitable for spawning. Cobble embeddedness measured to be 25% or less, a rating of 1, is considered to indicate good quality spawning substrate for salmon and steelhead. Sediment sources in Rail Creek should be mapped and rated according to their potential sediment yields, and control measures should be taken.

- 5) Inventory and map sources of stream bank erosion and prioritize them according to present and potential sediment yield. Identified sites should then be treated to reduce the amount of fine sediments entering the stream.

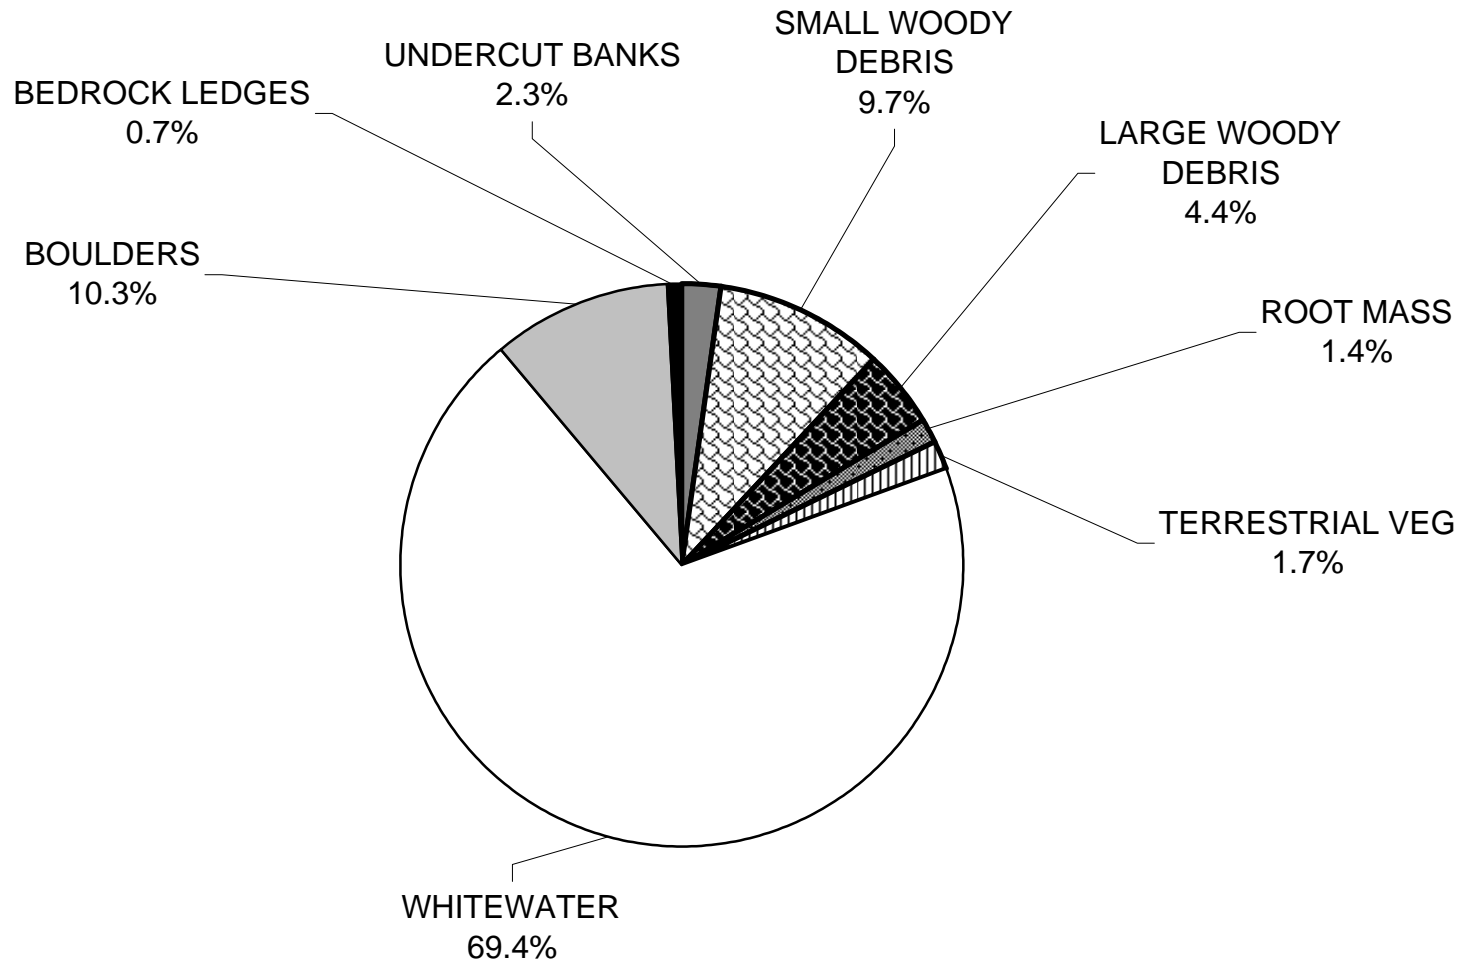
GRAPH 7

Table 5 summarizes mean percent cover by habitat type. Whitewater is the dominant cover types in Rail Creek. Graph 7 describes the pool cover in Rail Creek. Whitewater is the dominant pool cover type followed by boulders.

The mean shelter rating for pools was 55. The shelter rating in the flatwater habitats was 43. A pool shelter rating of approximately 100 is desirable. The amount of cover that now exists is being provided primarily by whitewater in Rail Creek. Whitewater is the dominant cover type in pools followed by boulders. Log and root wad cover structures in the pool and flatwater habitats would enhance both summer and winter salmonid habitat. Log cover structures provide rearing fry with protection from predation, rest from water velocity, and also divide territorial units to reduce density related competition.

- 4) Increase woody cover in the pools and flatwater habitat units. Most of the existing cover in the pools is from whitewater. Adding high quality complexity with woody cover in the pools is desirable.

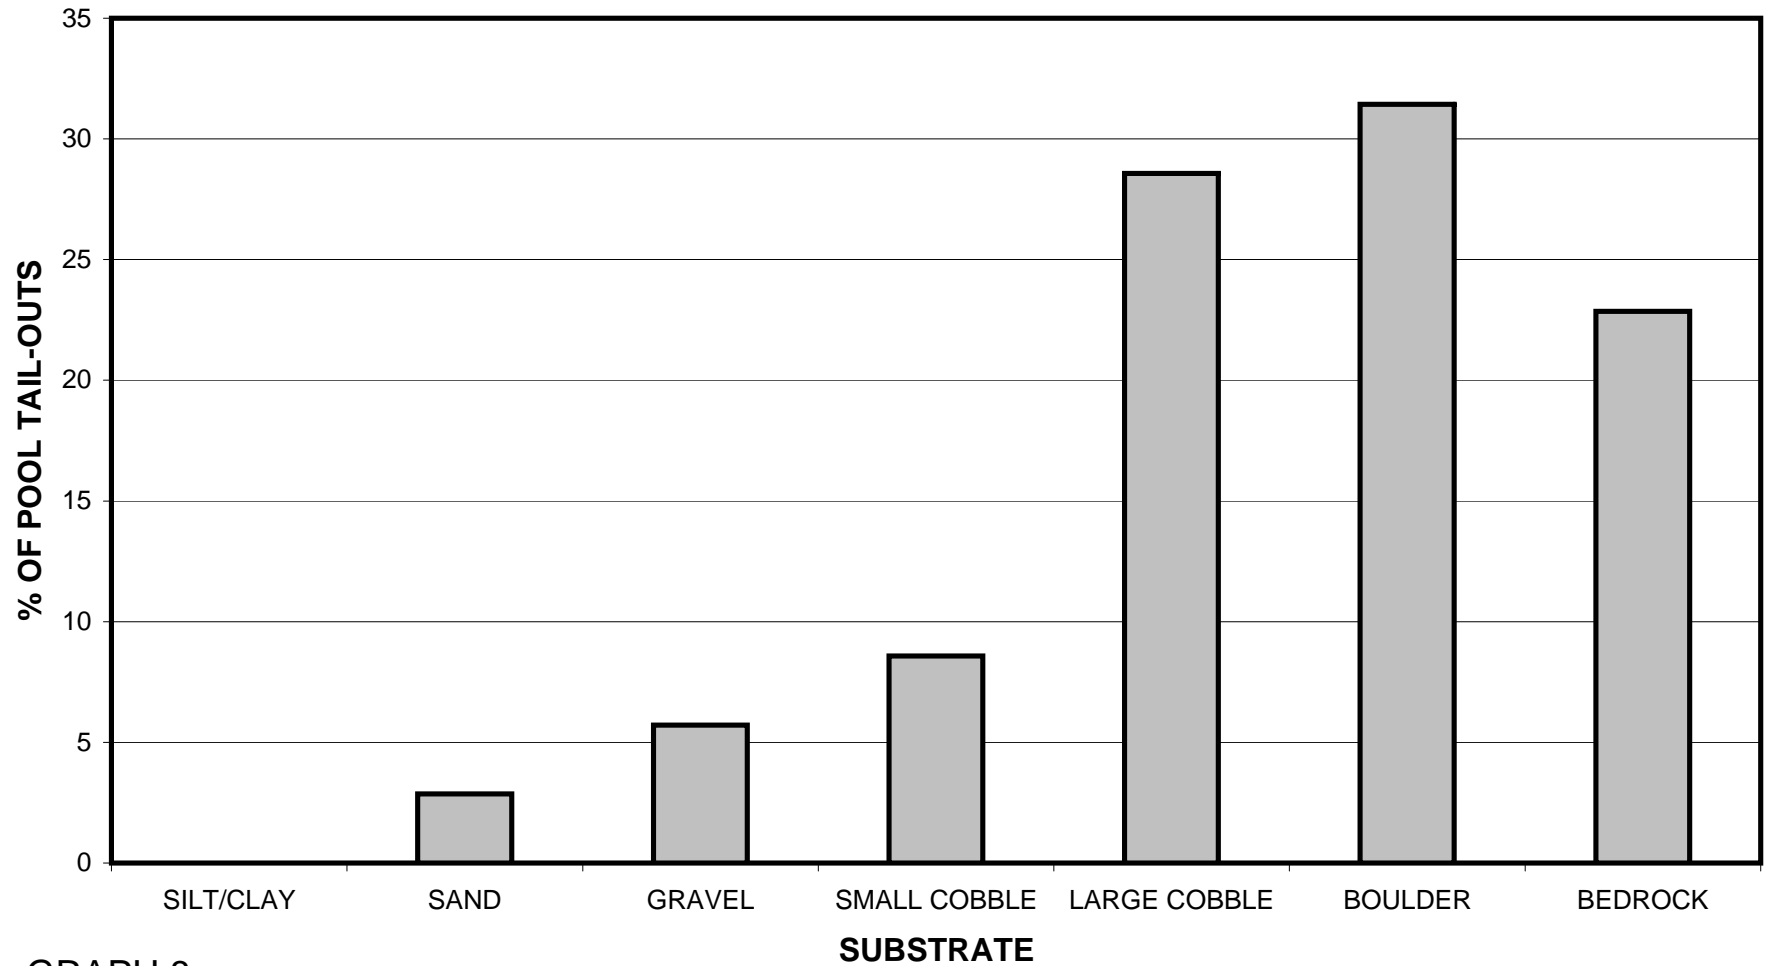
GRAPH 8

Table 6 summarizes the dominant substrate by habitat type. Graph 8 depicts the dominant substrate observed in pool tail-outs. Boulders were observed in 31% of pool tail-outs and large cobble observed in 29% of pool tail-outs.

Thirty of the 35 pool tail-outs had silt, sand, large cobble, boulders or bedrock as the dominant substrate. This is generally considered unsuitable for spawning salmonids.

- 8) Suitable size spawning substrate on Rail Creek is limited to relatively few reaches. Projects should be designed at suitable sites to trap and sort spawning gravel.

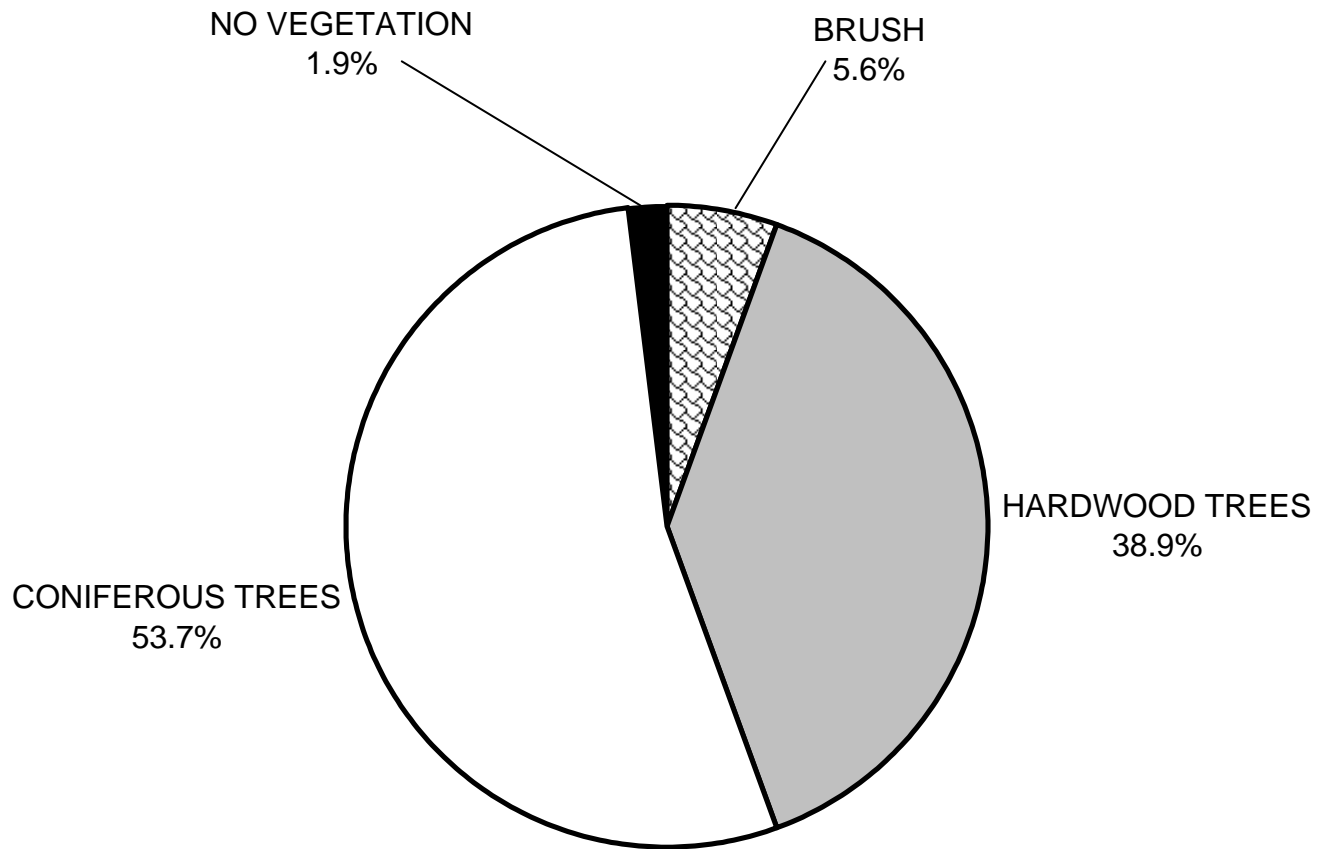
GRAPH 11

For the stream reach surveyed, the mean percent right bank vegetated was 88%. The mean percent left bank vegetated was 92%. The dominant elements composing the structure of the stream banks consisted of 44% sand/silt/clay, 34% cobble/gravel, 16% bedrock and 6% boulders, (Graph 10). Coniferous trees were the dominant vegetation type observed in 54% of the units surveyed. Additionally, 39% of the units surveyed had hardwood trees as the dominant vegetation type, 6% had brush and 2% had no vegetation (Graph 11).

The percentage of right and left bank covered with vegetation was 88% and 92% respectively. In areas of stream bank erosion or where bank vegetation is sparse, planting endemic species of coniferous and hardwood trees, in conjunction with bank stabilization, is recommended.
