**California Department of Fish and Game**  
**Sonoma Coast Watershed**  
**Stream Habitat Assessment Reports**  
**Furlong Gulch**

## **STREAM INVENTORY REPORT**

### **Furlong Gulch**

*Assessment Completed July 2008*

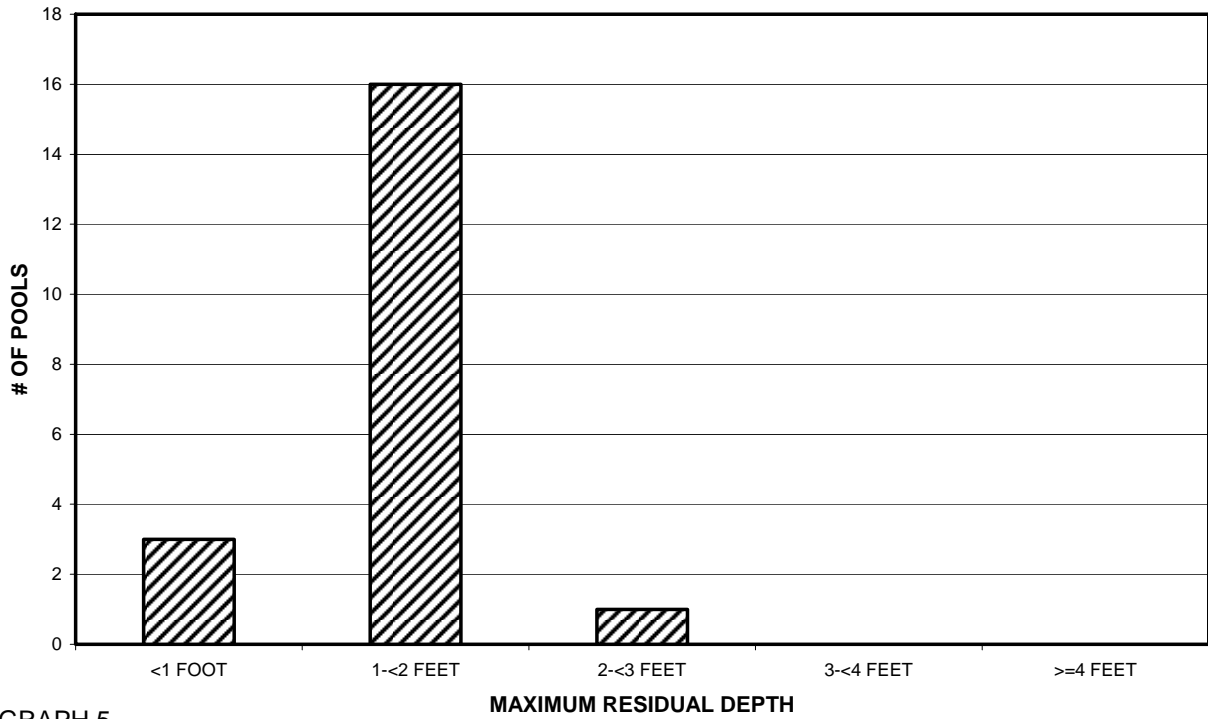
GRAPH 5

Table 4 is a summary of maximum residual pool depths by pool habitat types. Pool quality for salmonids increases with depth. One of the 20 pools (5%) had a residual depth of two feet or greater (Graph 5).

Flatwater habitat types comprised 14% of the total length of this survey, riffles 4%, and pools 11%. The pools are relatively shallow, with only 1 of the 20 (5%) pools having a maximum residual depth greater than 2 feet. In general, pool enhancement projects are considered when primary pools comprise less than 40% of the length of total stream habitat. In first and second

5. Where feasible, design and engineer pool enhancement structures to increase the number of pools. This must be done where the banks are stable or in conjunction with stream bank armor to prevent erosion.

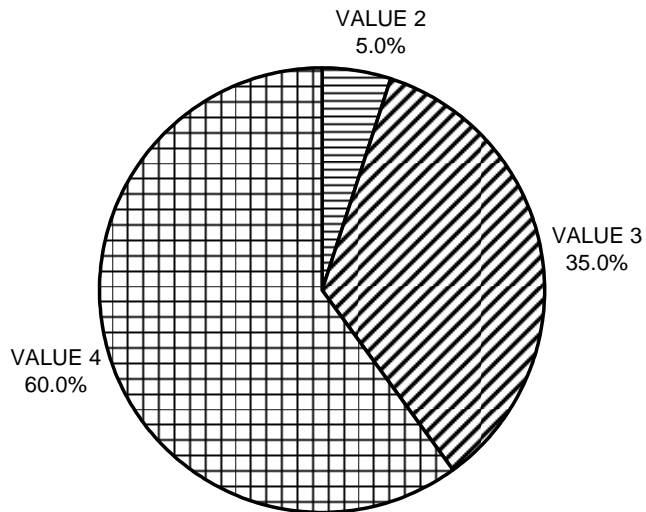
GRAPH 6

The depth of cobble embeddedness was estimated at pool tail-outs. Of the 20 pool tail-outs measured, 1 had a value of 2 (5%); 7 had a value of 3 (35%); and 12 had a value of 4 (60%), (Graph 6). On this scale, a value of 1 indicates the best spawning conditions and a value of 4 the worst. Additionally, a value of 5 was assigned to tail-outs deemed unsuited for spawning due to inappropriate substrate such as bedrock, log sills, boulders, or other considerations.

One of the 20 pool tail-outs measured had embeddedness ratings of 1 or 2. Nineteen of the pool tail-outs had embeddedness ratings of 3 or 4. None of the pool tail-outs had a rating of 5, which is considered unsuitable for spawning. Cobble embeddedness measured to be 25% or less, a rating of 1, is considered to indicate good quality spawning substrate for salmon and steelhead. Sediment sources in Furlong Gulch should be mapped and rated according to their potential sediment yields, and control measures should be taken.

1. Active and potential sediment sources related to the road system need to be identified, mapped, and treated according to their potential for sediment yield to the stream and its tributaries.

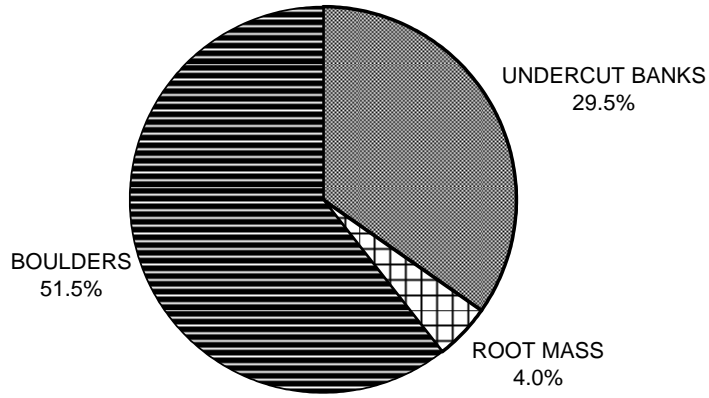
GRAPH 7

Table 5 summarizes mean percent cover by habitat type. Boulders are the dominant cover types in Furlong Gulch. Graph 7 describes the pool cover in Furlong Gulch. Boulders are the dominant pool cover type followed by undercut banks.

The mean shelter rating for pools was 3. The shelter rating in the flatwater habitats was 0. A pool shelter rating of approximately 100 is desirable. The amount of cover that now exists is being provided primarily by Boulders in Furlong Gulch. Boulders are the dominant cover type in pools followed by undercut banks. Log and root wad cover structures in the pool and flatwater habitats would enhance both summer and winter salmonid habitat. Log cover structure provides rearing fry with protection from predation, rest from water velocity, and also divides territorial units to reduce density related competition.

2. Increase woody cover in the pools and flatwater habitat units. Most of the existing cover in the pools is from boulders. Adding high quality complexity with woody cover in the pools is desirable.

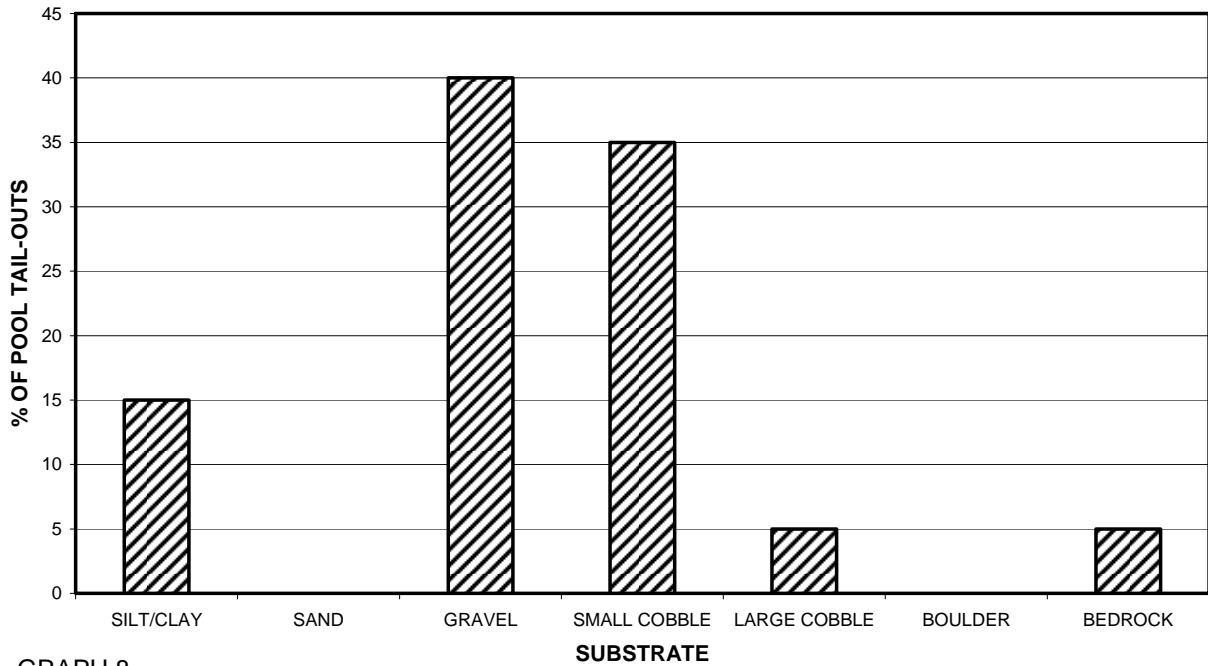
GRAPH 8

Table 6 summarizes the dominant substrate by habitat type. Graph 8 depicts the dominant substrate observed in pool tail-outs. Gravel was observed in 40% of pool tail-outs, and small Cobble was observed in 35% of pool tail-outs.

Fifteen of the 20 pool tail-outs measured had gravel or small cobble as the dominant substrate. This is generally considered good for spawning salmonids.

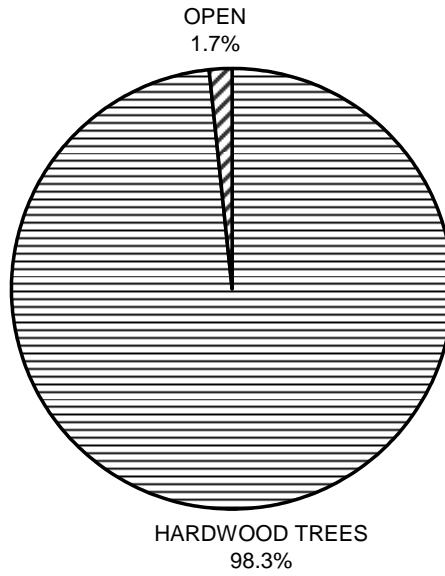
GRAPH 9

The mean percent canopy density for the surveyed length of Furlong Gulch was 98%. The mean percentages of hardwood and coniferous trees were 100% and 0%, respectively. Two percent of the canopy was open. Graph 9 describes the mean percent canopy in Furlong Gulch.

The mean percent canopy density for the stream was 98%. In general, revegetation projects are considered when canopy density is less than 80%.
