**CALIFORNIA DEPARTMENT OF FISH AND GAME  
STREAM INVENTORY REPORT**

Mill Creek

Report revised April 14, 2006

*Assessment Completed 2001*

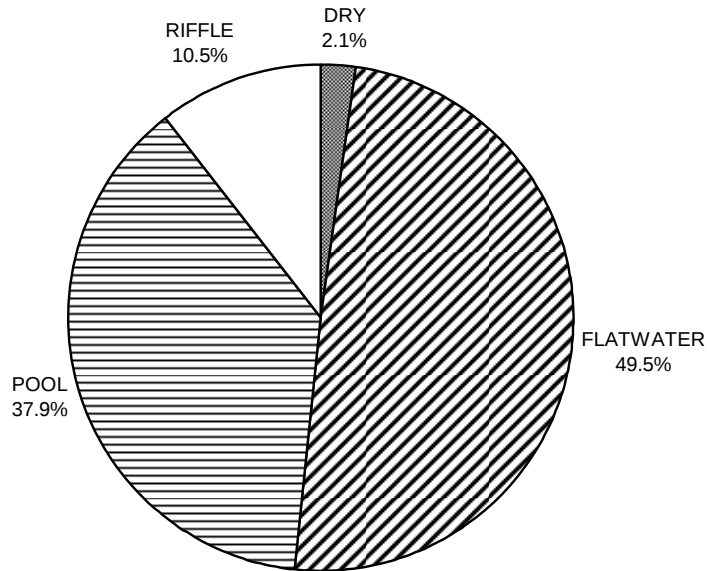
GRAPH 1

Table 1 summarizes the Level II riffle, flatwater, and pool habitat types. Based on frequency of *occurrence* there were 49.5% Flatwater units, 37.9% Pool units, 10.5% Riffle units and 2.1% Dry units (Graph 1). Based on total *length* there were 62.5% Dry units, 27.8% Flatwater units, 7.2% Pool units and 2.5% Riffle units (Table 1).

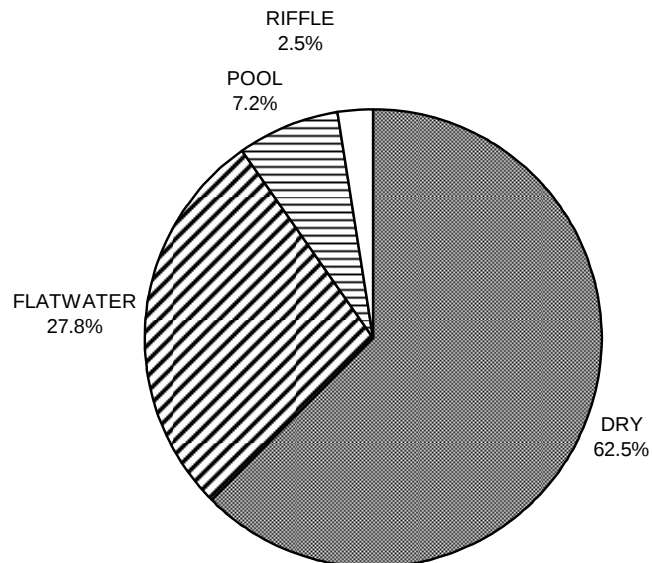
GRAPH 2

types were identified. The data is summarized in Table 2. The most frequent habitat types by percent *occurrence* were Run at 27%, Mid-Channel Pool at 21%, and Step Run at 16%. By percent total *length*, Dry at 63%, Flatwater at 27.8%, and Pool at 7.2% (Graph 2).

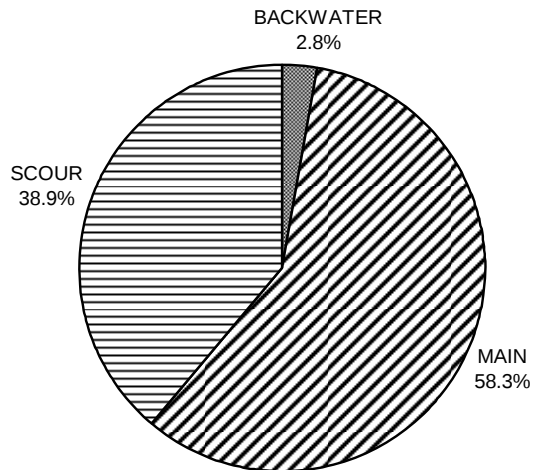
GRAPH 4

Thirty-six pools were identified (Table 3). Mid-Channel Pool pools were most often encountered at 58% (Graph 4), and comprised 68% of the total length of pools.

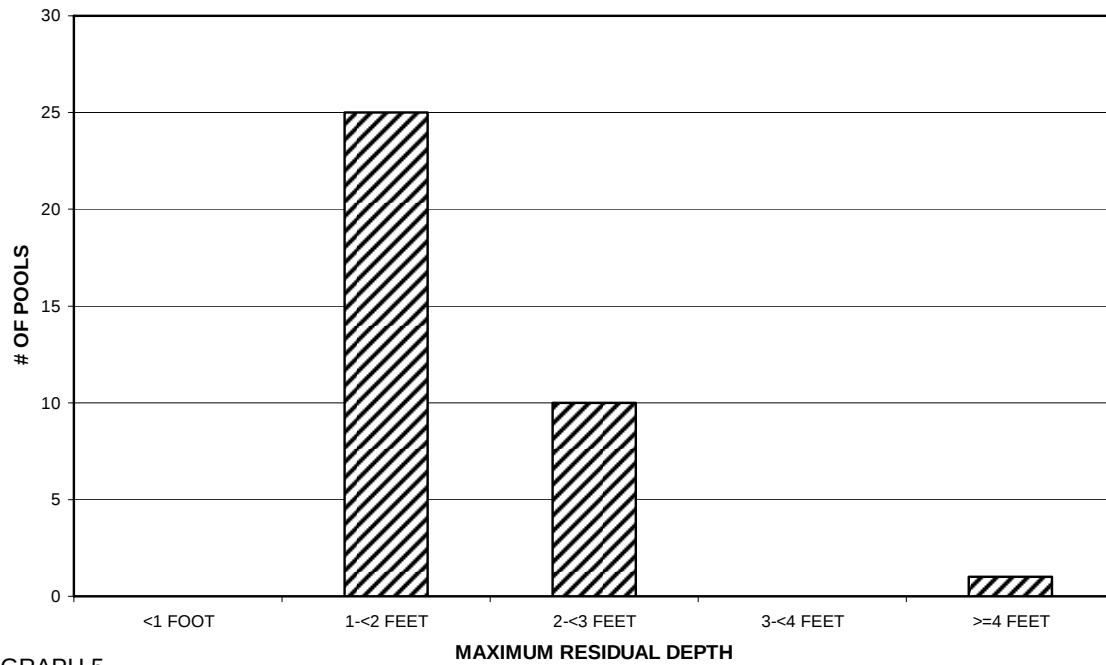
GRAPH 5

One of the 36 pools (3%) had a depth of three feet or greater (Graph 5). These deeper pools comprised 2% of the total length of stream habitat.

Pools comprised 7% of the total length of this survey. In third and fourth order streams a primary pool is defined to have a maximum depth of at least three feet, occupy at least half the width of the low flow channel, and be as long as the low flow channel width. In Mill Creek, the pools are relatively shallow with 3% having a maximum depth of at least three feet. These pools comprised

2% of the total length of stream habitat. In coastal coho and steelhead streams, it is generally desirable to have primary pools comprise approximately 50% of total habitat length.

- 3) Where feasible, design and engineer pool enhancement structures to increase the number of pools in both reaches. This must be done where the banks are stable or in conjunction with stream bank stabilization to prevent erosion.

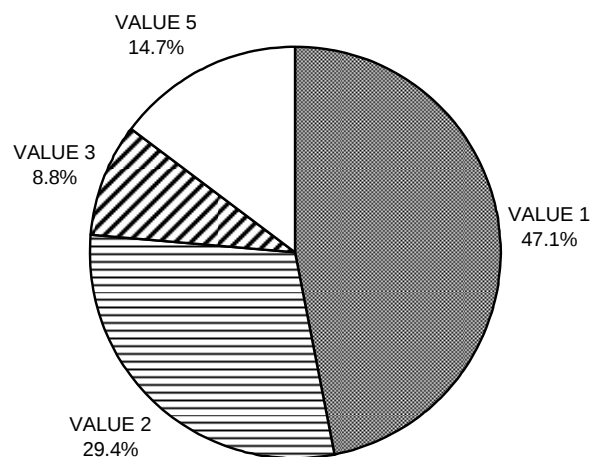
GRAPH 6

The depth of cobble embeddedness was estimated at pool tail-outs. Of the 35 pool tail-outs measured, 17 had a value of 1 (49%), ten had a value of 2 (29%) and three had a value of 3 (9%). Five (14%) riffles rated a 5 (unsuitable substrate type for spawning). On this scale, a value of one is best for fisheries. Gravel was the dominant substrate observed at pool tail-outs. Graph 6 describes percent embeddedness, and Graph 8 describes the dominant substrate in pool tail outs.

Nine percent of the pool tail-outs measured had embeddedness ratings of either 3 or 4. Forty-six percent had a rating of 1. Cobble embeddedness measured to be 25% or less (a rating of 1) is considered best for the needs of salmon and steelhead.

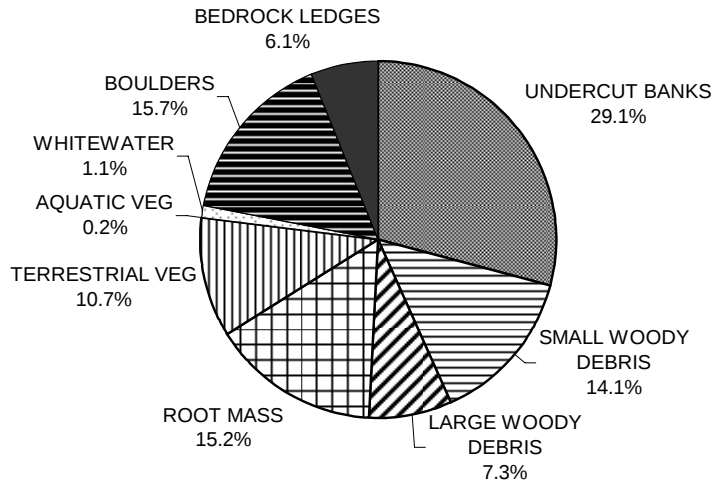
GRAPH 7

Table 5 summarizes fish shelter by habitat type. By percent area, the dominant pool shelter types were Undercut Banks at 29%, Boulders at 16%, and Root Mass at 15%. Graph 7 describes the pool shelter in Mill Creek.

The mean shelter rating for pools was 25. However, a pool shelter rating of approximately 80 is desirable. The relatively small amount of pool shelter that now exists is being provided primarily by Undercut Banks at 27%, Large Wood at 17%, Small Wood at 15%, Boulders at 13% and Root Mass at 13%. Log and root wad cover in the pool and flatwater habitats would improve both summer and winter salmonid habitat. Log cover provides rearing fry with protection from predation, rest from water velocity, and also divides territorial units to reduce density related competition.

- 2) Where feasible, increase woody cover in the pool and flatwater habitat units along the entire stream. Adding high quality complexity with larger woody cover is desirable. Combination cover/scour structures constructed with boulders and woody debris would be effective in many flatwater and pool locations in the upper reaches. This must be done where the banks are stable or in conjunction with stream bank stabilization to prevent erosion.

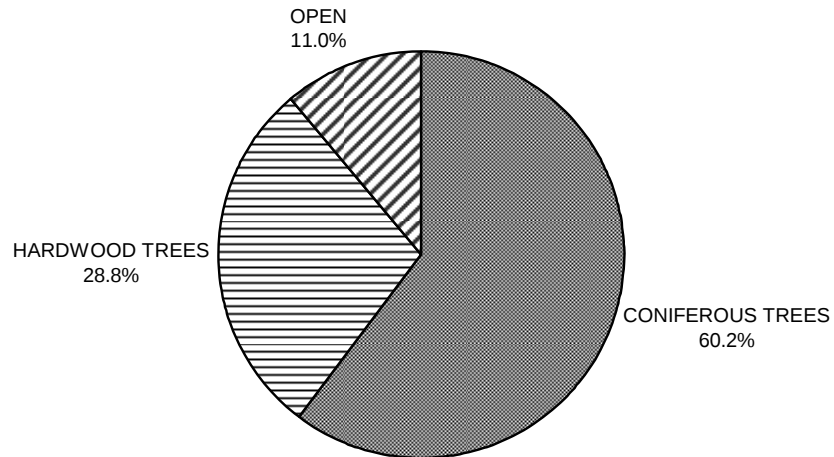
GRAPH 9

The mean percent canopy density for the stream reach surveyed was 89%. The mean percentages of deciduous and evergreen trees were 32% and 68%, respectively (Table 7). Graph 9 describes the canopy for the entire survey and Table 8 describes the canopy by reach.

The mean percent canopy for the survey was 89%. This is a high percentage of canopy, since at least 80 percent is generally considered desirable.

- 4) Increase the canopy on Mill Creek by planting willow, alder, redwood, and Douglas fir along the stream where shade canopy is not at acceptable levels (portions of Reach 1). Near-stream riparian planting along any portion of the stream should be encouraged to provide bank stability and a buffering against agricultural, grazing and urban runoff.

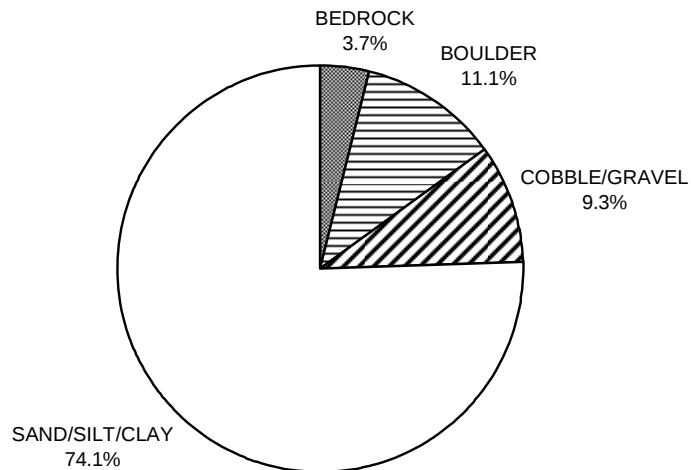
GRAPH 10

For the entire stream reach surveyed, the mean percent of the right and left bank vegetated was 92% each (Table 9). For the habitat units measured, the dominant vegetation types for the stream banks were: 48% Brush, 32% Evergreen Trees, and 8% Bare Soil. (Graph 8) The dominant substrate for the stream banks were: 74% Silt, Clay & Sand, 11% Boulder, 9% Cobble & Gravel and 4% Bedrock (Graph 10).
