**Arana Gulch Watershed Enhancement
Plan Phase 1:
Steelhead and Sediment Assessments,
Santa Cruz County, California**

February 2002

Balance Project Assignment 99005.08

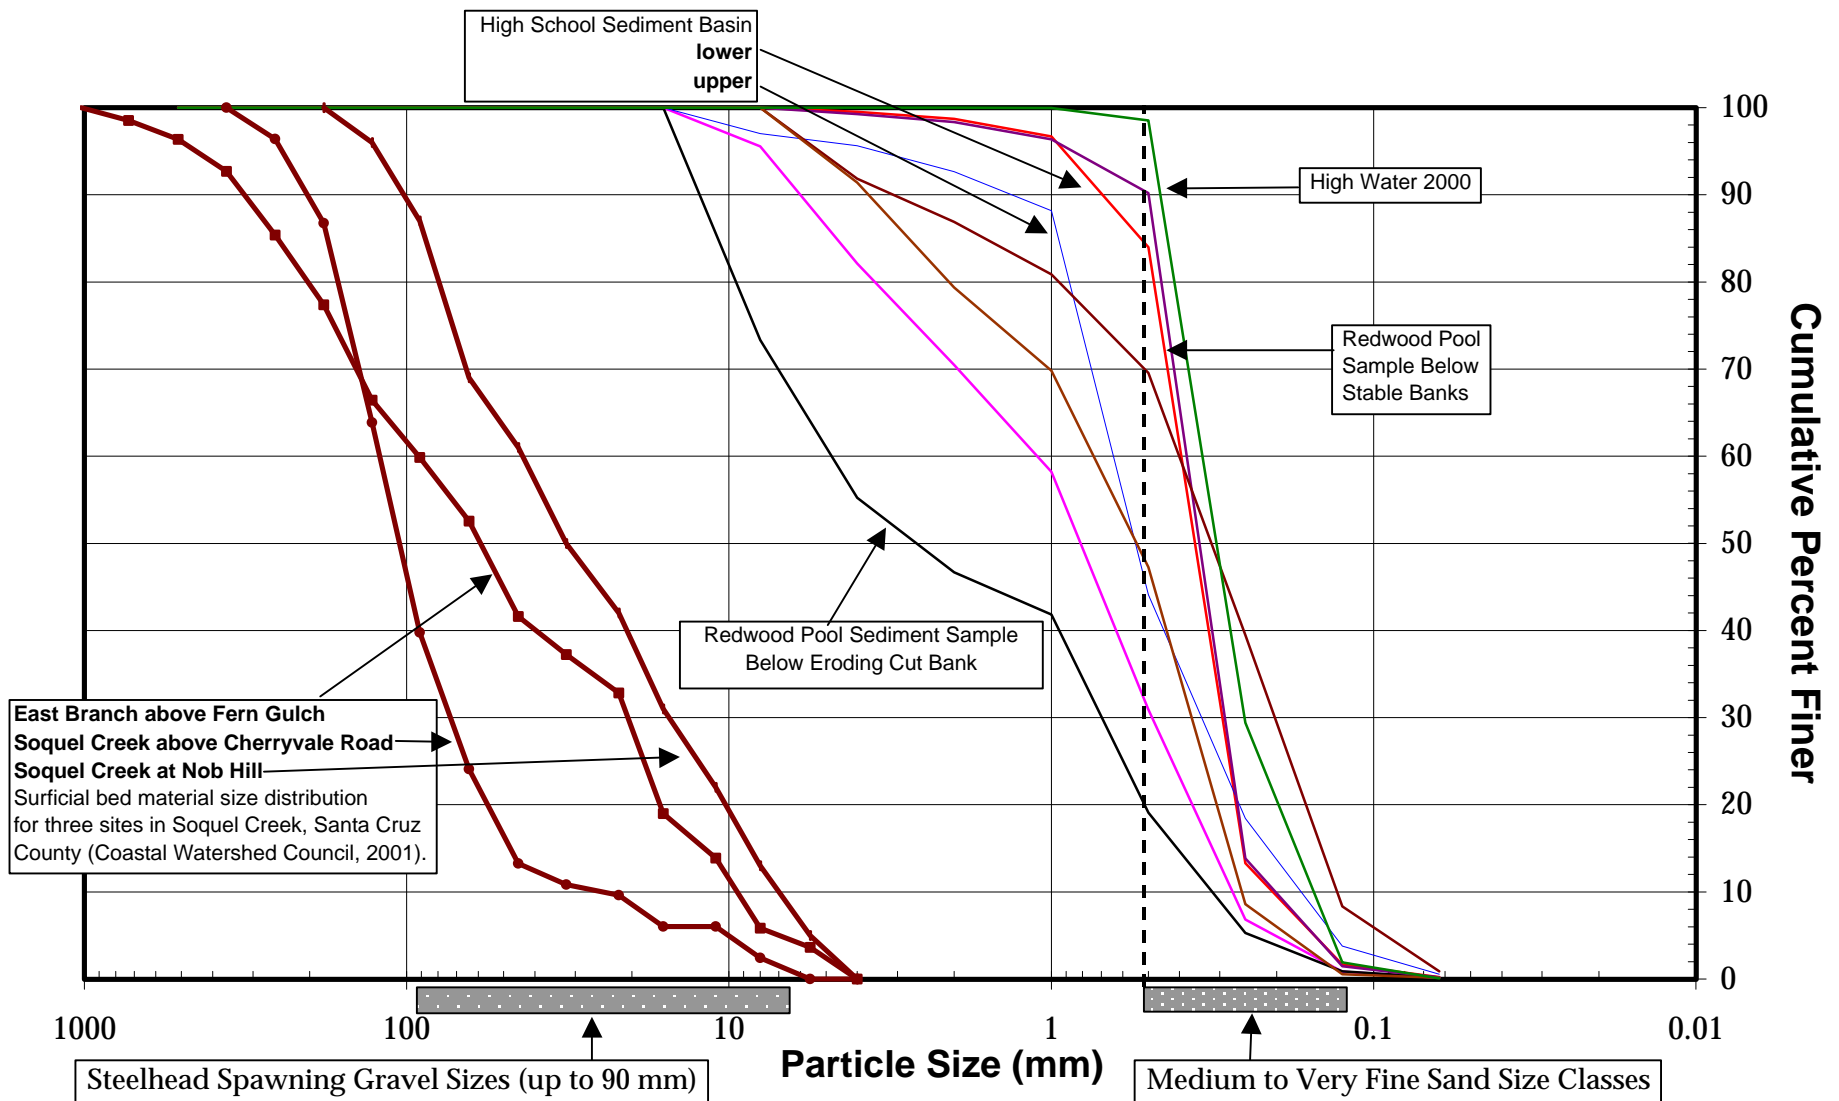
Figure ES-2: Particle-size distribution of sediment samples from the channel and high water marks of Arana Gulch.

Note that the 50 percentile for 6 out of 8 samples falls within or near the medium to fine sand class sizes and that sizes needed for steelhead spawning were found in only three samples, one being situated below an eroding road bank. Three samples collected from nearby Soquel Creek are shown for comparison. The size distribution curves illustrate that the coarsest material found in Arana corresponds to the finest size fractions sampled in Soquel Creek

Sand-sized sediment fills almost all pools, holes, and other resting places in Arana Gulch from the headwaters to the mouth at the Santa Cruz Small Craft Harbor (**Figure ES-2**). Further, riffles throughout the creek are mantled with sand. In part, the sand is intrinsic to the stream, since Arana Gulch has evolved in a sandy geologic environment; however, the extent to which sand overwhelms pools and riffles in this stream system is probably much greater than usually prevailed under natural conditions. The underlying sandstones and siltstones (Purisima Formation), as well as unconsolidated terrace deposits tend to weather to sand and silt, with very little gravel- or cobble-sized debris. Silts and clays tend to wash rapidly through this relatively short, steep watershed, leaving significant volumes of sand for the stream either to (a) transport to Monterey Bay or (b) store in its channel or floodplain.² Channel reaches situated below logjams and culverts on the eastern, central and western branches of Arana Gulch do contain gravel and cobbles, often buried beneath a foot or more of sandy sediments. For these coarser materials to provide spawning or rearing habitat, the volume of sand in the stream will need to be curtailed. The volumes of sand in the channel have been growing since the watershed has been settled, grazed, farmed, and cleared, and as the networks of roads, paths, and gullies expand. As long as the sandstone canyons are occupied, well-planned stewardship of the streams can help offset the effects of these uses.

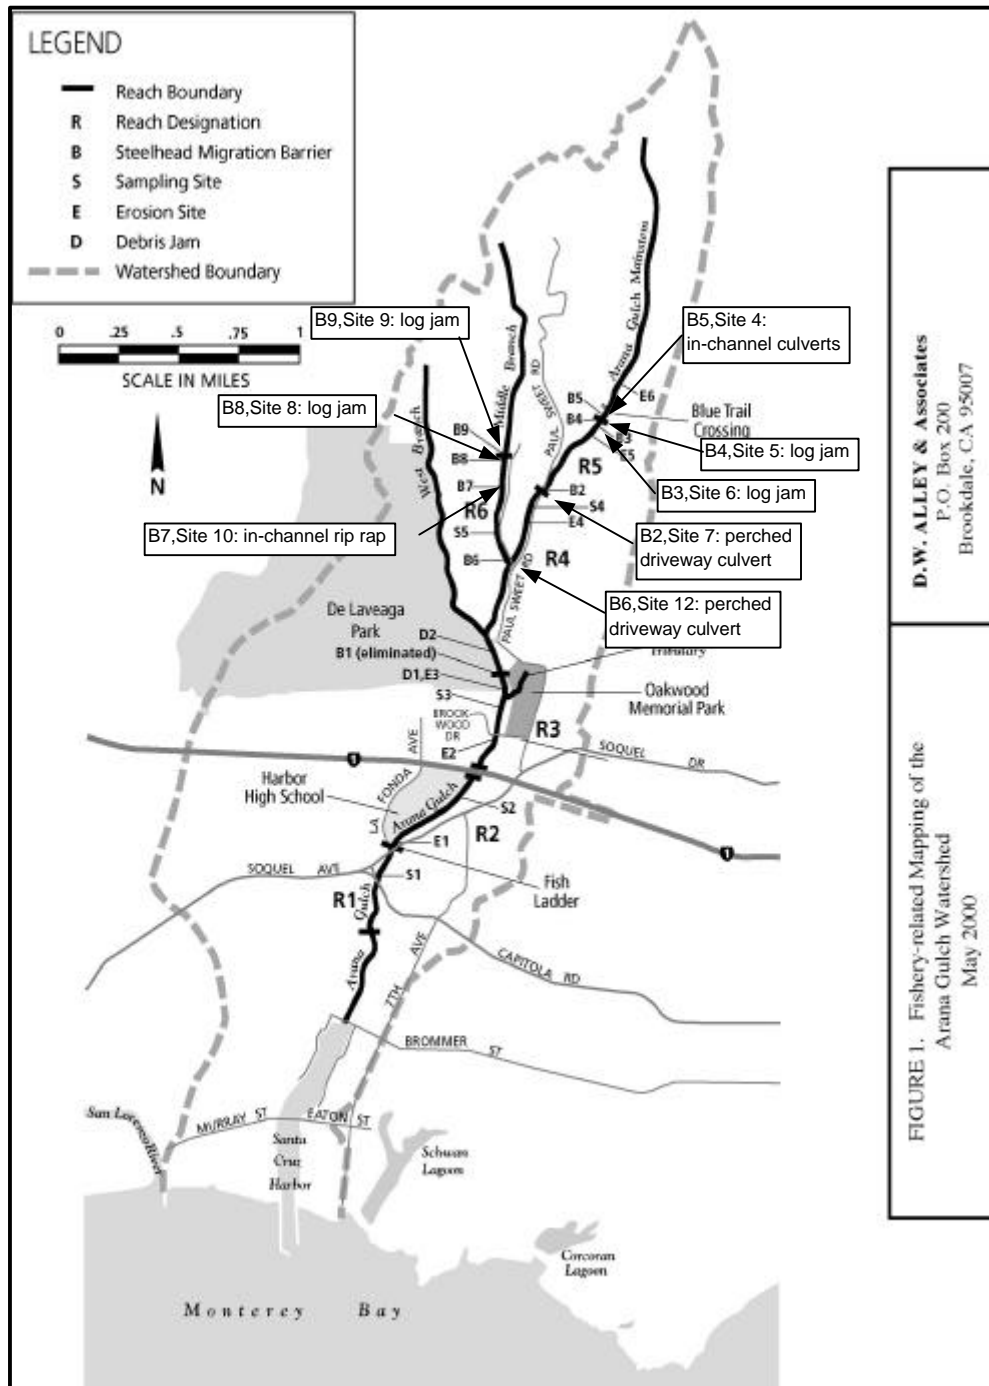
Figure 4.1: Arana Gulch watershed with the locations of fish passage barriers, fish sampling sites and erosion sites noted.

Channel reaches as defined for the fisheries assessment are shown. Site numbers corresponding to the Chapters 4 and 7 are also given. Map borrowed from Alley (2000). Text boxes added by Balance Hydrologics.

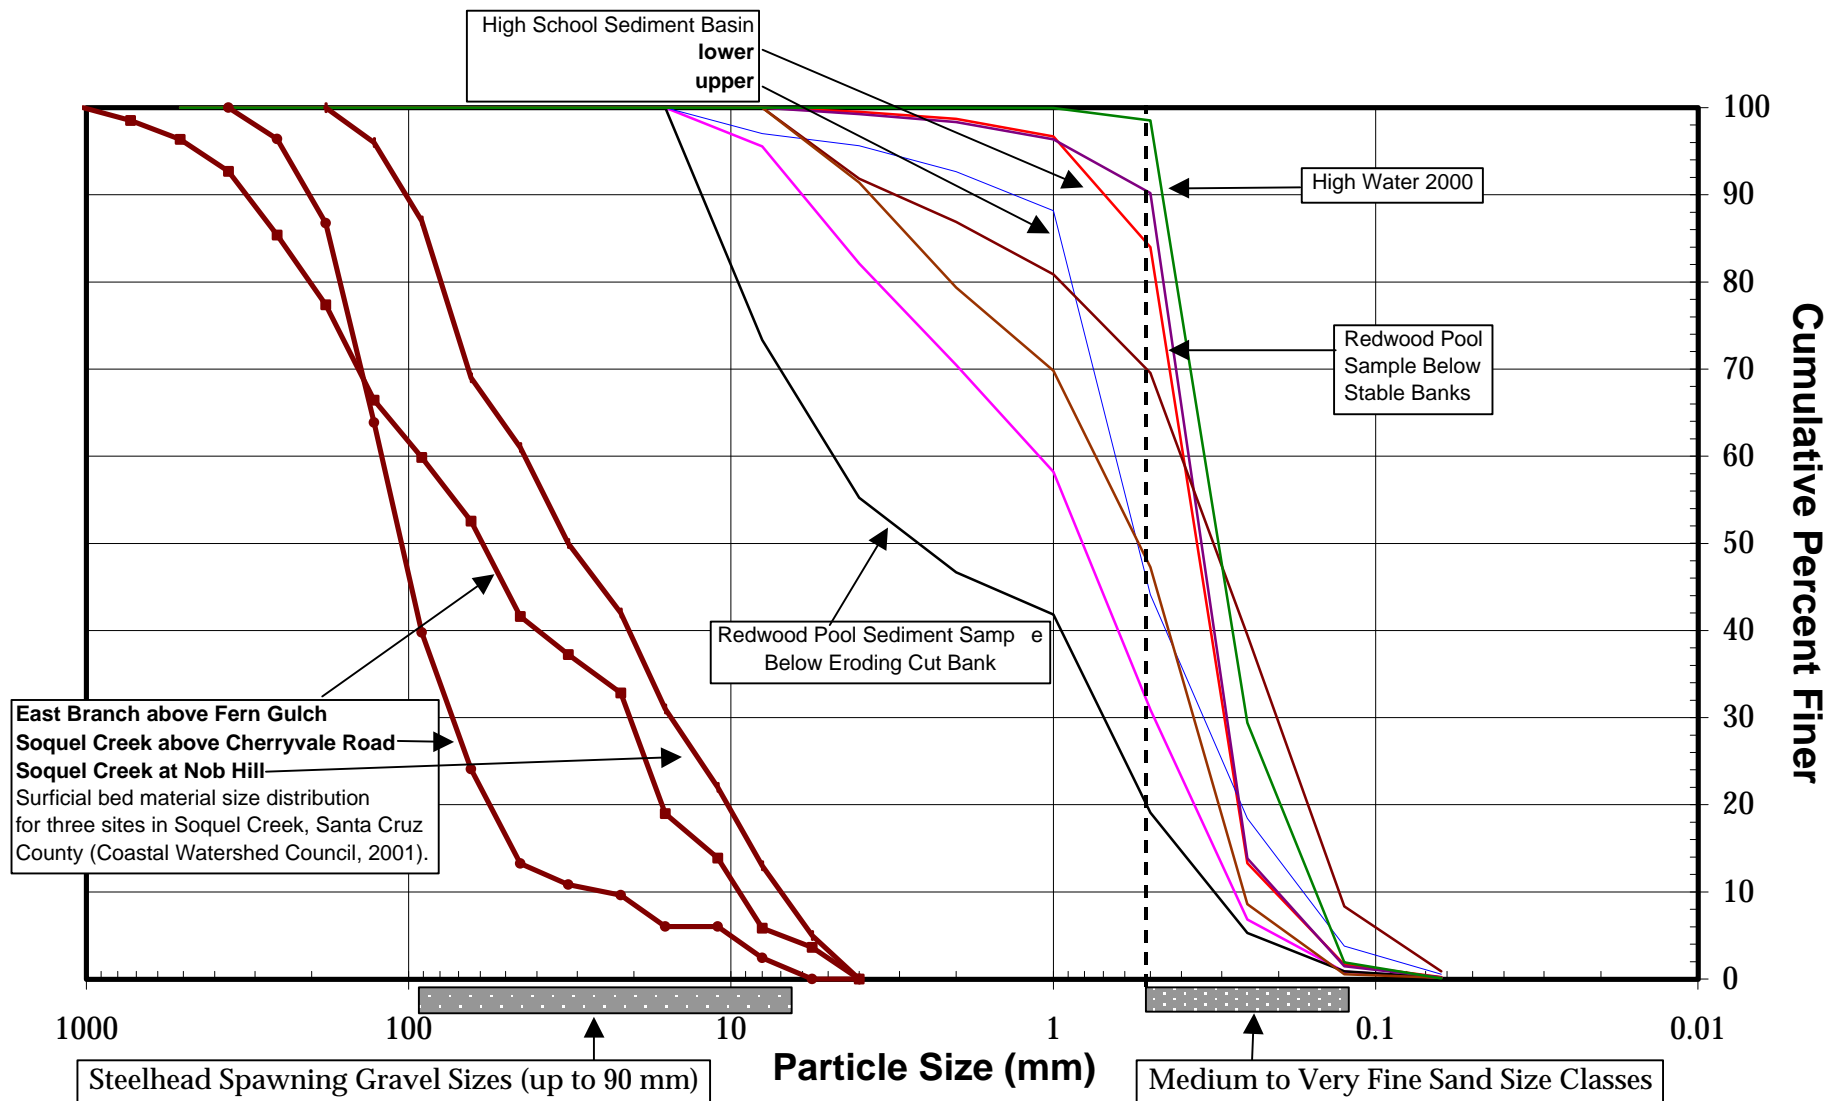
Figure 5.1: Particle-size distribution of sediment samples from the channel and high water marks of Arana Gulch.

Note that the 50 percentile for 6 out of 8 samples falls within or near the medium to fine sand class sizes and that sizes needed for steelhead spawning were found in only three samples, one being situated below an eroding road bank. Three samples collected from nearby Soquel Creek are shown for comparison. The size distribution curves illustrate that the coarsest material found in Arana corresponds to the finest size fractions sampled in Soquel Creek
