**Mission Village VTTM 61105 Project**  
**Oak Tree Report**  
**Los Angeles County, California**

**December 2006**

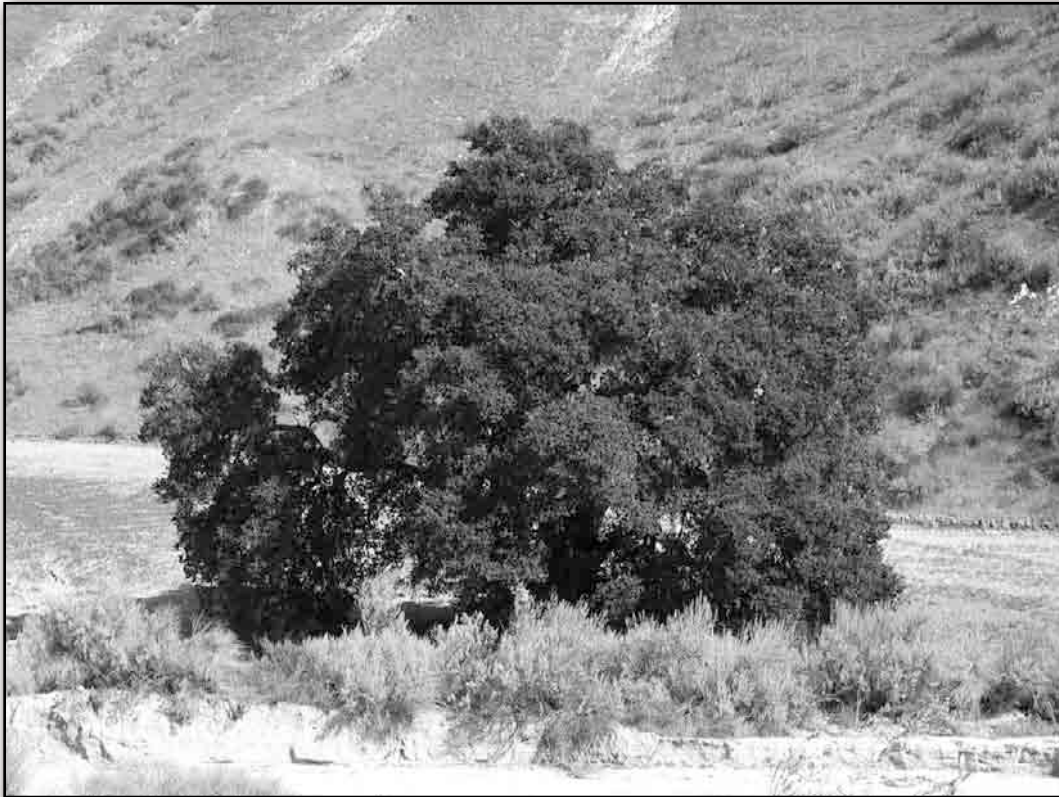
**“A” = Excellent:** A healthy and vigorous tree characteristic of its species and reasonably free of any visible signs of stress, disease, or pest infestation.

**Figure 4** – Photo of Oak Tree with an “A” (Excellent) Letter Grade

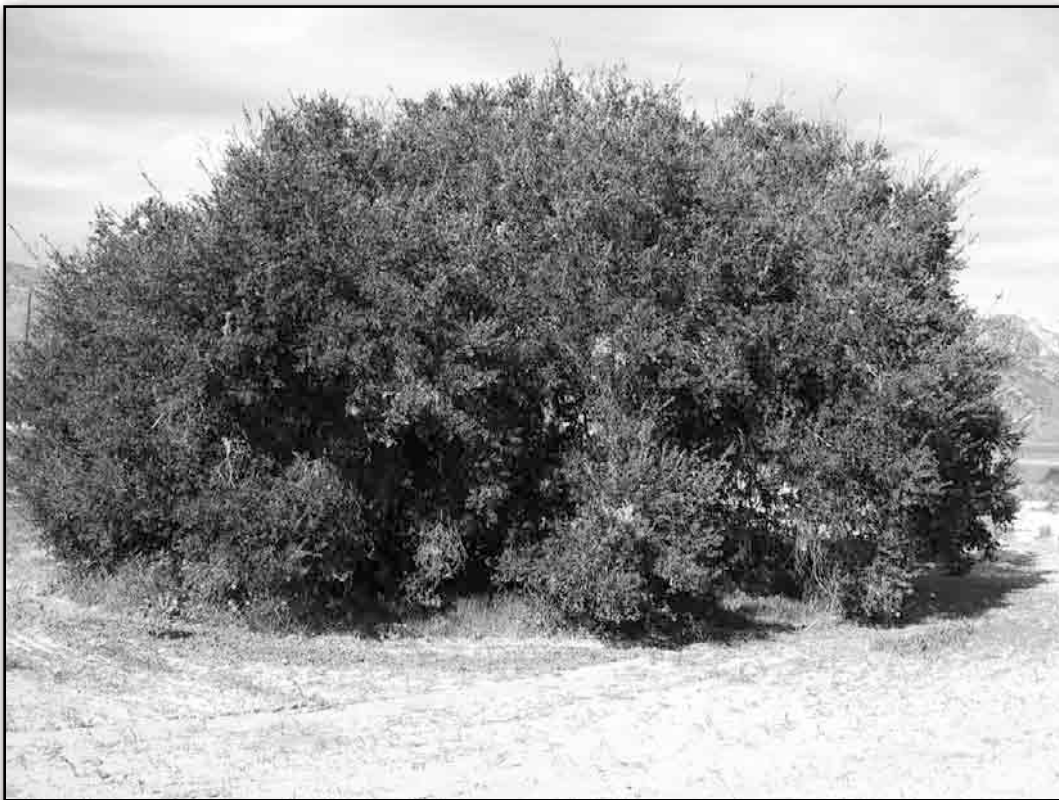
**“B” = Good:** A healthy and vigorous tree with minor visible signs of stress, disease, and/or pest infestation. Some maintenance measures may need to be implemented such as, pruning of dead wood or broken branches.

**Figure 5** – Photo of Oak Tree with an “B” (Good) Letter Grade

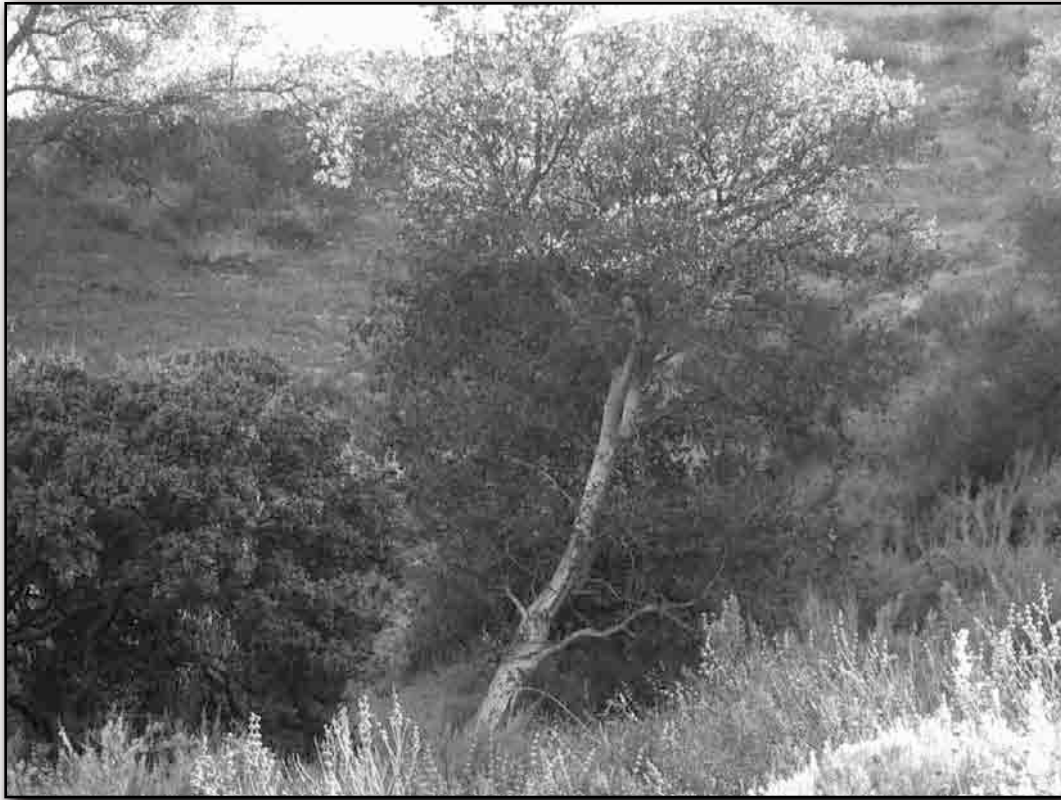
**“C” = Fair:** Although healthy in overall appearance, there is abnormal amount of stress or disease/insect infestation, and a substantial amount of maintenance may be needed.

**Figure 6** – Photo of Oak Tree with an “C” (Fair) Letter Grade

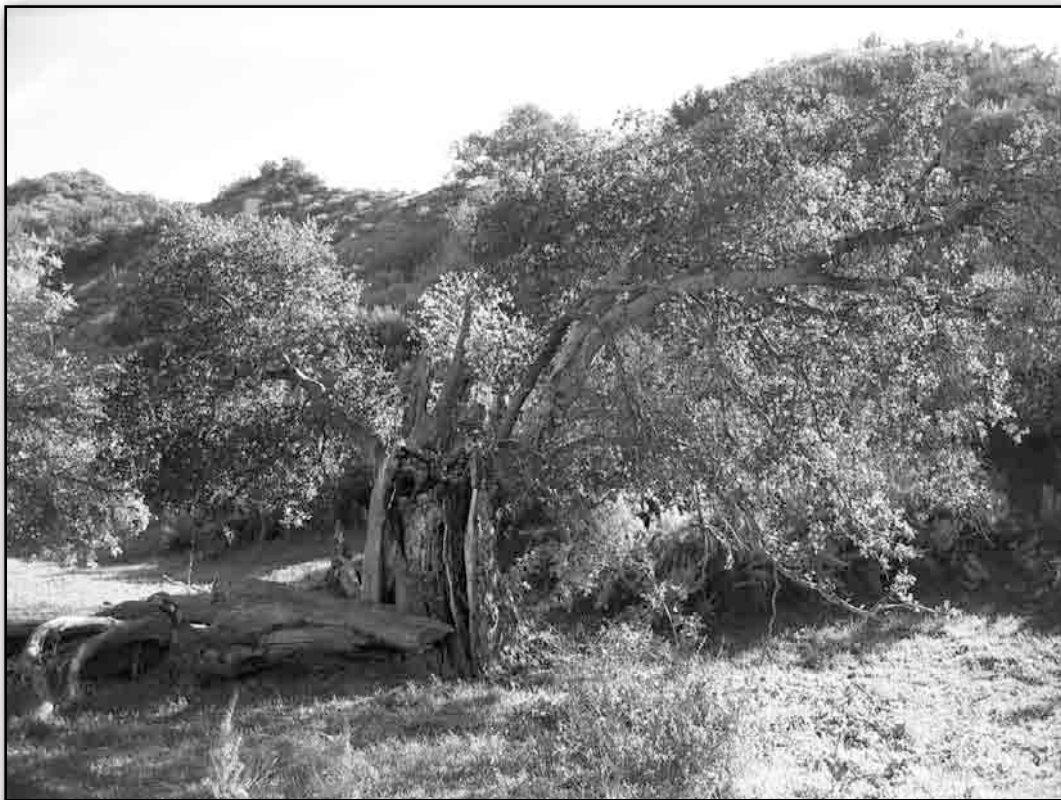
**“D” = Poor:** A tree that may be exhibiting a substantial amount of stress, disease, or insect damage than what the amount that is expected for the species. The tree may be in a state of rapid decline, which may vary greatly in sings of dieback, necrosis, or other symptoms caused by pathogens or insect pests.

**Figure 7** – Photo of Oak Tree with an “D” (Poor) Letter Grade

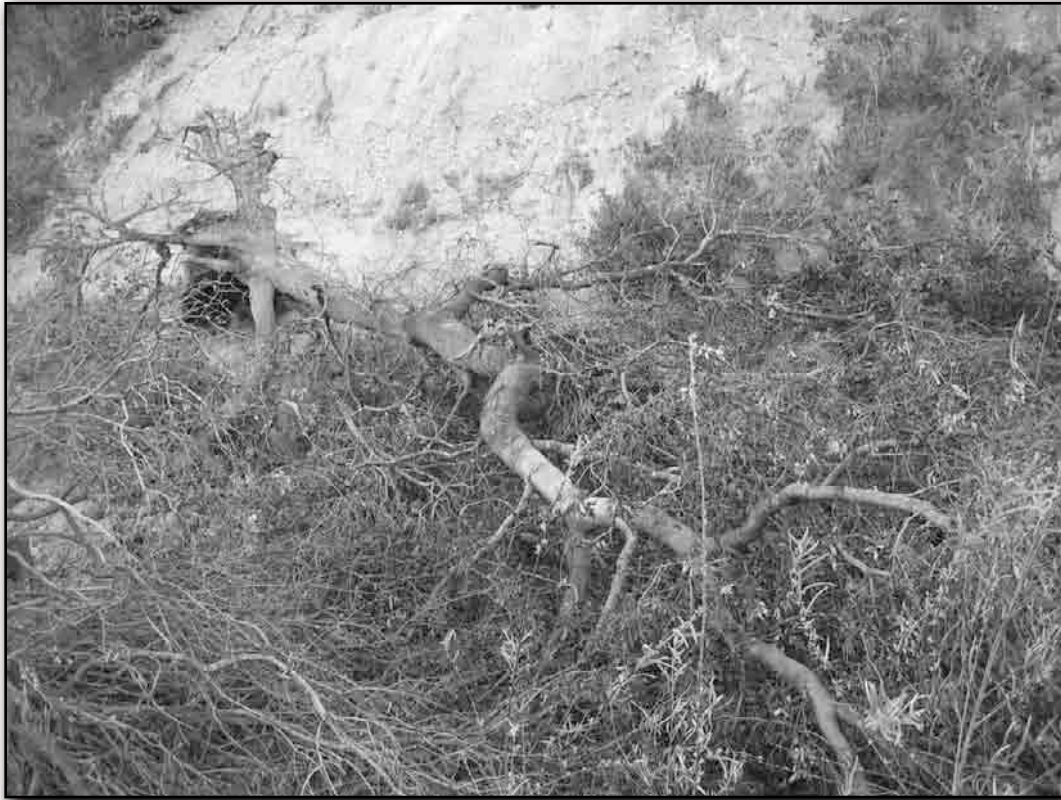
**Figure 8** – Photo of Oak Tree with an “E” (Almost Dead) Letter Grade

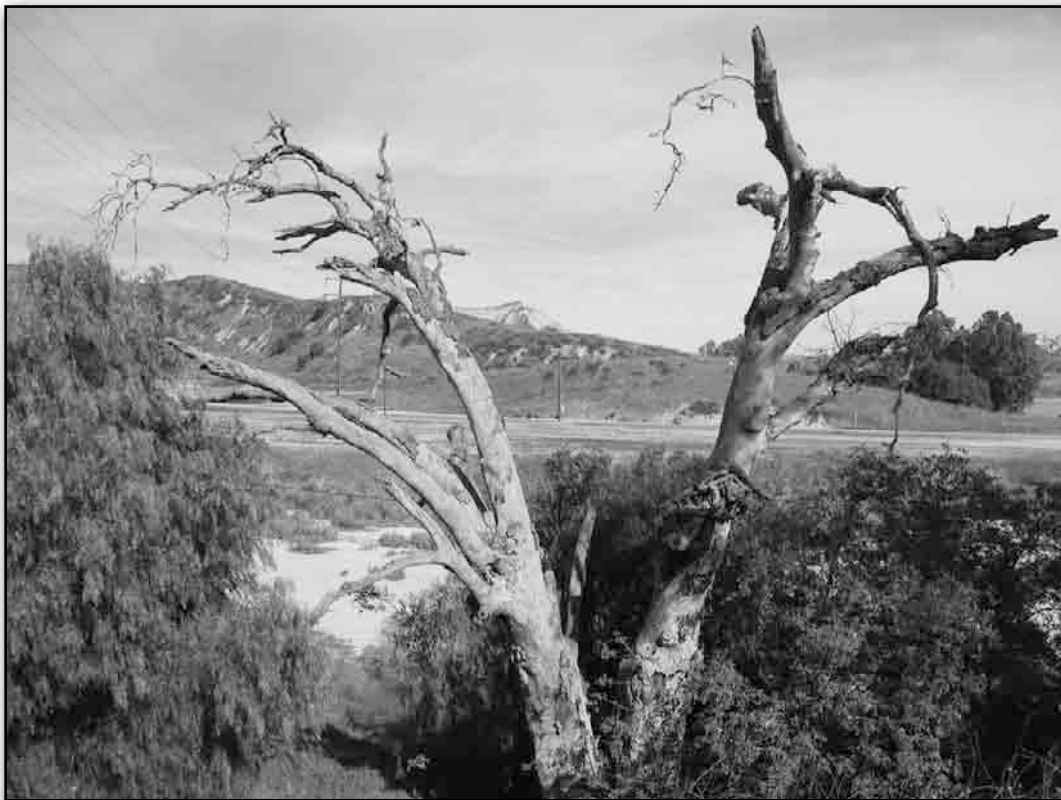
**Figure 9** – Photo of Oak Tree with an “F” (Dead) Letter Grade
