**California Department of Fish and Wildlife
Marin County
San Pablo Bay Watershed
Stream Habitat Assessment Reports**

San Pablo Creek

Surveyed 2010

STREAM INVENTORY REPORT

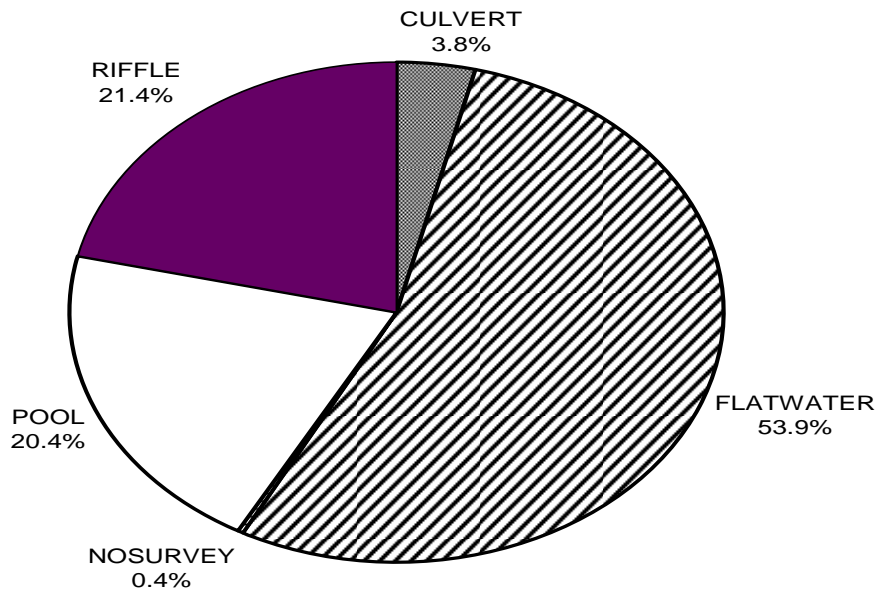
GRAPH 1

Table 1 summarizes the Level II riffle, flatwater, and pool habitat types. Based on frequency of occurrence there were <1% no survey units, 21% riffle units, 54% flatwater units, 4% culvert units, and 20% pool units (Graph 1). Based on total length of Level II habitat types there were 5% no survey units, 12% riffle units, 62% flatwater units, 6% culvert units, and 15% pool units (Graph 2).

**SAN PABLO CREEK 2010
HABITAT TYPES BY PERCENT OCCURRENCE**

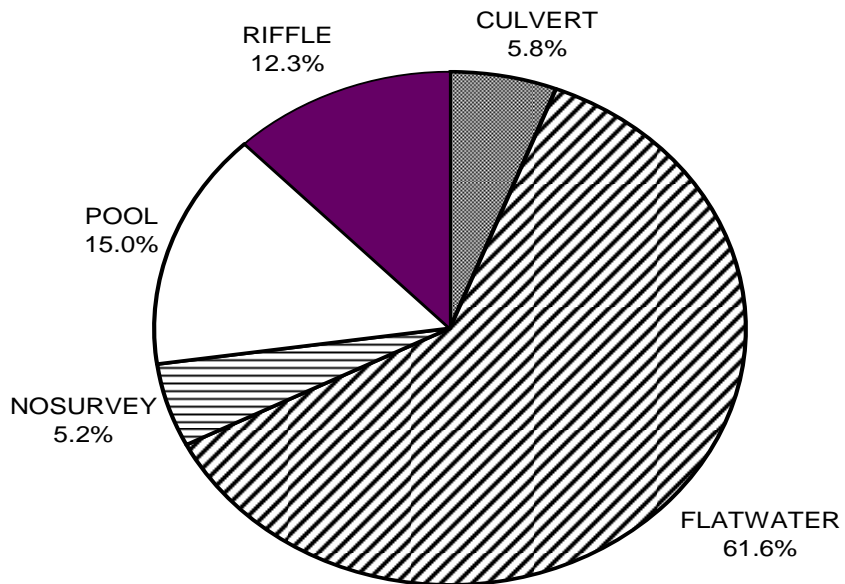
GRAPH 2

**SAN PABLO CREEK 2010
HABITAT TYPES BY PERCENT TOTAL LENGTH**

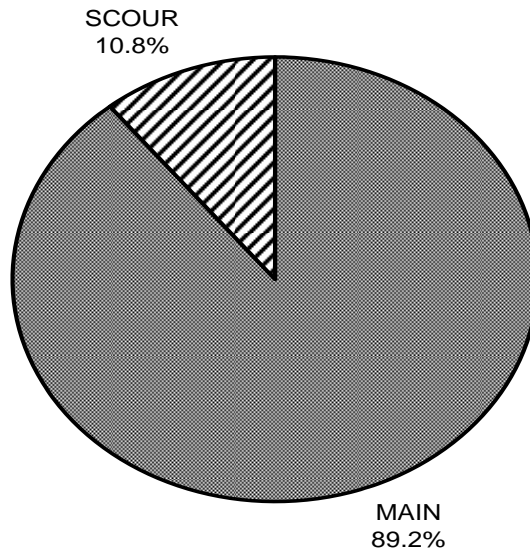
GRAPH 4

A total of 102 pools were identified (Table 3). Main Channel pools were the most frequently

encountered, at 89%, and comprised 92% of the total length of all pools (Graph 4).

SAN PABLO CREEK 2010 POOL TYPES BY PERCENT OCCURRENCE

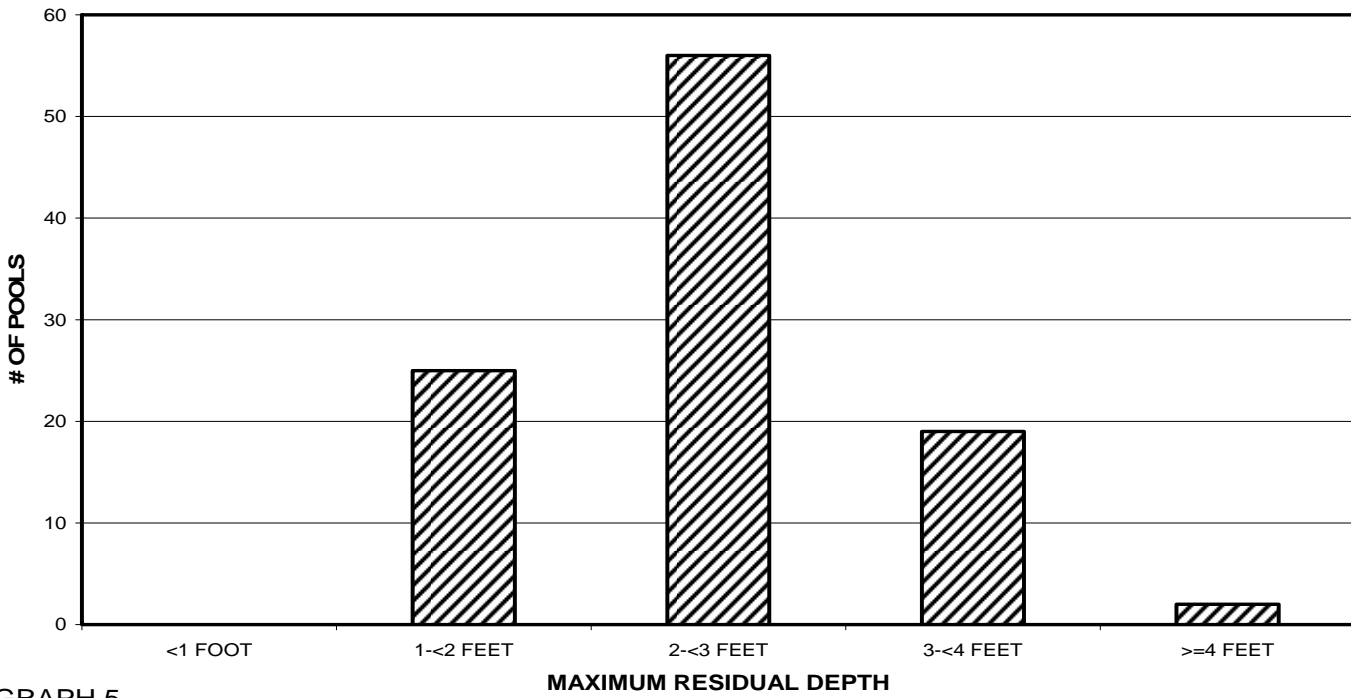
GRAPH 5

Table 4 is a summary of maximum residual pool depths by pool habitat types. Pool quality for salmonids increases with depth. Twenty-one of the 102 pools (21%) had a residual depth of three feet or greater (Graph 5).

**SAN PABLO CREEK 2010
MAXIMUM DEPTH IN POOLS**

- 3) Where feasible, design and engineer pool enhancement structures to increase the number of pools. This must be done where the banks are stable or in conjunction with stream bank armor to prevent erosion.

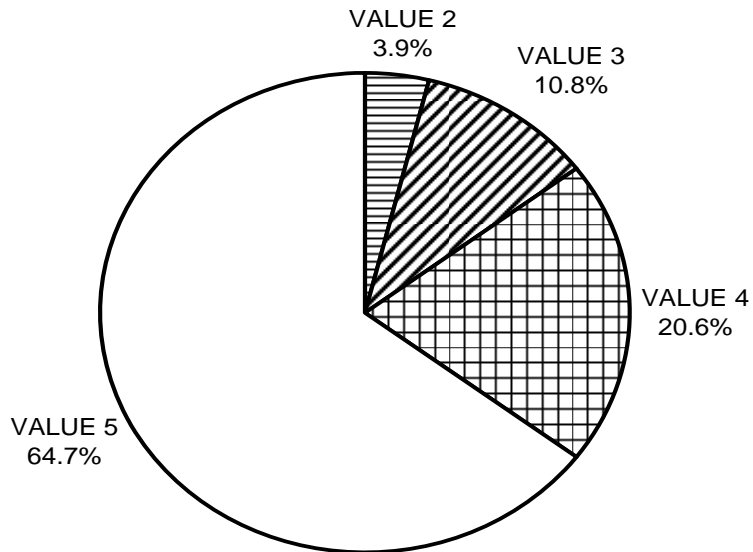
GRAPH 6

The depth of cobble embeddedness was estimated at pool tail-outs. Of the 102 pool tail-outs measured, 4 had a value of 2 (3.9%); 11 had a value of 3 (10.8%); 21 had a value of 4 (20.6%); and 66 had a value of 5 (64.7%) (Graph 6). On this scale, a value of 1 indicates the best spawning conditions and a value of 4 the worst. Additionally, a value of 5 was assigned to tail-outs deemed unsuited for spawning due to inappropriate substrate such as bedrock, log sills, boulders, or other considerations.

Four of the 102 pool tail-outs measured had embeddedness ratings of 1 or 2. Thirty two of the pool tail-outs had embeddedness ratings of 3 or 4. Sixty six of the pool tail-outs had a rating of 5, which is considered unsuitable for spawning. Cobble embeddedness measured to be 25% or less, a rating of 1, is considered to indicate good quality spawning substrate for salmon and steelhead. Sediment sources in San Pablo Creek should be mapped and rated according to their potential sediment yields, and control measures should be taken.

**SAN PABLO CREEK 2010
PERCENT EMBEDDEDNESS**

- 2) Inventory and map sources of stream bank erosion and prioritize them according to present and potential sediment yield. Identified sites should then be treated to reduce the amount of fine sediments entering the stream. Active and potential sediment sources related to the road system need to be identified, mapped, and treated according to their potential for sediment yield to the stream and its tributaries.

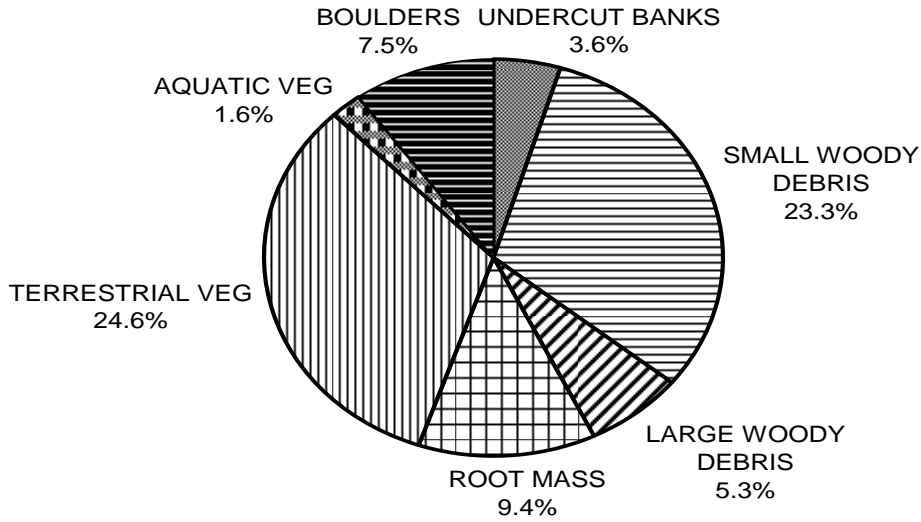
GRAPH 7

Table 5 summarizes mean percent cover by habitat type. Terrestrial Vegetation is the dominant cover types in San Pablo Creek. Graph 7 describes the pool cover in San Pablo Creek. Terrestrial Vegetation is the dominant pool cover type followed by small woody debris.

The mean shelter rating for pools was 19. The shelter rating in the flatwater habitats was 4. A pool shelter rating of approximately 100 is desirable. The amount of cover that now exists is being provided primarily by Terrestrial Vegetation in San Pablo Creek. Terrestrial Vegetation is the dominant cover type in pools followed by small woody debris. Log and root wad cover structures in the pool and flatwater habitats would enhance both summer and winter salmonid habitat. Log cover structure provides rearing fry with protection from predation, rest from water velocity, and also divides territorial units to reduce density related competition.

**SAN PABLO CREEK 2010
MEAN PERCENT COVER TYPES IN POOLS**

- 4) Increase woody cover in the pools and flatwater habitat units. Most of the existing cover in the pools is from Boulders and Terrestrial Vegetation. Adding high quality complexity with woody cover in the pools is desirable.

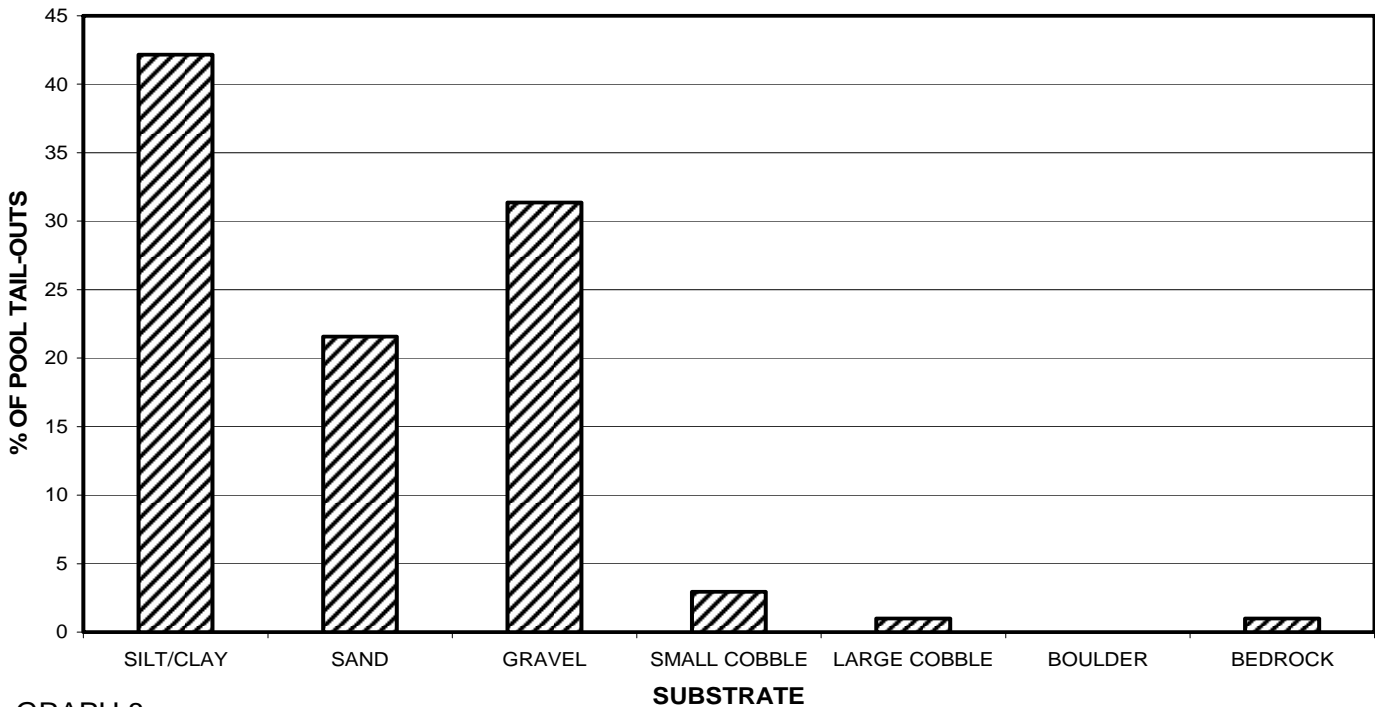
GRAPH 8

Table 6 summarizes the dominant substrate by habitat type. Graph 8 depicts the dominant substrate observed in pool tail-outs. A silt/clay substrate type was observed in 42% of pool tail-outs and gravel observed in 31% of pool tail-outs.

Sixty seven of the 102 pool tail-outs had silt, sand, large cobble, boulders or bedrock as the dominant substrate. This is generally considered unsuitable for spawning salmonids.

**SAN PABLO CREEK 2010
SUBSTRATE COMPOSITION IN POOL TAIL-OUTS**

- 5) Suitable size spawning substrate on San Pablo Creek is limited to relatively few reaches. Projects should be designed at suitable sites to trap and sort spawning gravel.

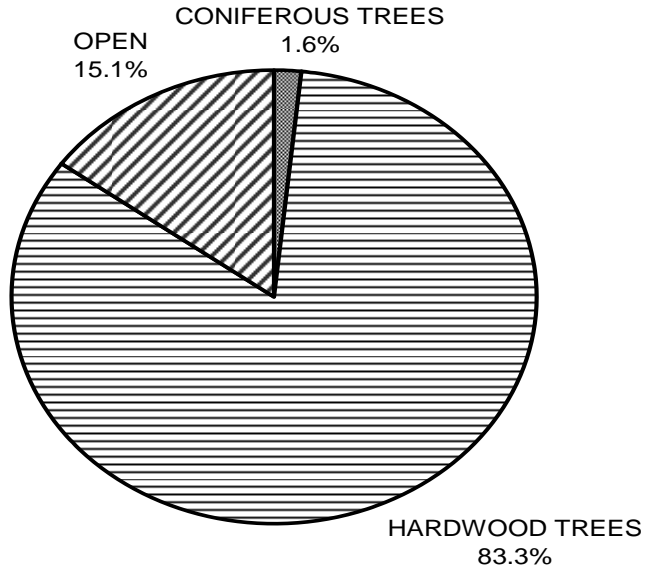
GRAPH 9

The mean percent canopy density for the surveyed length of San Pablo Creek was 85%. The mean percentages of hardwood and coniferous trees were 98% and 2%, respectively. Fifteen percent of the canopy was open. Graph 9 describes the mean percent canopy in San Pablo Creek.

The mean percent canopy density for the stream was 85%. Reach 2 had a canopy density of 78.8% and Reach 4 had a canopy density of 87.8%. In general, revegetation projects are considered when canopy density is less than 80%.

**SAN PABLO CREEK 2010
MEAN PERCENT CANOPY**

- 6) Increase the canopy throughout San Pablo Creek by planting appropriate native vegetation like willow, alder, redwood, and Douglas fir along the stream where shade canopy is not at acceptable levels. In many cases, planting will need to be

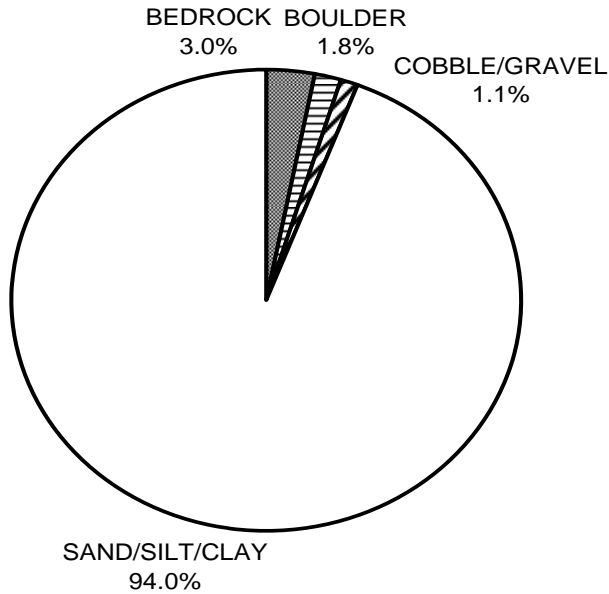
GRAPH 10

For the stream reach surveyed, the mean percent right bank vegetated was 77%. The mean percent left bank vegetated was 74%. The dominant elements composing the structure of the stream banks consisted of 3% bedrock, 2% boulder, 1% cobble/gravel, and 94% sand/silt/clay (Graph 10). Deciduous trees were the dominant vegetation type observed in 82% of the units surveyed. Additionally, 14% of the units surveyed had brush as the dominant vegetation type, and 1% had grass as the dominant vegetation (Graph 11).

**SAN PABLO CREEK 2010
DOMINANT BANK COMPOSITION IN SURVEY REACH**

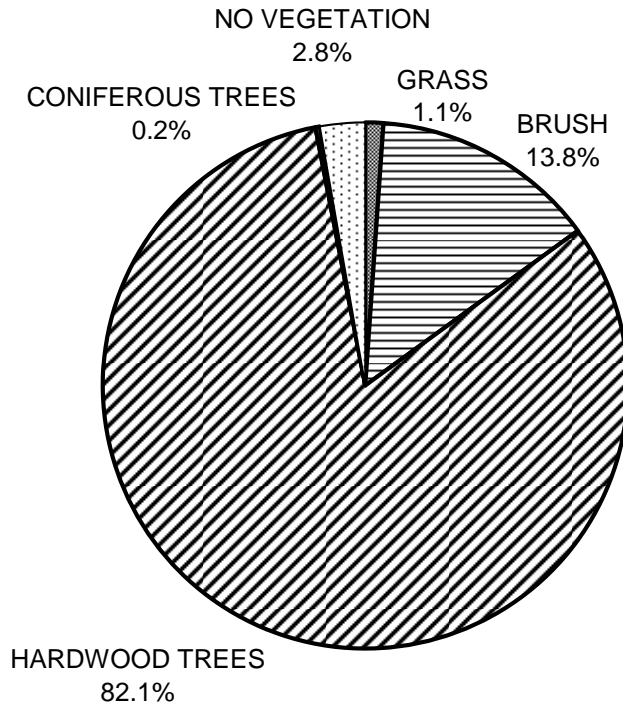
GRAPH 11

The percentage of right and left bank covered with vegetation was 77% and 74%, respectively. In areas of stream bank erosion or where bank vegetation is sparse, planting endemic species of coniferous and hardwood trees, in conjunction with bank stabilization, is recommended.

SAN PABLO CREEK 2010 DOMINANT BANK VEGETATION IN SURVEY REACH
