**California Department of Fish and Wildlife
East Marin County
San Francisco Bay Watersheds
Stream Habitat Assessment Reports**

Sleepy Hollow Creek

*Surveyed 2009
Report Completed in 2013*

STREAM INVENTORY REPORT

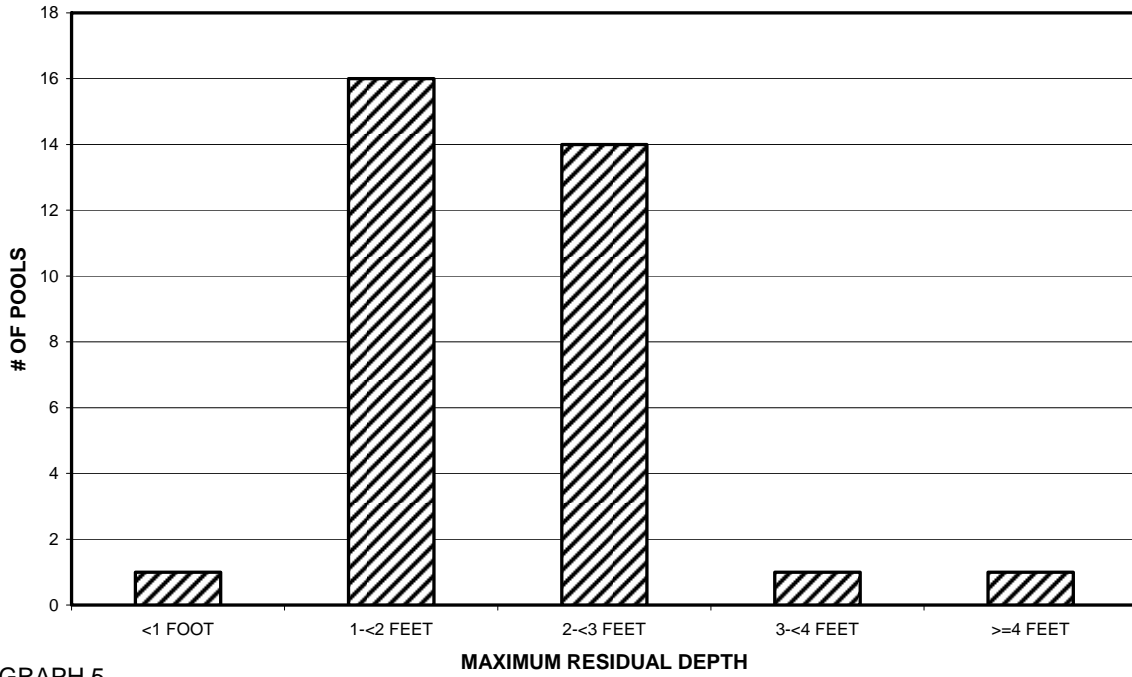
GRAPH 5

Table 4 is a summary of maximum residual pool depths by pool habitat types. Pool quality for salmonids increases with depth. Fifteen of the 33 pools (45%) had a residual depth of two feet or greater (Graph 5).

Flatwater habitat types comprised 27% of the total length of this survey, riffles 8%, and pools 6%. The pools are relatively deep, with 15 of the 33 (45%) pools having a maximum residual depth greater than two feet. In general, pool enhancement projects are considered when primary pools comprise less than 40% of the length of total stream habitat. In first and second order streams, a primary pool is defined to have a maximum residual depth of at least two feet, occupy at least half the width of the low flow channel, and be as long as the low flow channel width. Installing structures that will increase or deepen pool habitat is recommended for locations where

- 3) Where feasible, design and engineer pool enhancement structures to increase the number of pools. This must be done where the banks are stable or in conjunction with stream bank armor to prevent erosion.

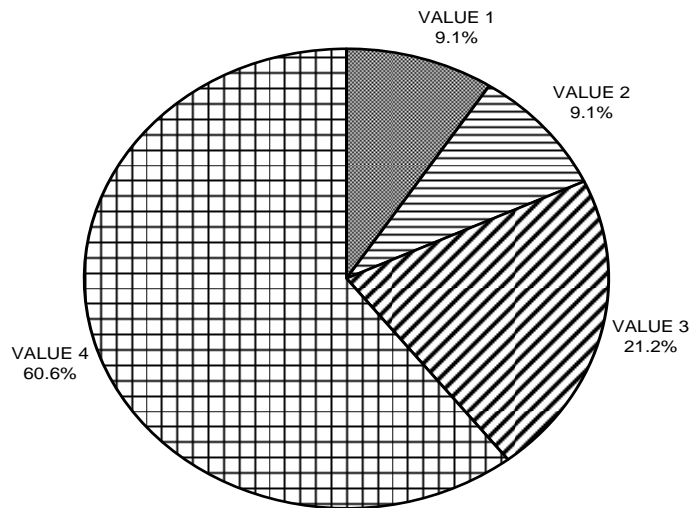
GRAPH 6

The depth of cobble embeddedness was estimated at pool tail-outs. Of the 33 pool tail-outs measured, 3 had a value of 1 (9%), 3 had a value of 2 (9%), 7 had a value of 3 (21%), 20 had a value of 4 (61%) (Graph 6). On this scale, a value of 1 indicates the best spawning conditions and a value of 4 the worst. Additionally, a value of 5 was assigned to tail-outs deemed unsuited for spawning due to inappropriate substrate such as bedrock, log sills, boulders, or other considerations.

Six of the 33 pool tail-outs measured had embeddedness ratings of 1 or 2. Twenty-seven of the pool tail-outs had embeddedness ratings of 3 or 4. Zero of the pool tail-outs had a rating of 5, which is considered unsuitable for spawning. Cobble embeddedness measured to be 25% or less, a rating of 1, is considered to indicate good quality spawning substrate for salmon and steelhead. Sediment sources in Sleepy Hollow Creek should be mapped and rated according to their potential sediment yields, and control measures should be taken.

- 6) Inventory and map sources of stream bank erosion and prioritize them according to present and potential sediment yield. Identified sites should then be treated to reduce the amount of fine sediments entering the stream. Active and potential sediment sources related to the road system need to be identified, mapped, and treated according to their potential for sediment yield to the stream and its tributaries.

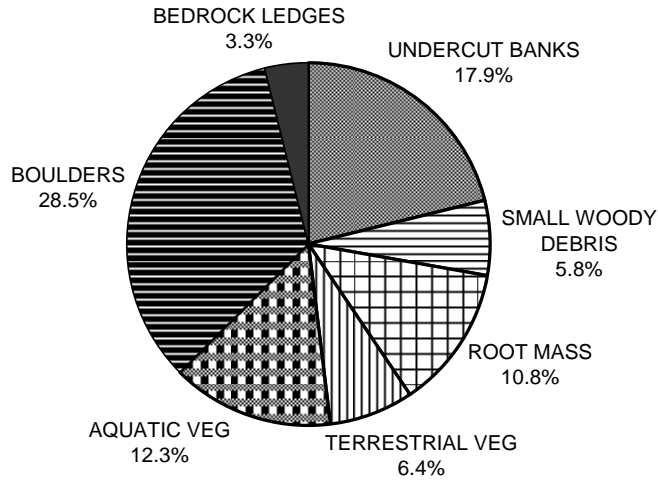
GRAPH 7

Table 5 summarizes mean percent cover by habitat type. Boulders are the dominant cover type in Sleepy Hollow Creek. Graph 7 describes the pool cover in Sleepy Hollow Creek. Boulders are the dominant pool cover type, followed by undercut banks.

The mean shelter rating for pools is 21. The shelter rating in the flatwater habitats is 14. A pool shelter rating of approximately 100 is desirable. The amount of cover that now exists is being provided primarily by boulders in Sleepy Hollow Creek. Boulders are the dominant cover type in pools, followed by undercut banks. Log and root wad cover structures in the pool and flatwater habitats would enhance both summer and winter salmonid habitat. Log cover structure provides rearing fry with protection from predation, rest from water velocity, and also divides territorial units to reduce density related competition.

- 4) Increase woody cover in the pools and flatwater habitat units. Most of the existing cover in the pools is from Boulders. Adding high quality complexity with woody cover in the pools is desirable.

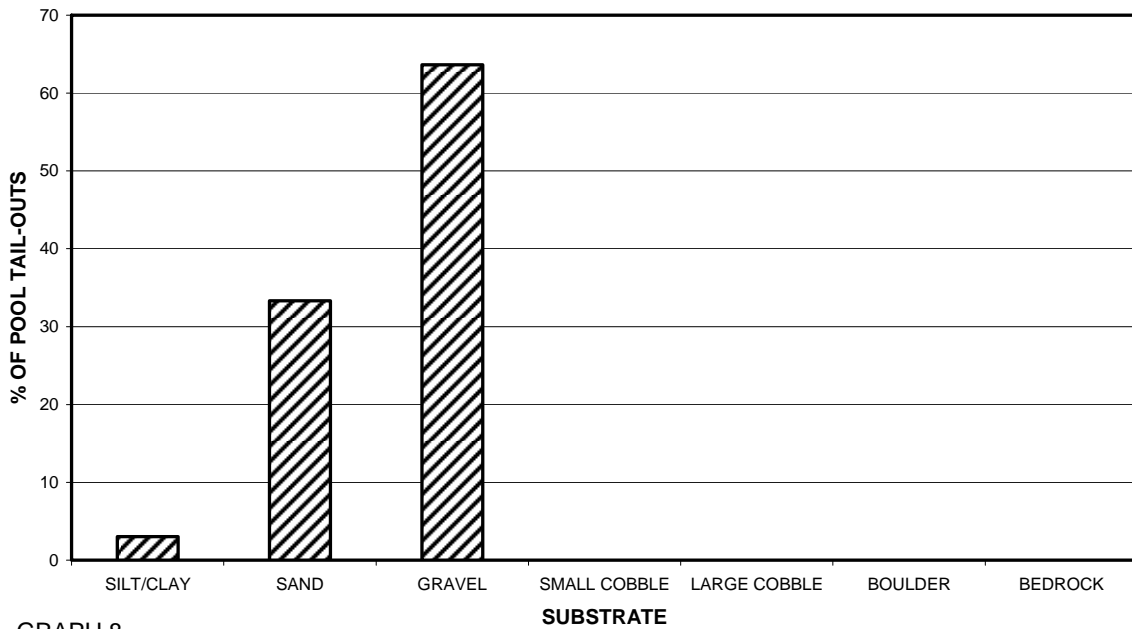
GRAPH 8

Table 6 summarizes the dominant substrate by habitat type. Graph 8 depicts the dominant substrate observed in pool tail-outs. Gravel was the dominant substrate observed in 64% of pool tail-outs; and sand substrate was observed in 33% of pool tail-outs.

Twenty-one of the 33 pool tail-outs measured had gravel and small cobble as the dominant substrate. This is generally considered good for spawning salmonids.

- 9) Suitable size spawning substrate on Sleepy Hollow Creek is limited to relatively few reaches. Projects should be designed at suitable sites to trap and sort spawning gravel.

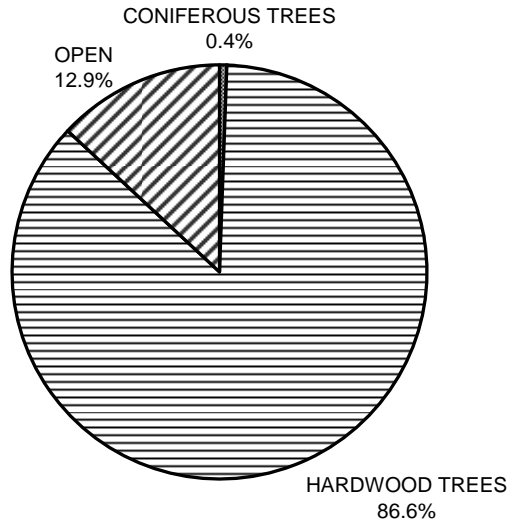
GRAPH 9

The mean percent canopy density for the surveyed length of Sleepy Hollow Creek was 87%. Of the canopy present, the mean percentages of hardwood and coniferous trees were 100% and 0%, respectively. Thirteen percent of the canopy was open. Graph 9 describes the mean percent canopy in Sleepy Hollow Creek.

The mean percent canopy density for the stream was 87%. In general, revegetation projects are considered when canopy density is less than 80%.

- 8) Increase the canopy on Sleepy Hollow Creek by planting appropriate native vegetation like willow, alder, redwood, and Douglas fir along the stream where shade canopy is not at acceptable levels. The reaches above this survey section should be inventoried and treated as well, since the water flowing here is affected from
