**California Department of Fish and Wildlife
East Marin County
San Francisco Bay Watersheds
Stream Habitat Assessment Reports**

Warner Creek

Surveyed 2009

STREAM INVENTORY REPORT

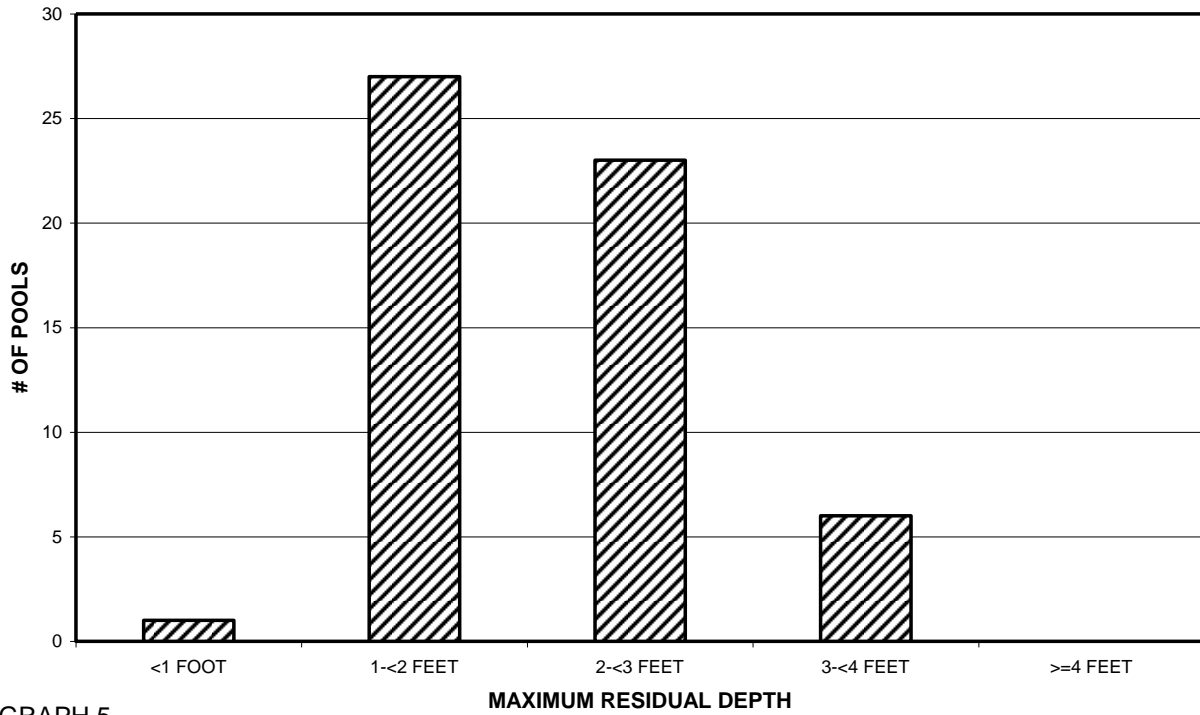
GRAPH 5

Table 4 is a summary of maximum residual pool depths by pool habitat types. Pool quality for salmonids increases with depth. Twenty-nine of the 57 pools (51%) had a residual depth of two feet or greater (Graph 5).

Flatwater habitat types comprised 50% of the total length of this survey, riffles 11%, and pools 20%. The pools are relatively deep, with only 29 of the 57 (51%) pools having a maximum residual depth greater than 2 feet. In general, pool enhancement projects are considered when primary pools comprise less than 40% of the length of total stream habitat. In first and second order streams, a primary pool is defined to have a maximum residual depth of at least two feet, occupy at least half the width of the low flow channel, and be as long as the low flow channel width.

Installing structures that will increase or deepen pool habitat is recommended for locations where their installation will not be threatened by high stream energy, or where their installation will not conflict with the modification of any log debris accumulations (LDA's) in the stream.

- 2) Where feasible, design and engineer pool enhancement structures to increase the number of pools. This must be done where the banks are stable or in conjunction with stream bank armor to prevent erosion.

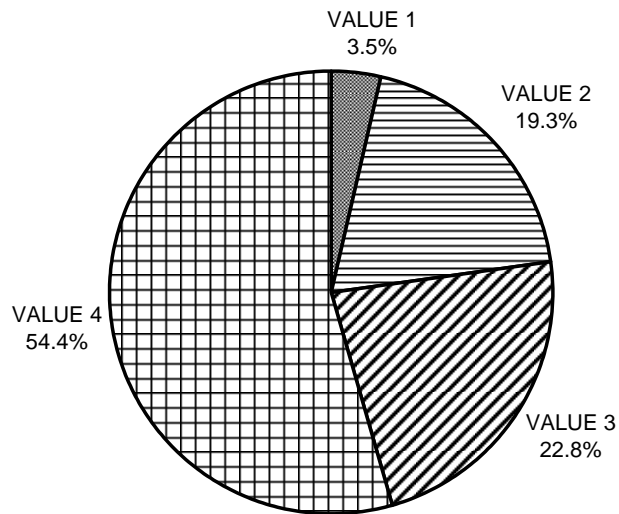
GRAPH 6

The depth of cobble embeddedness was estimated at pool tail-outs. Of the 57 pool tail-outs measured, 2 had a value of 1 (3.5%); 11 had a value of 2 (19.3%); 13 had a value of 3 (22.8%); 31 had a value of 4 (54.4%); (Graph 6). On this scale, a value of 1 indicates the best spawning conditions and a value of 4 the worst. Additionally, a value of 5 was assigned to tail-outs deemed unsuited for spawning due to inappropriate substrate such as bedrock, log sills, boulders, or other considerations.

Thirteen of the 57 pool tail-outs measured had embeddedness ratings of 1 or 2. Forty-four of the pool tail-outs had embeddedness ratings of 3 or 4. None of the pool tail-outs had a rating of 5, which is considered unsuitable for spawning. Cobble embeddedness measured to be 25% or less, a rating of 1, is considered to indicate good quality spawning substrate for salmon and steelhead. Sediment sources in Warner Creek should be mapped and rated according to their potential sediment yields, and control measures should be taken.

- 4) Inventory and map sources of stream bank erosion and prioritize them according to present and potential sediment yield. Identified sites should then be treated to reduce the amount of fine sediments entering the stream. Active and potential sediment sources related to the road system need to be identified, mapped, and treated according to their potential for sediment yield to the stream and its tributaries.

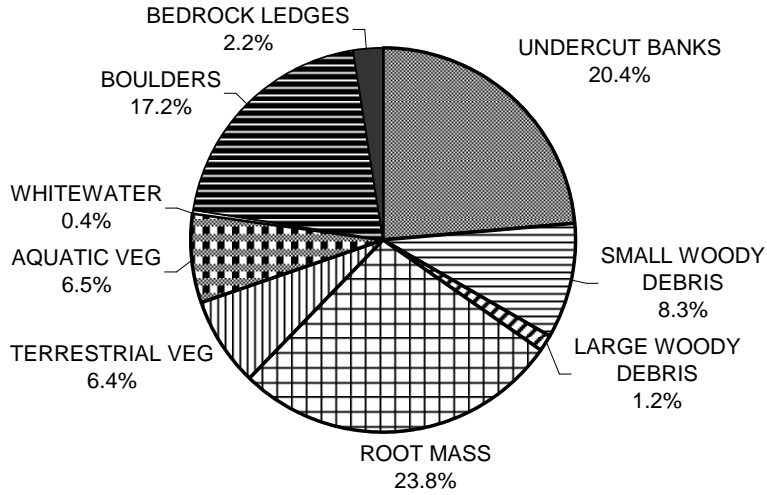
GRAPH 7

Table 5 summarizes mean percent cover by habitat type. Boulders are the dominant cover types in Warner Creek. Graph 7 describes the pool cover in Warner Creek. Root Mass is the dominant pool cover type followed by undercut banks.

The mean shelter rating for pools was 21. The shelter rating in the flatwater habitats was 11. A pool shelter rating of approximately 100 is desirable. The amount of cover that now exists is being provided primarily by Boulders in Warner Creek. Root Mass is the dominant cover type in pools followed by undercut banks. Log and root wad cover structures in the pool and flatwater habitats would enhance both summer and winter salmonid habitat. Log cover structure provides rearing fry with protection from predation, rest from water velocity, and also divides territorial units to reduce density related competition.

- 1) Increase woody cover in the pools and flatwater habitat units. Most of the existing cover in the pools is from Boulders. Adding high quality complexity with woody cover in the pools is desirable.

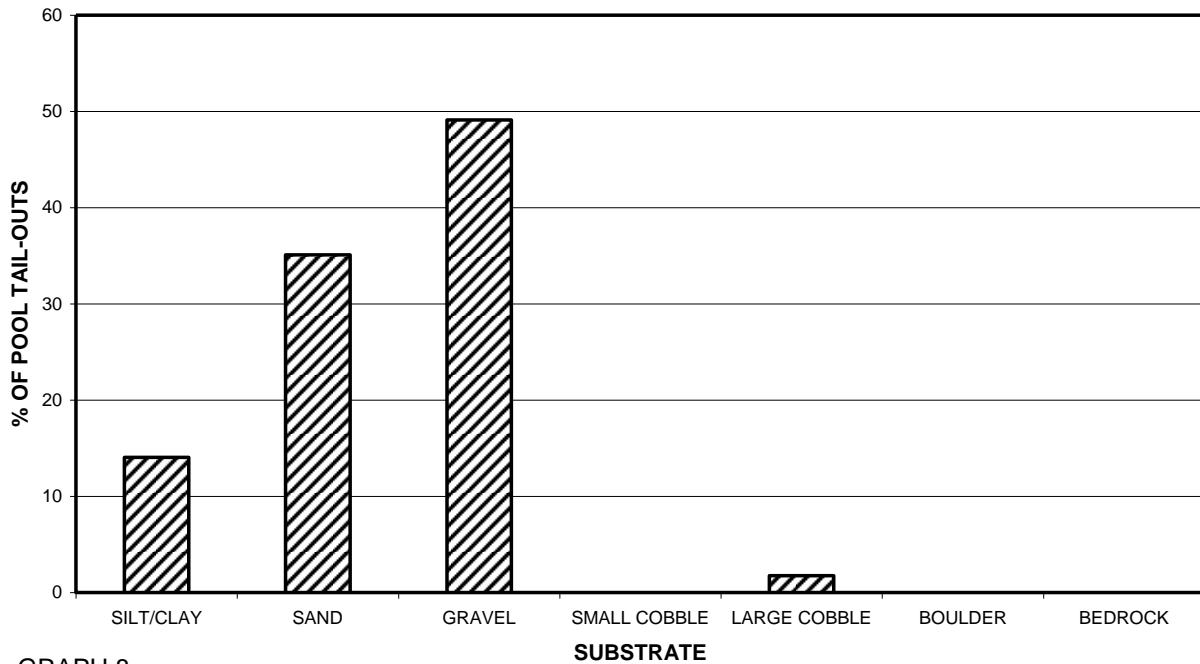
GRAPH 8

Table 6 summarizes the dominant substrate by habitat type. Graph 8 depicts the dominant substrate observed in pool tail-outs. Sand dominance was observed in 35% of pool tail-outs, and gravel dominance was observed in 49% of pool tail-outs.

Twenty-nine of the 57 pool tail-outs had silt, sand, large cobble, boulders or bedrock as the dominant substrate. This is generally considered unsuitable for spawning salmonids.

- 7) Suitable size spawning substrate on Warner Creek is limited to relatively few reaches. Projects should be designed at suitable sites to trap and sort spawning gravel.

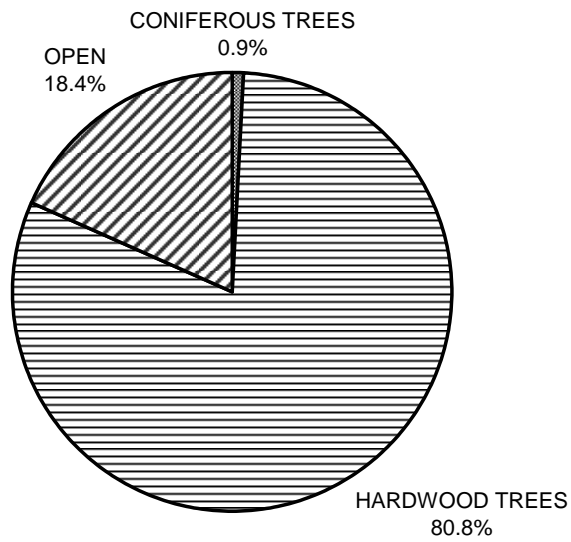
GRAPH 9

The mean percent canopy density for the surveyed length of Warner Creek was 82%. The mean percentages of hardwood and coniferous trees were 99% and 1%, respectively. Eighteen percent of the canopy was open. Graph 9 describes the mean percent canopy in Warner Creek.

The mean percent canopy density for the stream was 82%. In general, revegetation projects are considered when canopy density is less than 80%.

- 8) Increase the canopy on Warner Creek by planting appropriate native vegetation like willow, alder, redwood, and Douglas fir along the stream where shade canopy is not at acceptable levels. The reaches above this survey section should be inventoried and

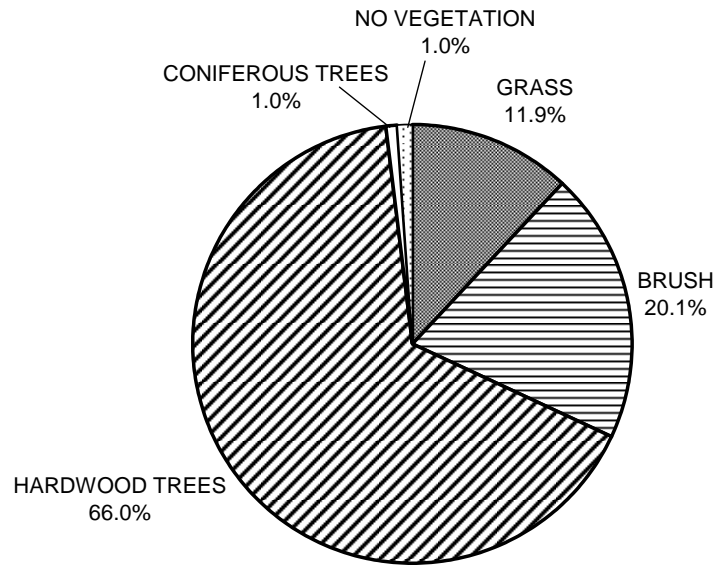
GRAPH 11

For the stream reach surveyed, the mean percent right bank vegetated was 54%. The mean percent left bank vegetated was 59%. The dominant elements composing the structure of the stream banks consisted of 18% bedrock, 4% boulder, 78% sand/silt/clay, (Graph 10). Deciduous trees were the dominant vegetation type observed in 66% of the units surveyed. Additionally, 20% of the units surveyed had brush as the dominant vegetation type, and 12% had grass as the dominant vegetation (Graph 11).

The percentage of right and left bank covered with vegetation was 54% and 59%, respectively. In areas of stream bank erosion or where bank vegetation is sparse, planting endemic species of coniferous and hardwood trees, in conjunction with bank stabilization, is recommended.
