**California Department of Fish and Wildlife
Contra Costa County
San Pablo Bay Watershed
Stream Habitat Assessment Reports**

Wildcat Creek

Surveyed 2010

STREAM INVENTORY REPORT

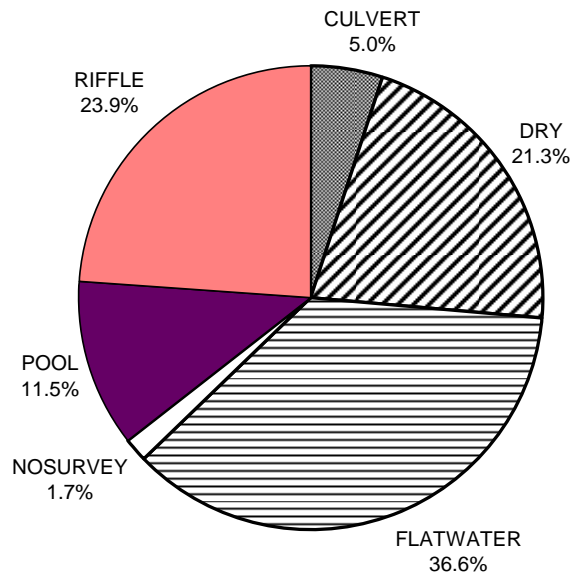
GRAPH 2

Table 1 summarizes the Level II riffle, flatwater, and pool habitat types. Based on frequency of occurrence there were 7% dry units, 24% pool units, 37% flatwater units, 4% culvert units, 28% riffle units, <1% nosurvey units, (Graph 1). Based on total length of Level II habitat types there were 21% dry units, 12% pool units, 37% flatwater units, 5% culvert units, 24% riffle units, 2% nosurvey units (Graph 2).

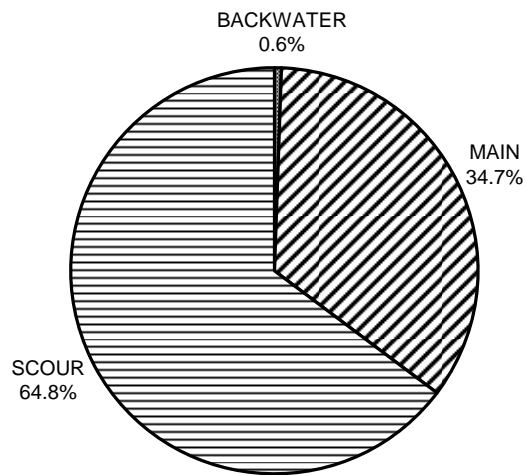
GRAPH 4

A total of 176 pools were identified (Table 3). Scour pools were the most frequently encountered, at 65%, and comprised 64% of the total length of all pools (Graph 4).

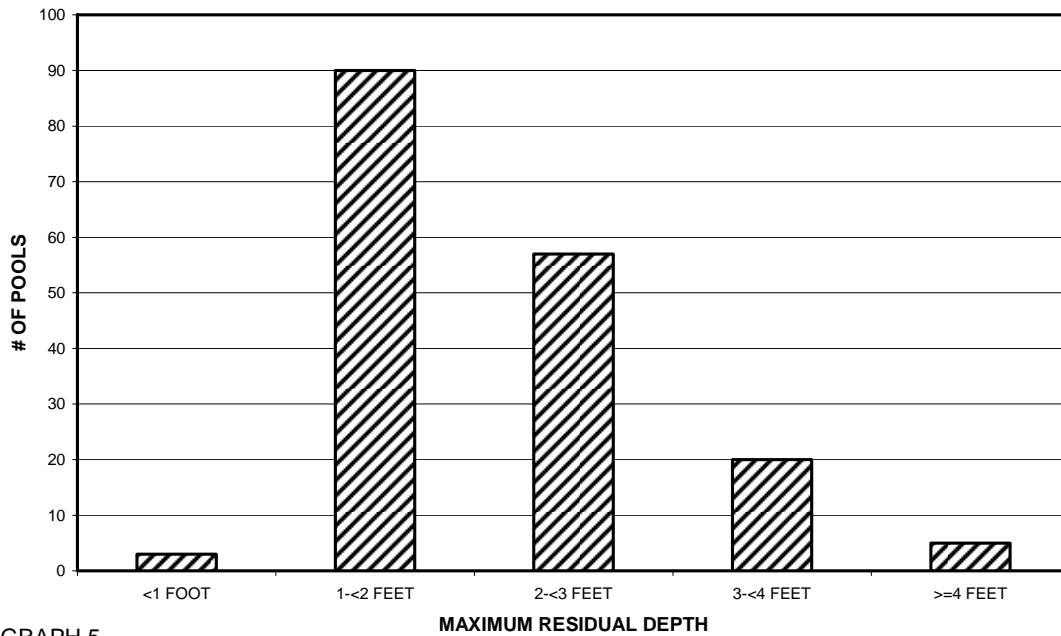
GRAPH 5

Table 4 is a summary of maximum residual pool depths by pool habitat types. Pool quality for salmonids increases with depth. Ninety of the 175 pools (47%) had a residual depth of two feet or greater (Graph 5).

Fifty seven of the 175 pools (14%) had a residual depth of three feet or greater (Graph 5).

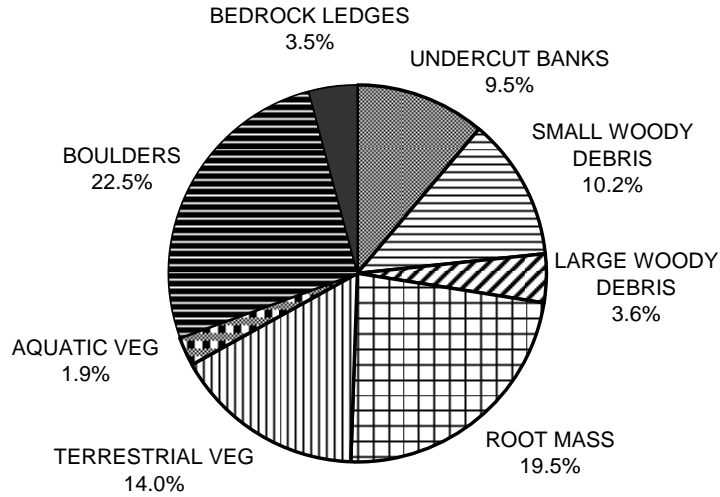
GRAPH 7

Table 5 summarizes mean percent cover by habitat type. Boulders are the dominant cover types in Wildcat Creek. Graph 7 describes the pool cover in Wildcat Creek. Boulders are the dominant pool cover type followed by root mass.

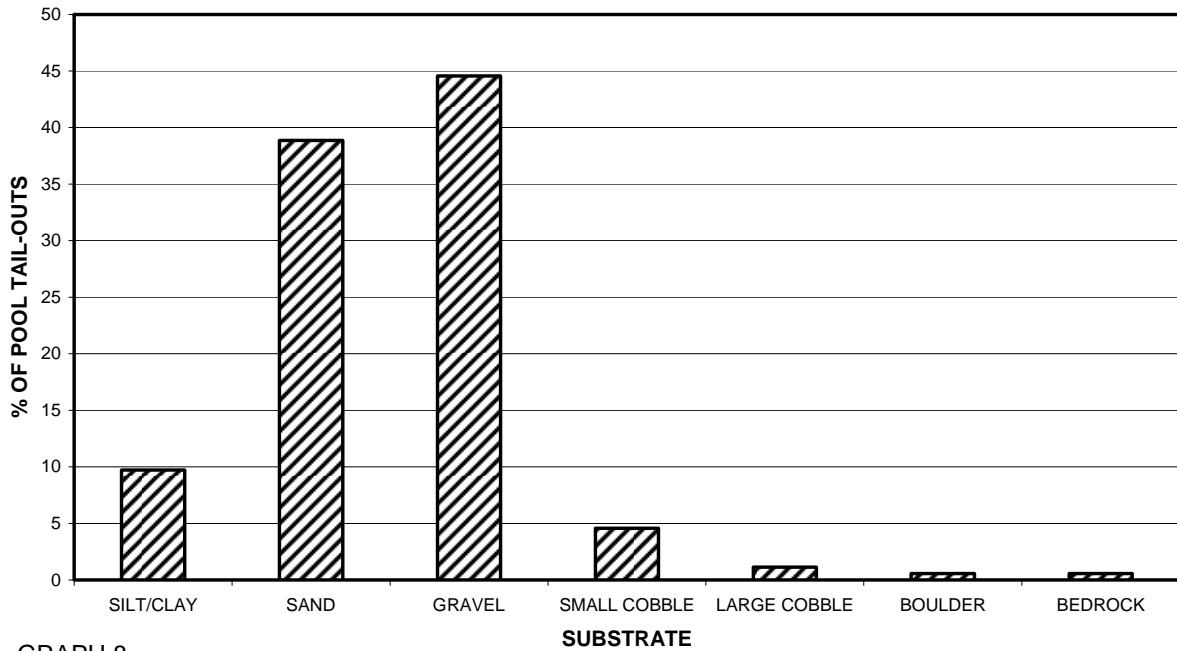
GRAPH 8

Table 6 summarizes the dominant substrate by habitat type. Graph 8 depicts the dominant substrate observed in pool tail-outs with sand observed in 39% of pool tail-outs and gravel observed in 45% of pool tail-outs.

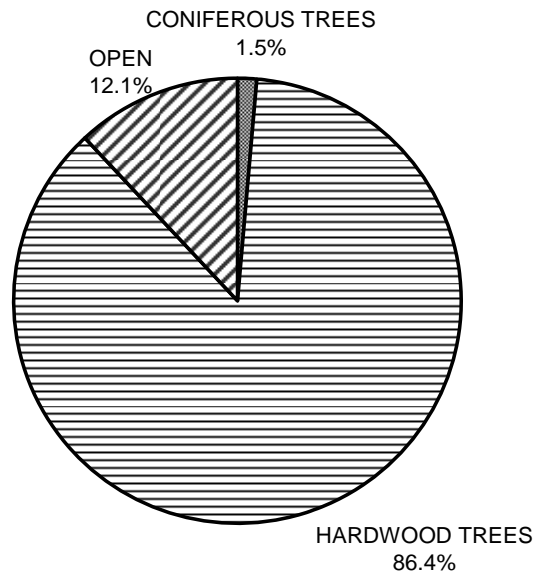
GRAPH 9

The mean percent canopy density for the surveyed length of Wildcat Creek was 88%. The mean percentages of hardwood and coniferous trees were 98% and 2%, respectively. Twelve percent of the canopy was open. Graph 9 describes the mean percent canopy in Wildcat Creek.

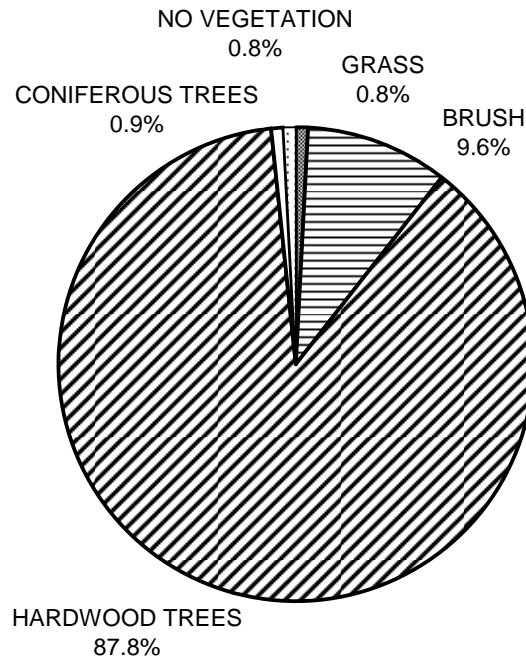
GRAPH 11

For the stream reach surveyed, the mean percent right bank vegetated was 70%. The mean percent left bank vegetated was 73%. The dominant elements composing the structure of the stream banks consisted of 10% bedrock, 4% boulder, 1% cobble/gravel, 85% sand/silt/clay, (Graph 10). Hardwood trees were the dominant vegetation type observed in 88% of the units surveyed. Additionally, 10% of the units surveyed had brush as the dominant vegetation type, and 1% had coniferous trees as the dominant vegetation (Graph 11).
