**California Department of Fish and Wildlife
Marin County
San Pablo Bay Watershed
Stream Habitat Assessment Reports**

Wilson Creek

Surveyed 2010

STREAM INVENTORY REPORT

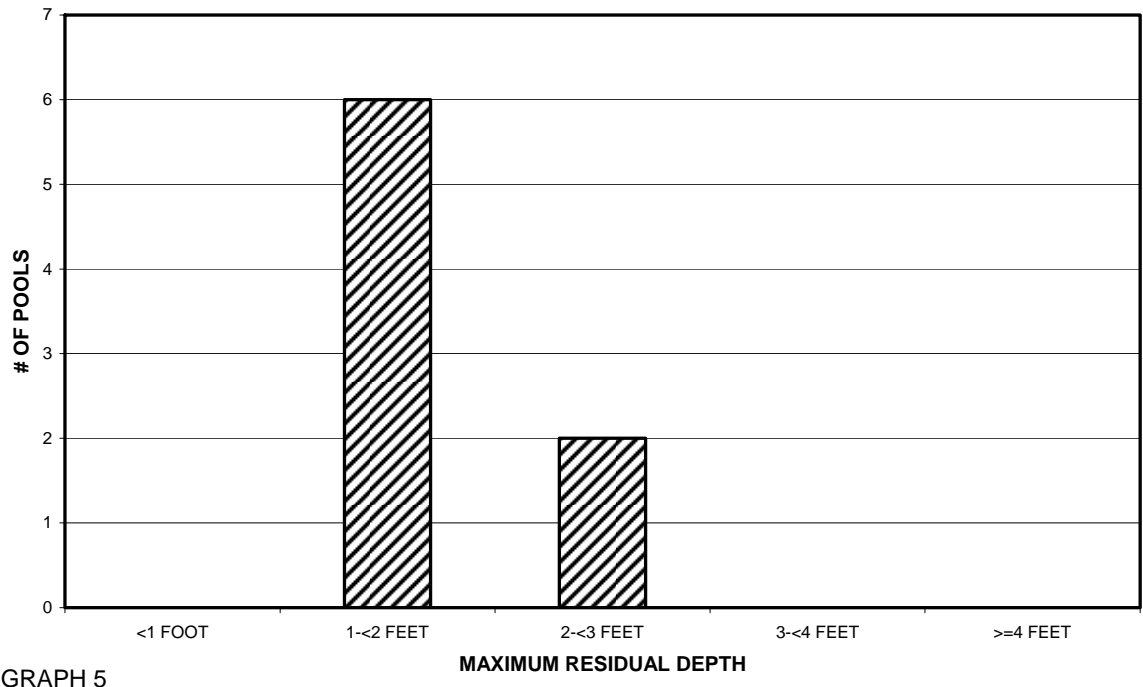
GRAPH 5

Table 4 is a summary of maximum residual pool depths by pool habitat types. Pool quality for salmonids increases with depth. Two of the 8 pools (25%) had a residual depth of two feet or greater (Graph 5).

Zero of the 8 pools (0%) had a residual depth of three feet or greater (Graph 5).

Flatwater habitat types comprised 27% of the total length of this survey, riffles 2%, and pools 3%. The pools are relatively shallow, with only 2 of the 8 (25%) pools having a maximum residual depth greater than 2 feet. In general, pool enhancement projects are considered when primary pools comprise less than 40% of the length of total stream habitat. In first and second order streams, a primary pool is defined to have a maximum residual depth of at least two feet, occupy at least half the width of the low flow channel, and be as long as the low flow channel width. Installing structures that will increase or deepen pool habitat is recommended for locations where their installation will not be threatened by high stream energy, or where their

- 1) Where feasible, design and engineer pool enhancement structures to increase the number of pools. This must be done where the banks are stable or in conjunction with stream bank armor to prevent erosion.
- 2) Increase woody cover in the pools and flatwater habitat units. Most of the existing cover in the pools is from Aquatic Vegetation. Adding high quality complexity with

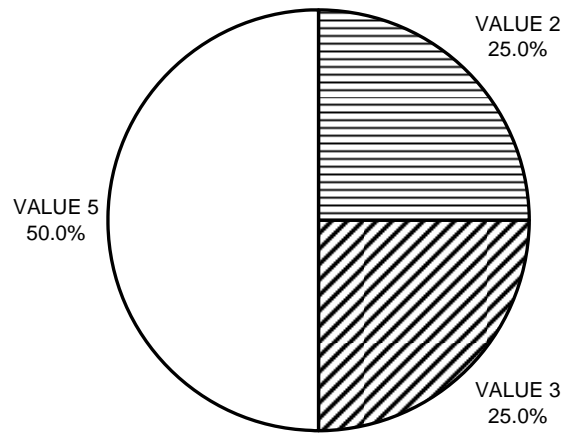
GRAPH 6

The depth of cobble embeddedness was estimated at pool tail-outs. Of the 8 pool tail-outs measured, 2 had a value of 2 (25%); 2 had a value of 3 (25%); 4 had a value of 5 (50%) (Graph 6). On this scale, a value of 1 indicates the best spawning conditions and a value of 4 the worst. Additionally, a value of 5 was assigned to tail-outs deemed unsuited for spawning due to inappropriate substrate such as bedrock, log sills, boulders, or other considerations.

Two of the 8 pool tail-outs measured had embeddedness ratings of 1 or 2. Two of the pool tail-outs had embeddedness ratings of 3 or 4. Four of the pool tail-outs had a rating of 5, which is considered unsuitable for spawning. Cobble embeddedness measured to be 25% or less, a rating of 1, is considered to indicate good quality spawning substrate for salmon and steelhead. Sediment sources in Wilson Creek should be mapped and rated according to their potential sediment yields, and control measures should be taken.

- 5) Inventory and map sources of stream bank erosion and prioritize them according to present and potential sediment yield. Identified sites should then be treated to reduce the amount of fine sediments entering the stream. Active and potential sediment sources related to the road system need to be identified, mapped, and treated according to their potential for sediment yield to the stream and its tributaries.

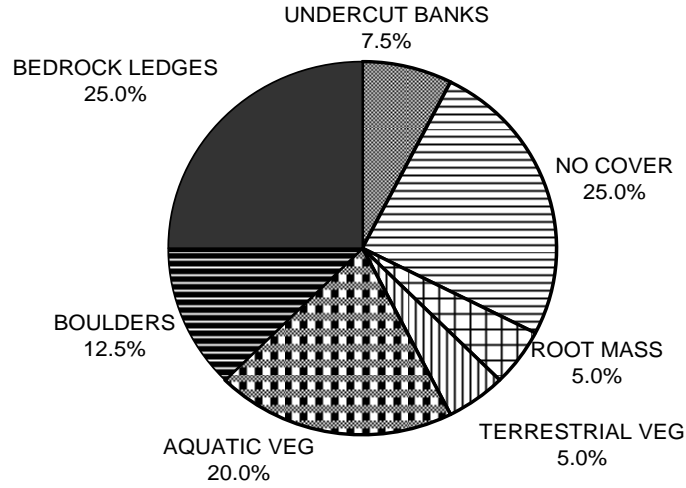
GRAPH 7

Table 5 summarizes mean percent cover by habitat type. Aquatic Vegetation is/are the dominant cover types in Wilson Creek. Graph 7 describes the pool cover in Wilson Creek. Bedrock Ledges are the dominant pool cover type followed by aquatic vegetation.

The mean shelter rating for pools was 9. The shelter rating in the flatwater habitats was 8. A pool shelter rating of approximately 100 is desirable. The amount of cover that now exists is being provided primarily by Aquatic Vegetation in Wilson Creek. Bedrock Ledges are the dominant cover type in pools followed by aquatic vegetation. Log and root wad cover structures in the pool and flatwater habitats would enhance both summer and winter salmonid habitat. Log cover structure provides rearing fry with protection from predation, rest from water velocity, and also divides territorial units to reduce density related competition.

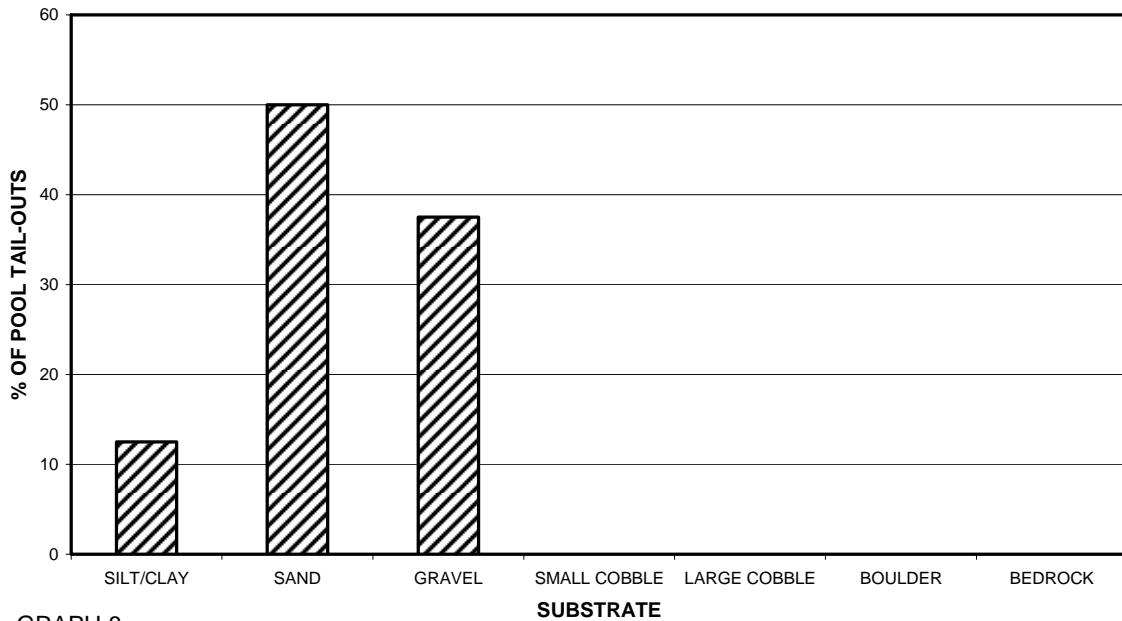
GRAPH 8

Table 6 summarizes the dominant substrate by habitat type. Graph 8 depicts the dominant substrate observed in pool tail-outs: sand observed in 50% of pool tail-outs, gravel observed in 38% of pool tail-outs.

Three of the 8 pool tail-outs measured had gravel or small cobble as the dominant substrate. This is generally considered good for spawning salmonids.

- 3) Suitable size spawning substrate on Wilson Creek is limited to relatively few reaches. Projects should be designed at suitable sites to trap and sort spawning gravel.

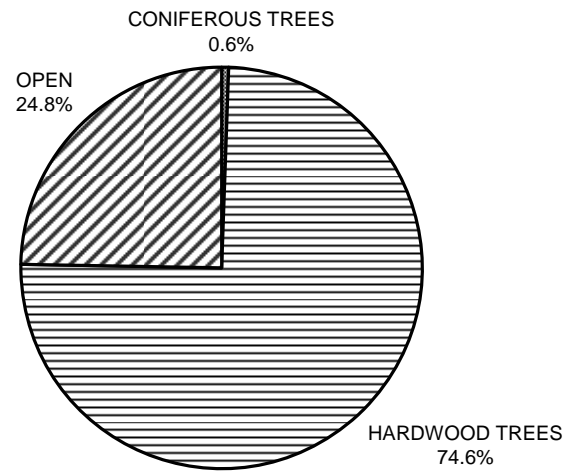
GRAPH 9

The mean percent canopy density for the surveyed length of Wilson Creek was 75%. The mean percentages of hardwood and coniferous trees were 99% and 1%, respectively. Twenty five percent of the canopy was open. Graph 9 describes the mean percent canopy in Wilson Creek.

The mean percent canopy density for the stream was 75%. In general, revegetation projects are considered when canopy density is less than 80%.

- 6) Increase the canopy throughout Wilson Creek by planting appropriate native vegetation like willow, alder, redwood, and Douglas fir along the stream where shade canopy is not at acceptable levels. The reaches above this survey section should be inventoried and treated as well, since the water flowing here is affected from upstream. In many cases, planting will need to be coordinated to follow bank stabilization or upslope erosion control projects.

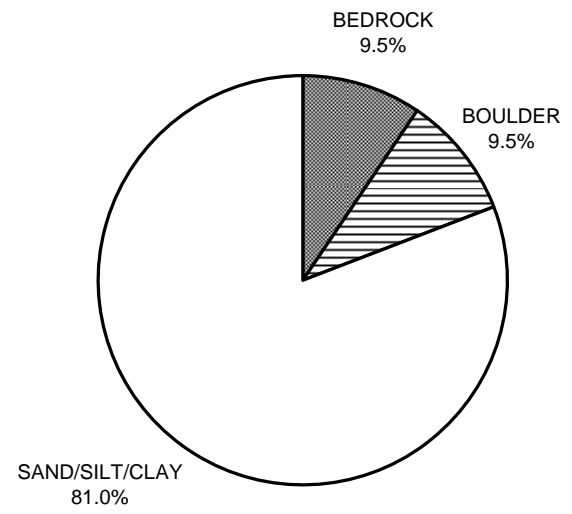
GRAPH 10

For the stream reach surveyed, the mean percent right bank vegetated was 61%. The mean percent left bank vegetated was 64%. The dominant elements composing the structure of the stream banks consisted of 10% bedrock, 10% boulder, 81% sand/silt/clay, (Graph 10). Hardwood Trees were the dominant vegetation type observed in 88% of the units surveyed. Additionally, 12% of the units surveyed had brush as the dominant vegetation type (Graph 11).

The percentage of right and left bank covered with vegetation was 61% and 64%, respectively. In areas of stream bank erosion or where bank vegetation is sparse, planting endemic species of coniferous and hardwood trees, in conjunction with bank stabilization, is recommended.
