CALIFORNIA DEPARTMENT OF FISH AND WILDLIFE

STREAM INVENTORY REPORT

“Pleasant Valley”

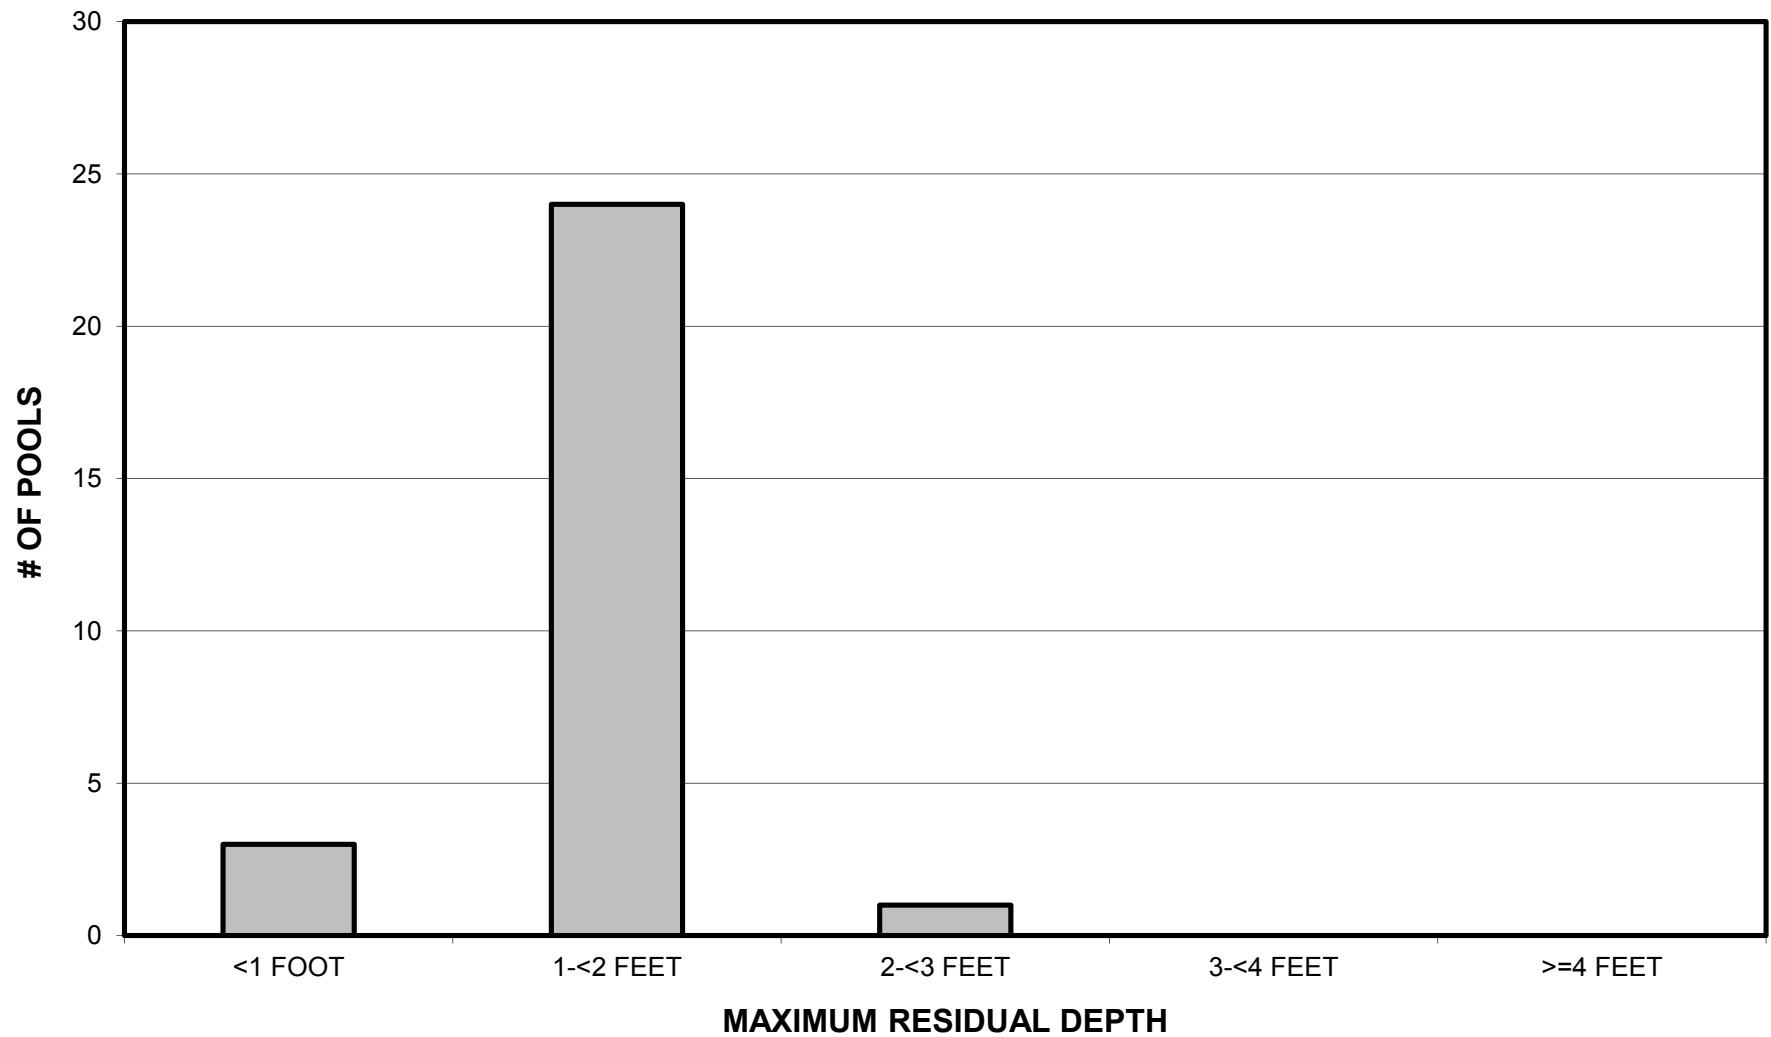
GRAPH 5

Table 4 is a summary of maximum residual pool depths by pool habitat types. Pool quality for salmonids increases with depth. One of the 28 pools (4%) had a residual depth of two feet or greater (Graph 5).

Flatwater habitat types comprised 41% of the total length of this survey, riffles 16%, and pools 14%. One of the 28 (4%) pools had a maximum residual depth greater than two feet. In general, pool enhancement projects are considered when primary pools comprise less than 40% of the length of total stream habitat. In first and second order streams, a primary pool is defined to have a maximum residual depth of at least two feet, occupy at least half the width of the low flow channel, and be as long as the low flow channel width. Installing structures that will increase or deepen pool habitat is recommended.

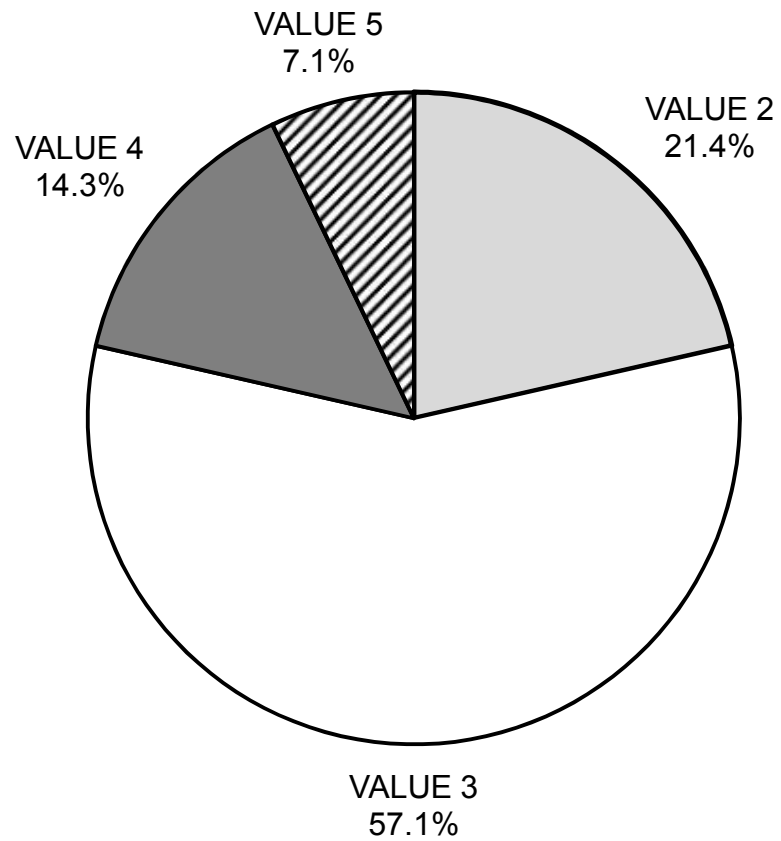
GRAPH 6

The depth of cobble embeddedness was estimated at pool tail-outs. Of the 28 pool tail-outs measured, six had a value of 2 (21.4%); 16 had a value of 3 (57.1%); four had a value of 4 (14.3%); two had a value of 5 (7.1%) (Graph 6). On this scale, a value of 1 indicates the highest quality of spawning substrate. Additionally, a value of 5 was assigned to tail-outs deemed unsuitable for spawning due to inappropriate substrate such as bedrock, log sills, boulders, or other considerations.

Six of the 28 pool tail-outs measured had embeddedness ratings of 1 or 2. Twenty of the pool tail-outs had embeddedness ratings of 3 or 4. Two of the pool tail-outs had a rating of 5, which is considered unsuitable for spawning. Cobble embeddedness measured to be 25% or less, a rating of 1, is considered to indicate good quality spawning substrate for salmon and steelhead. Sediment sources in Pleasant Valley should be mapped and rated according to their potential sediment yields, and control measures should be taken.

- 2) Inventory and map sources of stream bank erosion and prioritize them according to present and potential sediment yield. Identified sites should then be treated to reduce the amount of fine sediments entering the stream.

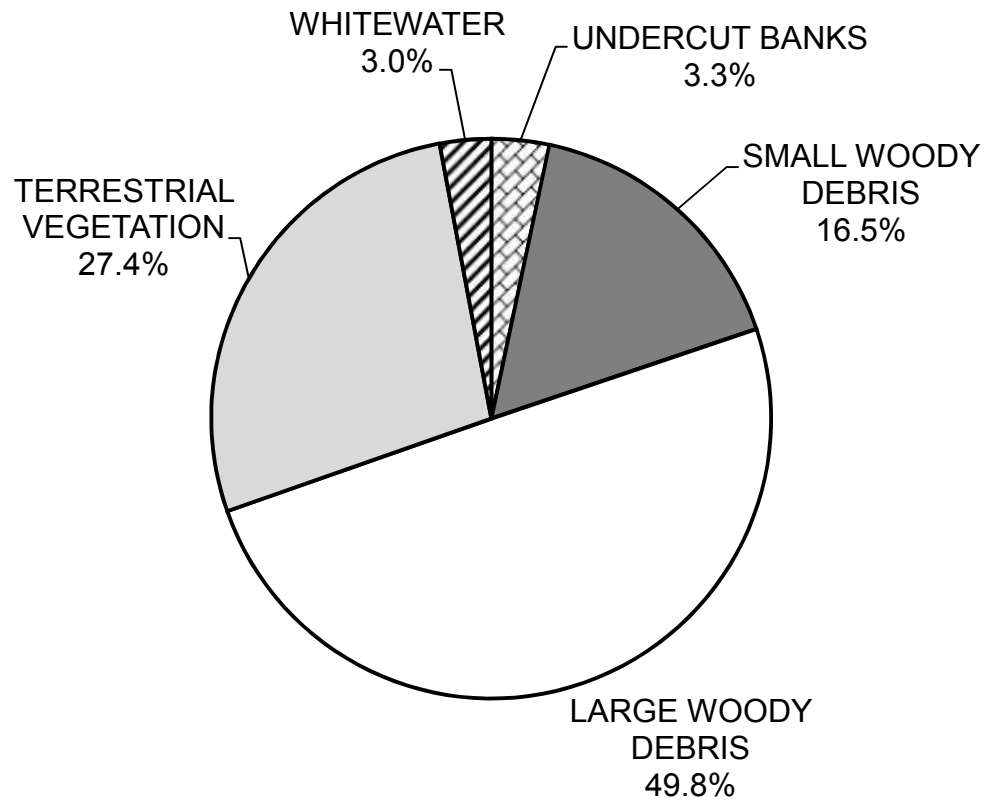
GRAPH 7

Table 5 summarizes mean percent cover by habitat type. Large woody debris is the dominant cover type in Pleasant Valley. Graph 7 describes the pool cover in Pleasant Valley. Large

woody debris is the dominant pool cover type followed by terrestrial vegetation.

The mean shelter rating for pools is 33. The shelter rating in the flatwater habitats is 19. A pool shelter rating of approximately 100 is desirable. The amount of cover that now exists is being provided primarily by large woody debris in Pleasant Valley. Large woody debris is the dominant cover type in pools followed by terrestrial vegetation. Log and root wad cover structures in the pool and flatwater habitats would enhance both summer and winter salmonid habitat. Log cover structures provide rearing fry with protection from predation, rest from water velocity, and also divide territorial units to reduce density related competition.

- 1) Increase woody cover in the pools and flatwater habitat units. Most of the existing cover in the pools is from large woody debris. Adding high quality complexity with woody cover in the pools is desirable.

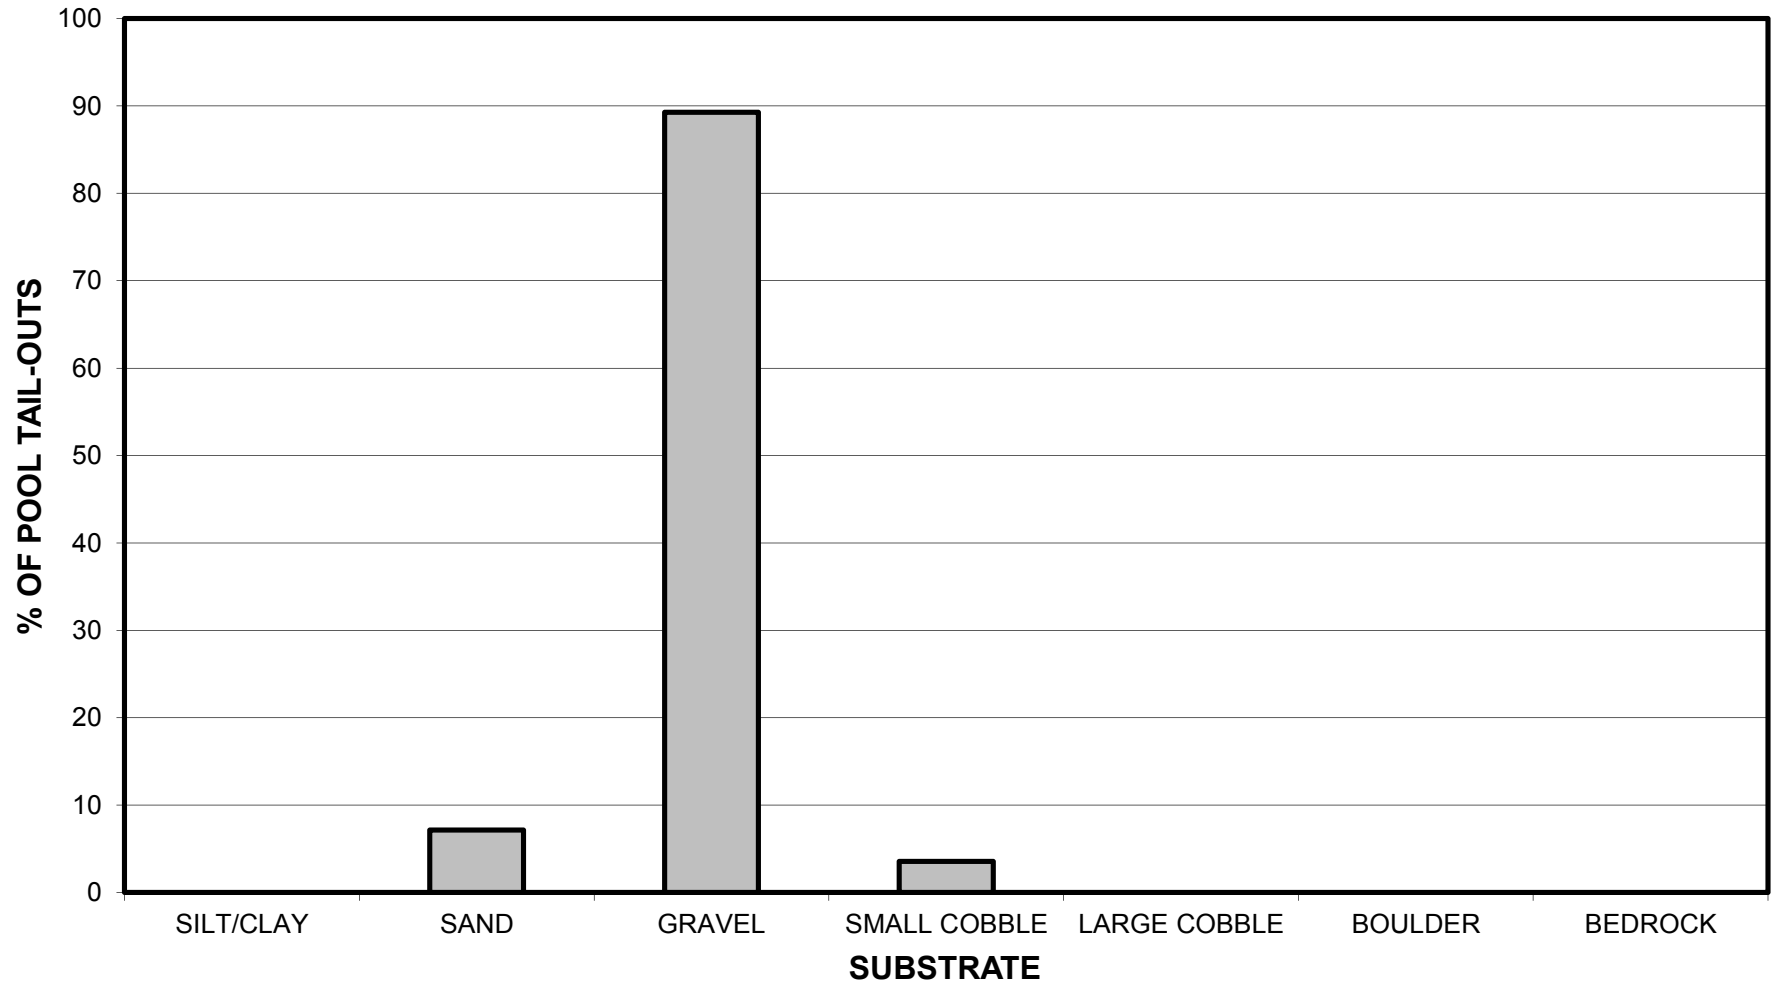
GRAPH 8

Table 6 summarizes the dominant substrate by habitat type. Graph 8 depicts the dominant substrate observed in pool tail-outs. Gravel was the dominant substrate observed in 89% of the pool tail-outs. Sand was the next most frequently observed dominant substrate type and occurred in 7% of the pool tail-outs.

Twenty-six of the 28 pool tail-outs measured had gravel or small cobble as the dominant substrate. This is generally considered good for spawning salmonids.
