CALIFORNIA DEPARTMENT OF FISH AND WILDLIFE

STREAM INVENTORY REPORT

Blanton Creek

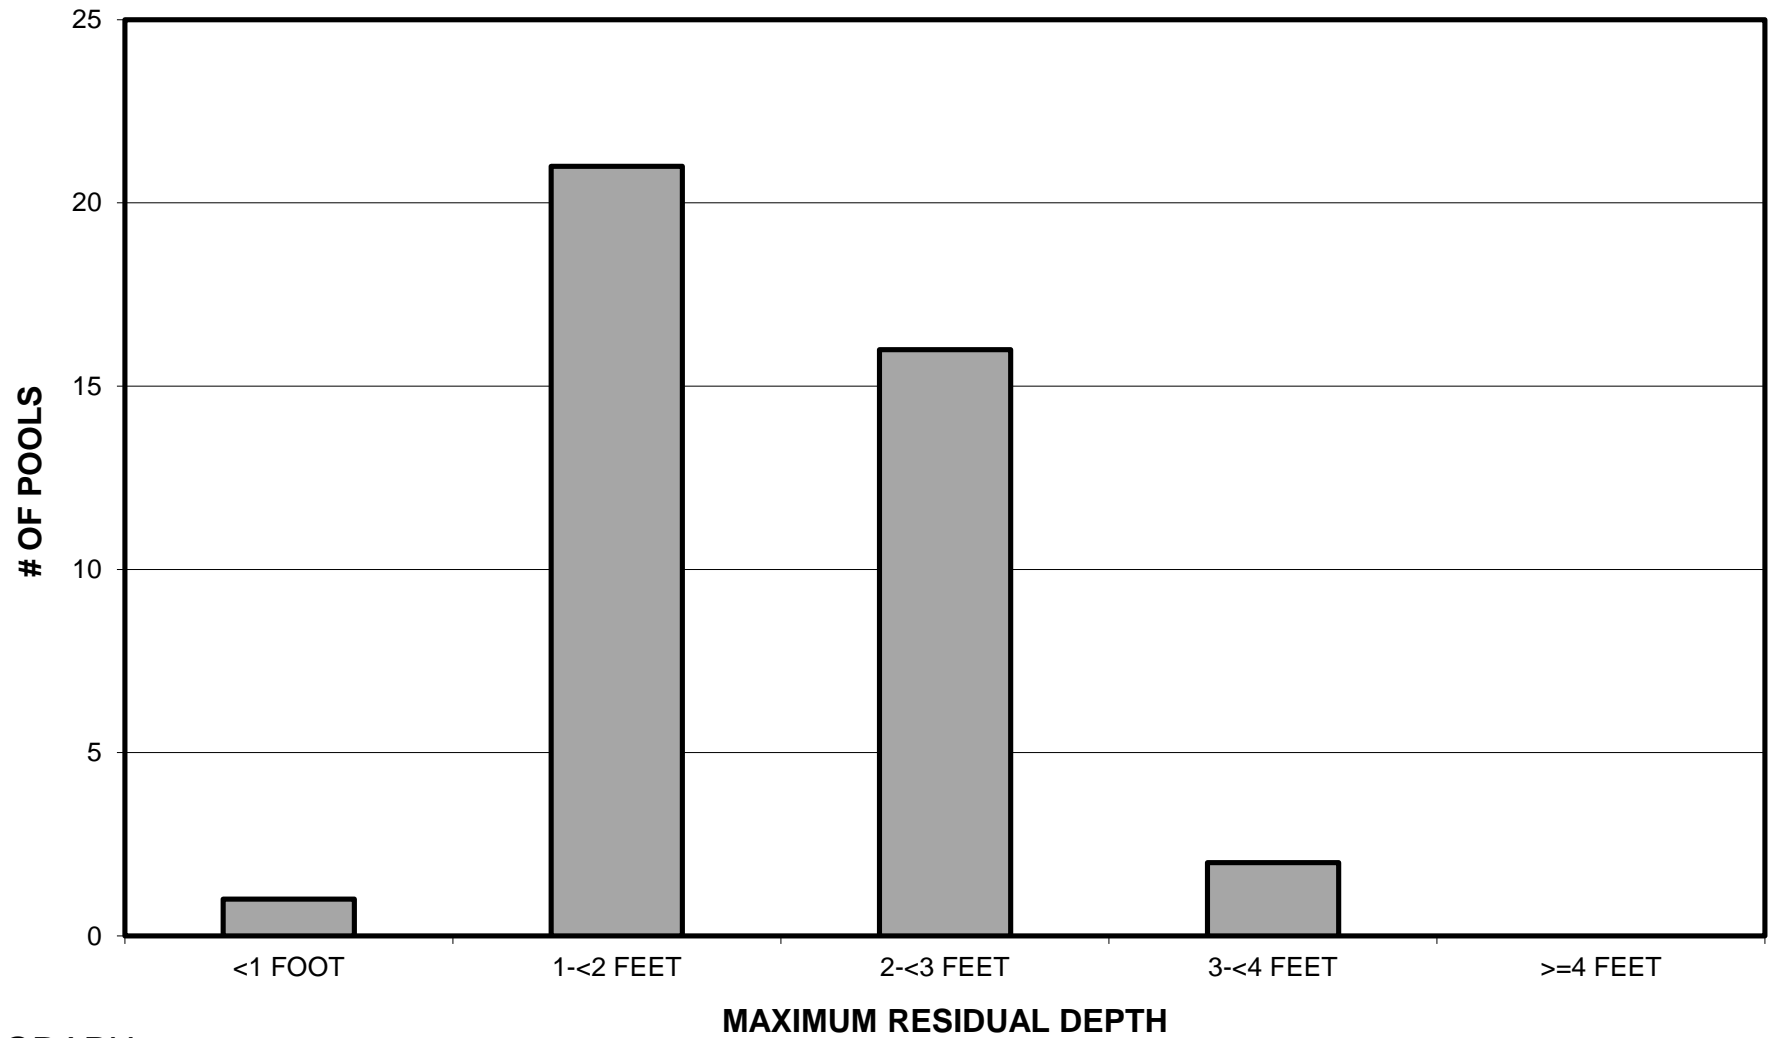
GRAPH 5

Table 4 is a summary of maximum residual pool depths by pool habitat types. Pool quality for salmonids increases with depth. Eighteen of the 40 pools (45%) had a residual depth of two feet or greater (Graph 5).

Flatwater habitat types comprised 43% of the total length of this survey, riffles 33%, and pools 24%. 18 of the 40 (45%) pools had a maximum residual depth greater than two feet. In general, pool enhancement projects are considered when primary pools comprise less than 40% of the length of total stream habitat. In first and second order streams, a primary pool is defined to have a maximum residual depth of at least two feet, occupy at least half the width of the low flow channel, and be as long as the low flow channel. Installing structures that will increase or deepen pool habitat is recommended for locations where their installation will not be threatened by high stream energy, or where their installation will not conflict with the modification of the numerous log debris accumulations (LDA's) in the stream.

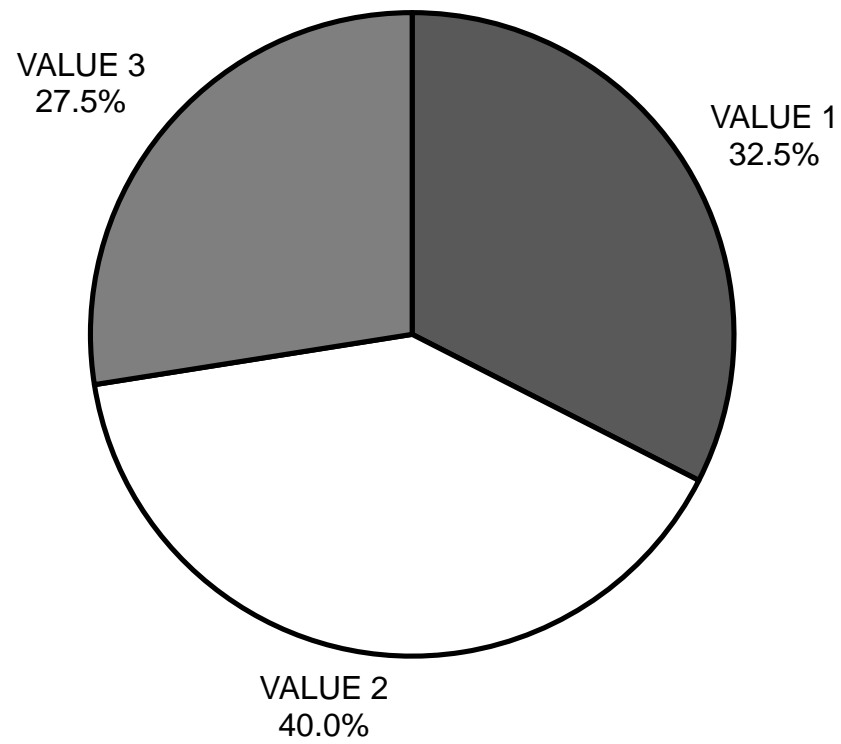
GRAPH 6

The depth of cobble embeddedness was estimated at pool tail-outs. Of the 40 pool tail-outs measured, 13 had a value of 1 (32.5%); 16 had a value of 2 (40%); 11 had a value of 3 (27.5%);

(Graph 6). On this scale, a value of 1 indicates the best spawning conditions and a value of 4 the worst. Additionally, a value of 5 was assigned to tail-outs deemed not suitable for spawning due to inappropriate substrate such as bedrock, log sills, boulders, or other considerations.

Twenty-nine of the 40 pool tail-outs measured had embeddedness ratings of 1 or 2. Eleven of the pool tail-outs had embeddedness ratings of 3 or 4. None of the pool tail-outs had a rating of

5, which is considered unsuitable for spawning. Cobble embeddedness measured to be 25% or less, a rating of 1, is considered to indicate good quality spawning substrate for salmon and steelhead. Sediment sources in Blanton Creek should be mapped and rated according to their potential sediment yields, and control measures should be taken.

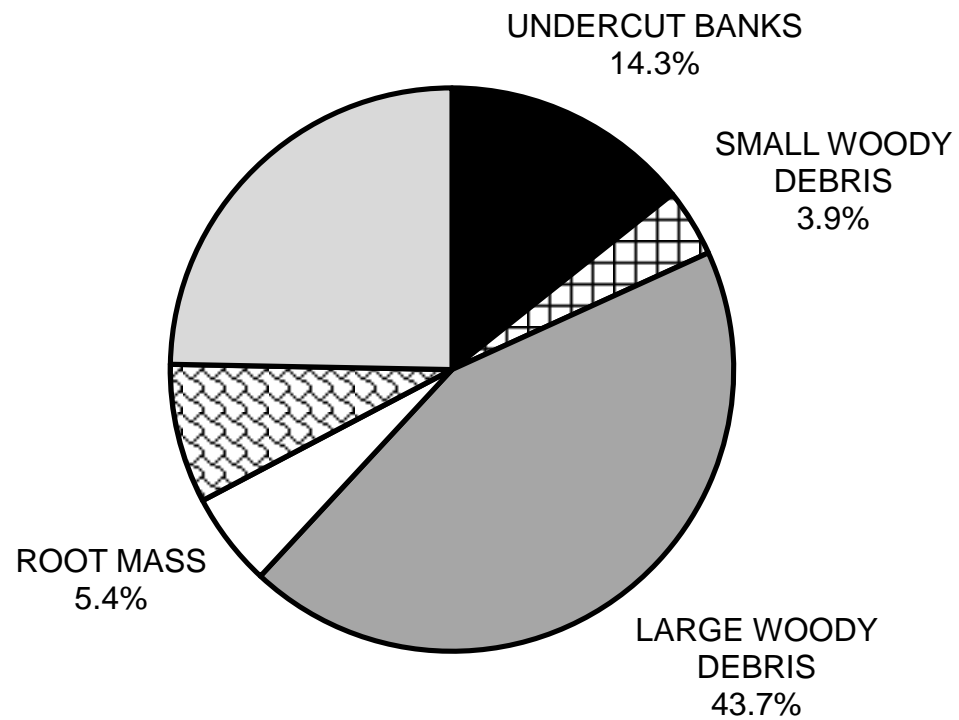
GRAPH 7

Table 5 summarizes mean percent cover by habitat type. Large woody debris is the dominant cover type in Blanton Creek. Graph 7 describes the pool cover in Blanton Creek. Large woody debris is the dominant pool cover type followed by boulders.

The mean shelter rating for pools is 56. The shelter rating in the flatwater habitats is 6. A pool shelter rating of approximately 100 is desirable. The amount of cover that now exists is being provided primarily by large woody debris in Blanton Creek. Large woody debris is the dominant cover type in pools followed by boulders. Log and root wad cover structures in the pool and flatwater habitats would enhance both summer and winter salmonid habitat. Log cover structures provide rearing fry with protection from predation, rest from water velocity, and also divide territorial units to reduce density related competition.

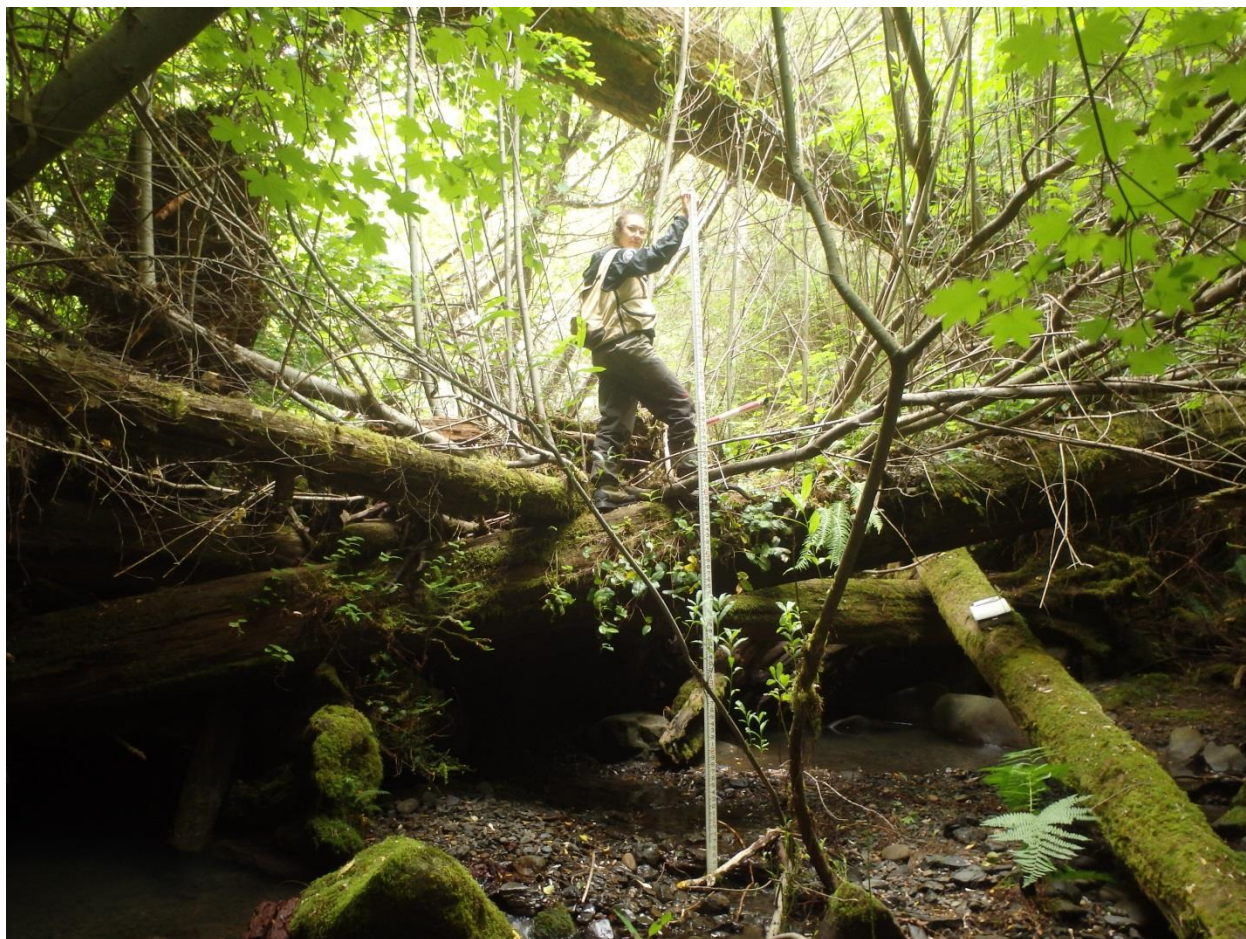
| 2772 | 0117.00 | Log debris accumulation (LDA) #1 is 7' high x 42' wide x 25' long and contains 12 pieces of large woody debris (LWD). Water flows through the LDA and there are no visible gaps in it. Sediment is being retained in the approximate dimensions of 41' wide x 37' long x 6' deep. The sediment is mostly gravel. The LDA is a possible barrier to salmonids. Fish were not observed above the LDA. |

Photo 1: LDA at habitat unit # 117. Emily Moloney pictured. (Photo taken 5-31-16)

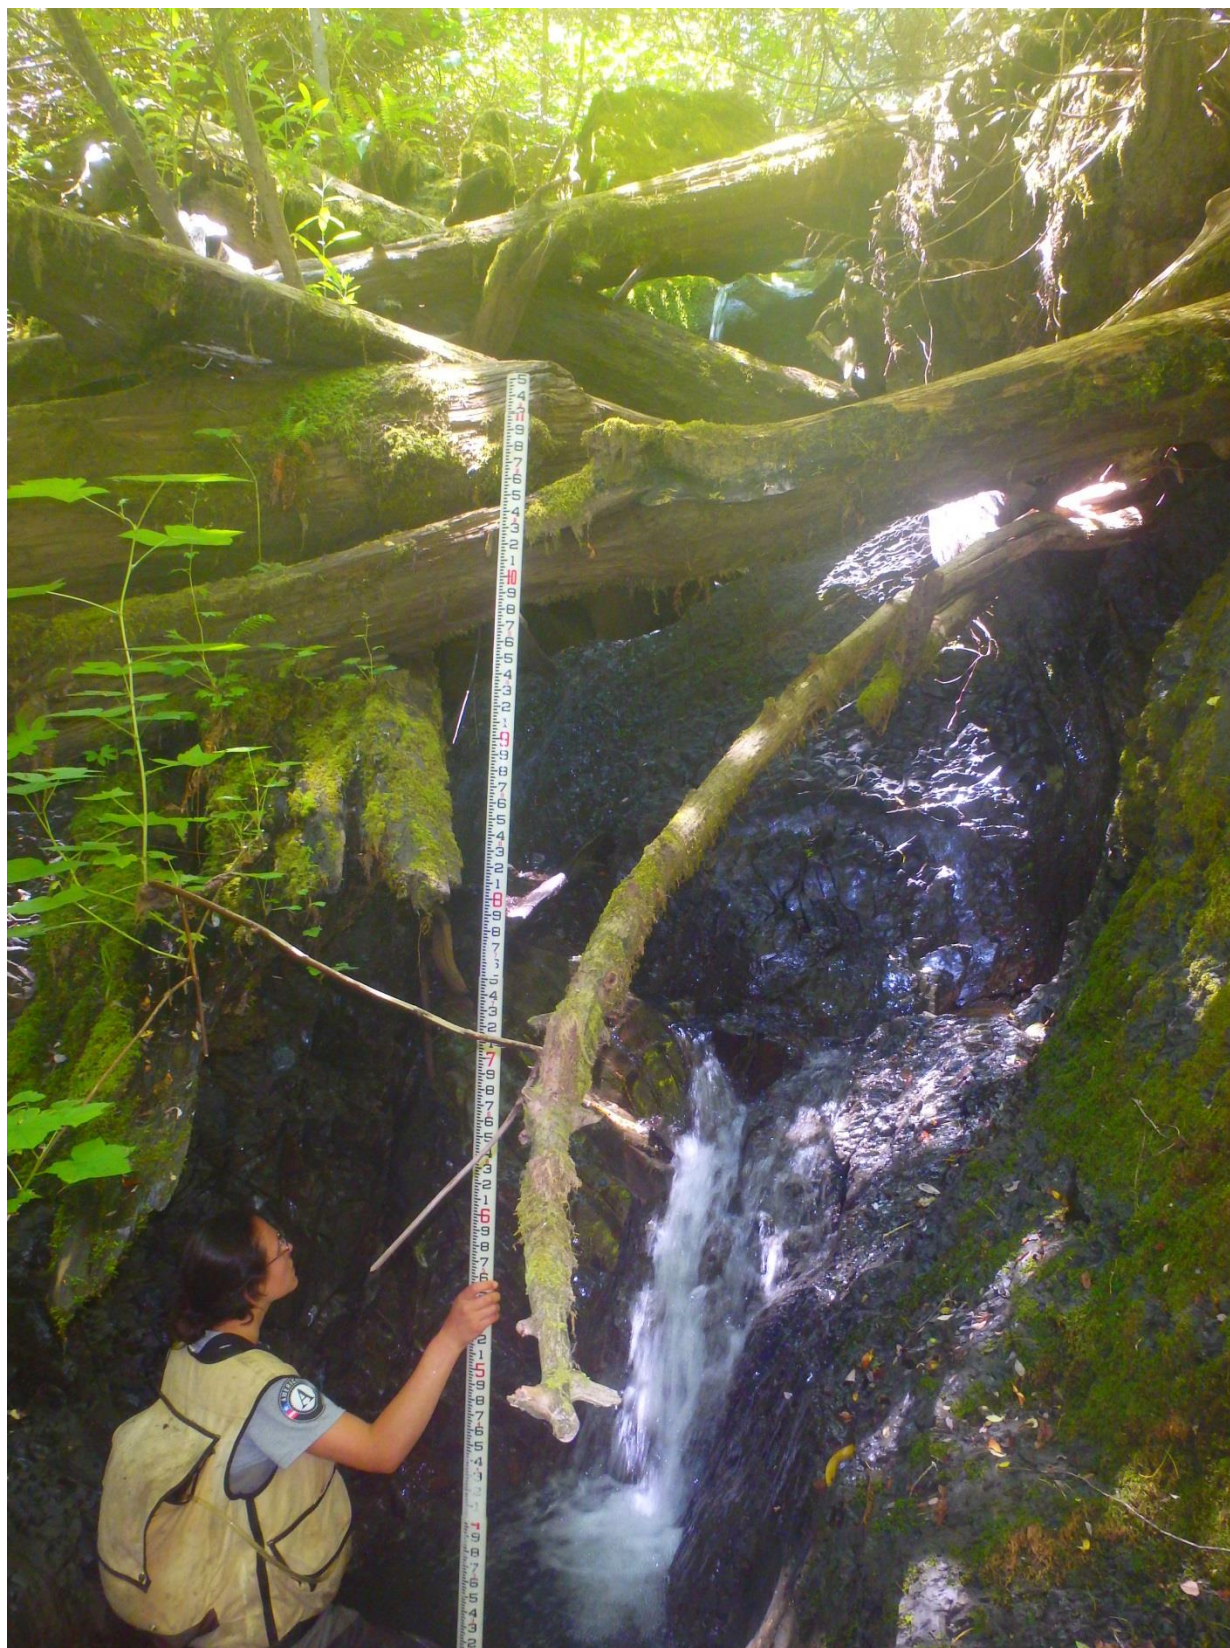
| 3841 | 0164.00 | End of survey due to a high gradient bedrock cascade, approximately 24' tall. |

Photo 2: End of survey at habitat unit # 164 at a bedrock chute and boulder cascade. The entire barrier is approximately 24' high. Emily Moloney pictured. (Photo taken 6-6-16)
