CALIFORNIA DEPARTMENT OF FISH AND WILDLIFE

STREAM INVENTORY REPORT

Bridge Creek

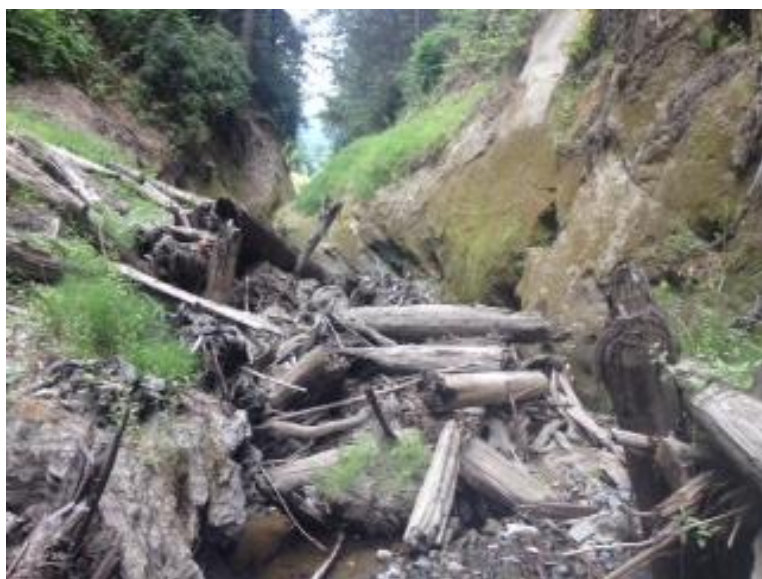
| Position (ft): | Habitat unit #: | Comments: |
|---|---|--|
| 752 | 0029.00 | There are many pieces of large wood throughout this unit. The left bank is steep. Throughout units 029-033 there is a large number of logs both within and out of bank full. Sizes range from small to large old growth root wads. Some logs have silver tags. There was a possible landslide on both sides. The log jams do not span entire bankfull at one given point so it is not a log debris accumulation (LDA), but may be a possible barrier during different seasons and/or salmonid life cycle stages. |

Photo 1: Habitat units #27-30. Large amount of woody debris accumulated in canyon (Photo taken 7-6-16).

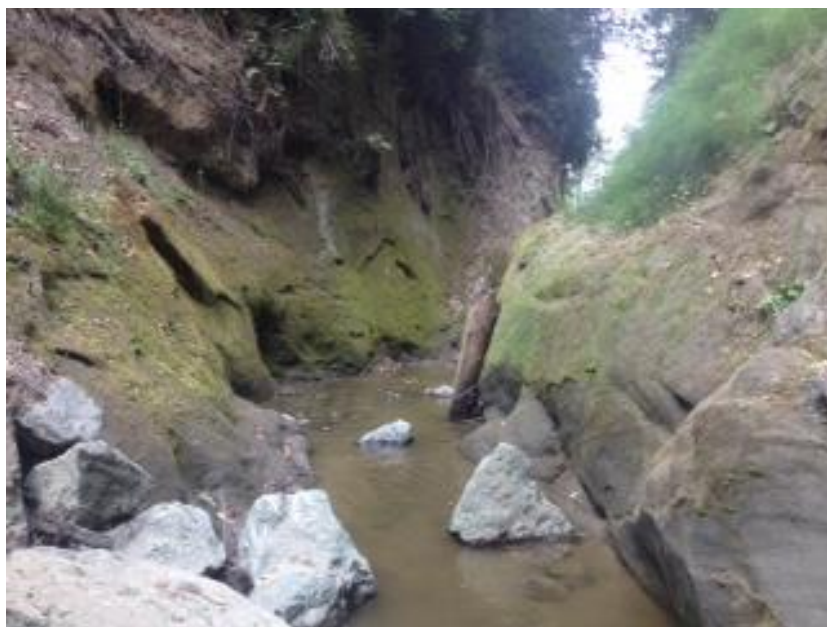
Photo 2: Habitat unit #31, upstream of woody debris (Photo taken 7-6-16).

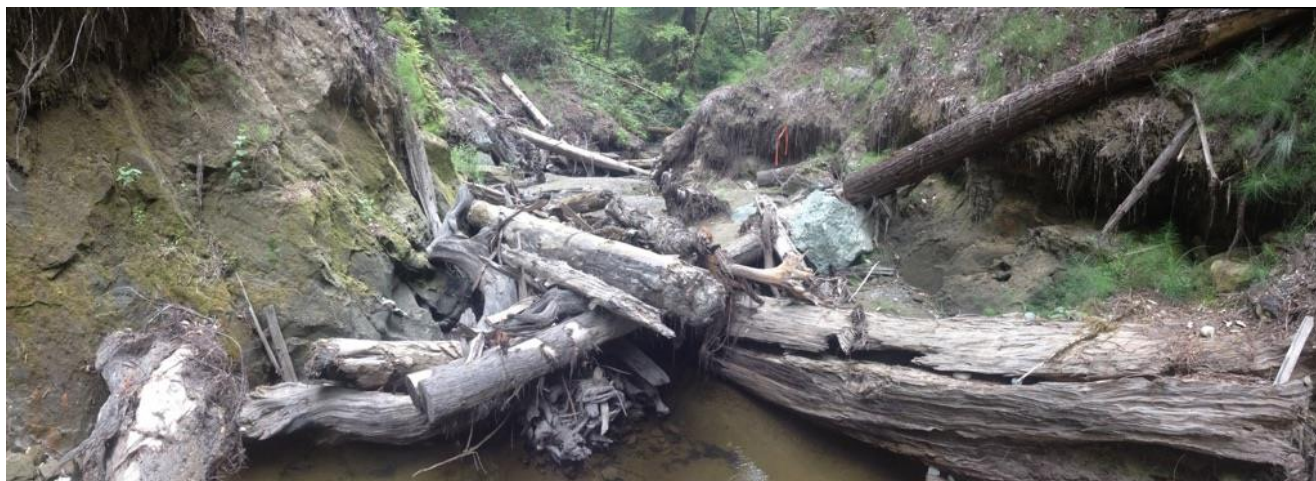
| 921 | 0040.00 | LDA #1 is 7.5' high x 24' wide x 16' long and contains 5 pieces of LWD. Water flows through the LDA and there are visible gaps in it. Sediment is being retained in the approximate dimensions of 21' wide x 18' long x 4' deep. The sediment is sand. The LDA is a possible barrier to salmonids as it has tightly knit wood. Fish were not observed above the LDA. In the event of high flows the LDA would have a plunge of about 4'. |

Photo 3: LDA#1 at habitat unit #40 (Photo taken 7-6-16).
