CALIFORNIA DEPARTMENT OF FISH AND WILDLIFE

STREAM INVENTORY REPORT

Cooper Mill Creek

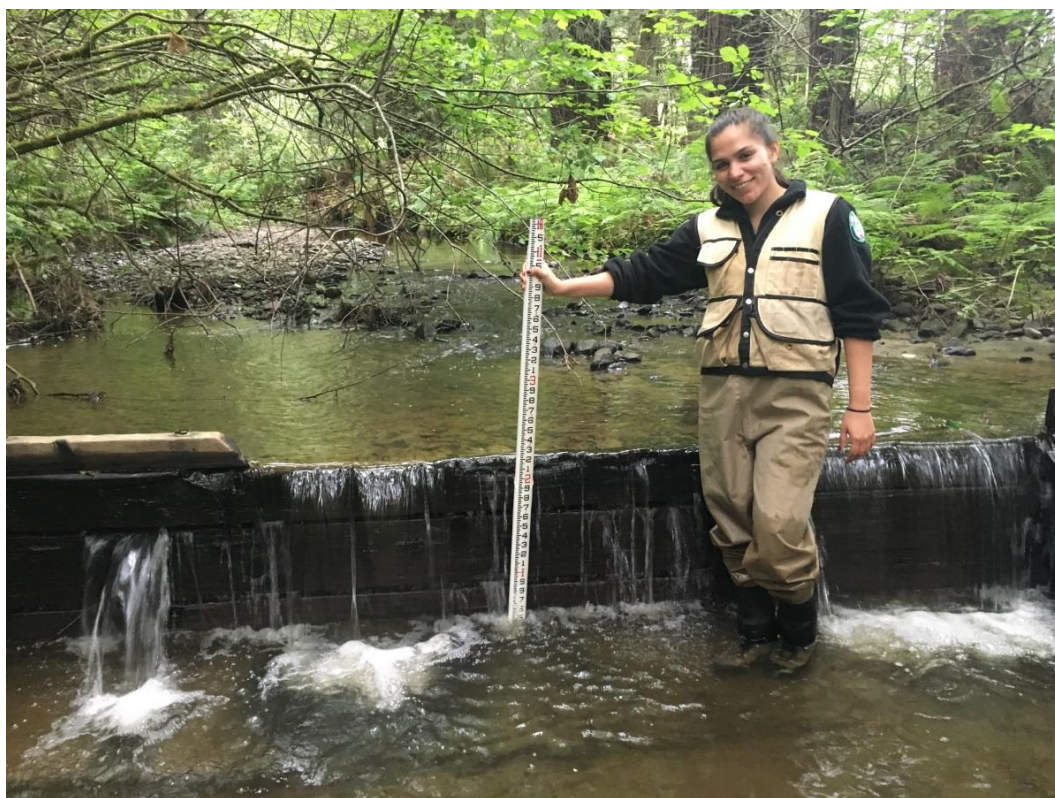
Photo 1. Wooden weir (Habitat # 0071.00) that forms seasonal barrier. Structure was formerly associated with the PALCO fish rearing facility that is no longer in use. Photo taken 5/25/2016.

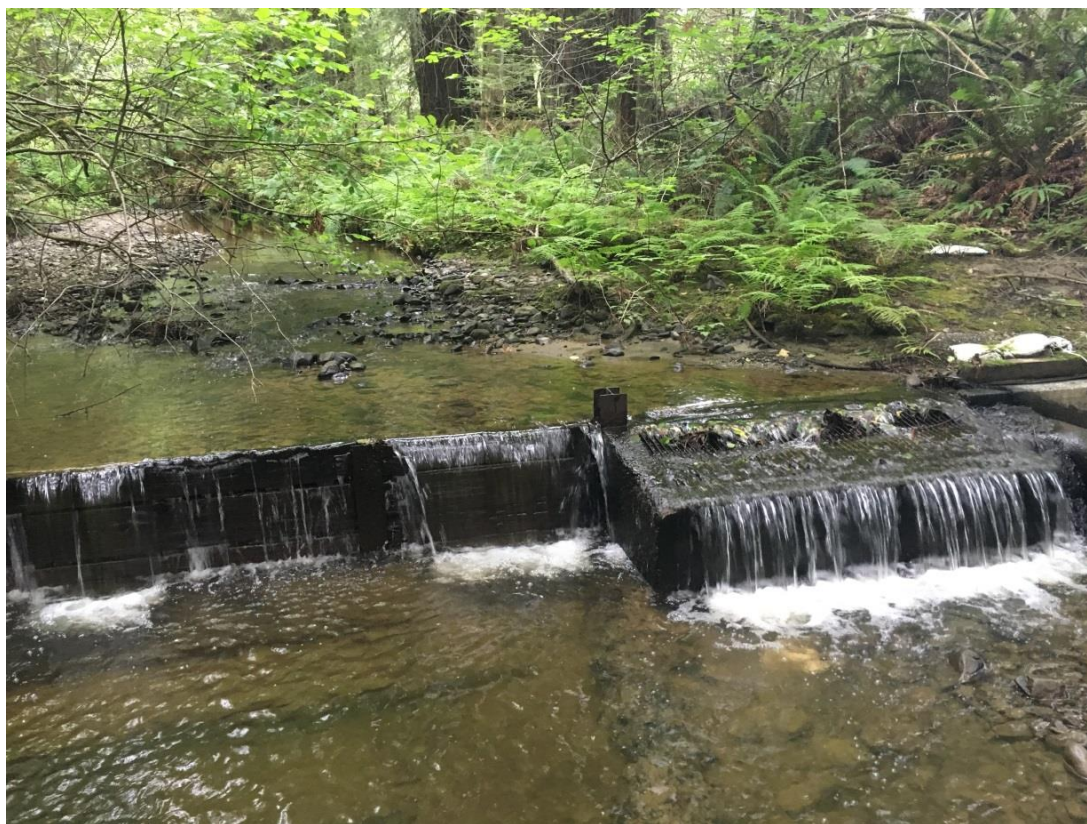
Photo 2. Same wooden weir pictured in Photo 1. Photo taken 5/25/2016.
