## CALIFORNIA DEPARTMENT OF FISH AND WILDLIFE

### STREAM INVENTORY REPORT

#### Corner Creek

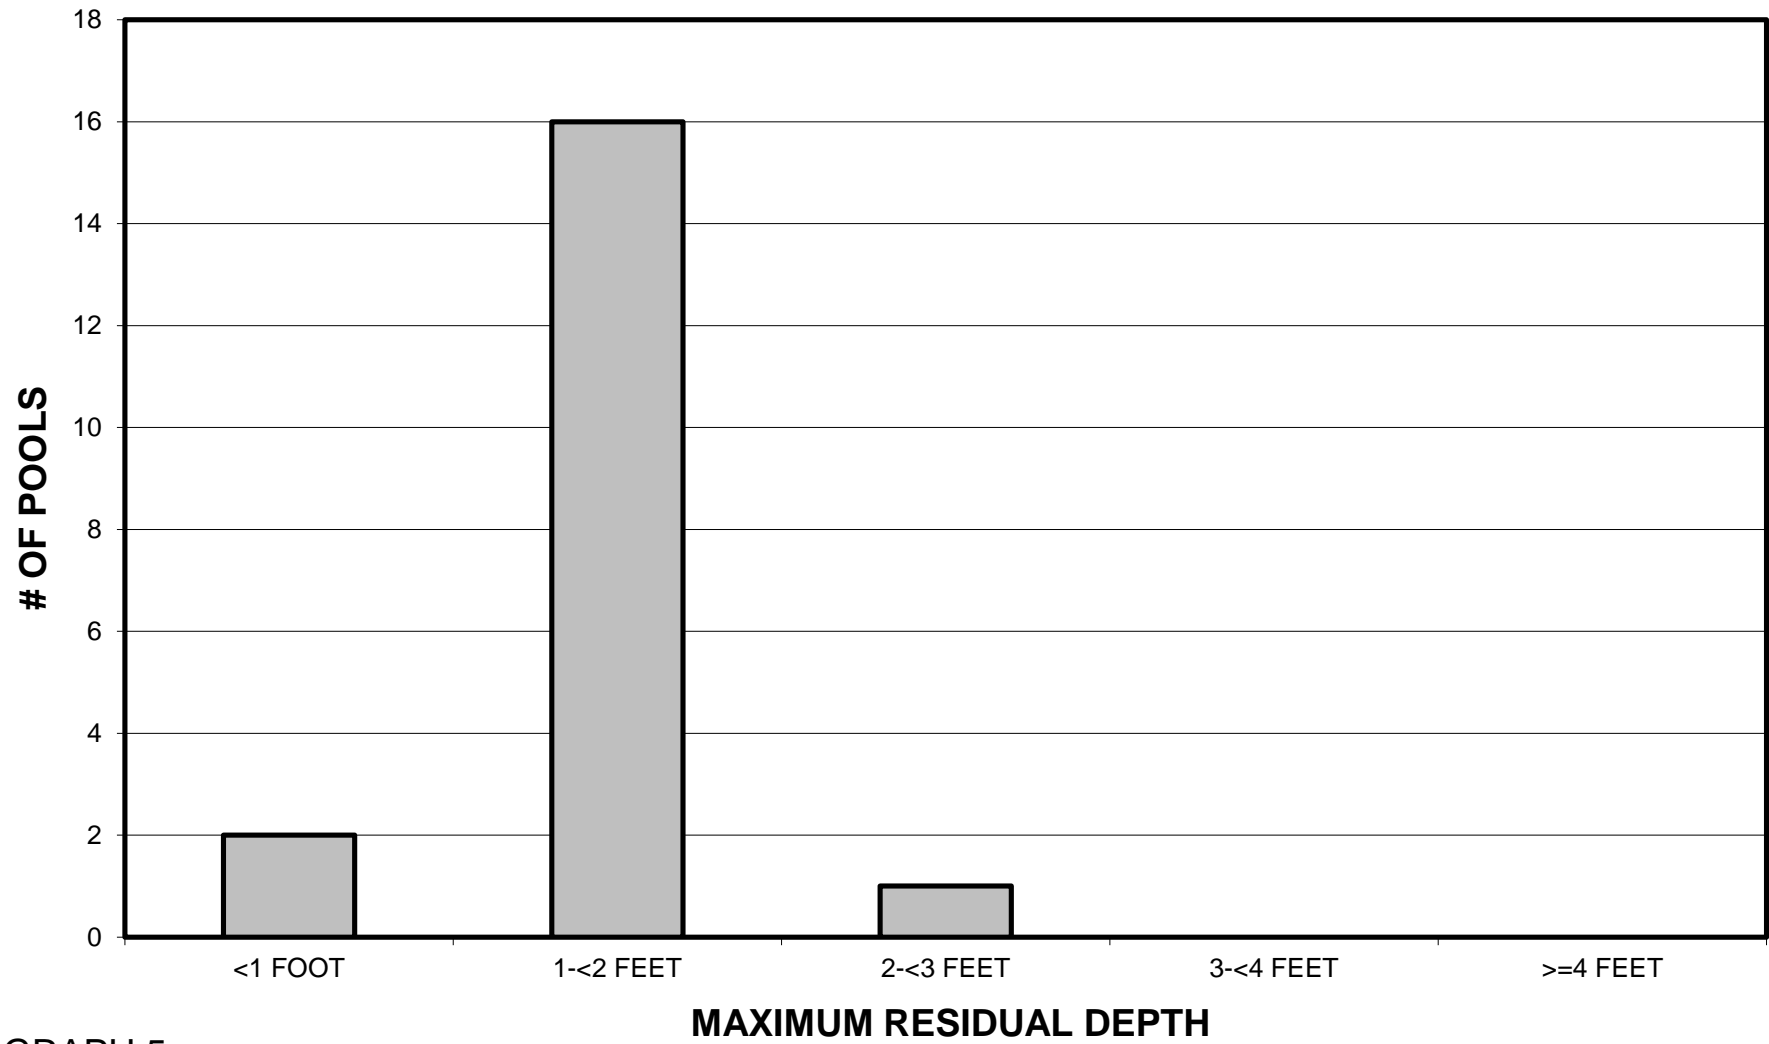
GRAPH 5

Table 4 is a summary of maximum residual pool depths by pool habitat types. Pool quality for salmonids increases with depth. One of the 19 pools (5%) had a residual depth of two feet or greater (Graph 5).

Flatwater habitat types comprised 46% of the total length of this survey, riffles 35%, and pools 19%. One of the 19 (5%) pools had a maximum residual depth greater than two feet. In general, pool enhancement projects are considered when primary pools comprise less than 40% of the length of total stream habitat. In first and second order streams, a primary pool is defined to have a maximum residual depth of at least two feet, occupy at least half the width of the low flow channel, and be as long as the low flow channel width. Installing structures that will increase or deepen pool habitat is recommended.

**CORNER CREEK 2016  
MAXIMUM DEPTH IN POOLS**

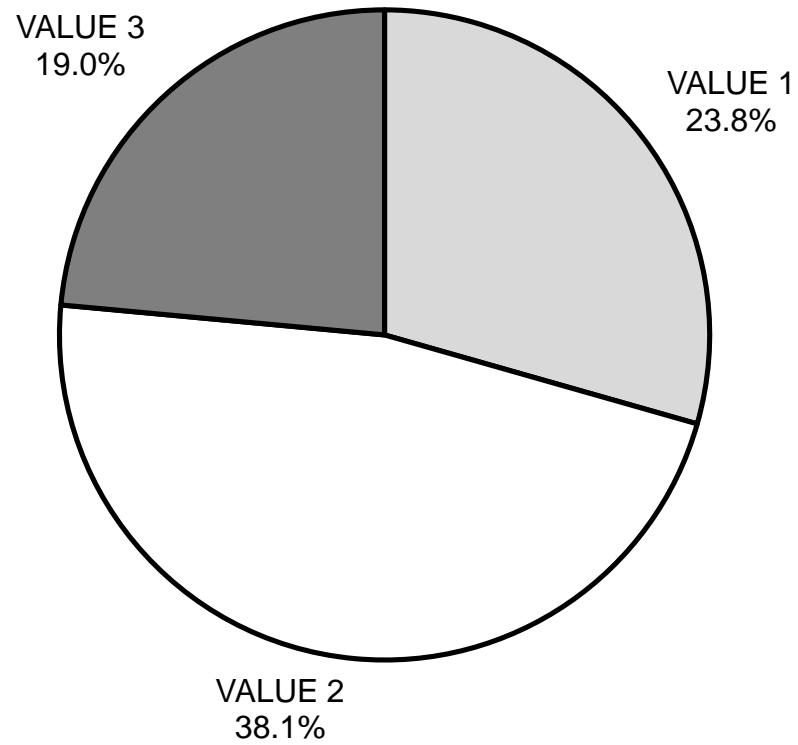
GRAPH 6

The depth of cobble embeddedness was estimated at pool tail-outs. Of the 21 pool tail-outs measured, 5 had a value of 1 (23.8%); 8 had a value of 2 (38.1%); 4 had a value of 3 (19%); and 4 had a value of 5 (19%) (Graph 6). On this scale, a value of 1 indicates the highest quality of spawning substrate. Additionally, a value of 5 was assigned to tail-outs deemed unsuitable for spawning due to inappropriate substrate such as bedrock, log sills, boulders, or other considerations.

Thirteen of the 21 pool tail-outs measured had embeddedness ratings of 1 or 2. Four of the pool tail-outs had embeddedness ratings of 3 or 4. Four of the pool tail-outs had a rating of 5, which is considered unsuitable for spawning. Cobble embeddedness measured to be 25% or less, a rating of 1, is considered to indicate good quality spawning substrate for salmon and steelhead.

# CORNER CREEK 2016 PERCENT EMBEDDEDNESS

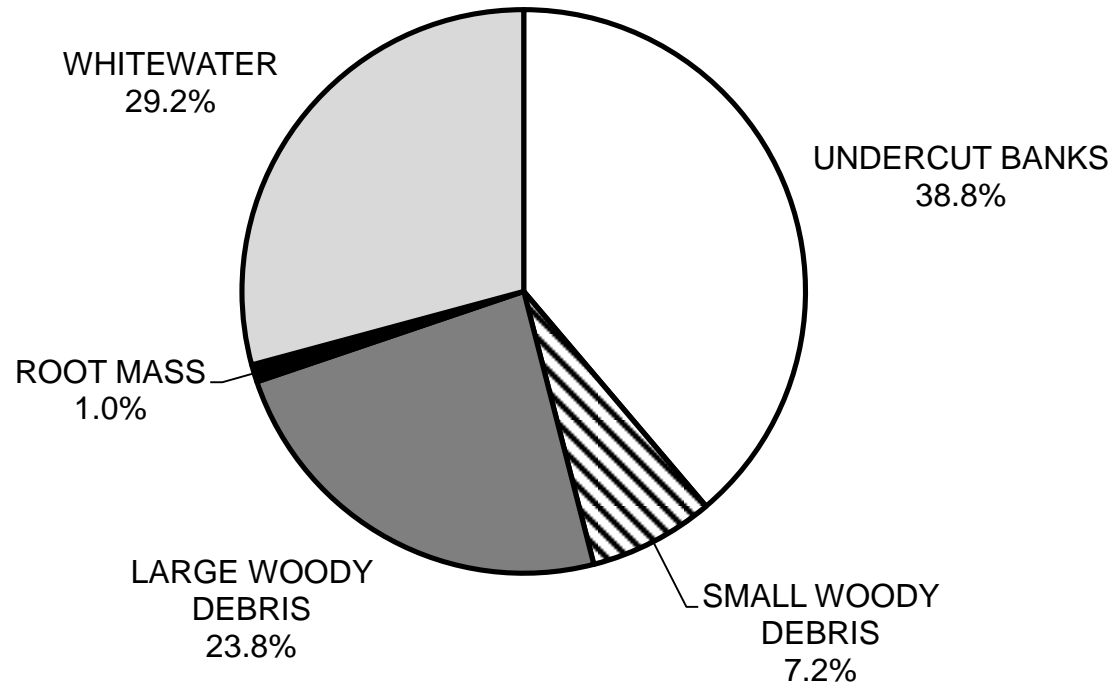
GRAPH 7

Table 5 summarizes mean percent cover by habitat type. Graph 7 describes the pool cover in Corner Creek. Undercut banks are the dominant pool cover type followed by boulders.

The mean shelter rating for pools is 41. The shelter rating in the flatwater habitats is 16. A pool shelter rating of approximately 100 is desirable. The amount of cover that now exists is being provided primarily by undercut banks in Corner Creek. Undercut banks are the dominant cover type in pools followed by boulders. Log and root wad cover structures in the pool and flatwater habitats would enhance both summer and winter salmonid habitat. Log cover structures provide rearing fry with protection from predation, rest from water velocity, and also divide territorial units to reduce density related competition.

# **CORNER CREEK 2016 MEAN PERCENT COVER TYPES IN POOLS**

- 1) Increase woody cover in the pools and flatwater habitat units. Most of the existing cover in the pools is from undercut banks. Adding high quality complexity with woody cover in the pools is desirable.
- 2) Suitable size spawning substrate on Corner Creek is limited to relatively few reaches. Projects should be designed at suitable sites to trap and sort spawning gravel.
- 3) The limited water temperature data available suggest that maximum temperatures are within the acceptable range for juvenile salmonids. To establish more complete and meaningful temperature regime information, 24-hour monitoring during the July and August temperature extreme period should be performed for three to five years.

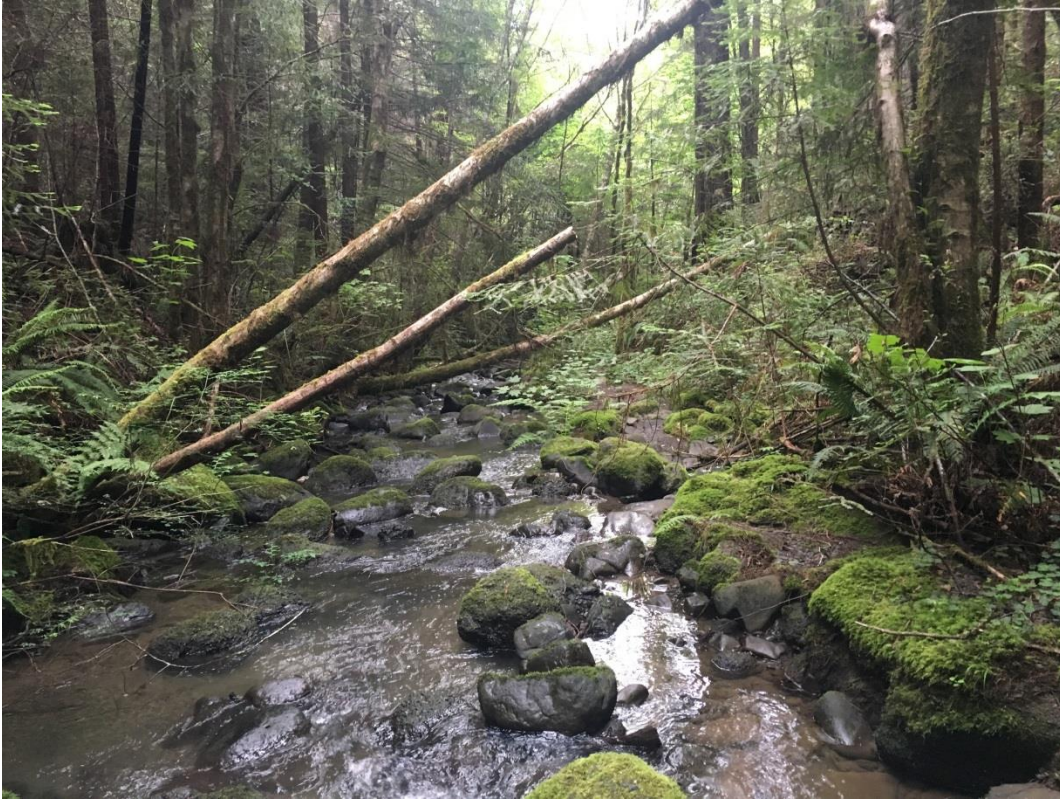
Photo 1. Lower Corner Creek (photo taken 5/24/2016).

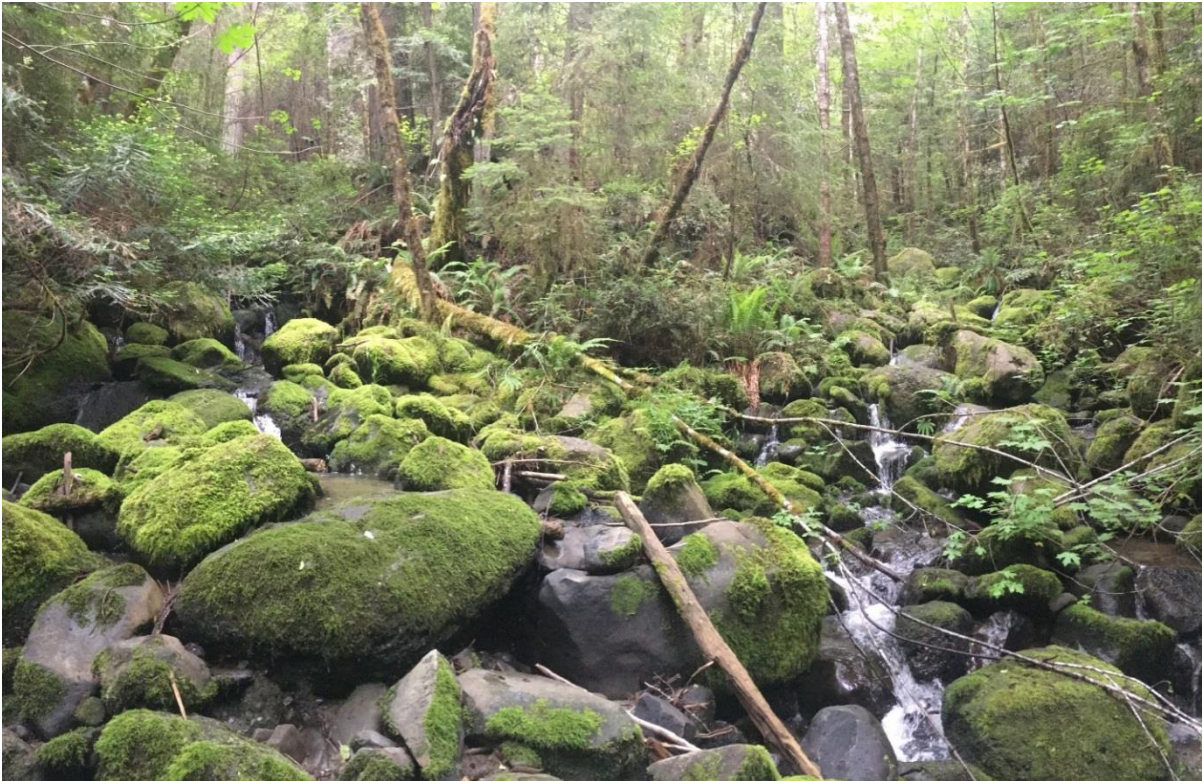
Photo 2. End of survey (Habitat Unit # 80). Channel splits into multiple channels and  $>10\%$  gradient occurs for more than 1,000 feet (photo taken 5/24/2016).
