CALIFORNIA DEPARTMENT OF FISH AND WILDLIFE

STREAM INVENTORY REPORT

West Fork Sproul Creek

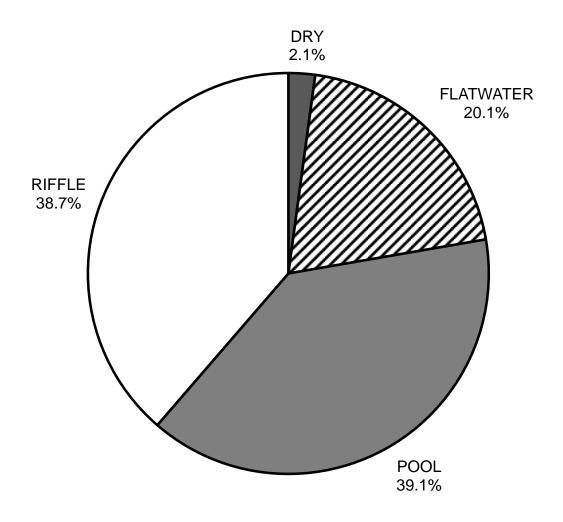
WEST FORK SPROUL CREEK 2006 HABITAT TYPES BY PERCENT OCCURRENCE

Table 1 summarizes the Level II riffle, flatwater, and pool habitat types. Based on frequency of occurrence there were 39% pool units, 39% riffle units, and 20% flatwater units (Graph 1). Based on total length of Level II habitat types there were 55% pool units, 23% riffle units, and 21% flatwater units (Graph 2).

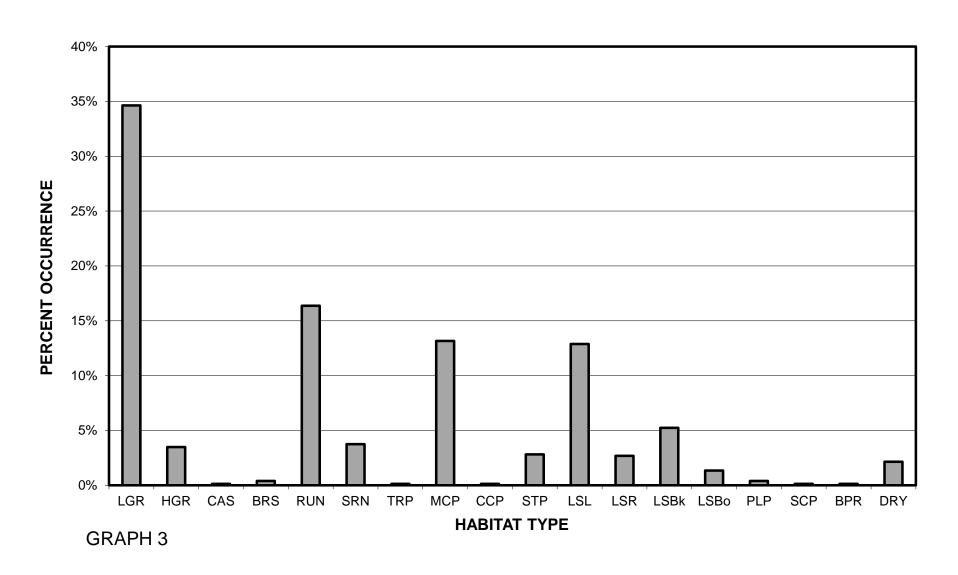
WEST FORK SPROUL CREEK 2006 HABITAT TYPES BY PERCENT OCCURRENCE

Eighteen-Level IV habitat types were identified (Table 2). The most frequent habitat types by percent occurrence were low gradient riffle units, 35%; run units, 16%; mid-channel pool units, 13%; lateral scour pool-log enhanced units, 13%. (Graph 3). Based on percent total length, low gradient riffle units made up 21%, mid-channel pool units 20%, and run units 17%.

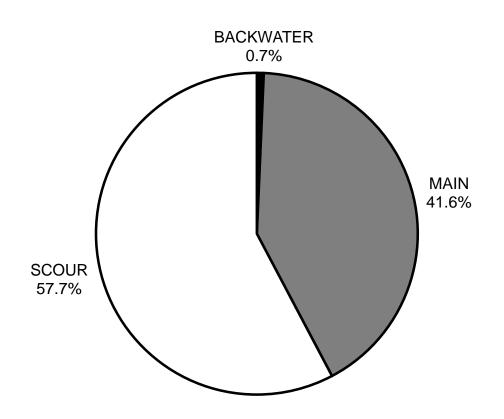
WEST FORK SPROUL CREEK 2006 POOL TYPES BY PERCENT OCCURRENCE

A total of 291 pools were identified (Table 3). Scour pools were the most frequently encountered at 58% (Graph 4), and comprised 52% of the total length of all pools (Table 3).

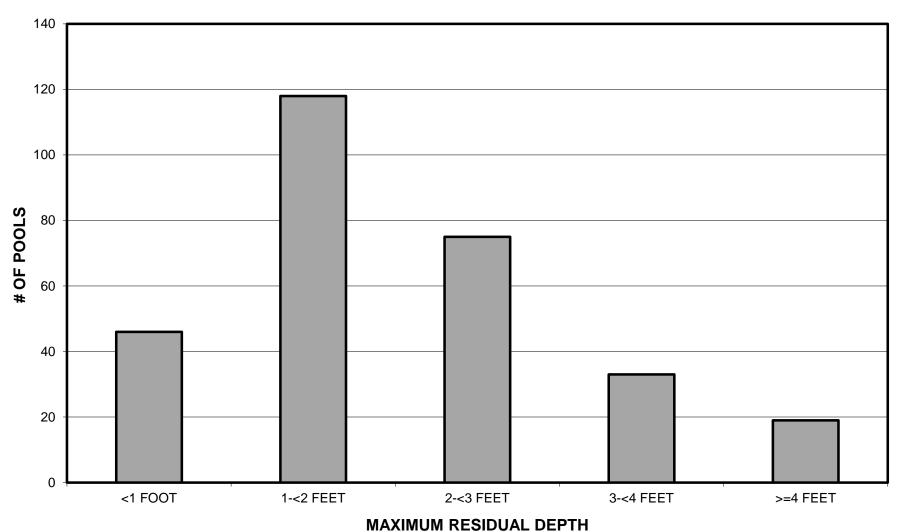
GRAPH 5

Table 4 is a summary of maximum residual pool depths by pool habitat types. Pool quality for salmonids increases with depth. One hundred twenty-seven of the 291 pools (44%) had a residual depth of two feet or greater (Graph 5).

Flatwater habitat types comprised 21% of the total length of this survey, riffles 23%, and pools 55%. One hundred twenty-seven of the 291 (44%) pools had a maximum residual depth greater than two feet. In general, pool enhancement projects are considered when primary pools comprise less than 40% of the length of total stream habitat. In first and second order streams, a

primary pool is defined to have a maximum residual depth of at least two feet, occupy at least half the width of the low flow channel, and be as long as the low flow channel width. Installing structures that will increase or deepen pool habitat is recommended.

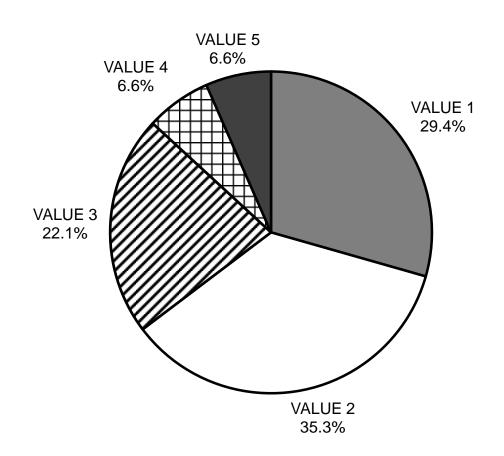
WEST FORK SPROUL CREEK 2006 PERCENT EMBEDDEDNESS

The depth of cobble embeddedness was estimated at pool tail-outs. Of the 289 pool tail-outs measured, 85 had a value of 1 (29.4%); 102 had a value of 2 (35.3%); 64 had a value of 3

(22.1%); 19 had a value of 4 (6.6%); 19 had a value of 5 (6.6%) (Graph 6). On this scale, a value of 1 indicates the best spawning conditions and a value of 4 the worst. Additionally, a value of 5 was assigned to tail-outs deemed not suitable for spawning due to inappropriate substrate such as bedrock, log sills, boulders, or other considerations.

One hundred eighty-seven of the 291 pool tail-outs measured had embeddedness ratings of 1 or 2. Eighty-three of the pool tail-outs had embeddedness ratings of 3 or 4. Nineteen of the pool tail-outs had a rating of 5, which is considered unsuitable for spawning. Cobble embeddedness measured to be 25% or less, a rating of 1, is considered to indicate good quality spawning substrate for salmon and steelhead. Sediment sources in West Fork Sproul Creek should be mapped and rated according to their potential sediment yields, and control measures should be taken.

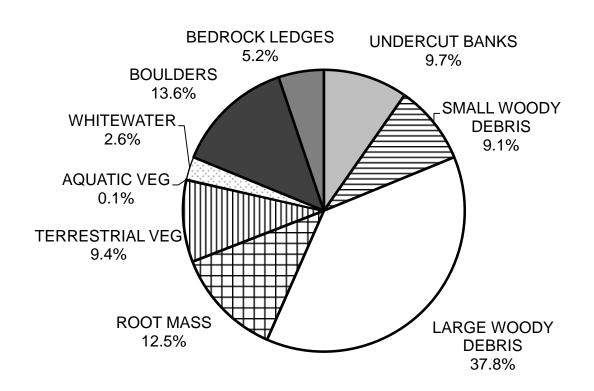
WEST FORK SPROUL CREEK 2006 MEAN PERCENT COVER TYPES IN POOLS

Table 5 summarizes mean percent cover by habitat type. Large woody debris is the dominant cover type in West Fork Sproul Creek. Graph 7 describes the pool cover in West Fork Sproul Creek. Large woody debris is the dominant pool cover type followed by boulders.

The mean shelter rating for pools is 35. The shelter rating in the flatwater habitats is 14. A pool shelter rating of approximately 100 is desirable. The amount of cover that now exists is being provided primarily by large woody debris in West Fork Sproul Creek. Large woody debris is the dominant cover type in pools followed by boulders. Log and root wad cover structures in the pool and flatwater habitats would enhance both summer and winter salmonid habitat. Log cover structures provide rearing fry with protection from predation, rest from water velocity, and also divide territorial units to reduce density related competition.

- 1) Increase woody cover in the pools and flatwater habitat units. Most of the existing cover in the pools is from large woody debris. Adding high quality complexity with woody cover in the pools is desirable.
- 2) Active and potential sediment sources related to the road system need to be identified, mapped, and treated according to their potential for sediment yield to the stream and its tributaries.

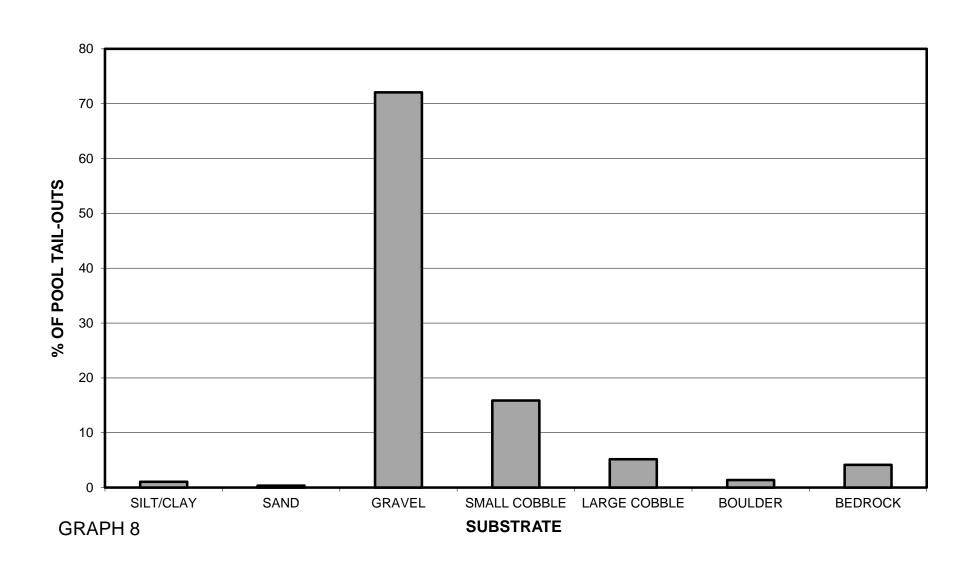
WEST FORK SPROUL CREEK 2006 SUBSTRATE COMPOSITION IN POOL TAIL-OUTS

Table 6 summarizes the dominant substrate by habitat type. Graph 8 depicts the dominant substrate observed in pool tail-outs. Gravel was the dominant substrate observed in 72% of pool tail-outs. Small cobble was the next most frequently observed dominant substrate type and occurred in 16% of pool tail-outs.

Two hundred fifty-five of the 291 pool tail-outs measured had gravel or small cobble as the dominant substrate. This is generally considered good for spawning salmonids.

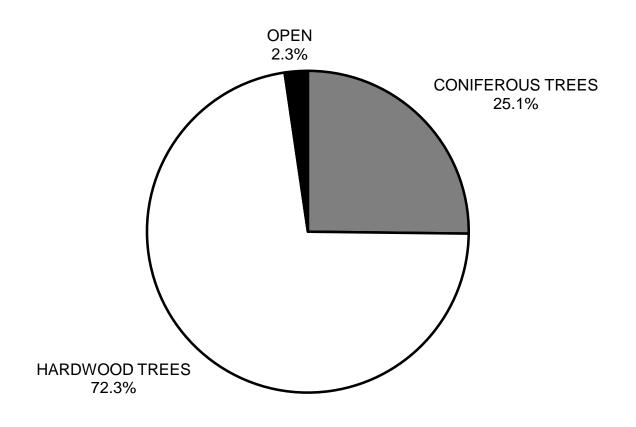
WEST FORK SPROUL CREEK 2006 MEAN PERCENT CANOPY

The mean percent canopy density for the surveyed length of West Fork Sproul Creek was 98%. Two percent of the canopy was open. Of the canopy present, the mean percentages of hardwood and coniferous trees were 74% and 26%, respectively. Graph 9 describes the mean percent canopy in West Fork Sproul Creek.

The mean percent canopy density for the stream was 98%. Reach 1 had a canopy density of 97%, Reach 2 had a canopy density of 98%, and Reach 3 had a canopy density of 97%. The percentage of right and left bank covered with vegetation was 99% and 99%, respectively.

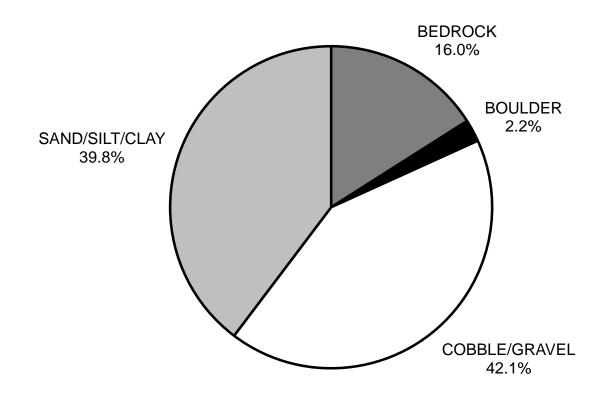
WEST FORK SPROUL CREEK 2006 DOMINANT BANK COMPOSITION IN SURVEY REACH

For the stream reach surveyed, the mean percent right bank vegetated was 99%. The mean percent left bank vegetated was 99%. The dominant elements composing the structure of the stream banks consisted of 42% cobble/gravel, 40% sand/silt/clay, 16% bedrock, and 2% boulder. (Graph 10). Deciduous trees were the dominant vegetation type observed in 77% of the units surveyed. Additionally, 17% of the units surveyed had coniferous trees as the dominant vegetation type, and 6% had brush as the dominant vegetation type (Graph 11).

- 3) Inventory and map sources of stream bank erosion and prioritize them according to present and potential sediment yield. Identified sites should then be treated to reduce the amount of fine sediments entering the stream.
- 4) The limited water temperature data available suggest that maximum temperatures are within the acceptable range for juvenile salmonids. To establish more complete and meaningful temperature regime information, 24-hour monitoring during the July and August temperature extreme period should be performed for 3 to 5 years.
