## CALIFORNIA DEPARTMENT OF FISH AND WILDLIFE

### STREAM INVENTORY REPORT

#### Noyo River

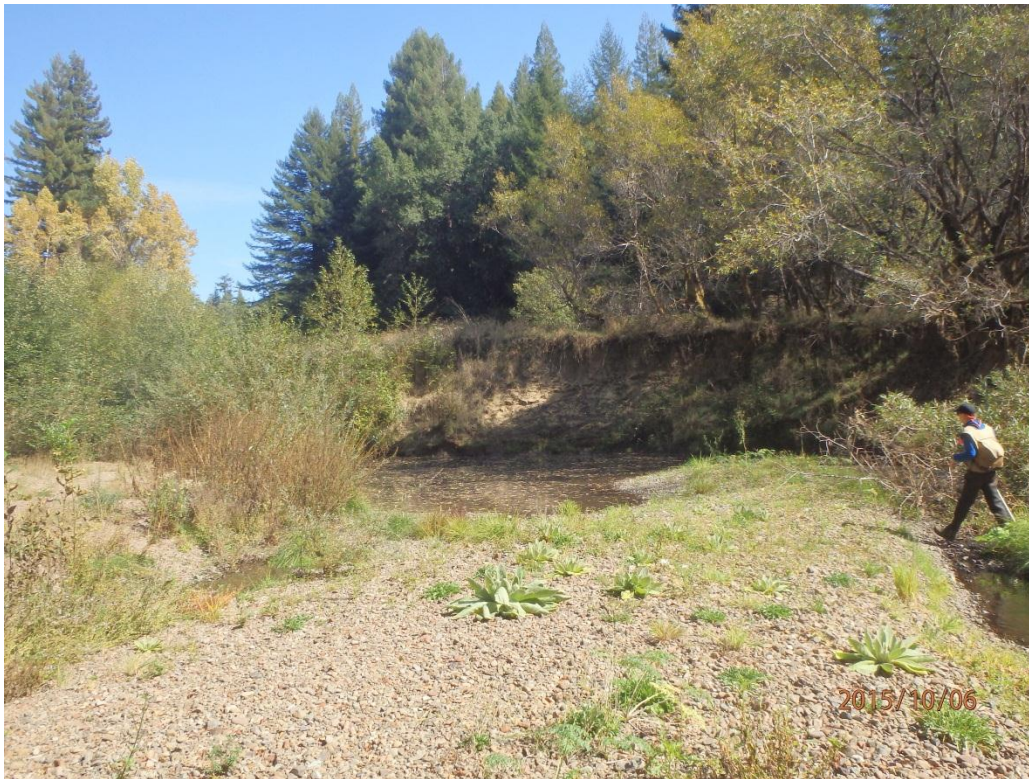
26785	0181.00	Right bank beach at property. Extremely steep. Dry left bank tributary but can hear water higher up. Probably water fall in winter.
27598	0185.00	Left bank erosion is 130' long x 15' high and is active.
28197	0189.00	Bridge #4 is the crossing for an unnamed road, and is 23' high x 12' wide x 123' long. It is an automobile bridge (made of steel and concrete) and is not a barrier to salmonids.
29651	0199.00	Left bank tributary is dry.
30850	0203.00	Redd flags from spawner season at the top of riffle.
32103	0206.02	Dry right bank tributary with two clogged, degraded culverts 40' up the bank.

Photo 2: Active erosion site at habitat unit #185, 27,725' upstream of SOS. Dave Lam pictured (Photo taken 10/6/15).

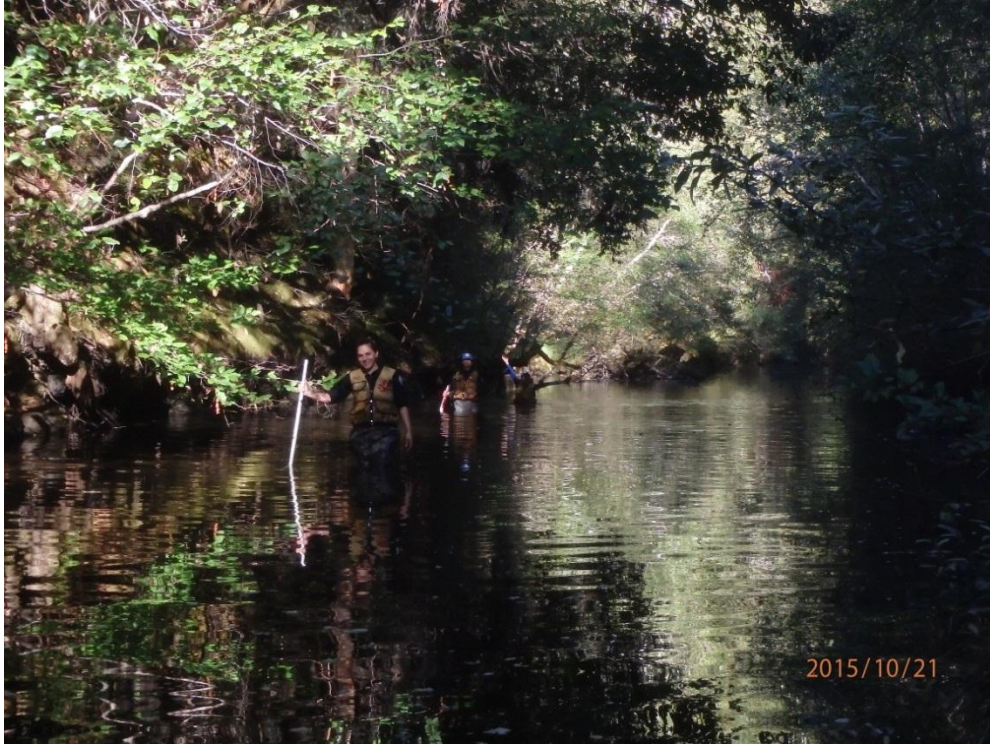
Photo 3: Extensive pool at habitat unit #410, 61,198' upstream of SOS. Nicole Bejar, Emily Moloney, and Alejandra Camacho pictured. (Photo taken 10/21/15)

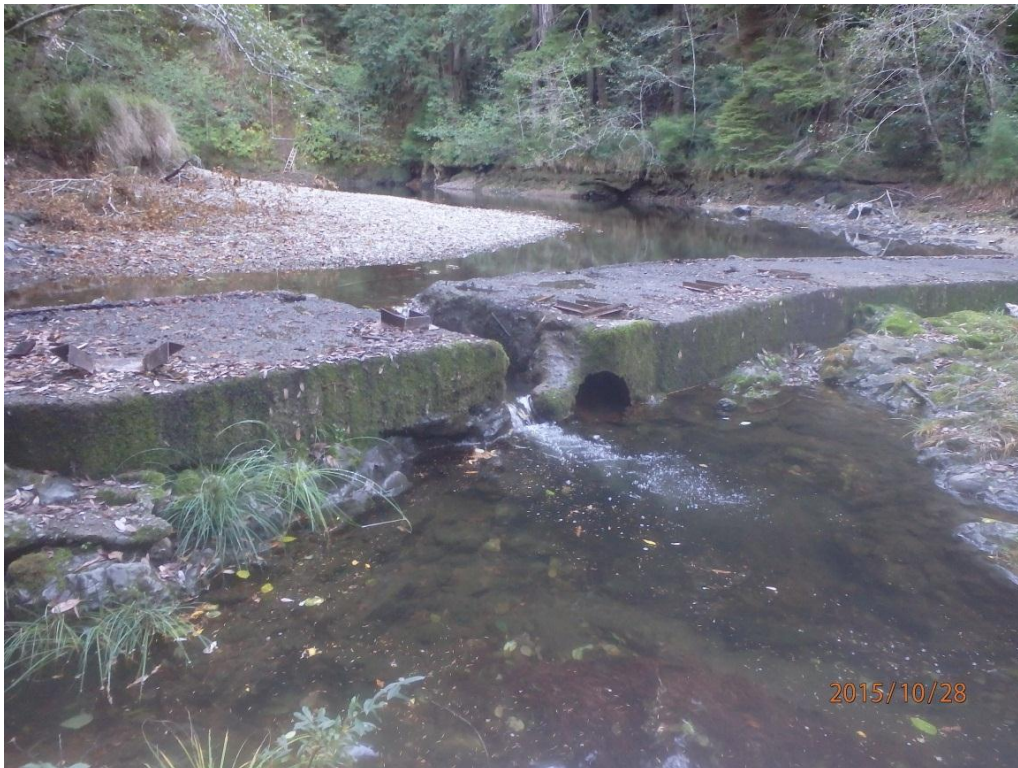
Photo 4: End of 2015 survey at temporary dam site at Camp Noyo, habitat unit 506-507, 74,450' upstream of SOS (Photo taken 10-28-15).

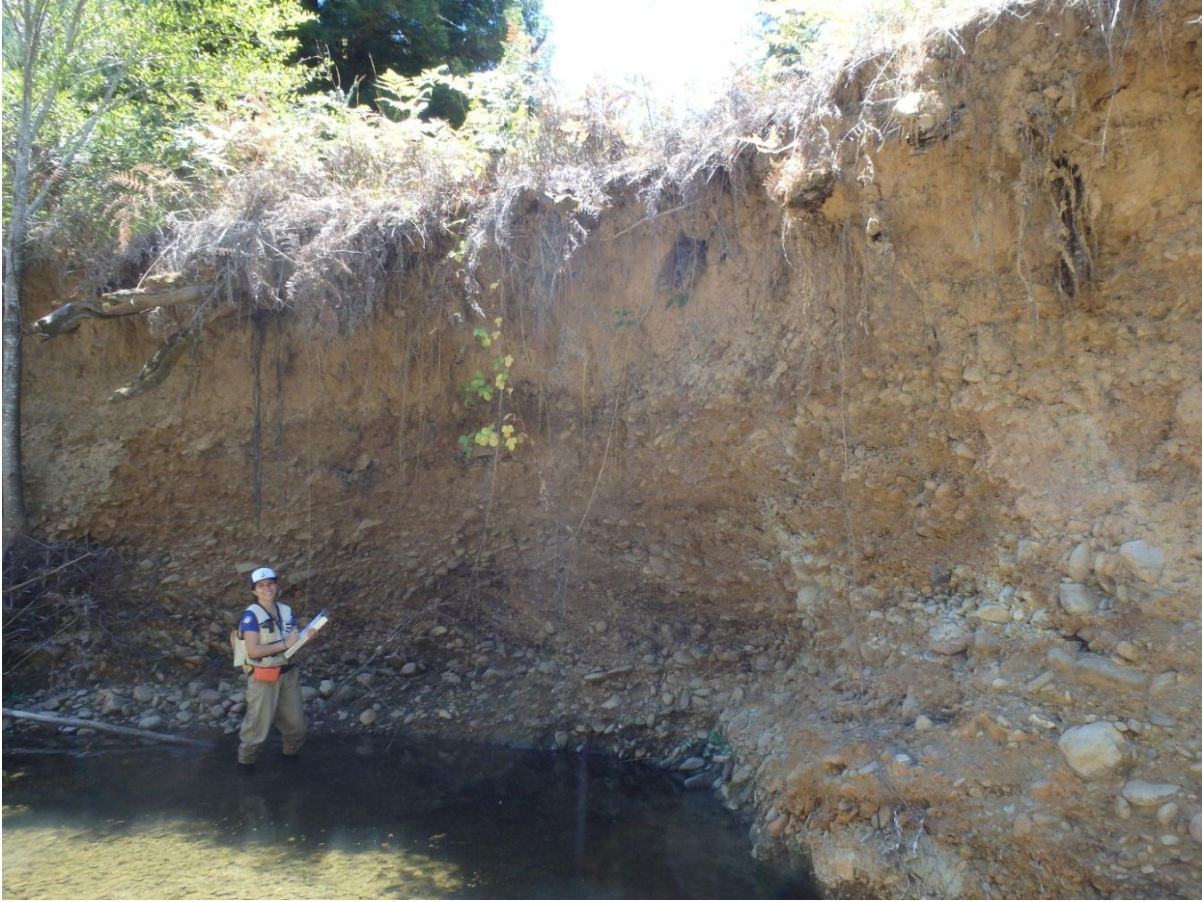
Photo 5: Erosion site at habitat unit #968, 131,640' upstream of SOS. Nicole Bejar pictured (Photo taken 8/2/16).

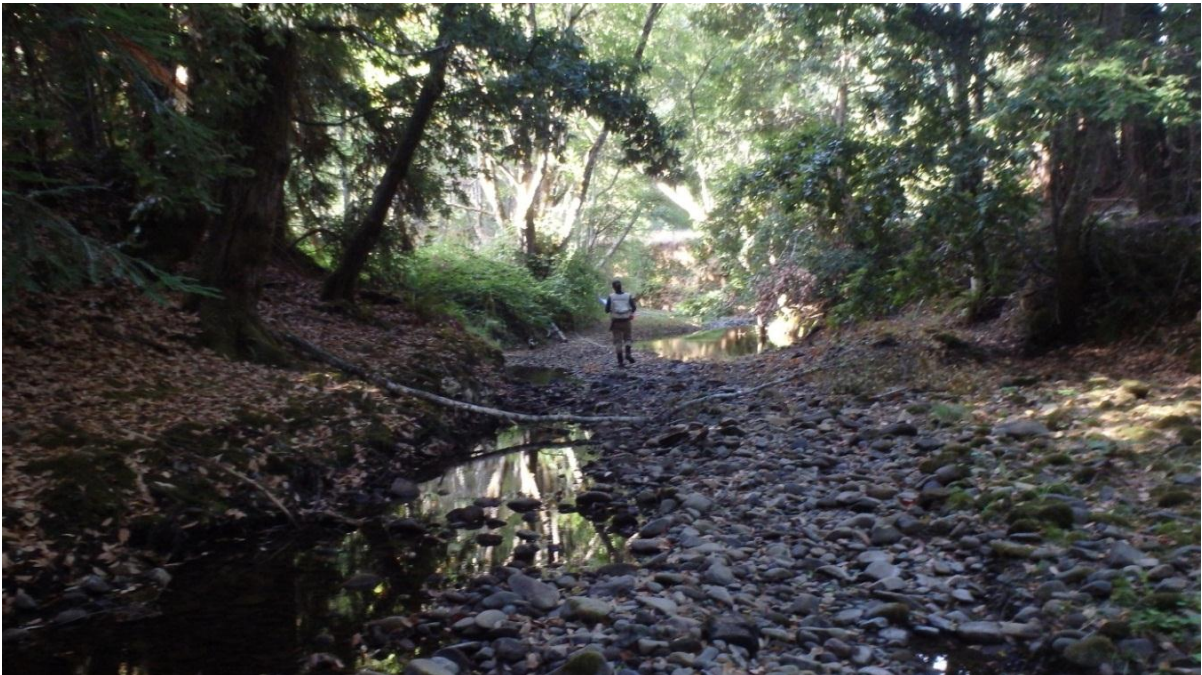
Photo 6: Low water conditions at habitat unit #1053, 136,154' upstream of SOS. Nicole Bejar pictured. (Photo taken 8/24/16)

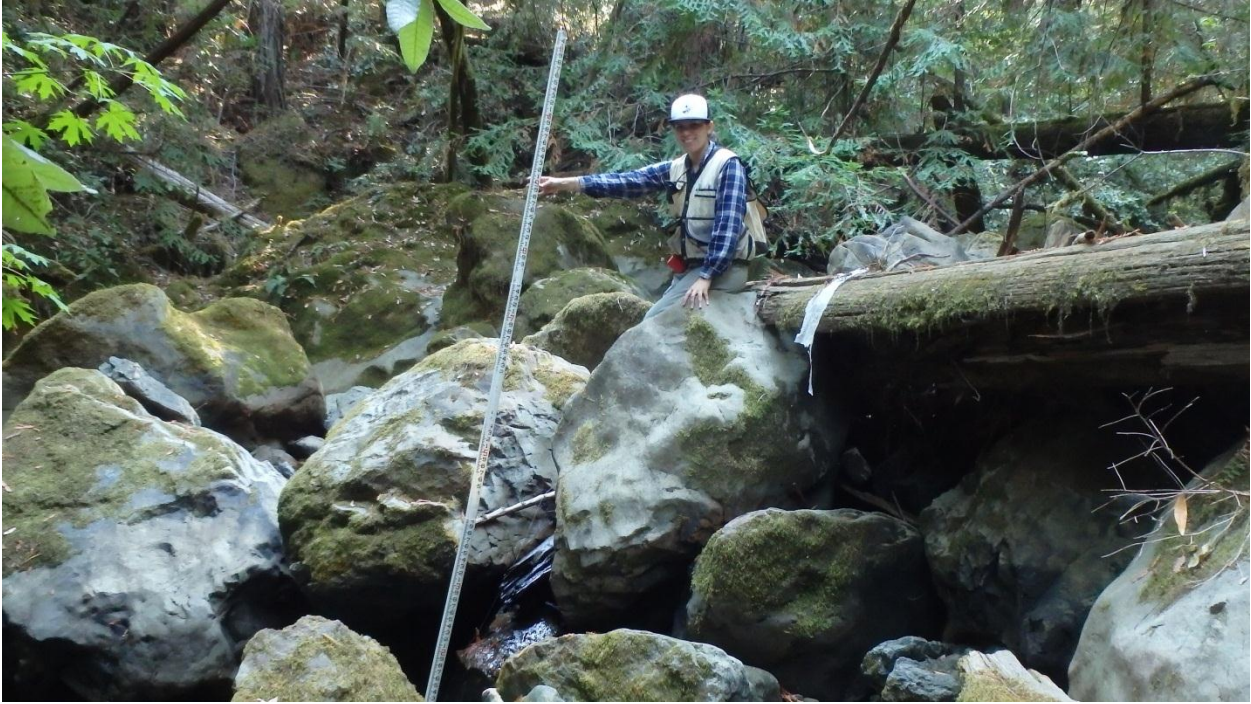
Photo 7: Boulder cascade at habitat unit # 1553, 158,778' upstream of SOS. Nicole Bejar pictured. (Photo taken 9/8/16)

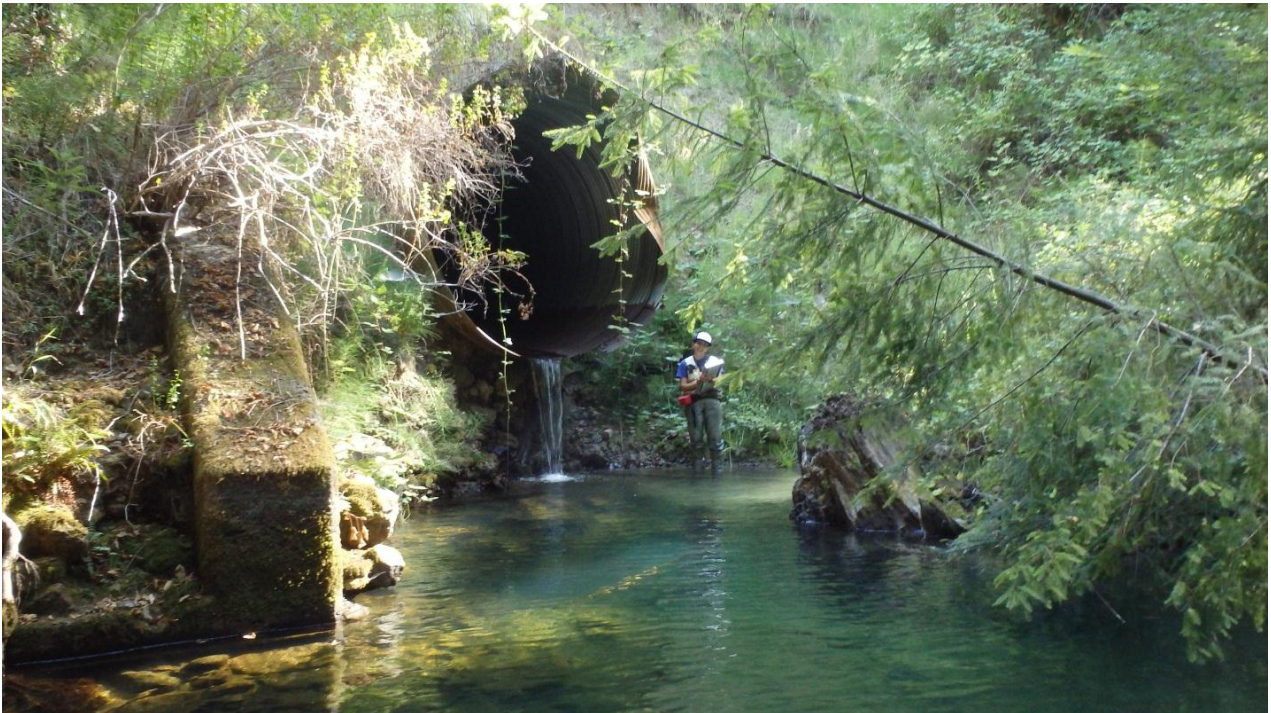
- 158740 1605.00 There is a 4.5' plunge over a culvert into 4.5' pool.
- 158830 1606.00 Culvert #1 is California Western Railroad and is 8.7' high x 8.7' wide x 140' long. It is composed of one culvert, and is made of CMP. The culvert's diameter is 8.7', its plunge height is 4.5', and it has a maximum depth of 5.7' within 5' of the outlet. The slope is 2%, and its condition is poor as it is rusted along bottom. It is a possible barrier to juvenile and adult salmonids, as the 4.5' plunge is an end to anadromy. Flow is running along bottom, no debris blocking channel in the culvert. CMP composes the bottom.

Photo 8: Culvert and probable end of anadromy at habitat unit #1605, 160,495' upstream of SOS. Nicole Bejar pictured. (Photo taken 9/12/16)

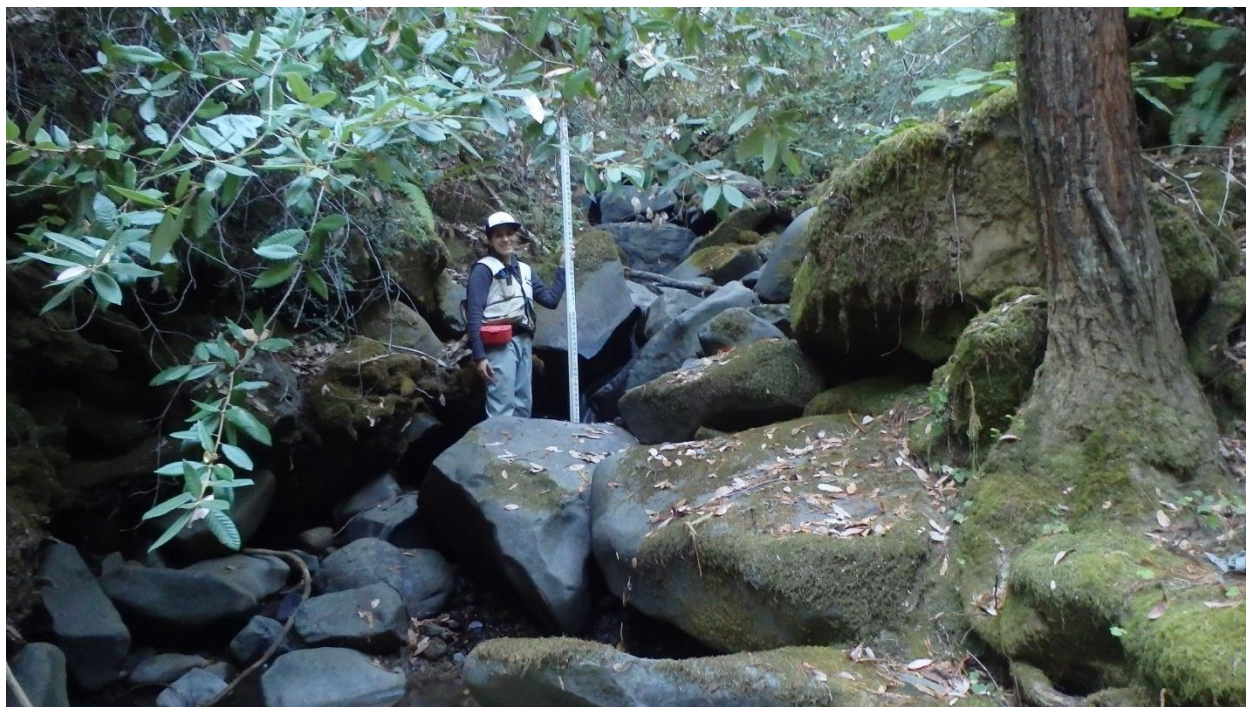
Photo 9: End of survey at habitat unit #1611, 160,924' upstream of SOS due to steep boulder cascade. Nicole Bejar pictured. (Photo taken 9/13/16)
