# Coldwater Post-Fire Restoration Project *(amended)*

*Recipient: Riverside Corona Resource Conservation District*

*Project Number: #8006.19.063336*

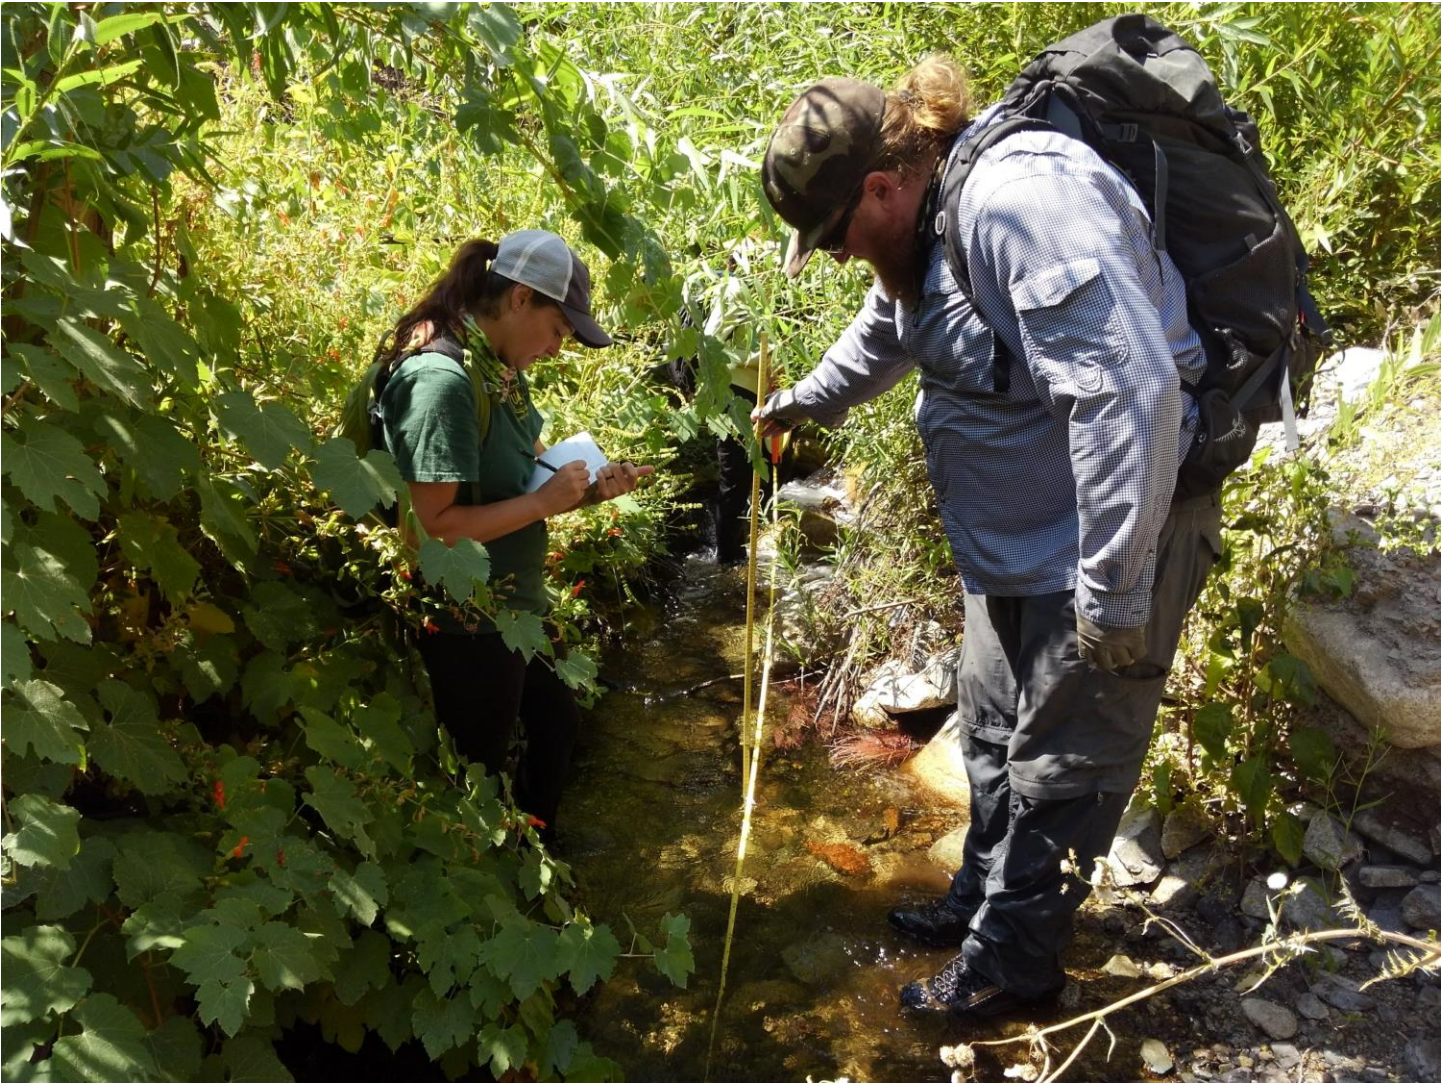
*Image 1: Habitat Assessment in Coldwater Creek*

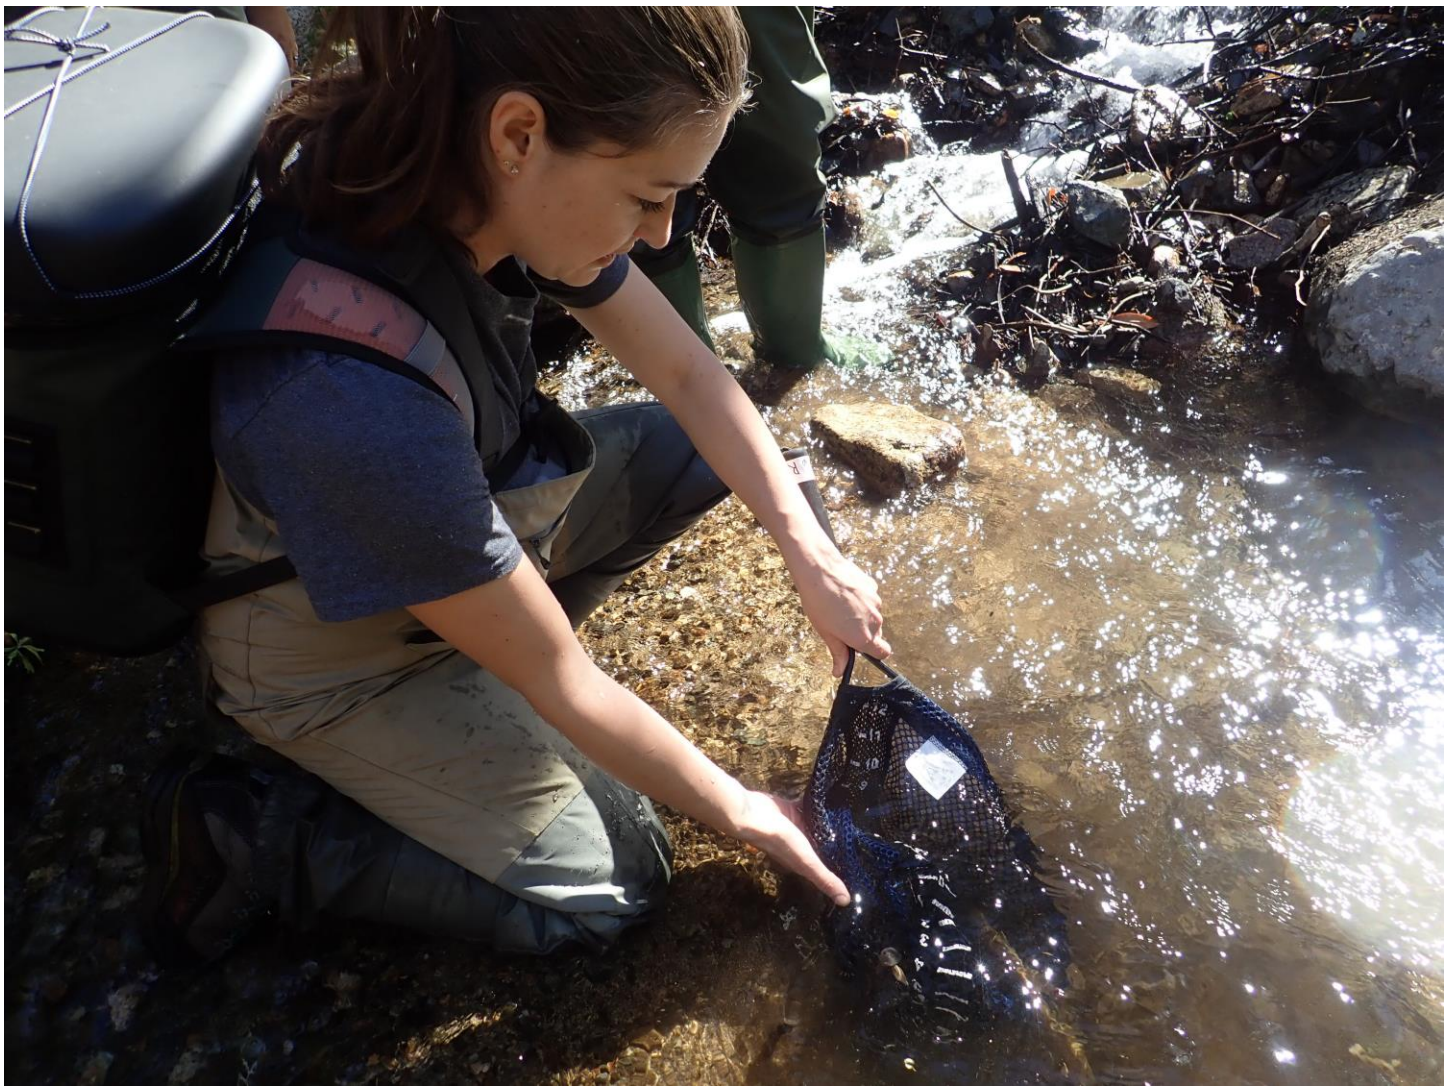
*Image 2: Returning fish to Coldwater*

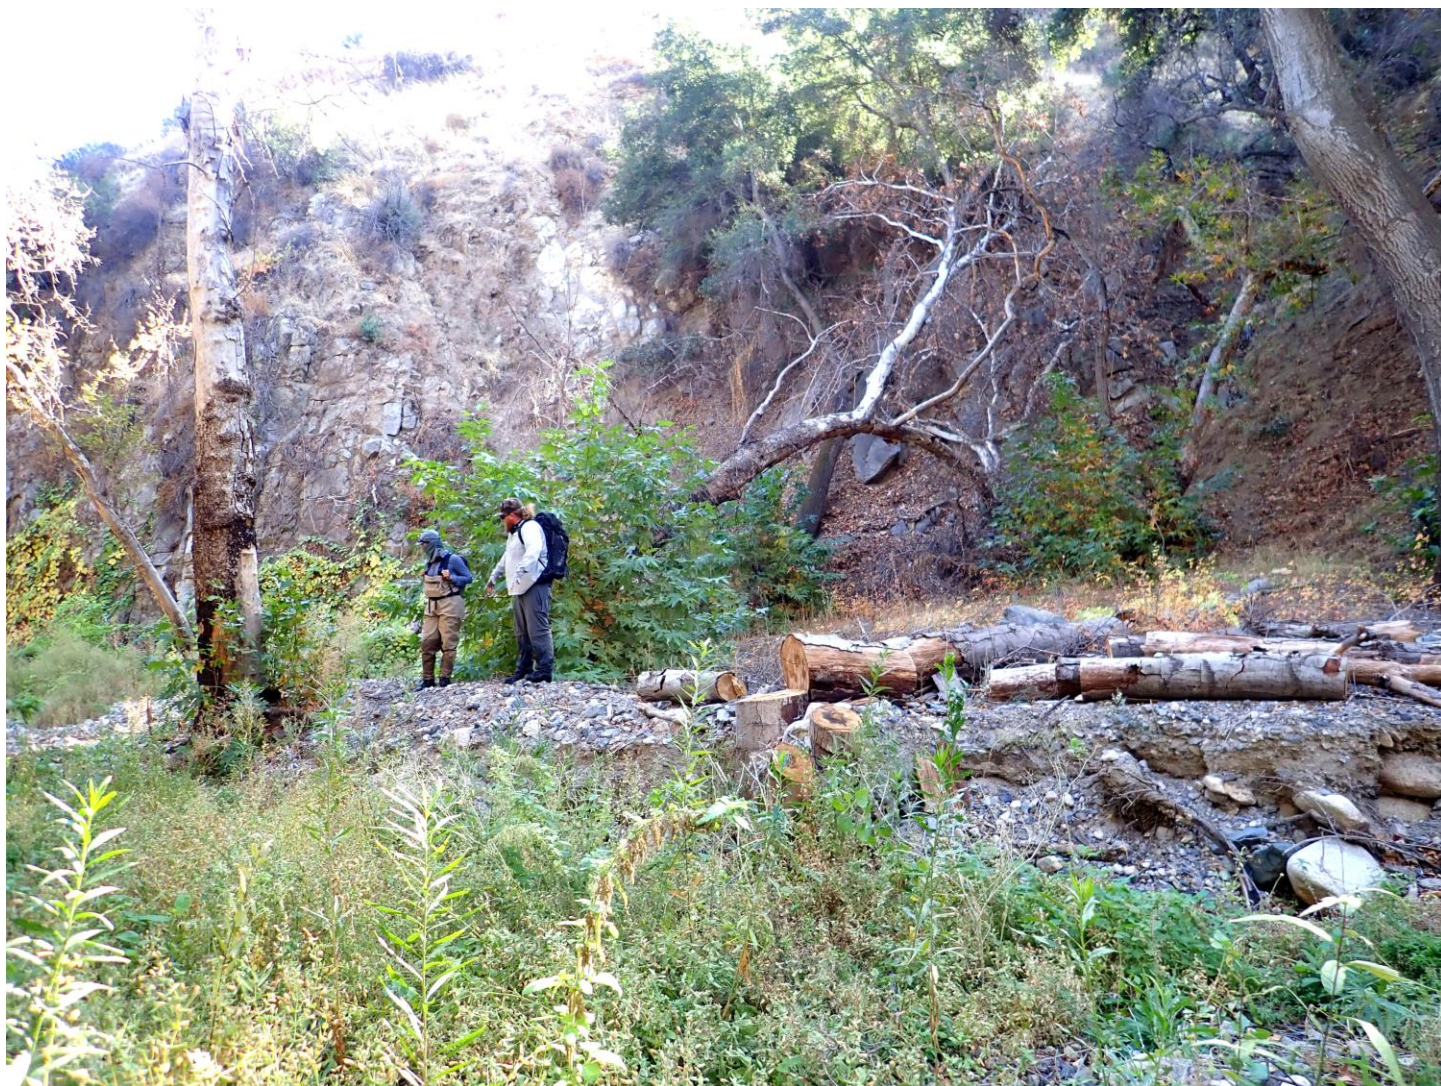
*Image 3: Deadfall Removal in Coldwater*

**50 seedling and sapling trees** (alder and sycamore) were planted or transplanted on-site, using plant material from the restoration location(s). Over **200 deadfall trees and debris dams** were removed after the fire and during the grant period by RCRC and Conservation Corps staff.

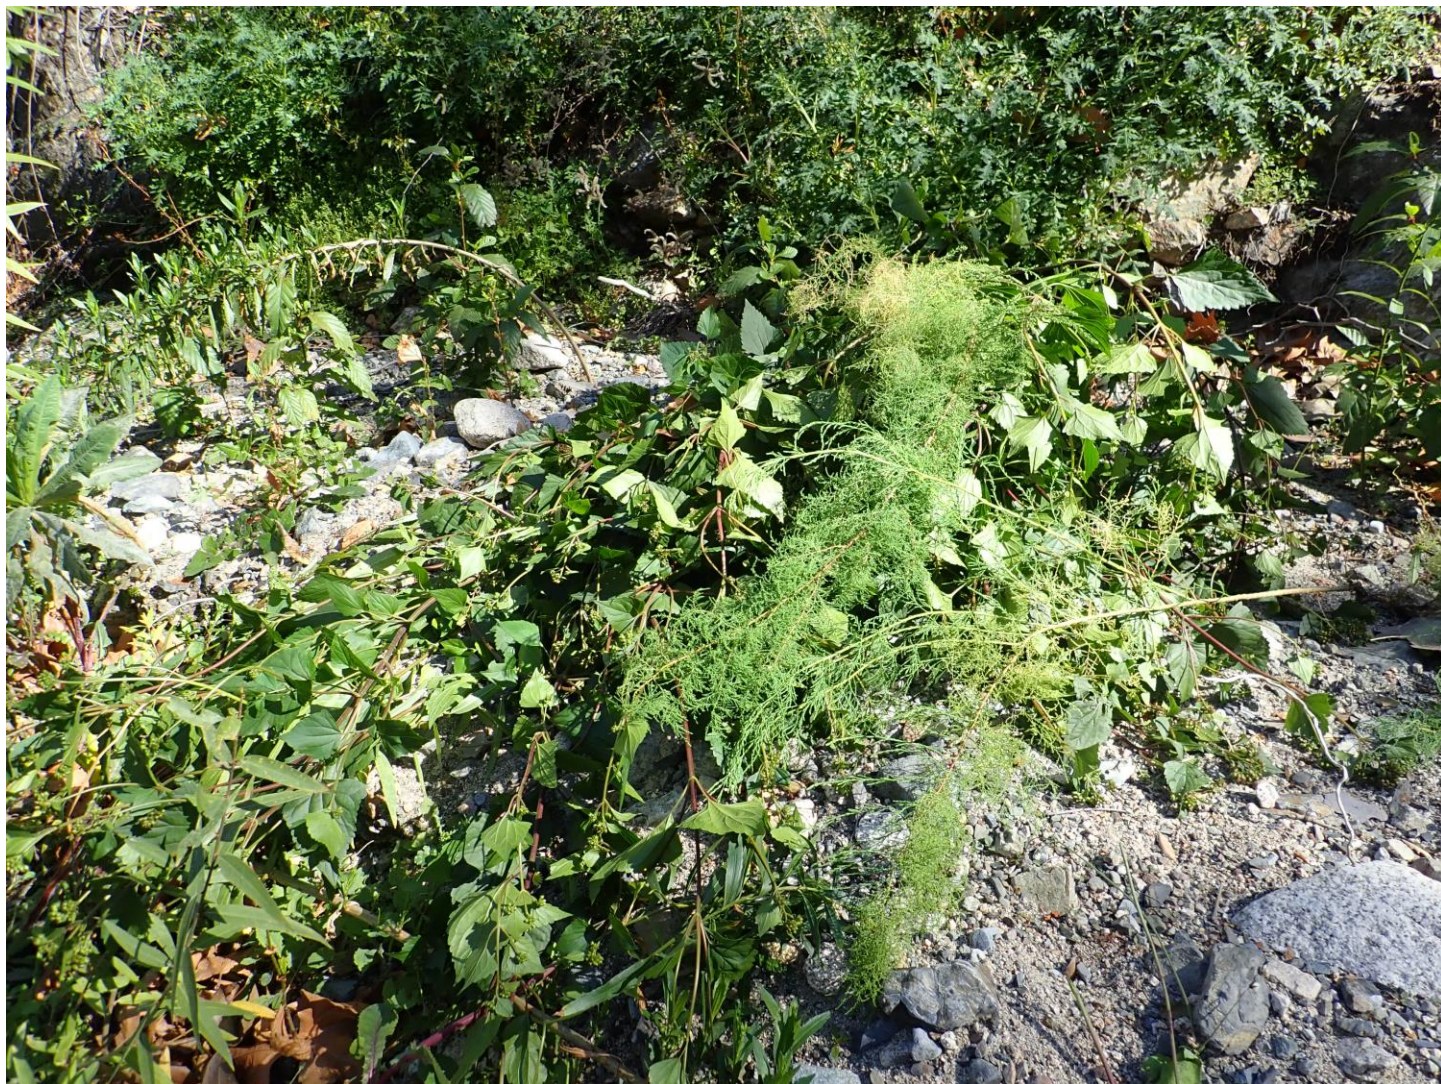
*Image 4: Tamarisk and Snakeroot control in Coldwater*

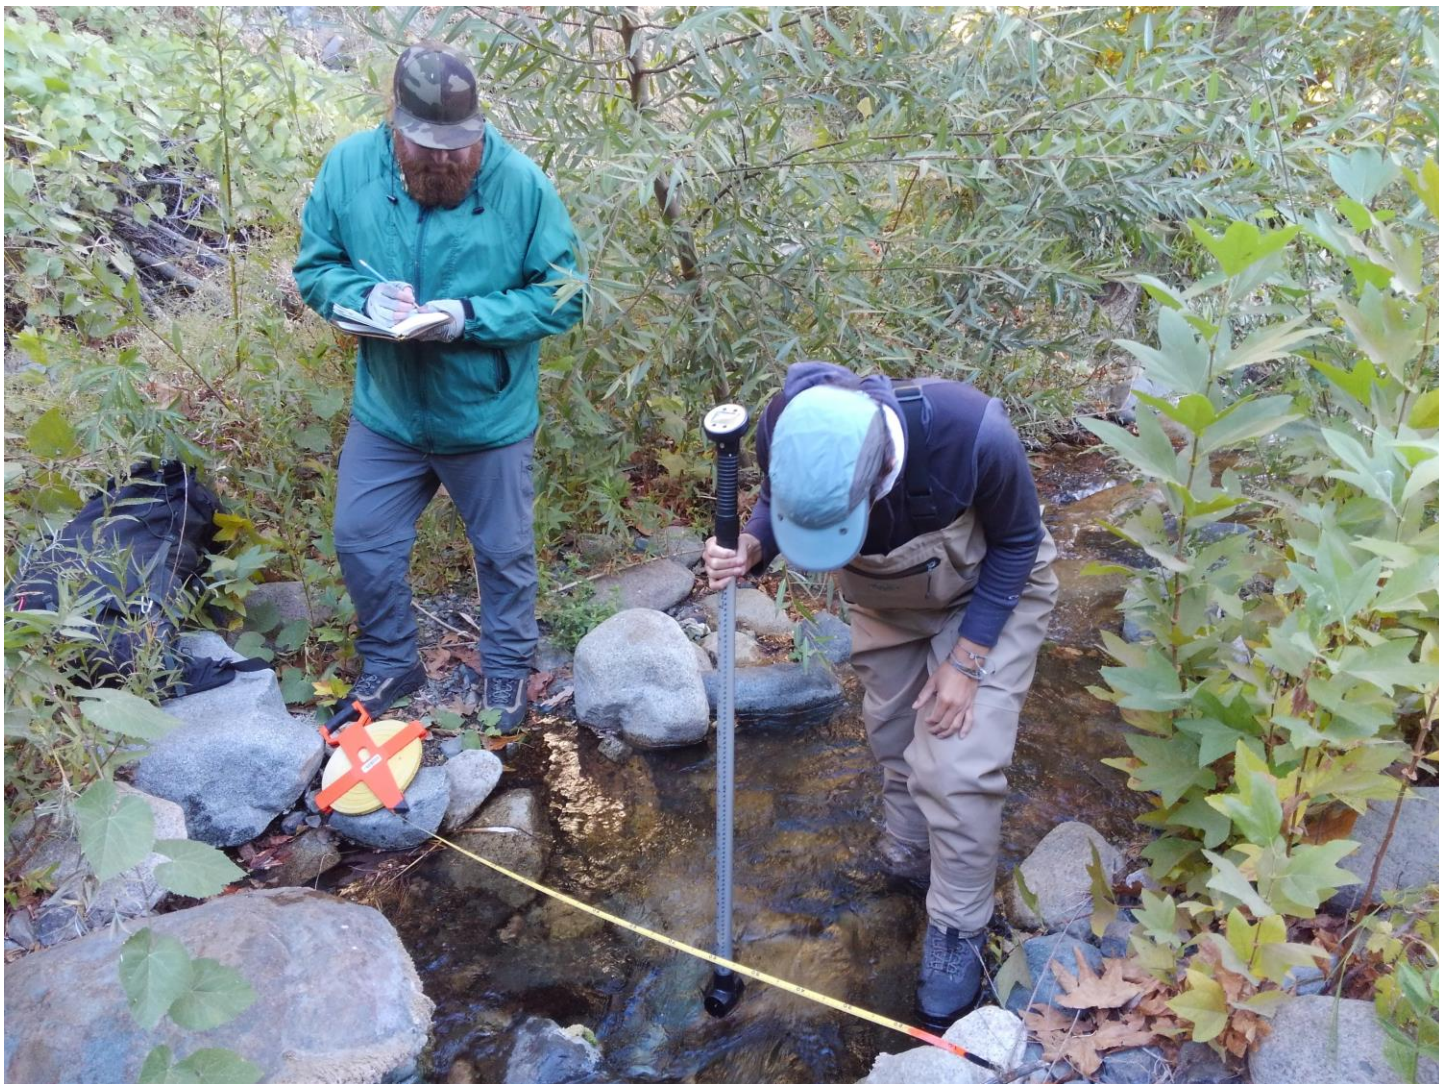
*Image 5. Flow Monitoring in Coldwater*
