CALIFORNIA DEPARTMENT OF FISH AND WILDLIFE

STREAM INVENTORY REPORT

Hare Creek

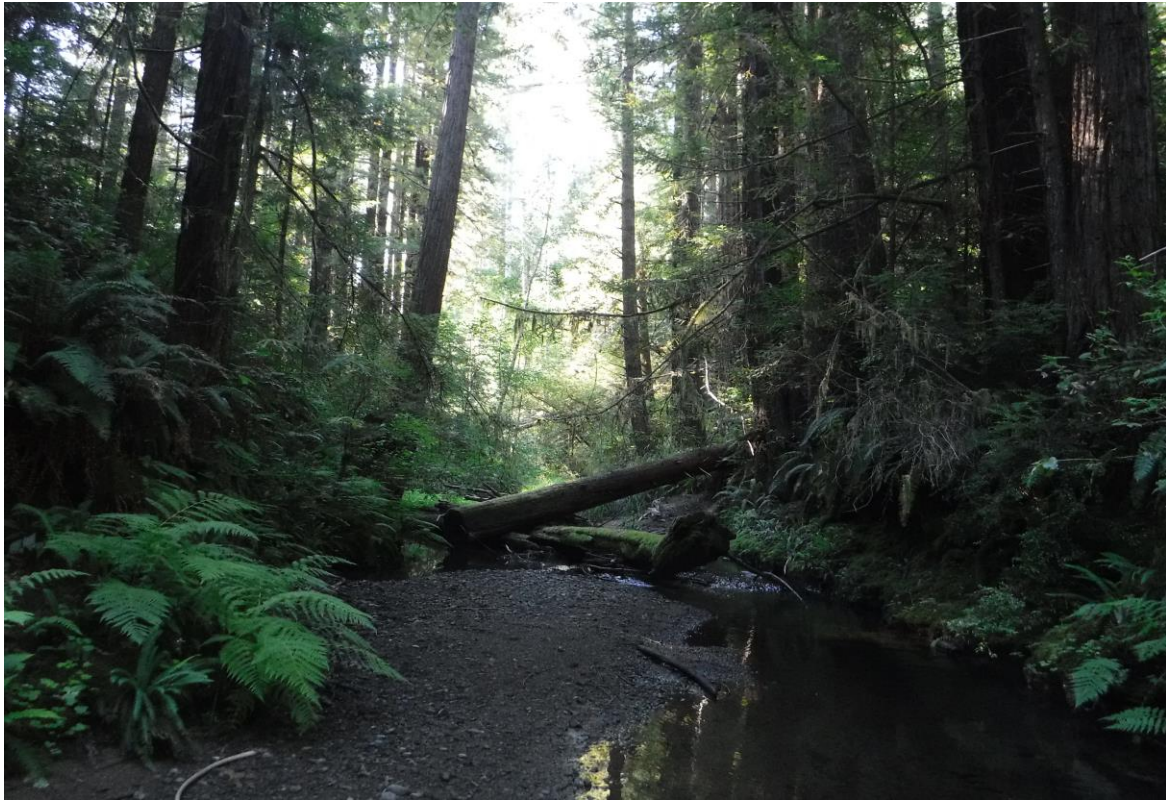
Photo 1: Run at habitat unit #311, 21,111' upstream of start of survey. (Photo taken 7/18/17)

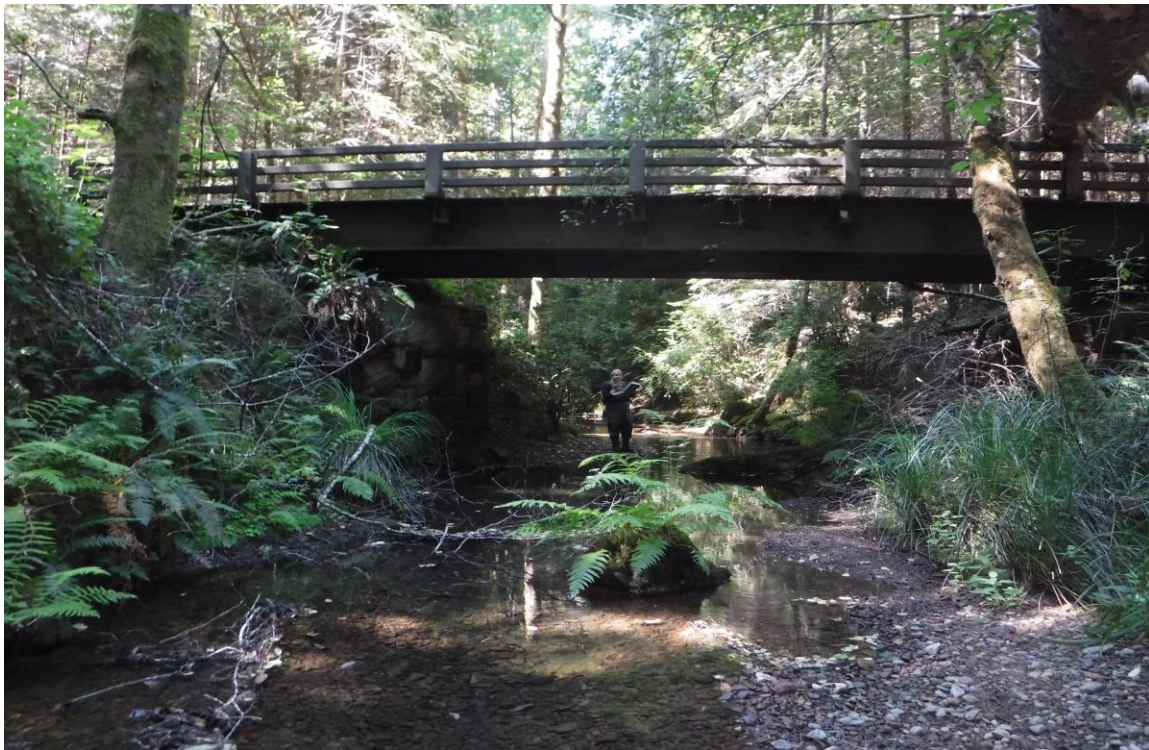
Photo 3: Bridge #1 at habitat unit #340; 22,683' upstream of start of survey. Looking downstream
Pictured: Kori Roberts. (Photo taken 8/2/17)

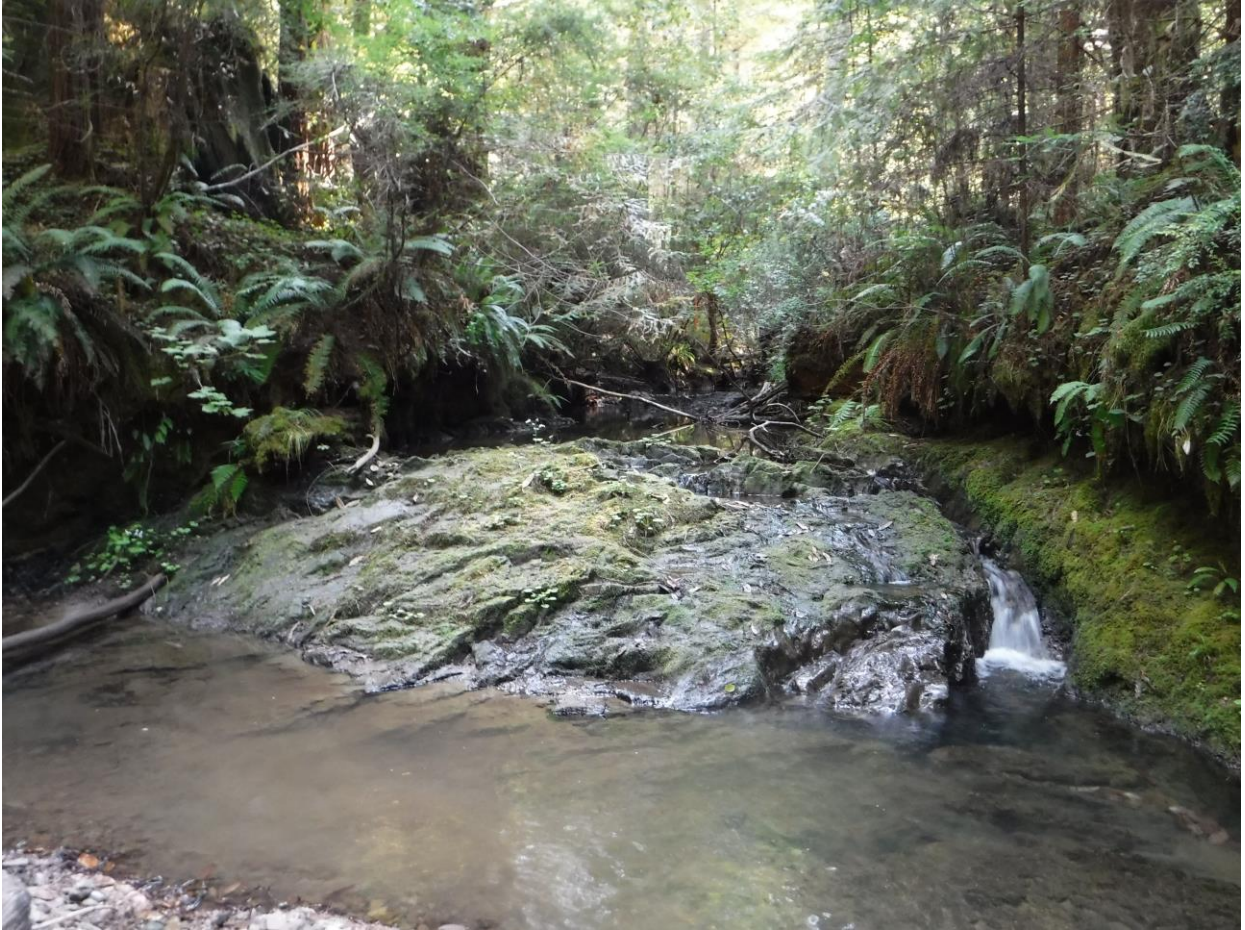
Photo 3: Bedrock substrate at habitat unit #455; 27,733' upstream of start of survey. Looking upstream. (Photo taken 8/3/17)
