CALIFORNIA DEPARTMENT OF FISH AND WILDLIFE

STREAM INVENTORY REPORT

CONNICK CREEK

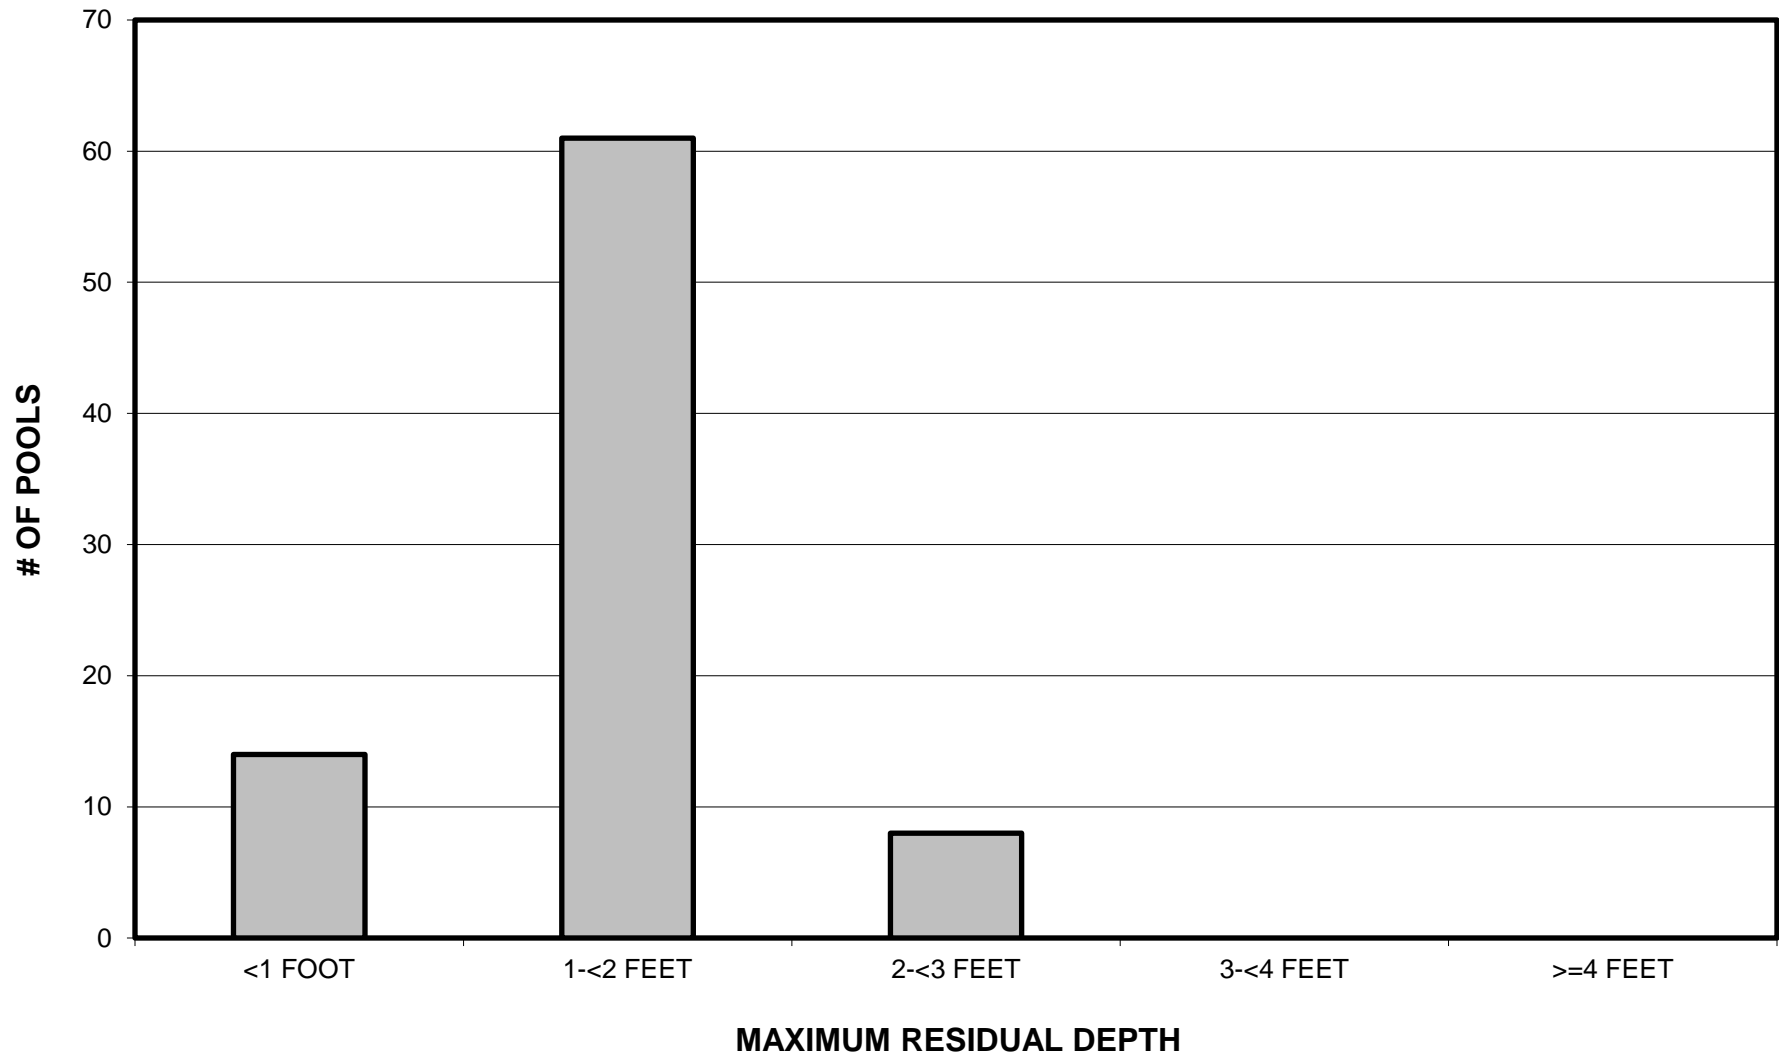
GRAPH 5

Table 4 is a summary of maximum residual pool depths by pool habitat types. Pool quality for salmonids increases with depth. Eight of the 83 pools (10%) had a residual depth of two feet or greater (Graph 5).

Flatwater habitat types comprised 36% of the total length of this survey, riffles 0%, pools 22%, and 41% dry units. Eight of the 83 (10%) pools had a maximum residual depth greater than 2 feet. In general, pool enhancement projects are considered when primary pools comprise less than 40% of the length of total stream habitat. In first and second order streams, a primary pool is defined to have a maximum residual depth of at least two feet, occupy at least half the width of the low flow channel, and be as long as the low flow channel width. Installing structures that will increase or deepen pool habitat is recommended.

- 5) Where feasible, design and engineer pool enhancement structures to increase the number of pools. This must be done where the banks are stable or in conjunction with stream bank armor to prevent erosion.

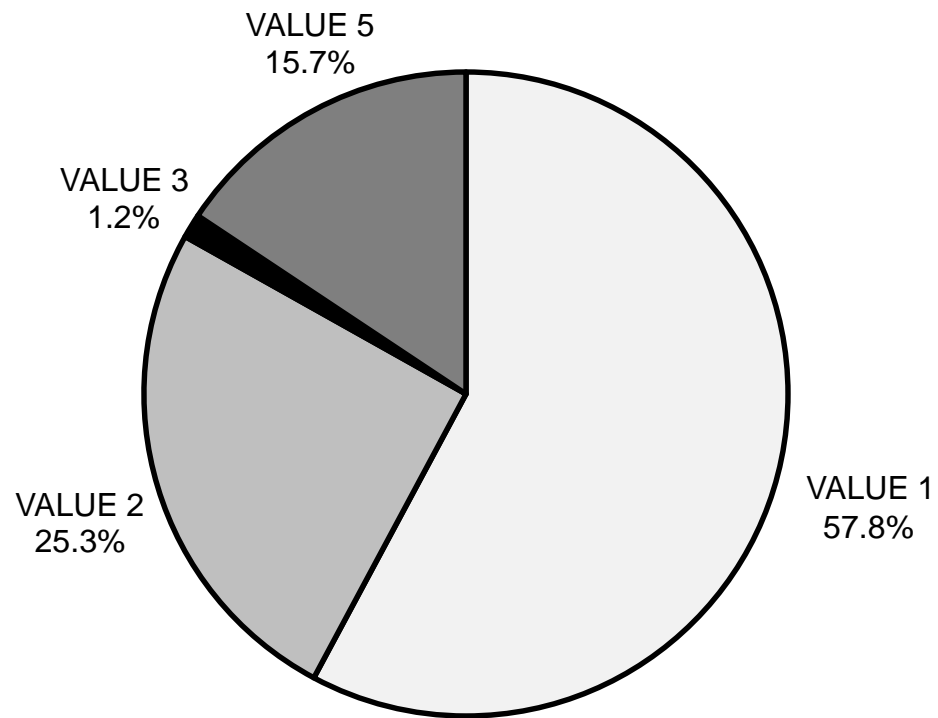
GRAPH 6

Sixty-nine of the 83 pool tail-outs measured had embeddedness ratings of 1 or 2. One of the pool tail-outs had embeddedness ratings of 3 or 4. Thirteen of the pool tail-outs had a rating of 5, which is considered unsuitable for spawning. Cobble embeddedness measured to be 25% or less, a rating of 1, is considered to indicate good quality spawning substrate for salmon and steelhead.

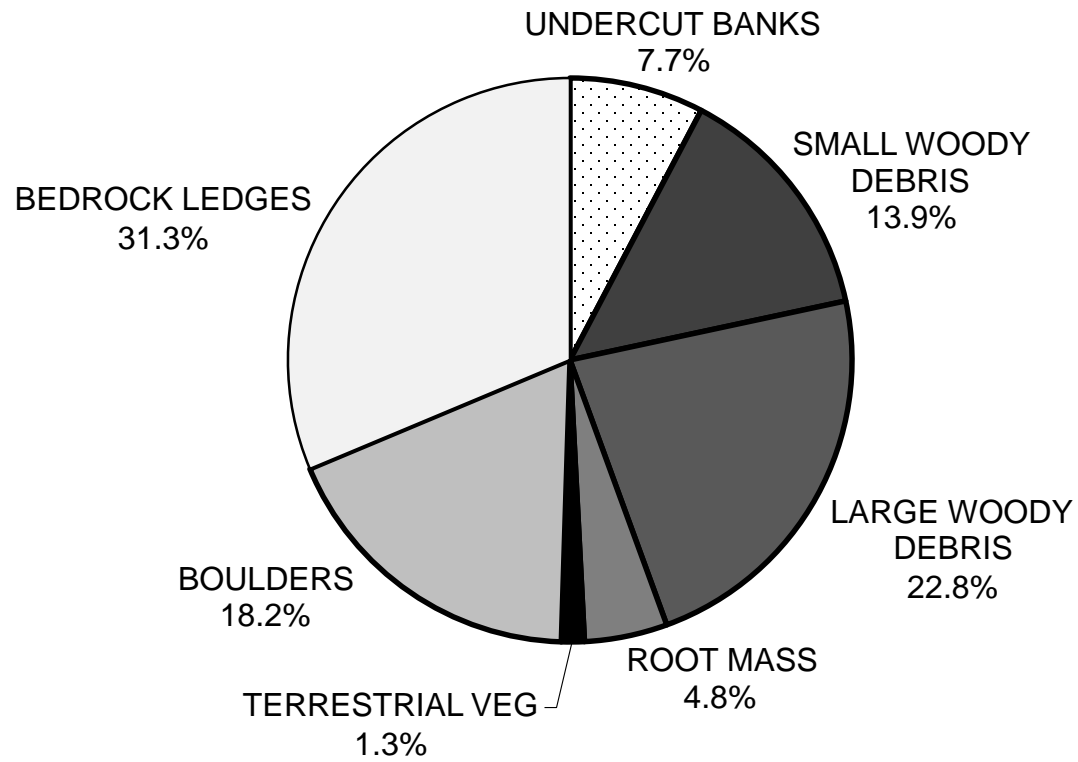
GRAPH 7

Table 5 summarizes mean percent cover by habitat type. Bedrock ledges are the dominant cover type in Connick Creek. Graph 7 describes the pool cover in Connick Creek. Bedrock ledges are the dominant pool cover type, followed by large woody debris.

The mean shelter rating for pools is 22. The shelter rating in the flatwater habitats is 0. A pool shelter rating of approximately 100 is desirable. The amount of cover that now exists is being provided primarily by bedrock ledges in Connick Creek. Bedrock ledges are the dominant cover type in pools followed by large woody debris. Log and rootwad cover structures in the pool and flatwater habitats would enhance both summer and winter salmonid habitat. Log cover structure provides rearing fry with protection from predation, rest from water velocity, and also divides territorial units to reduce density related competition.

- 1) Increase woody cover in the pools and flatwater habitat units. Most of the existing cover in the pools is from Bedrock ledges. Adding high quality complexity with woody cover in the pools is desirable.

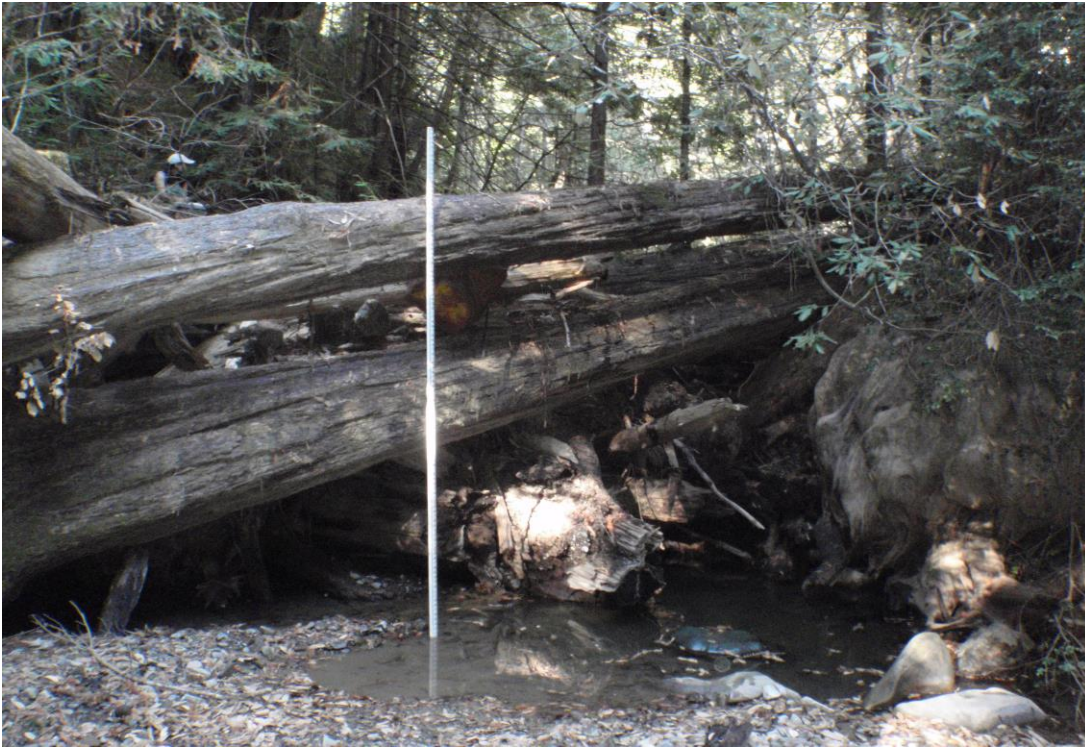
7027	0078.00	Log debris accumulation (LDA) #1 is 6' high x 28' wide x 10' long and contains 4 pieces of LWD. Water flows through the LDA and there are visible gaps in it. Sediment is being retained in the approximate dimensions of 9' wide, 11' long and 2.5' deep. The sediment ranges in size from silt to cobble. The LDA is not a possible barrier to salmonids. Juveniles can swim through the bottom, but there were dry units before and after the LDA. Fish were observed above the LDA.
7120	0080.00	Tributary #5 enters on the right bank. The slope of the tributary is estimated to be 10%. The tributary is not accessible to salmonids due to dry channel. There is also vegetation growing in the creek and debris. It is an incised, bedrock channel. Fish were not observed in the tributary.
7364	0084.00	There is a landslide on the left bank, it measures 120' long x 20' high. It is depositing gravel.

Photo 1: LDA #1 at habitat unit #078, 7,072' upstream from start of survey. Looking upstream.
(Photo taken: 9/25/17)

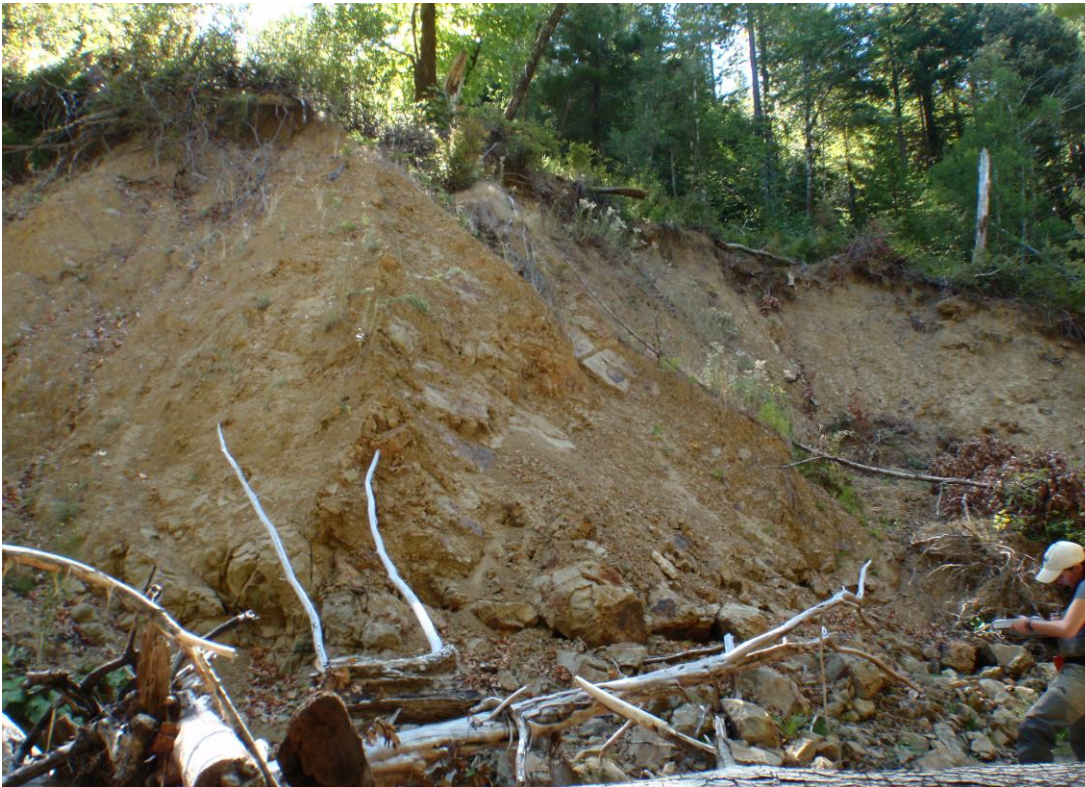
9182	0117.00	There is active erosion on the right bank, it measures 80' long x 40' high. It is depositing gravel.
9227	0119.00	Salmonid young-of-the-year (YOY) present.
9272	0121.00	LDA #3 is 10' high, 28.5' wide, 11' long and contains 6 pieces of LWD. Water flows through the LDA and there are visible gaps in it. Sediment is being retained in the approximate dimensions of 20' wide, 23' long and 2.5' deep. The sediment ranges in size from silt to cobble. The LDA is a possible barrier to juveniles. It is dry above the LDA. In high flows, juveniles can swim down and adults can jump over. Fish were observed above the LDA.
10061	0136.00	LDA #4 is 9.5' high, 34' wide, 30' long and contains 9 pieces of LWD. Water flows through the LDA and there are no visible gaps in it. Sediment is being retained in the approximate dimensions of 13' wide, 12' long and 7.5' deep. The sediment ranges in size from silt to cobble. The LDA is a possible barrier to juvenile salmonids. There is a dry unit below and above the LDA. In high flows, juveniles would not be able to swim down and adults could potentially jump over the top. Fish were observed above the LDA.

Photo 2: Land slide on right bank at habitat unit #117, 9,200' upstream from start of survey.
Pictured: Nicole Bejar. (Photo taken: 9/26/17)

- 3) Inventory and map sources of stream bank erosion and prioritize them according to present and potential sediment yield. Identified sites should then be treated to reduce the amount of fine sediments entering the stream.

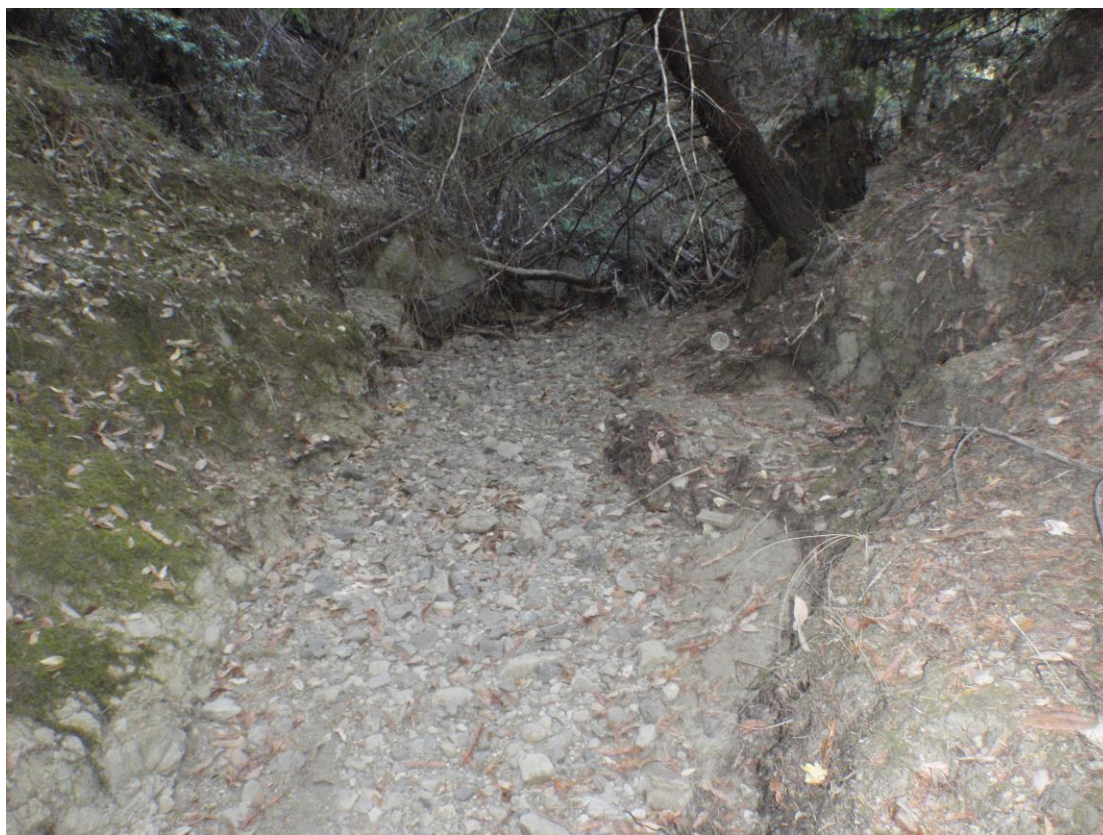
Photo 3: End of survey due to dry creek bed, 13,785' upstream from start of survey. Looking upstream.
(Photo taken: 10/3/17)
