CALIFORNIA DEPARTMENT OF FISH AND WILDLIFE

STREAM INVENTORY REPORT

Coulborn Creek

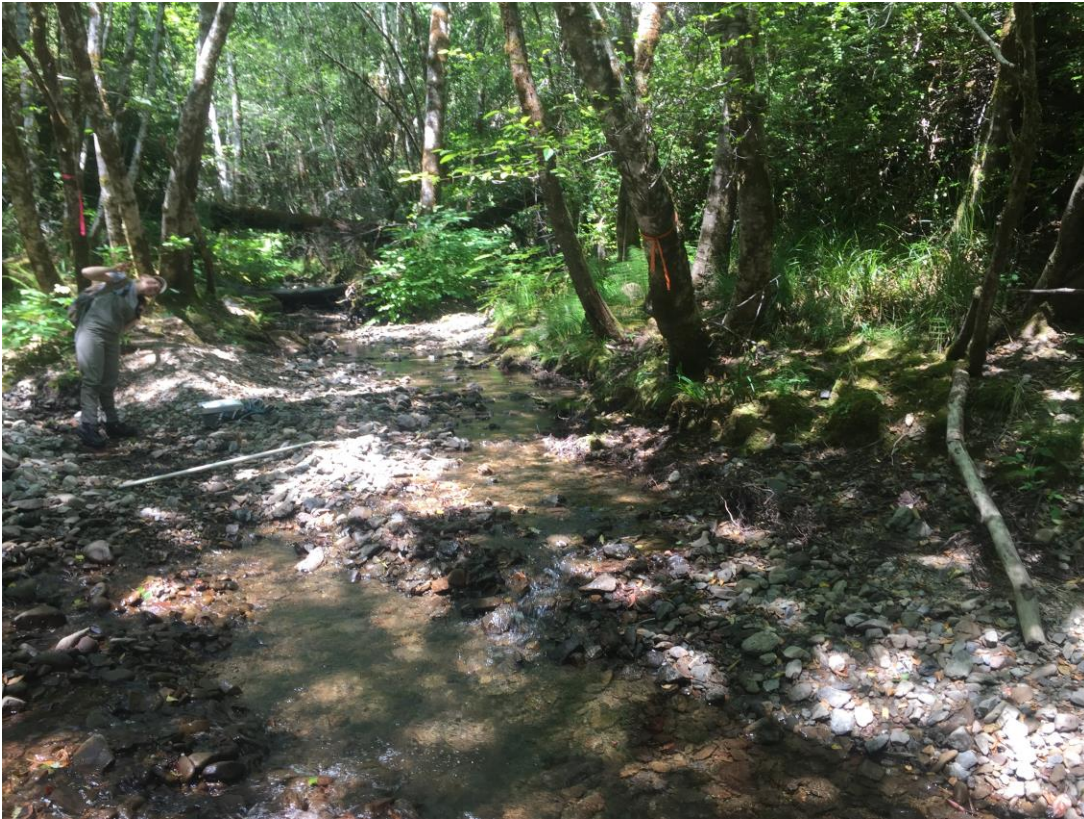
Photo 1: Start of survey at the confluence with Indian Creek. Looking upstream towards the mouth of Coulborn Creek. Pictured: Rachel Karlov. (Photo taken: 7/19/17)

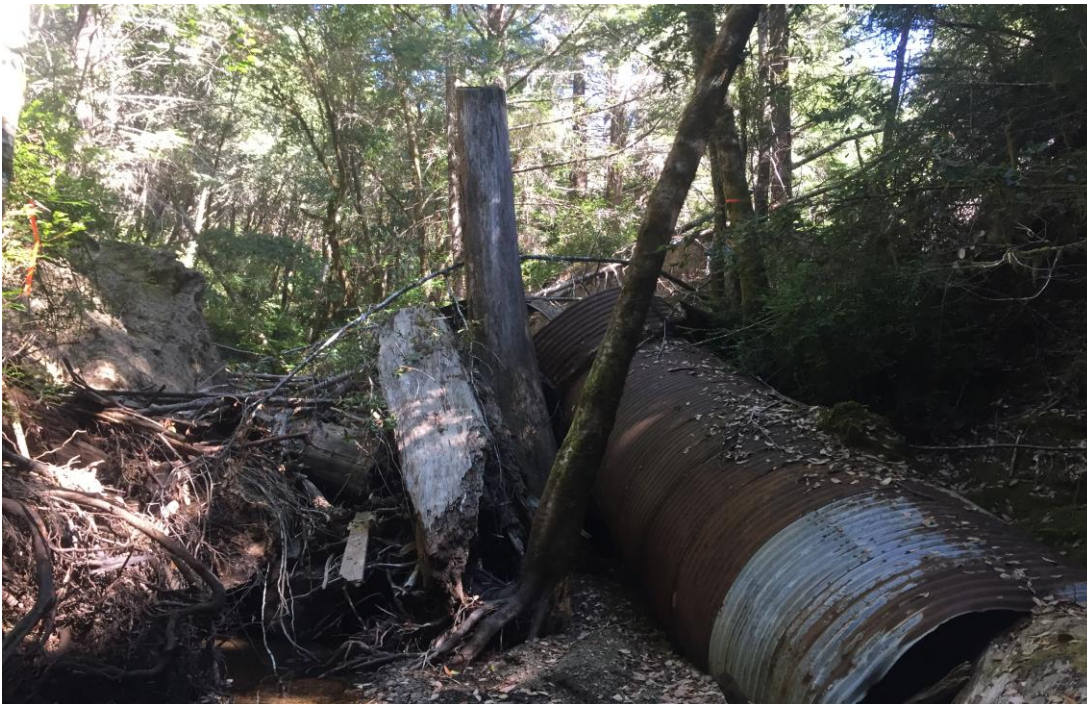
831	0021.00	Log debris accumulation (LDA) #1 is 10' high x 30' wide x 45' long and contains 14 pieces of large woody debris (LWD). Water flows through the LDA and there are visible gaps in it. Sediment is being retained in the approximate dimensions of 20' wide x 45' long x 4' deep. The sediment ranges in size from sand to gravel. The LDA is not a possible barrier to salmonids. Fish were observed above the LDA.
1278	0030.00	There is a bedrock canyon on the right and left banks.
1552	0035.00	There is a LWD Salmon Restoration Project (SRP).
2067	0045.00	Tributary #1 enters on the right bank. It contributes to approximately 2% of Coulborn Creek's flow. The water temperature of the tributary was 58° Fahrenheit, the water temperature downstream of the confluence was 58° Fahrenheit, and the water temperature upstream of the confluence was 58° Fahrenheit. The slope of the tributary is 2%. The tributary is accessible to salmonids. Fish were not observed in the tributary.

Photo 2: LDA at habitat unit #021, 830' upstream from start of survey. (Photo taken 7/19/17)

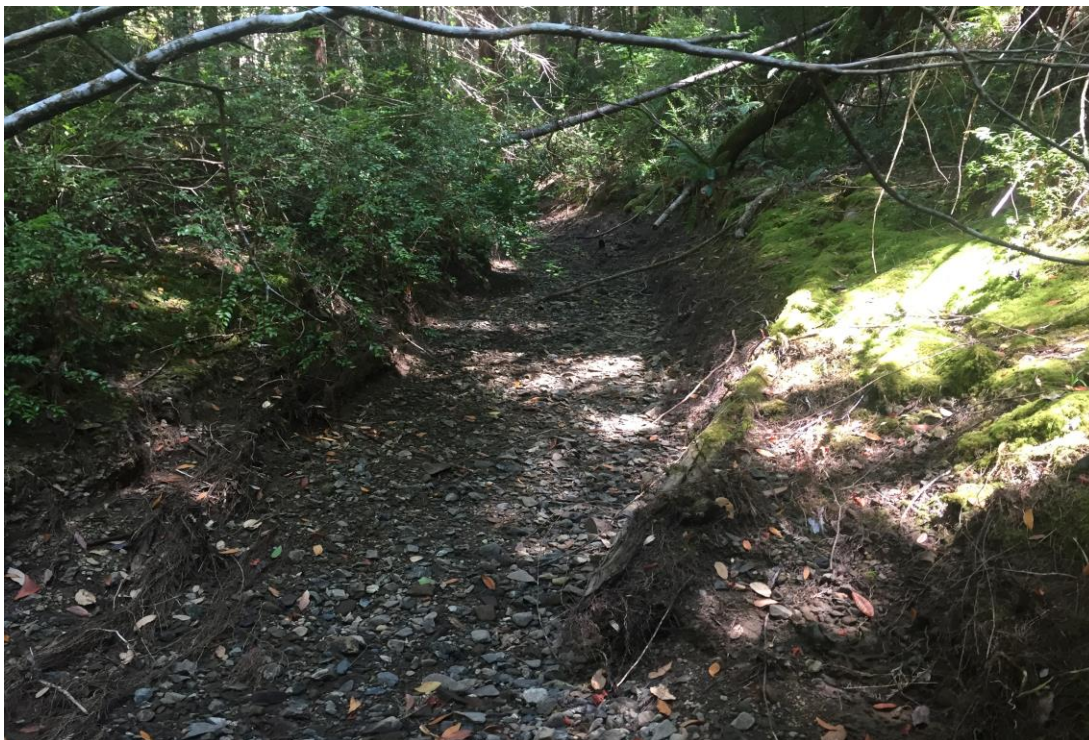
Photo 3: Dry creek bed at habitat unit #231, 9,465' upstream from start of survey. (Photo taken 7/25/17)
