CALIFORNIA DEPARTMENT OF FISH AND WILDLIFE

STREAM INVENTORY REPORT

Dinner Creek

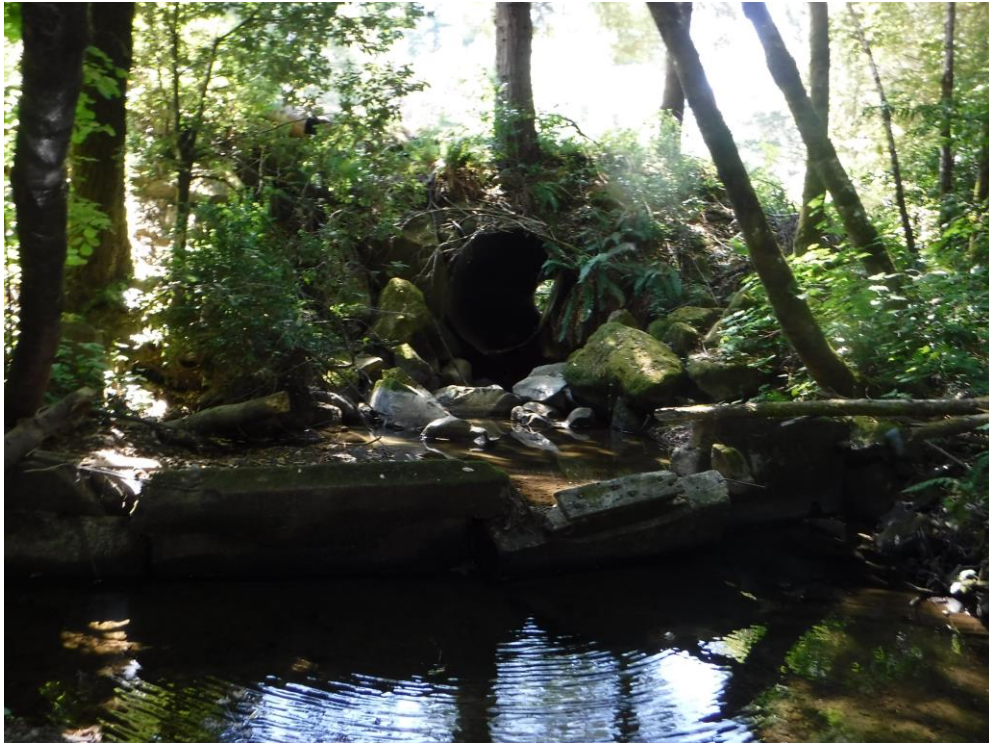
Photo 1: Culvert #3 at habitat unit #188, 6,201' upstream from start of survey. Pools (habitat units #185 & 186) separated by a cement Salmon Recovery Plan structure. (Photo taken 7/26/17)

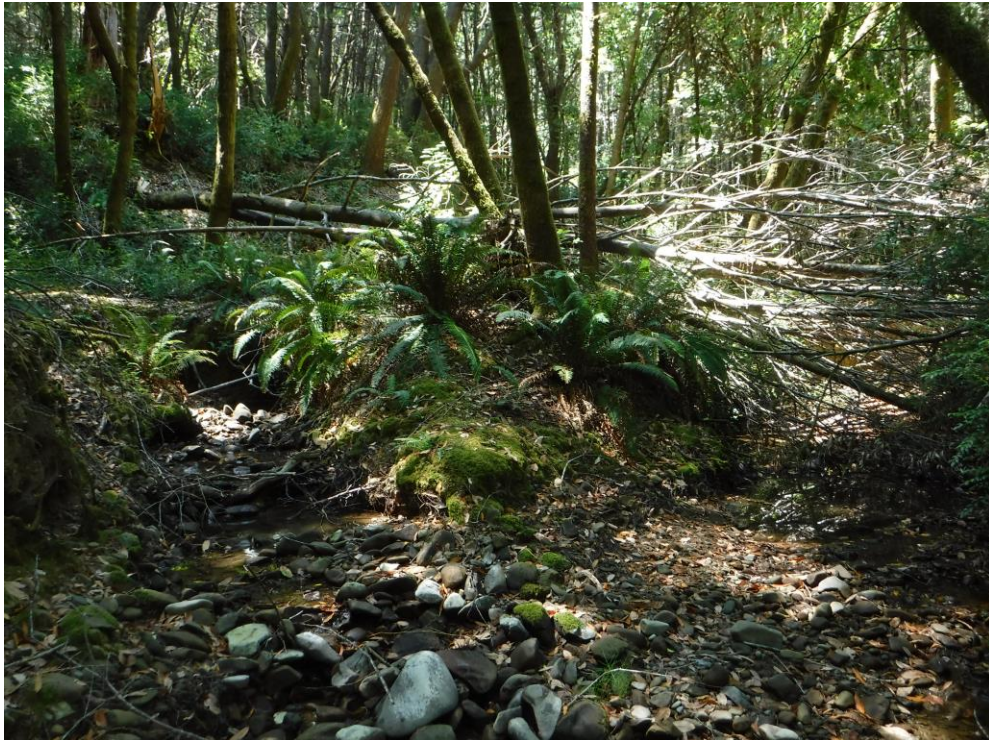
8239	0274.00	A dry tributary enter on the left bank.
8370	0278.00	There is erosion on the right bank.
9050	0306.00	Tributary #4 enters on the left bank. It contributes to approximately 50% of Dinner Creek's flow. The water temperature of the tributary was 60° Fahrenheit, the water temperature downstream of the confluence was 60° Fahrenheit, and the water temperature upstream of the confluence was 60° Fahrenheit. The slope of the tributary is 50%. The tributary is accessible to salmonids. Fish were observed in the tributary.
9680	0331.00	HU# 331 and 332 are separated by a LWD SRP spanning the channel.
9779	0334.00	A dry tributary enters from the right bank.
10304	0352.00	Tributary # enters on the right bank. It contributes to approximately 80% of Dinner Creek's flow. The water temperature of the tributary was 58° Fahrenheit, the water temperature downstream of the confluence was 60° Fahrenheit, and the water temperature upstream of the confluence was 65° Fahrenheit. The slope of the tributary is 2-4%. The tributary is accessible to salmonids. Fish were not observed in the tributary.

Photo 2: Tributary #4 at habitat unit #306, 9,250' upstream from start of survey. (Photo taken 7/26/17)

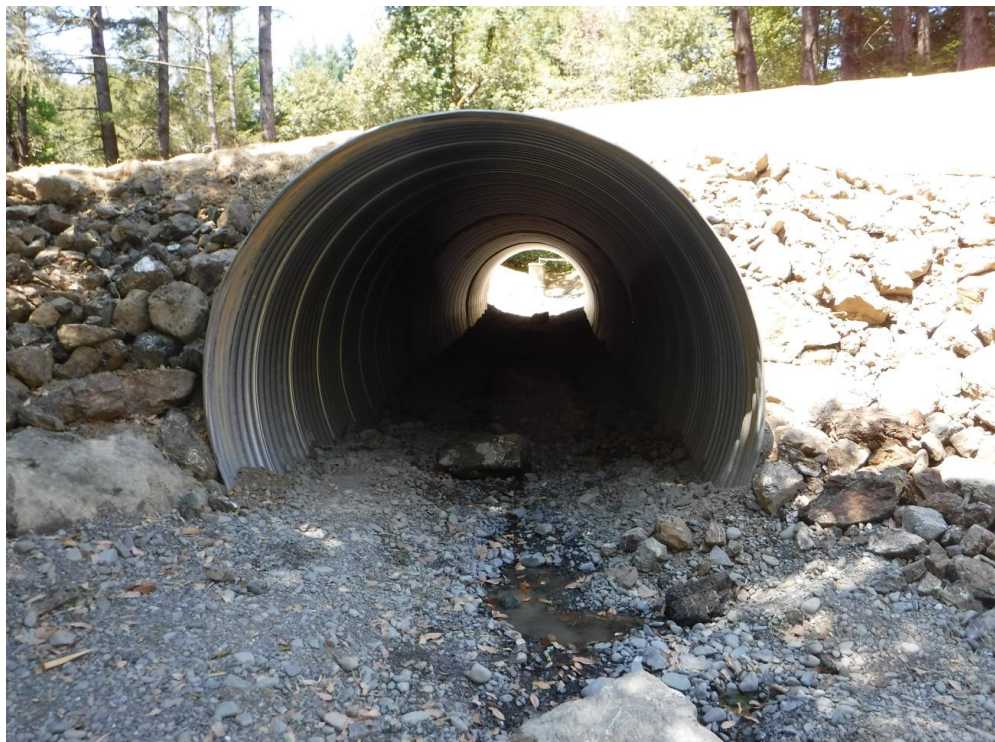
Photo 3: End of survey due to dry channel at habitat unit #355, 10,648' upstream from start of survey.
(Photo taken 7/26/17)
