CALIFORNIA DEPARTMENT OF FISH AND WILDLIFE

STREAM INVENTORY REPORT

Sebbas Creek

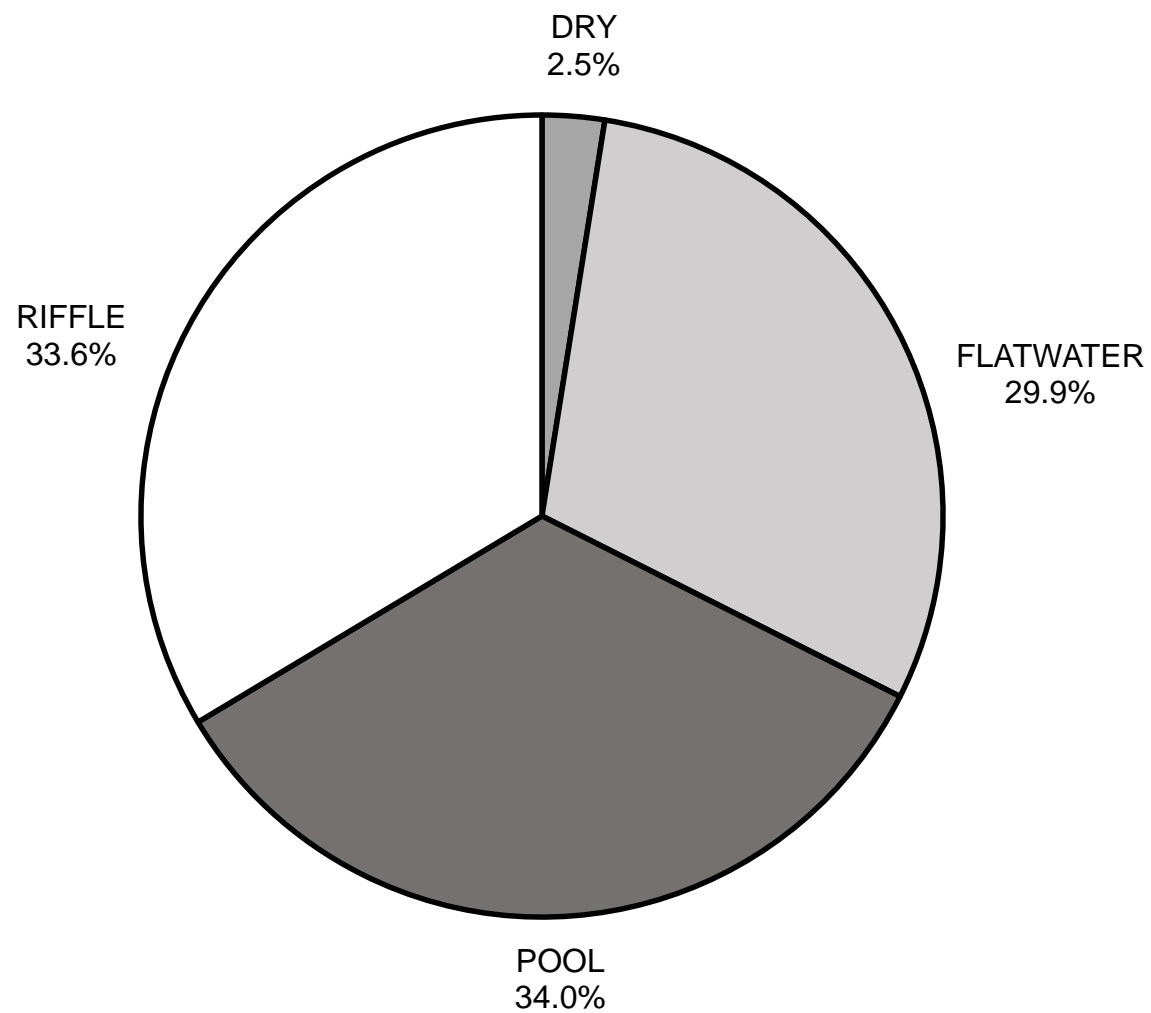
GRAPH 1

Table 1 summarizes the Level II riffle, flatwater, and pool habitat types. Based on frequency of occurrence there were 34% riffle units, 34% pool units, 30% flatwater units, and 3% dry units, (Graph 1). Based on total length of Level II habitat types there were 48% flatwater units, 27% pool units, 21% riffle units, and 4% dry units (Graph 2).

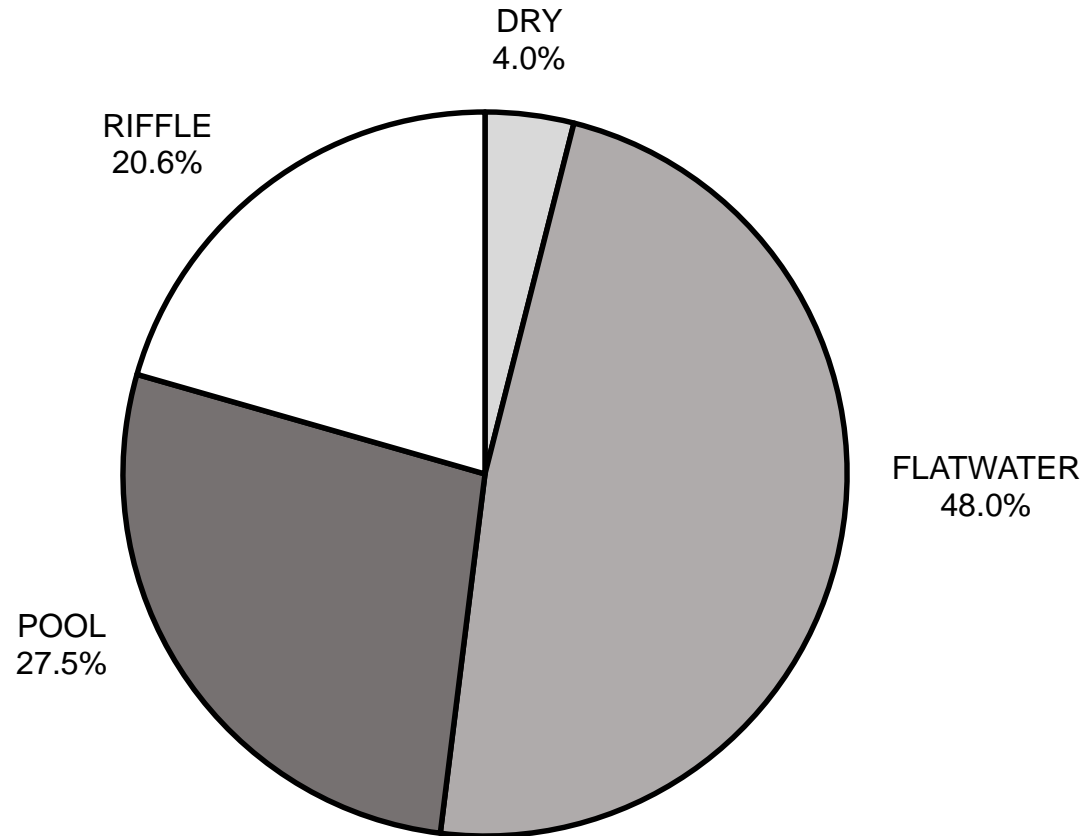
GRAPH 2

Flatwater habitat types comprised 48% of the total length of this survey, riffles 21%, pools 27%, and dry 4%. Fifty-two of the 176 (30%) pools had a maximum residual depth greater than 2 feet. In general, pool enhancement projects are considered when primary pools comprise less than 40% of the length of total stream habitat. In first and second order streams, a primary pool is defined to have a maximum residual depth of at least two feet, occupy at least half the width of the low flow channel, and be as long as the low flow channel width. Installing structures that will increase or deepen pool habitat is recommended.

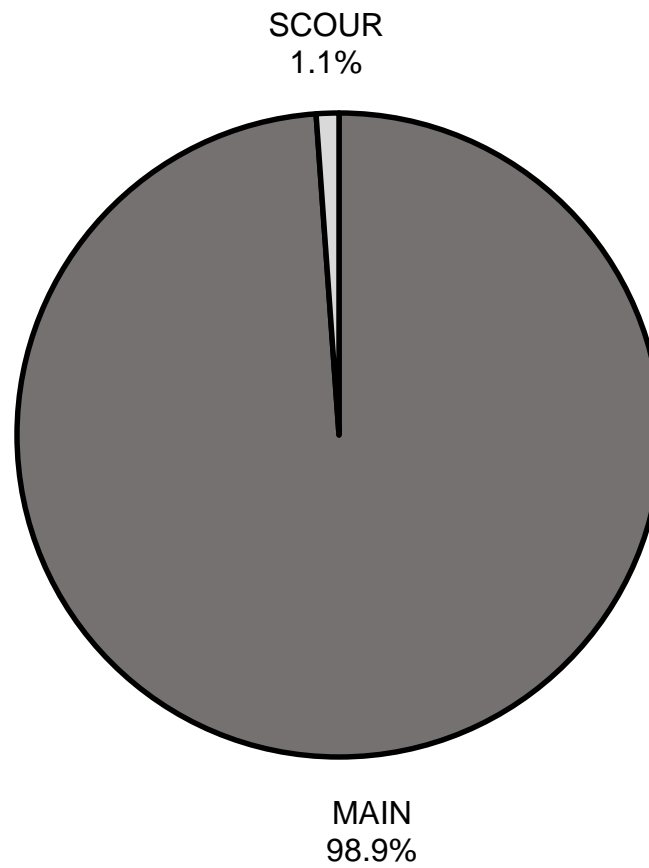
GRAPH 4

A total of 176 pools were identified (Table 3). Main channel pools were the most frequently encountered at 99% (Graph 4), and comprised 99% of the total length of all pools (Table 3).

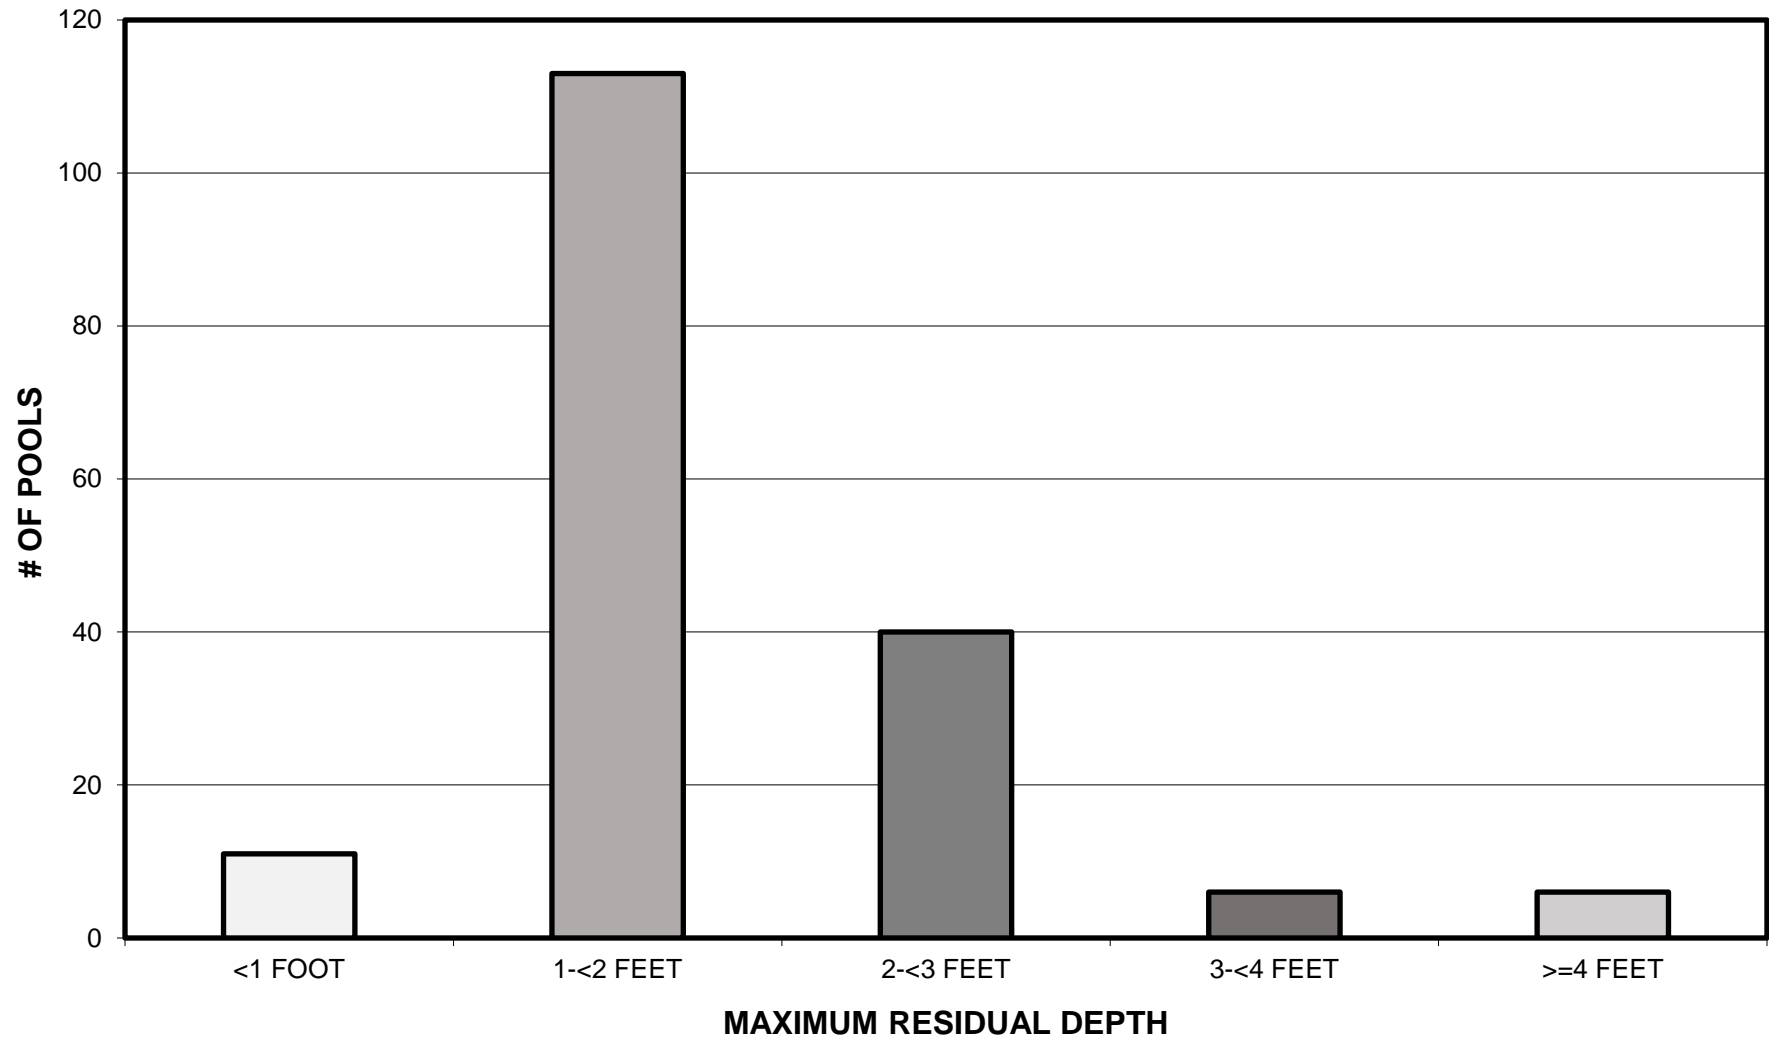
GRAPH 5

Table 4 is a summary of maximum residual pool depths by pool habitat types. Pool quality for salmonids increases with depth. Fifty-two of the 176 pools (30%) had a residual depth of two feet or greater (Graph 5).

- 3) Where feasible, design and engineer pool enhancement structures to increase the number of pools. This must be done where the banks are stable or in conjunction with stream bank armor to prevent erosion.

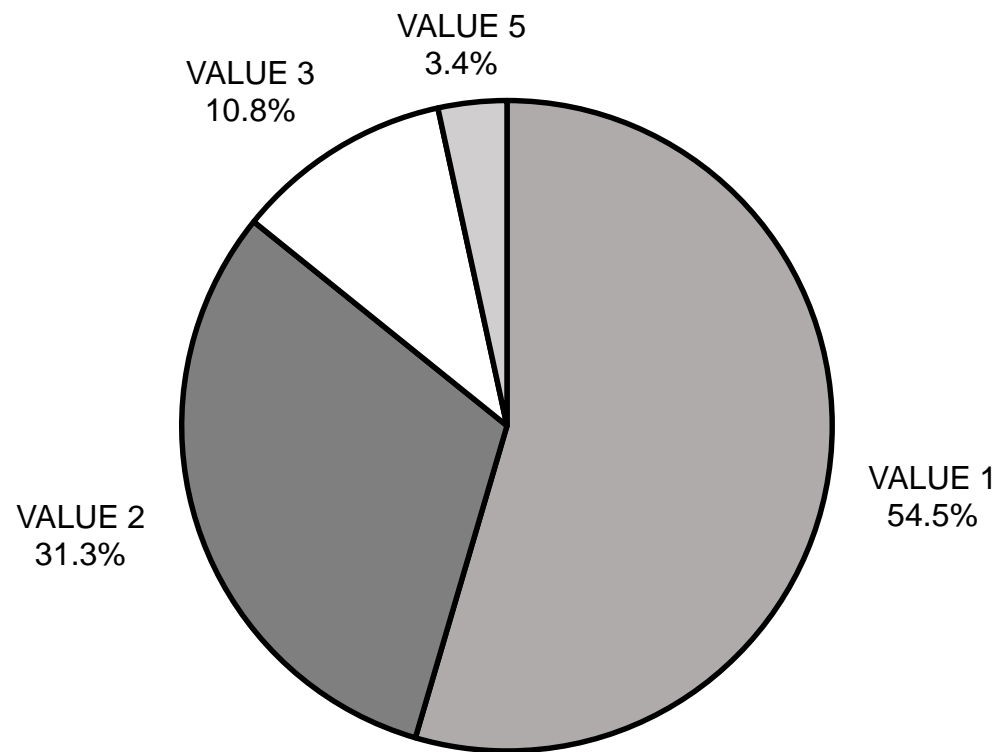
GRAPH 6

The depth of cobble embeddedness was estimated at pool tail-outs. Of the 176 pool tail-outs measured, 96 had a value of 1 (54.5%), 55 had a value of 2 (31.2%), 19 had a value of 3 (10.8%),

and 6 had a value of 5 (3.4%) (Graph 6). On this scale, a value of 1 indicates the highest quality of spawning substrate. Additionally, a value of 5 was assigned to tail-outs deemed unsuitable for spawning due to inappropriate substrate such as bedrock, log sills, boulders, or other considerations.

One hundred fifty-one of the 176 pool tail-outs measured had embeddedness ratings of 1 or 2. Nineteen of the pool tail-outs had embeddedness ratings of 3 or 4. Six of the pool tail-outs had a rating of 5, which is considered unsuitable for spawning. Cobble embeddedness measured to be

25% or less, a rating of 1, is considered to indicate good quality spawning substrate for salmon and steelhead.

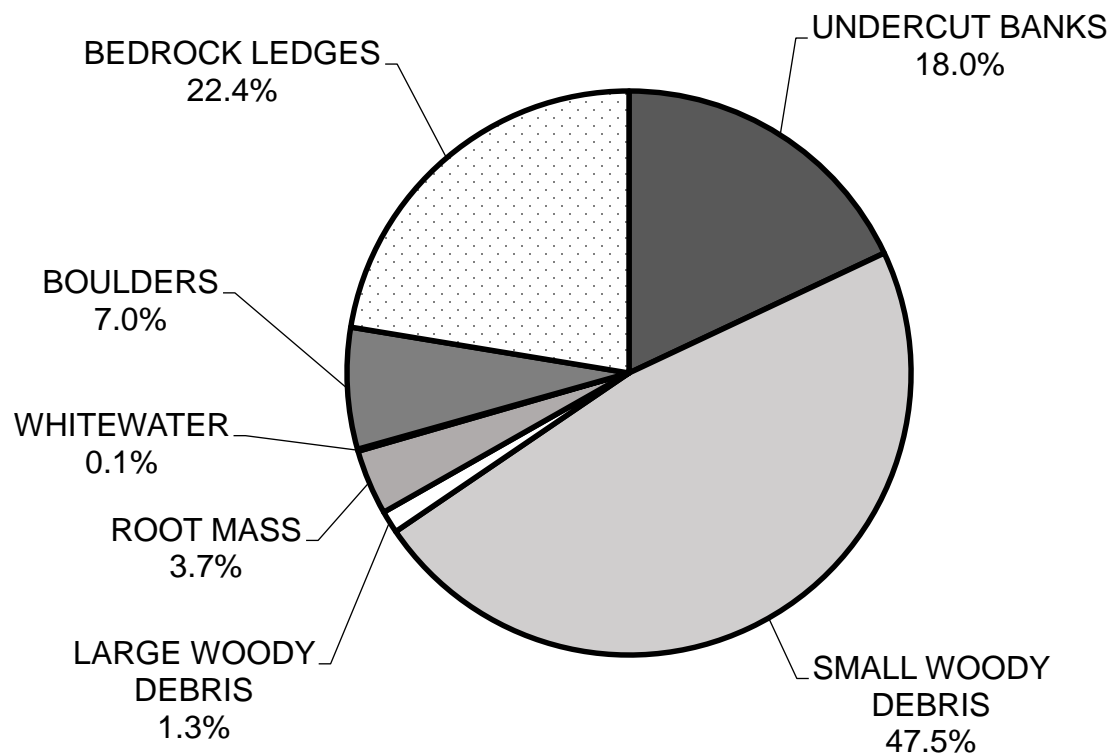
GRAPH 7

Table 5 summarizes mean percent cover by habitat type. Small woody debris is the dominant cover type in Sebbas Creek. Graph 7 describes the pool cover in Sebbas Creek. Small woody debris is the dominant pool cover type followed by bedrock ledges.

The mean shelter rating for pools is 30. The shelter rating in the flatwater habitats is 18. A pool shelter rating of approximately 100 is desirable. The amount of cover that now exists is being provided primarily by small woody debris in Sebbas Creek. Small woody debris is the dominant cover type in pools followed by bedrock ledges. Log and rootwad cover structures in the pool and flatwater habitats would enhance both summer and winter salmonid habitat. Log cover structure provides rearing fry with protection from predation, rest from water velocity, and also divides territorial units to reduce density related competition.

- 1) Increase woody cover in the pools and flatwater habitat units. Most of the existing cover in the pools is from small woody debris. Adding high quality complexity with woody cover in the pools is desirable.

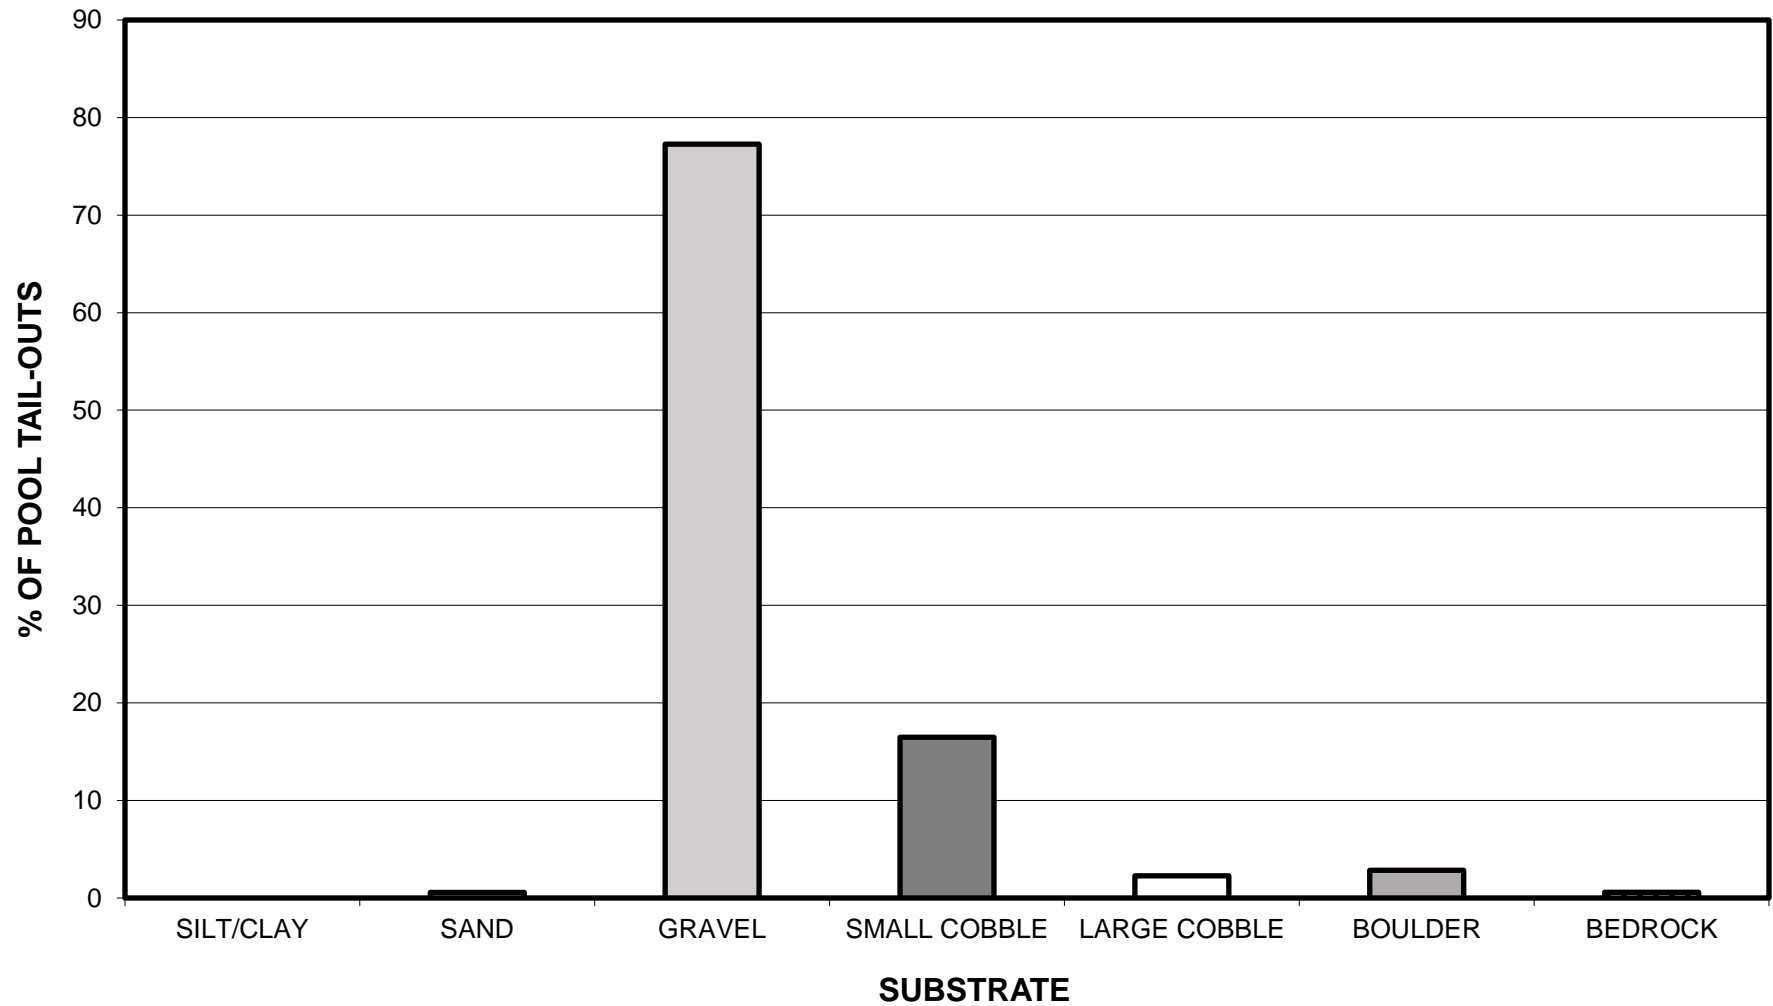
GRAPH 8

Table 6 summarizes the dominant substrate by habitat type. Graph 8 depicts the dominant substrate observed in pool tail-outs. Gravel was the dominant substrate type observed in 77% of pool tail-outs. Small cobble was the next most frequently observed dominant substrate type and occurred in 16% of pool tail-outs.

One hundred sixty-five of the 176 pool tail-outs measured had gravel or small cobble as the dominant substrate. This is generally considered good for spawning salmonids.

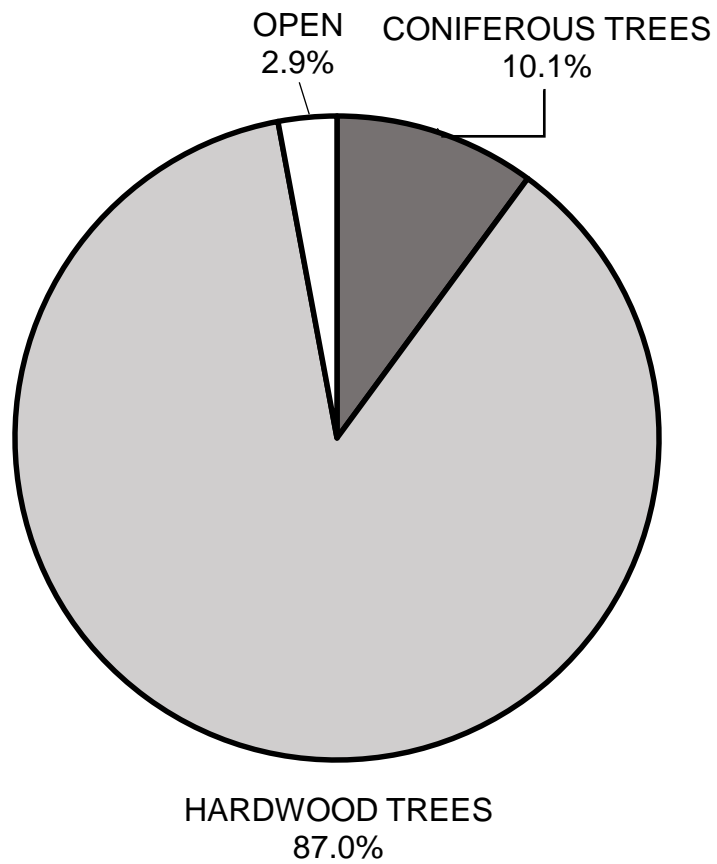
GRAPH 9

The mean percent canopy density for the surveyed length of Sebbas Creek was 97%. Three percent of the canopy was open. Of the canopy present, the mean percentages of hardwood and coniferous trees were 90% and 10%, respectively. Graph 9 describes the mean percent canopy in Sebbas Creek.

The mean percent canopy density for the stream was 97%. In general, revegetation projects are considered when canopy density is less than 80%.

- 4) While overall canopy density is 100% on Sebbas Creek, this canopy density is composed mainly of hardwood trees (90%). In order to provide more structure to the canopy, reduce water temperatures, and increase LWD recruitment consider planting appropriate native coniferous species like redwood and Douglas fir along the riparian corridor. Also where site conditions are appropriate consider cautious thinning of hardwoods to hasten the development of denser and more extensive coniferous canopy component. The

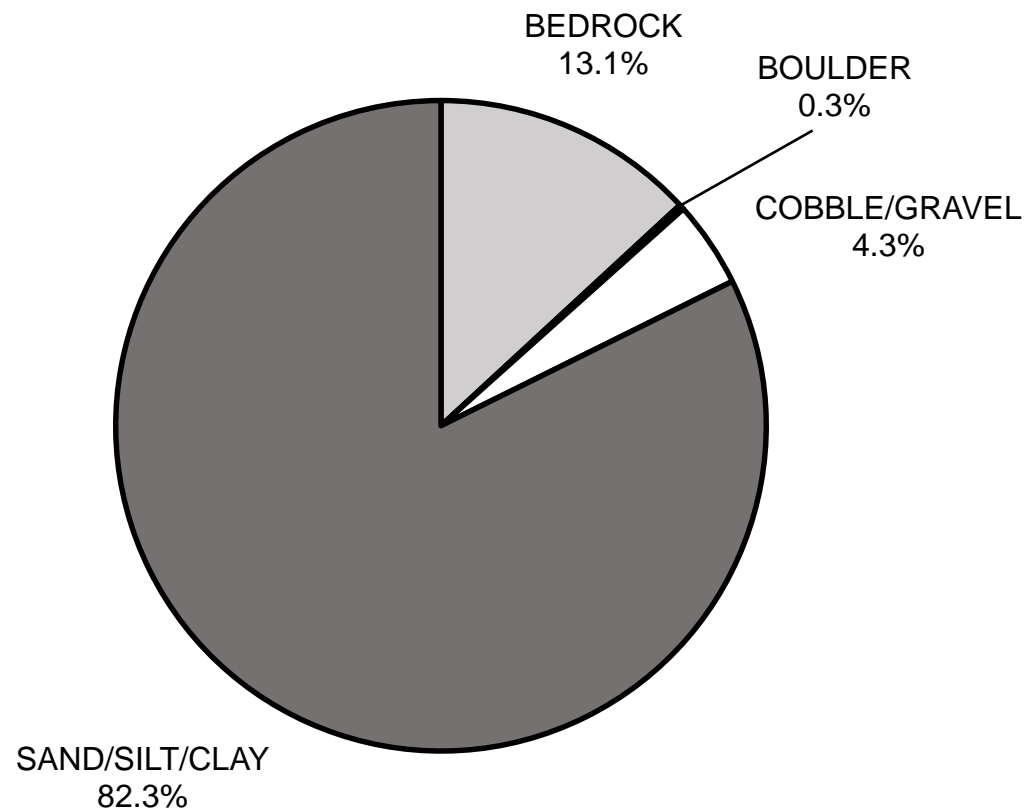
GRAPH 10

For the stream reach surveyed, the mean percent right bank vegetated was 100%. The mean percent left bank vegetated was 99%. The dominant elements composing the structure of the stream banks consisted of 82% sand/silt/clay, 13% bedrock, 4% cobble/gravel, and 0% boulder (Graph 10). Deciduous trees were the dominant vegetation type observed in 94.9% of the units surveyed. Additionally, 5.1% of the units surveyed had coniferous trees as the dominant vegetation type (Graph 11).

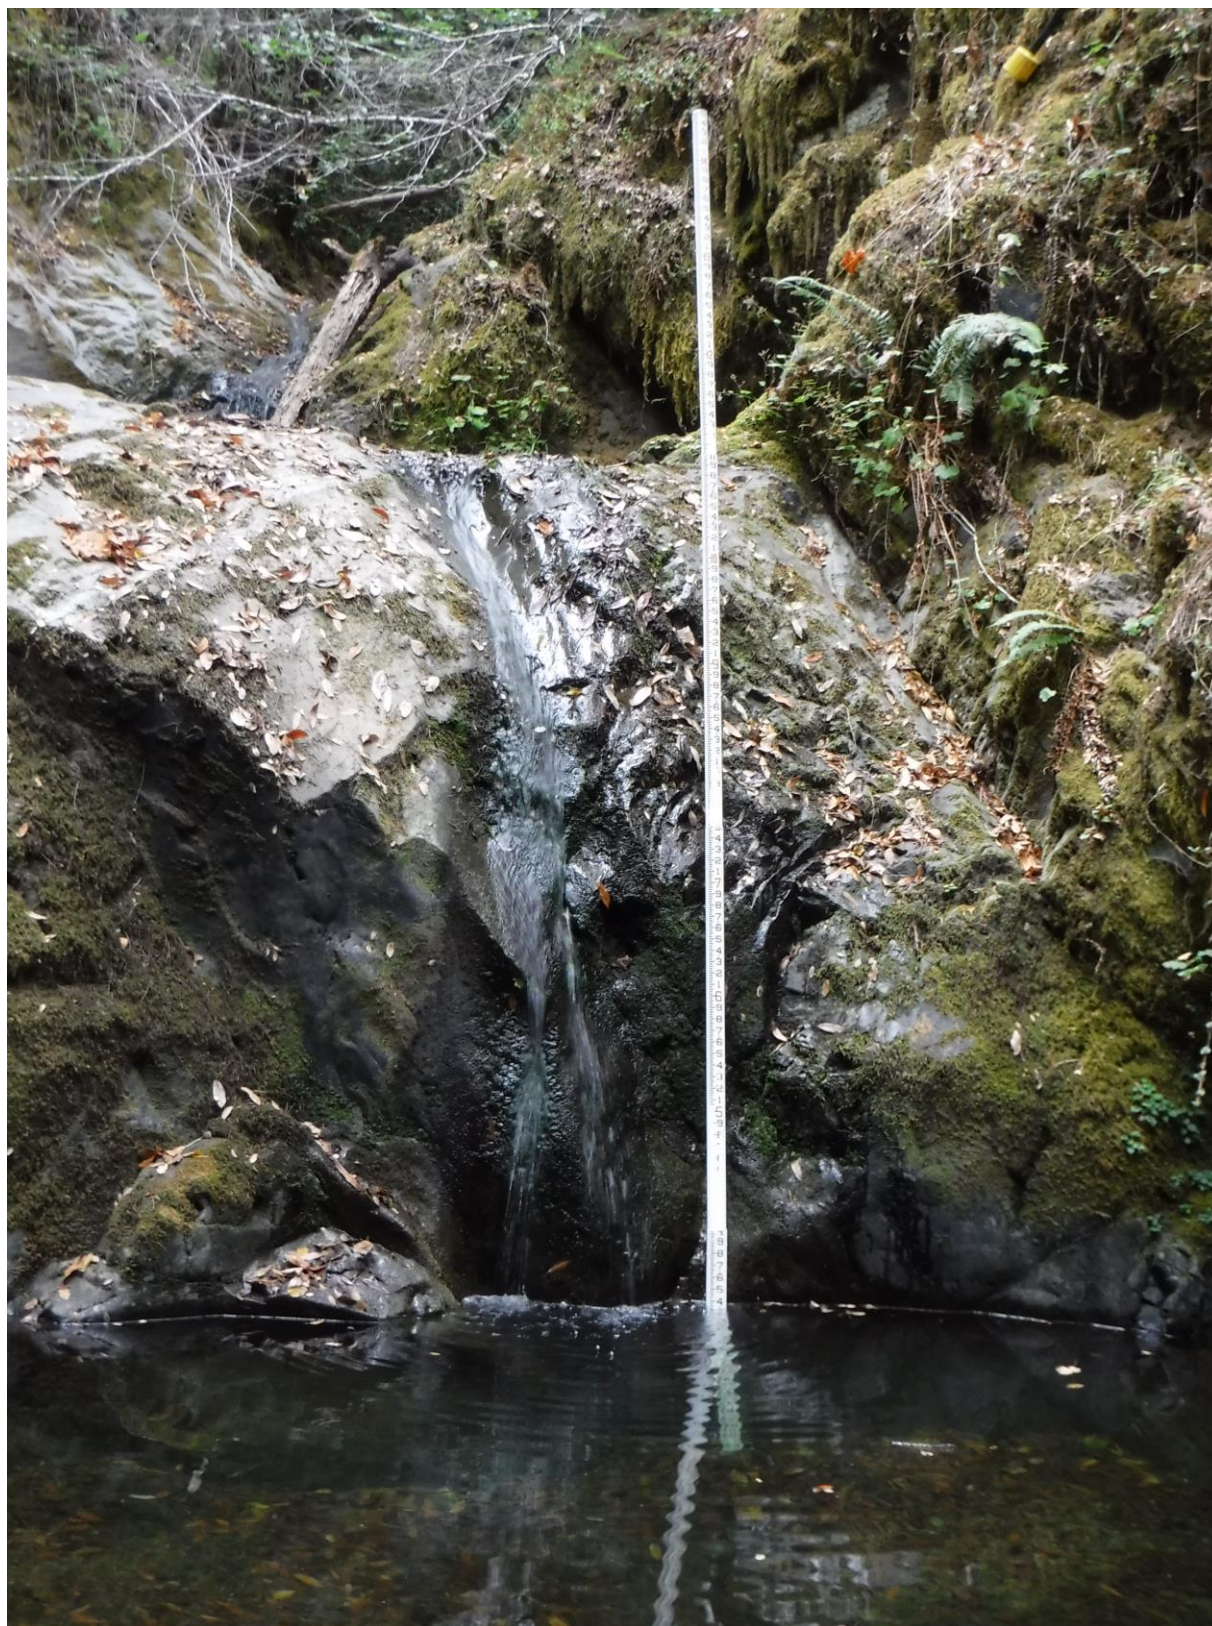
| 15861 | 0402.00 | 10' plunge over bedrock sheet into 3' deep pool. |

Photo 1: Plunge pool at habitat unit #402, 15,992' upstream from start of survey. (Photo taken 9/19/17)
