CALIFORNIA DEPARTMENT OF FISH AND WILDLIFE

STREAM INVENTORY REPORT

SEELY CREEK

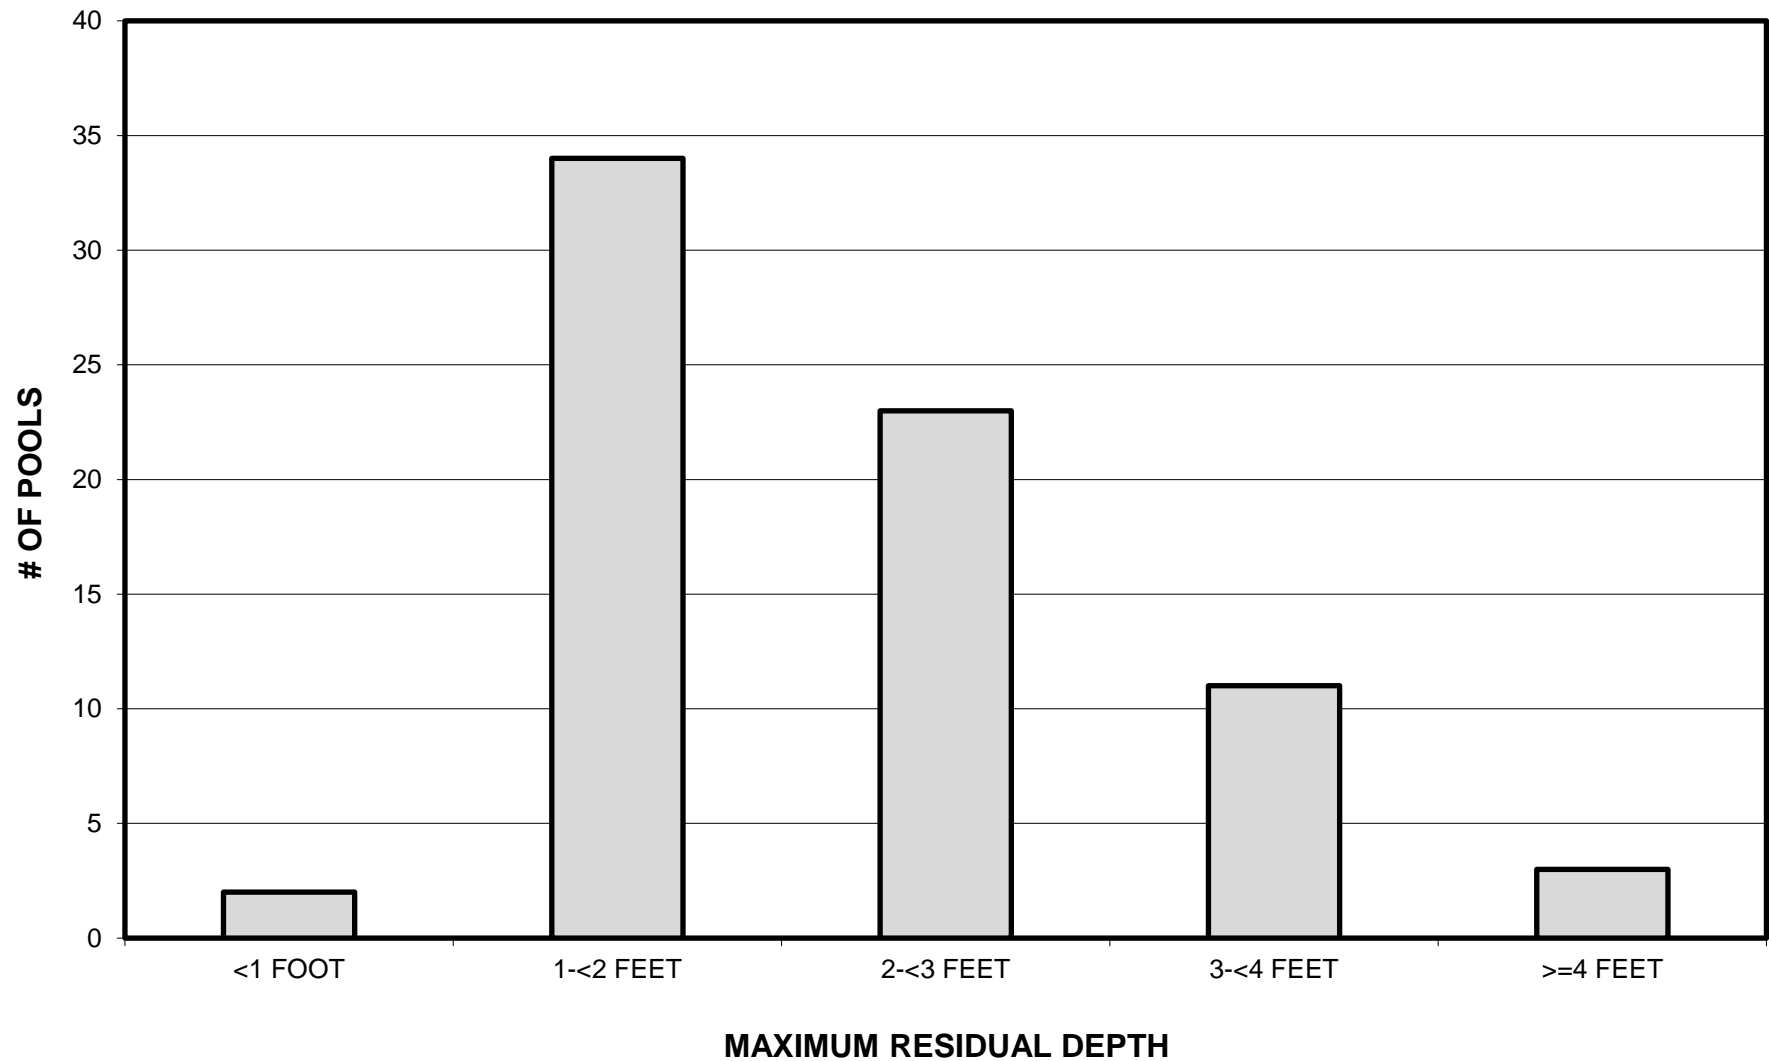
GRAPH 5

Table 4 is a summary of maximum residual pool depths by pool habitat types. Pool quality for salmonids increases with depth. Thirty-seven of the 73 pools (51%) had a residual depth of two feet or greater (Graph 5).

Flatwater habitat types comprised 36% of the total length of this survey, riffles 7%, and pools 57%. Thirty-seven of the 73 (51%) pools had a maximum residual depth greater than two feet. In general, pool enhancement projects are considered when primary pools comprise less than 40% of the length of total stream habitat. In first and second order streams, a primary pool is defined to have a maximum residual depth of at least two feet, occupy at least half the width of the low flow channel, and be as long as the low flow channel width.

- 5) Where feasible, design and engineer pool enhancement structures to increase the number of pools. This must be done where the banks are stable or in conjunction with stream bank armor to prevent erosion.

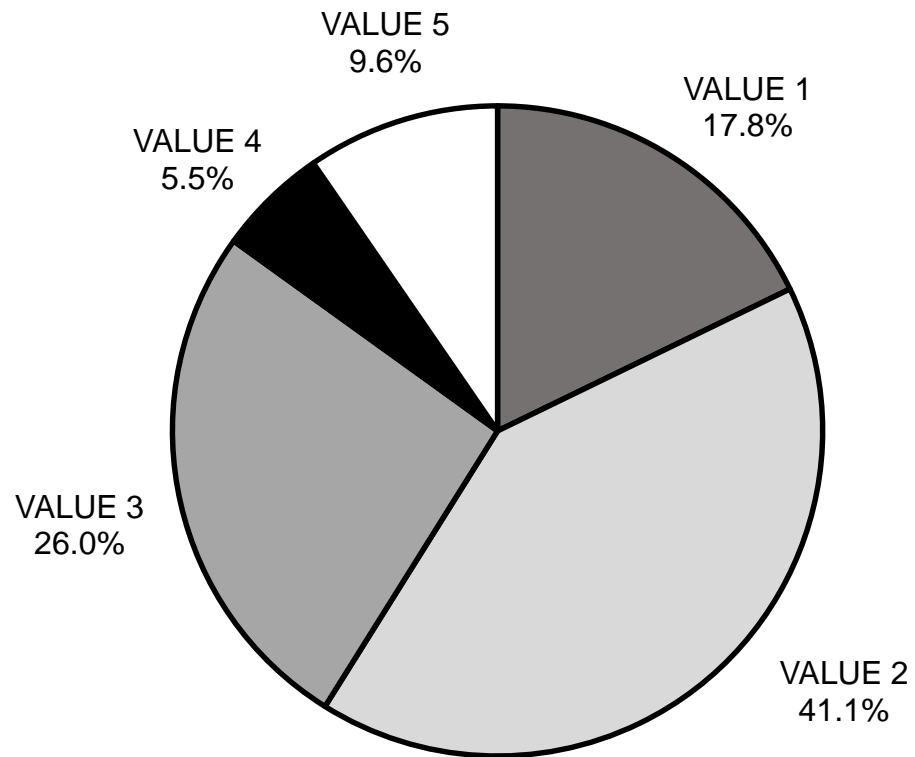
GRAPH 6

The depth of cobble embeddedness was estimated at pool tail-outs. Of the 73 pool tail-outs measured, 13 had a value of 1 (17.8%), 30 had a value of 2 (41.1%), 19 had a value of 3 (26%), 4 had a value of 4 (5.5%), 7 had a value of 5 (9.6%) (Graph 6). On this scale, a value of 1 indicates the best spawning conditions and a value of 4 the worst. Additionally, a value of 5 was assigned to tail-outs deemed not suitable for spawning due to inappropriate substrate such as bedrock, log sills, boulders, or other considerations.

Forty-three of the 73 pool tail-outs measured had embeddedness ratings of 1 or 2. Twenty-three of the pool tail-outs had embeddedness ratings of 3 or 4. Seven of the pool tail-outs had a rating of 5, which is considered unsuitable for spawning. Cobble embeddedness measured to be 25% or less, a rating of 1, is considered to indicate good quality spawning substrate for salmon and steelhead. Sediment sources in Seely Creek should be mapped and rated according to their potential sediment yields, and control measures should be taken.

- 2) Active and potential sediment sources related to the road system need to be identified, mapped, and treated according to their potential for sediment yield to the stream and its tributaries.

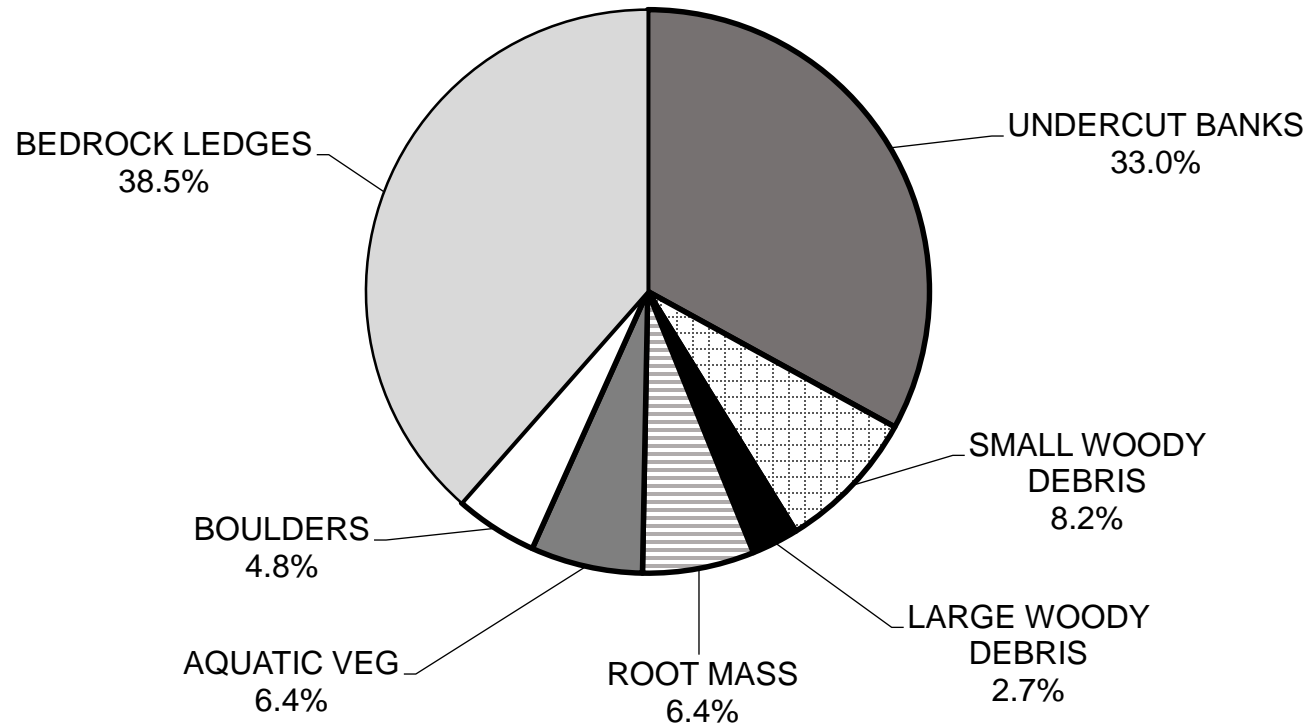
GRAPH 7

Table 5 summarizes mean percent cover by habitat type. Bedrock ledges are the dominant cover type in Seely Creek. Graph 7 describes the pool cover in Seely Creek. Bedrock ledges are the dominant pool cover type followed by undercut banks.

The mean shelter rating for pools is 28. The shelter rating in the flatwater habitats is 7. A pool shelter rating of approximately 100 is desirable. The amount of cover that now exists is being provided primarily by bedrock ledges in Seely Creek. Bedrock ledges are the dominant cover type in pools followed by undercut banks. Log and rootwad cover structures in the pool and flatwater habitats would enhance both summer and winter salmonid habitat. Log cover structures provide rearing fry with protection from predation, rest from water velocity, and also divide territorial units to reduce density related competition.

- 1) Increase woody cover in the pools and flatwater habitat units. Most of the existing cover in the pools is from Bedrock Ledges. Adding high quality complexity with woody cover in the pools is desirable.

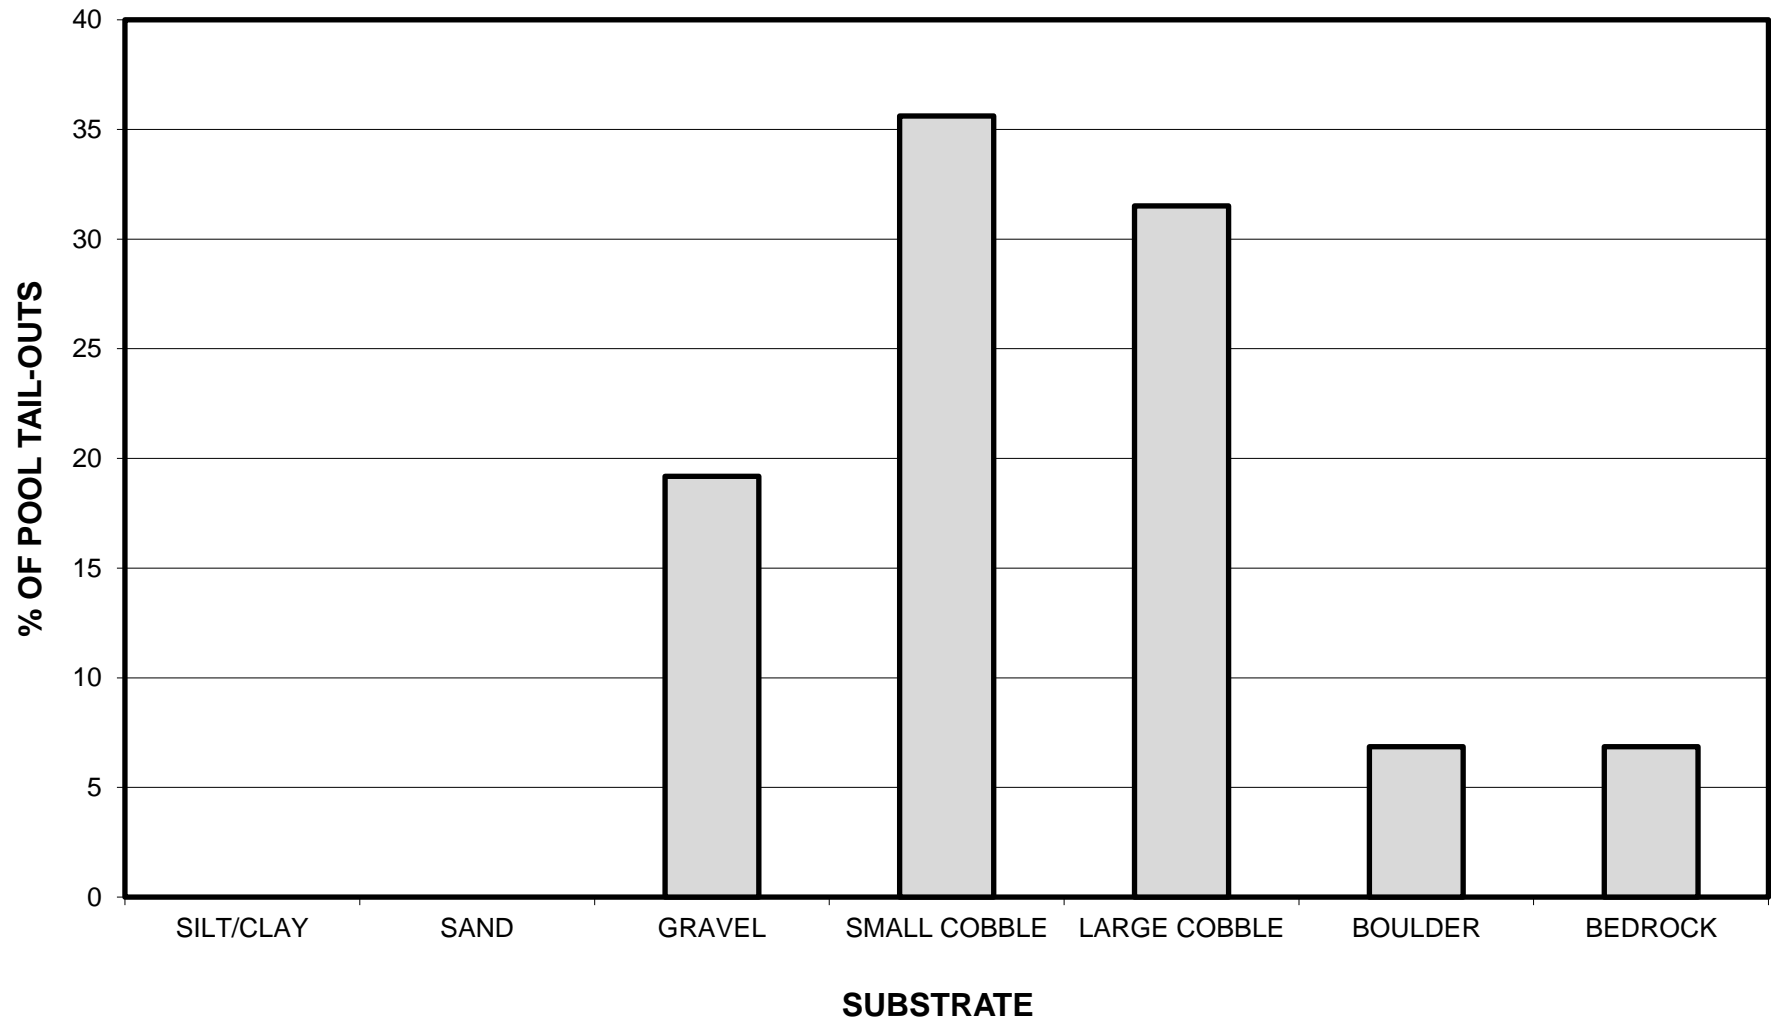
GRAPH 8

Table 6 summarizes the dominant substrate by habitat type. Graph 8 depicts the dominant substrate observed in pool tail-outs. Small cobble was the most dominate substrate type, observed in 36% of the pool tail-outs. Large cobble was the next most frequently observed dominant substrate type and occurred in 32% of the pool tail-outs.

Forty of the 73 pool tail-outs measured had gravel or small cobble as the dominant substrate. This is generally considered good for spawning salmonids.

- 3) Suitable size spawning substrate on Seely Creek is limited to relatively few reaches. Projects should be designed at suitable sites to trap and sort spawning gravel.

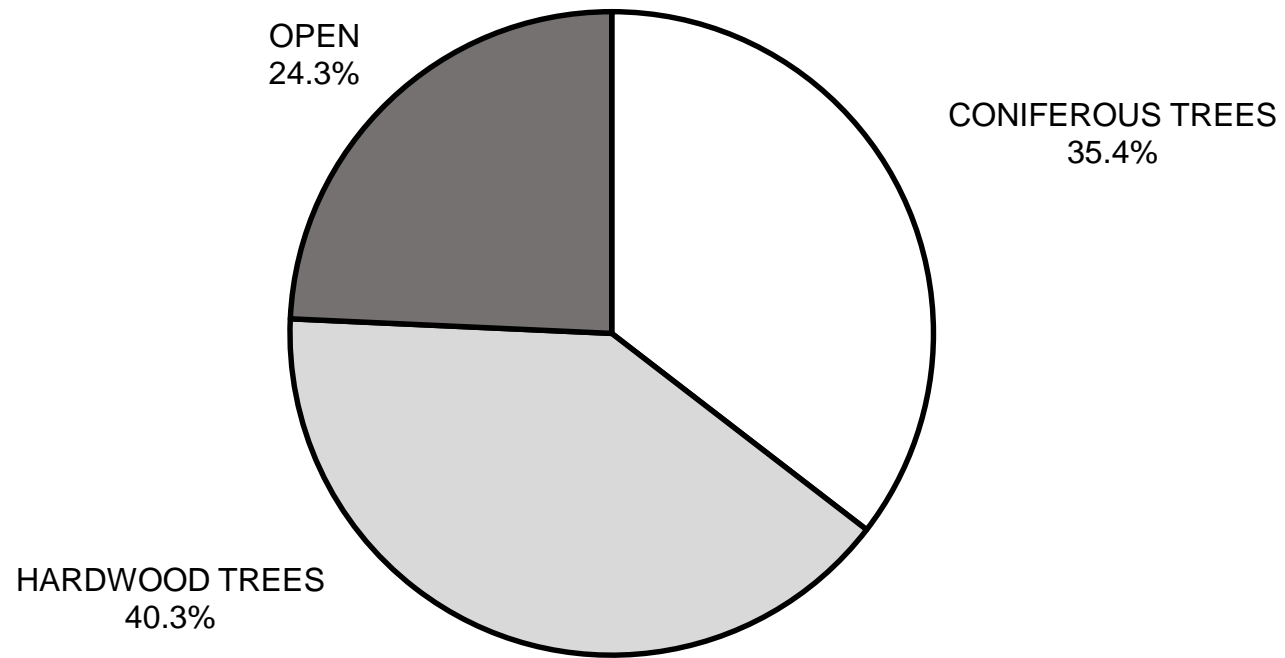
GRAPH 9

The mean percent canopy density for the surveyed length of Seely Creek was 76%. Twenty-four percent of the canopy was open. Of the canopy present, the mean percentages of hardwood and coniferous trees were 53% and 47%, respectively. Graph 9 describes the mean percent canopy in Seely Creek.

The mean percent canopy density for the stream was 76%. In general, revegetation projects are considered when canopy density is less than 80%. The percentage of right and left bank covered with vegetation were both 100%.

- 6) Increase the canopy on Seely Creek by planting appropriate native vegetation, particularly coniferous tree species like redwood, and Douglas fir along the stream where shade canopy is not at acceptable levels. The reaches above this survey section should be inventoried and treated as well, since the water flowing here is affected from upstream. In many cases, planting will need to be coordinated to follow bank stabilization or

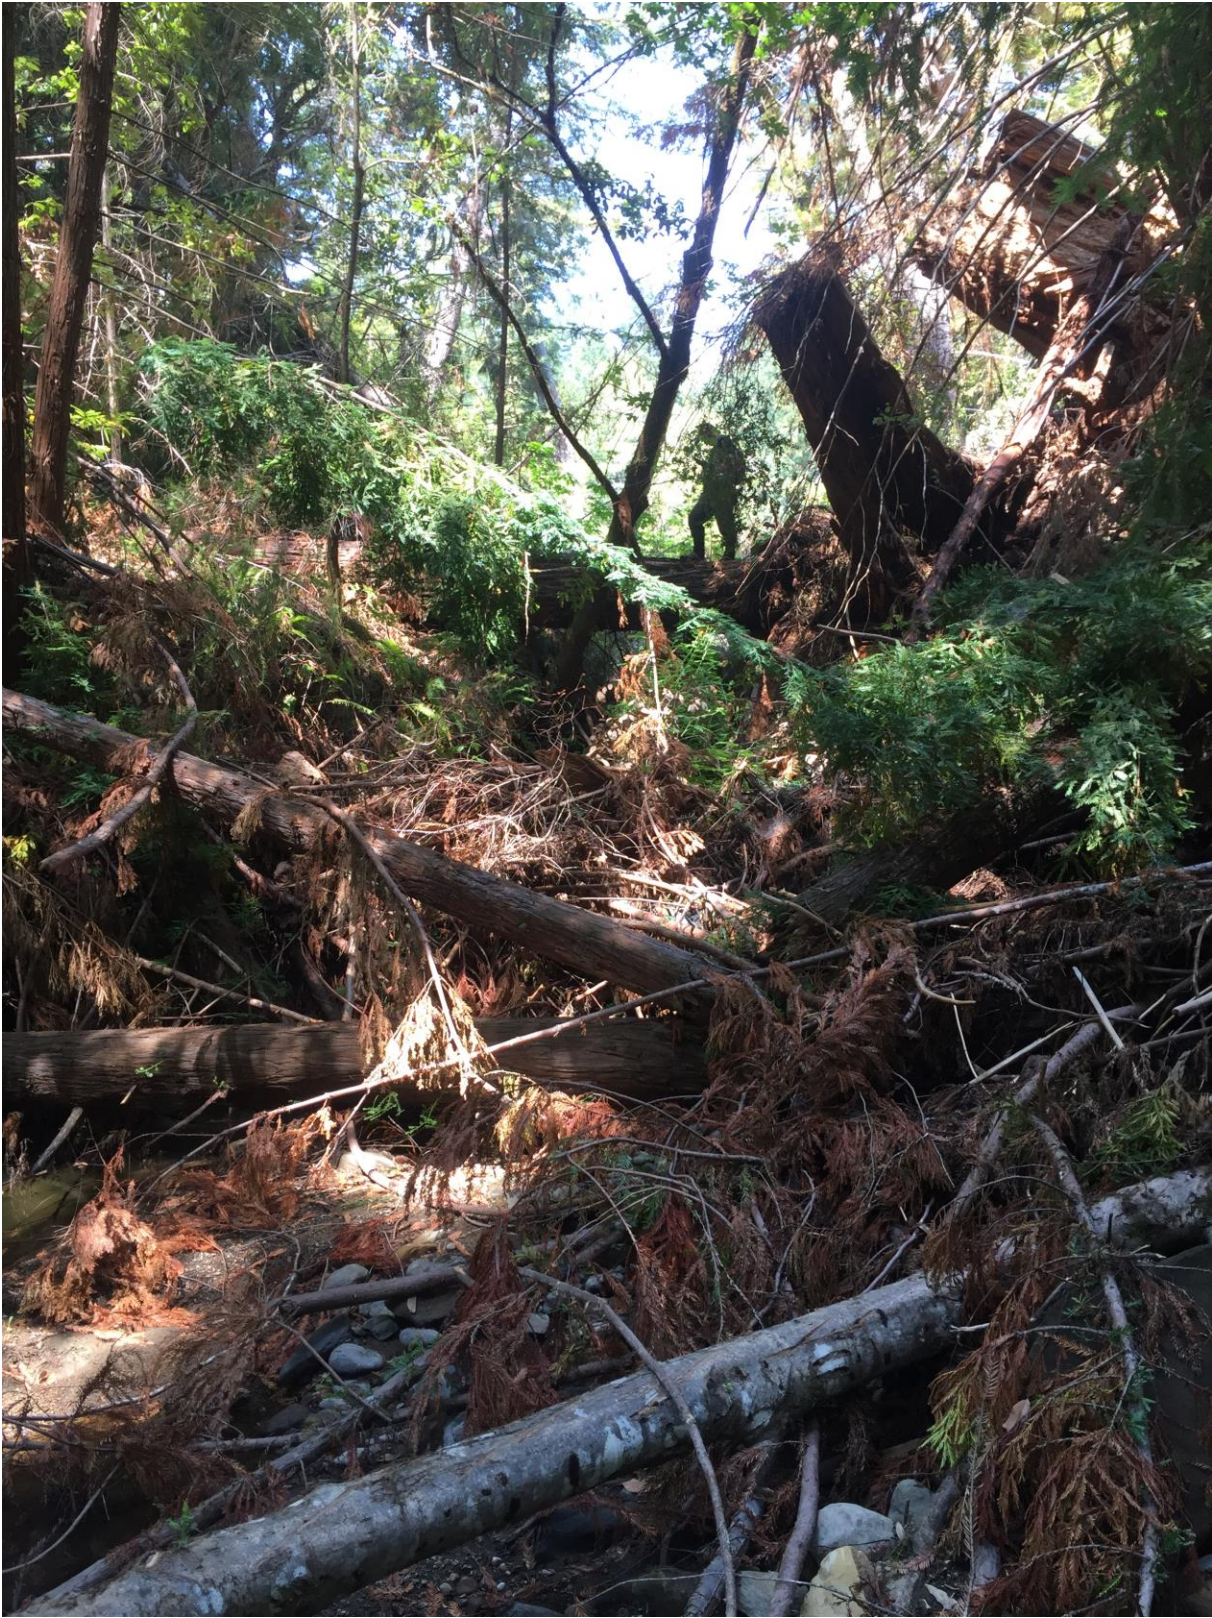
9030 0162.00 End of survey due to access. 200m short of last accessible parcel is an extensive landslide. Channel full with sediment, trees, and trash. Cut trees form LDA-like debris. Water flow is minimal through landslide. Last fish (YOY) observed in HU 161, the pool just prior to the landslide. Much of creek is comprised of bedrock and large cobble/boulders.

Photo 1: End of survey at habitat unit #162, 9,030' upstream of the start of survey. (Photo taken 7/30/17)
