CALIFORNIA DEPARTMENT OF FISH AND WILDLIFE

STREAM INVENTORY REPORT

Somerville Creek

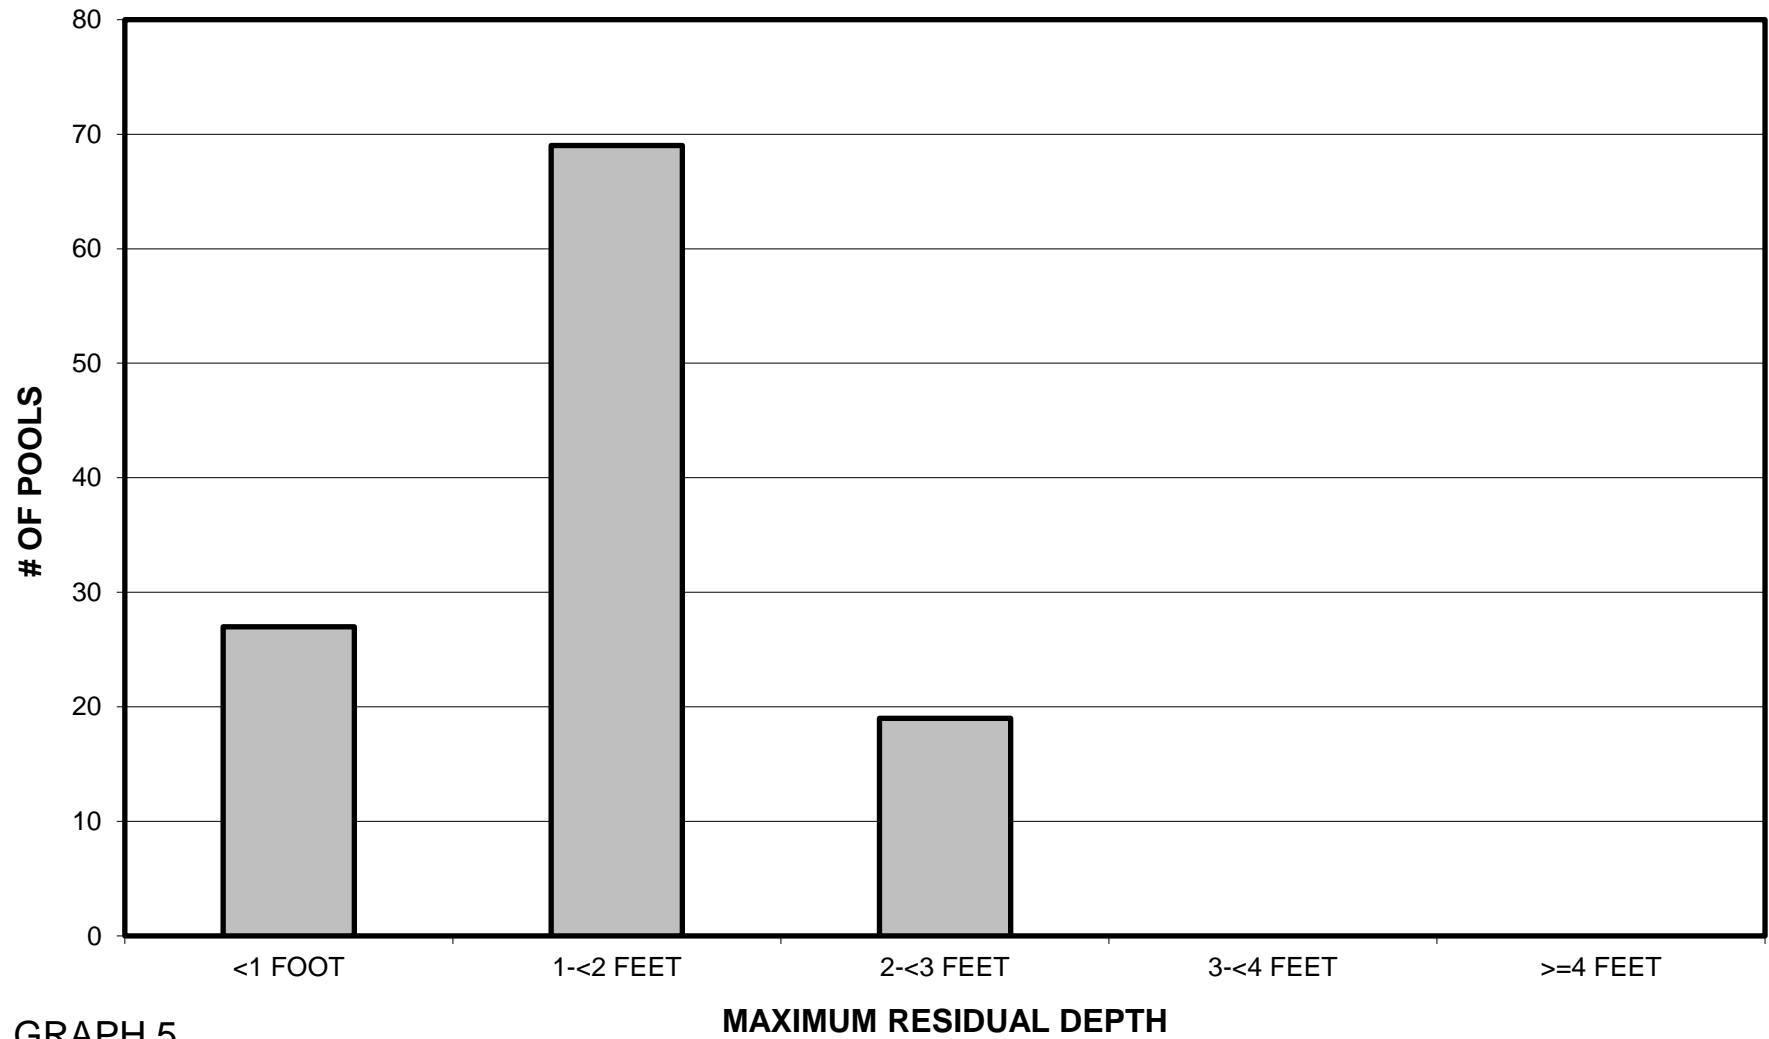
GRAPH 5

Table 4 is a summary of maximum residual pool depths by pool habitat types. Pool quality for salmonids increases with depth. Nineteen of the 115 pools (17%) had a residual depth of two feet or greater (Graph 5).

Flatwater habitat types comprised 54% of the total length of this survey, riffles 18%, and pools 21%. 19 of the 115 (17%) pools had a maximum residual depth greater than 2 feet. In general, pool enhancement projects are considered when primary pools comprise less than 40% of the length of total stream habitat. In first and second order streams, a primary pool is defined to have a maximum residual depth of at least two feet, occupy at least half the width of the low

flow channel, and be as long as the low flow channel width. Installing structures that will increase or deepen pool habitat is recommended.

- 6) Where feasible, design and engineer pool enhancement structures to increase the number of pools. This must be done where the banks are stable or in conjunction with stream bank armor to prevent erosion.

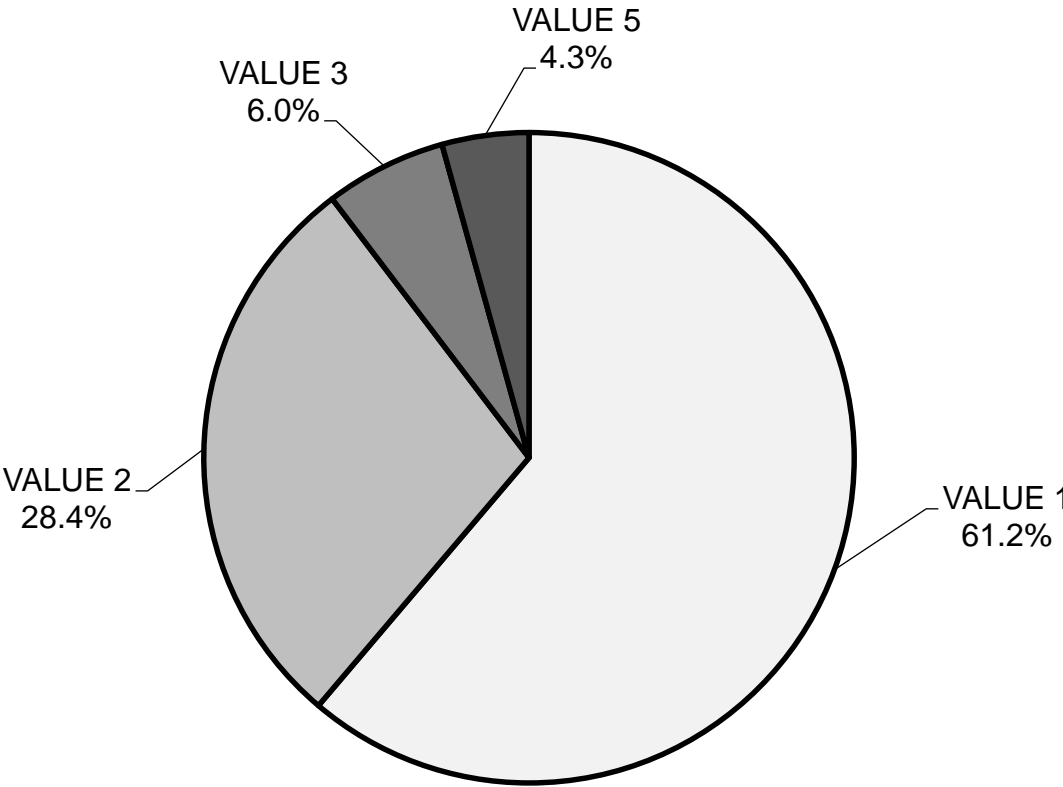
GRAPH 6

The depth of cobble embeddedness was estimated at pool tail-outs. Of the 116 pool tail-outs measured, 71 had a value of 1 (61.2%), 33 had a value of 2 (28.4%), 7 had a value of 3 (6%), and 5 had a value of 5 (4.3%) (Graph 6). On this scale, a value of 1 indicates the highest quality of spawning substrate. Additionally, a value of 5 was assigned to tail-outs deemed unsuitable for spawning due to inappropriate substrate such as bedrock, log sills, boulders, or other considerations.

One hundred four of the 116 pool tail-outs measured had embeddedness ratings of 1 or 2. Seven of the pool tail-outs had embeddedness ratings of 3 or 4. Five of the pool tail-outs had a rating of 5, which is considered unsuitable for spawning. Cobble embeddedness measured to be 25% or less, a rating of 1, is considered to indicate good quality spawning substrate for salmon and steelhead.

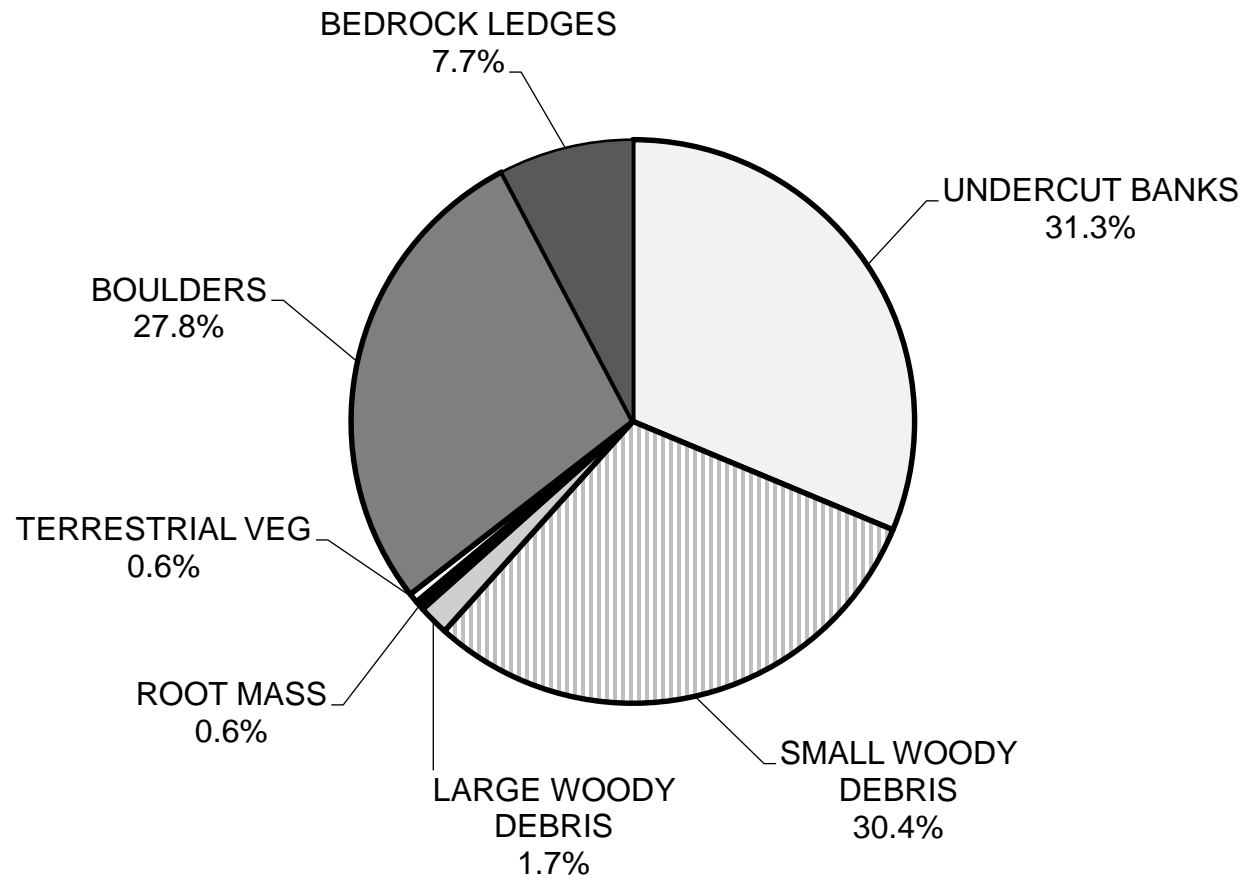
GRAPH 7

Table 5 summarizes mean percent cover by habitat type. Undercut banks is the dominant cover type in Somerville Creek. Graph 7 describes the pool cover in Somerville Creek. Undercut banks are the dominant pool cover type followed by small woody debris.

The mean shelter rating for pools is 27. The shelter rating in the flatwater habitats is 7. A pool shelter rating of approximately 100 is desirable. The amount of cover that now exists is being provided primarily by Undercut Banks in Somerville Creek. Undercut Banks are the dominant cover type in pools followed by small woody debris. Log and rootwad cover structures in the pool and flatwater habitats would enhance both summer and winter salmonid habitat. Log cover structure provides rearing fry with protection from predation, rest from water velocity, and also divides territorial units to reduce density related competition.

- 1) Increase woody cover in the pools and flatwater habitat units. Most of the existing cover in the pools is from undercut banks. Adding high quality complexity with woody cover in the pools is desirable.
- 2) Based on observed conditions (upper portion of Somerville Creek was dry) pools may become disconnected. Streamflow should be monitored to determine if it is limiting for salmonids.

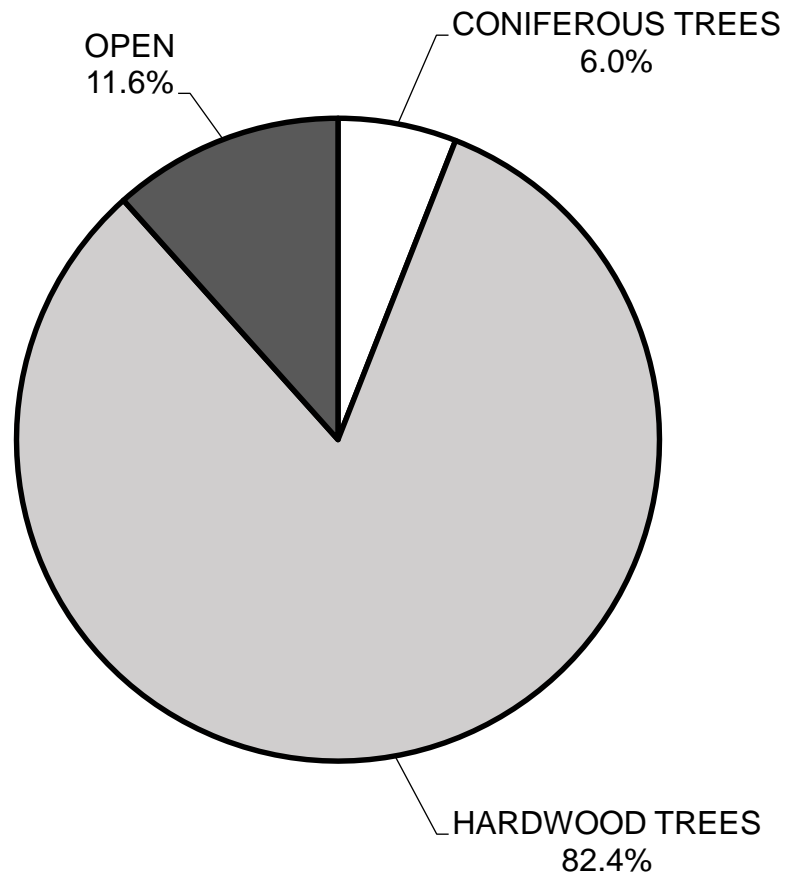
GRAPH 9

The mean percent canopy density for the surveyed length of Somerville Creek was 88%. Twelve percent of the canopy was open. Of the canopy present, the mean percentages of hardwood and coniferous trees were 93% and 7%, respectively. Graph 9 describes the mean percent canopy in Somerville Creek.

The mean percent canopy density for the stream was 88%. Reach 1 had a canopy density of 87.9%, and reach 2 had a canopy density of 100%. In general, revegetation projects are considered when canopy density is less than 80%.

- 7) While overall canopy density is 88% on Somerville Creek, this canopy density is composed predominantly of hardwood tree species (93%). In order to provide more structure to the canopy, reduce water temperatures, and increase LWD recruitment consider planting appropriate native coniferous species like redwood and Douglas fir along the riparian corridor. Also where site conditions are appropriate consider cautious thinning of hardwoods to hasten the development of denser and more extensive coniferous canopy component. The reaches above this survey section should be inventoried and treated as well, since the water flowing here is affected from upstream. In many cases, planting will need to be coordinated to follow bank stabilization or upslope erosion control projects.

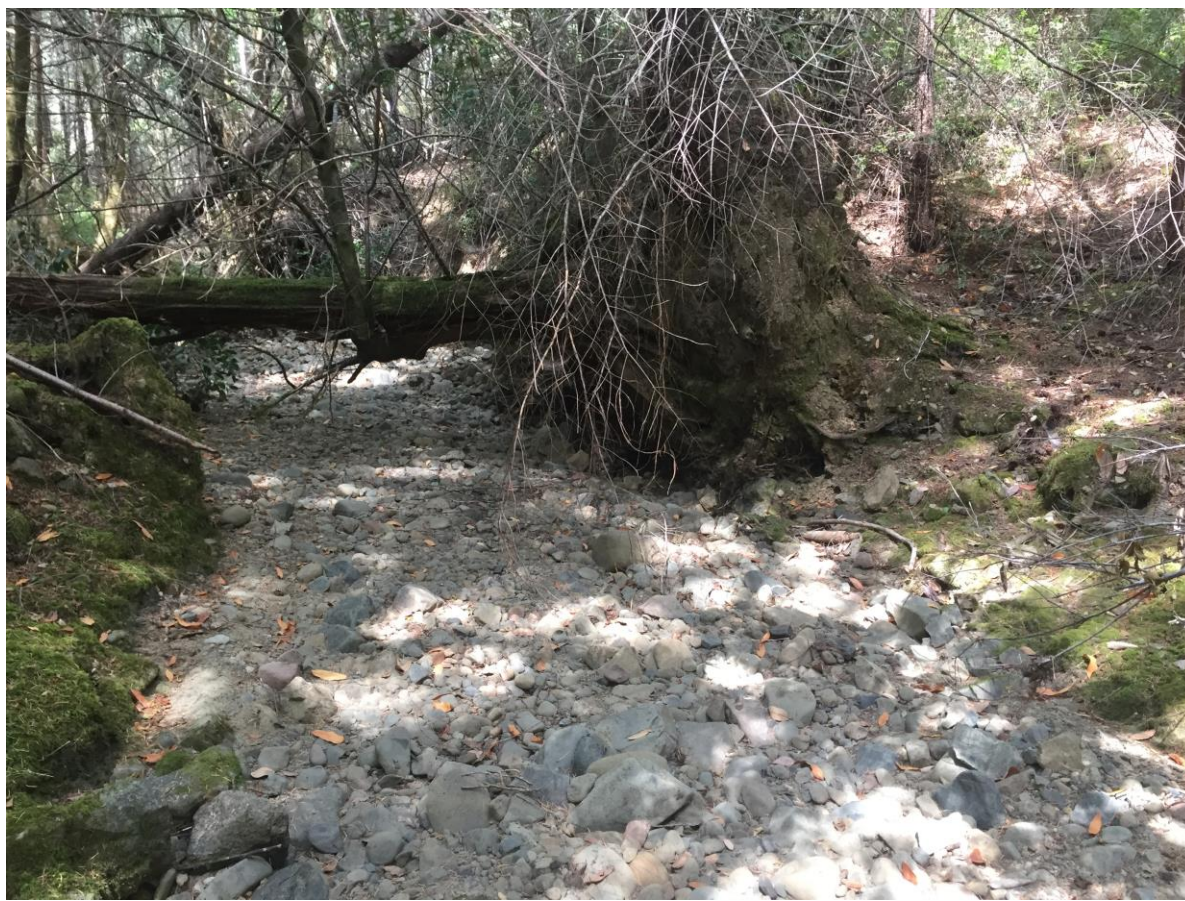
Photo 1: Dry channel at unknown habitat unit. (Photo taken 8/22/17)

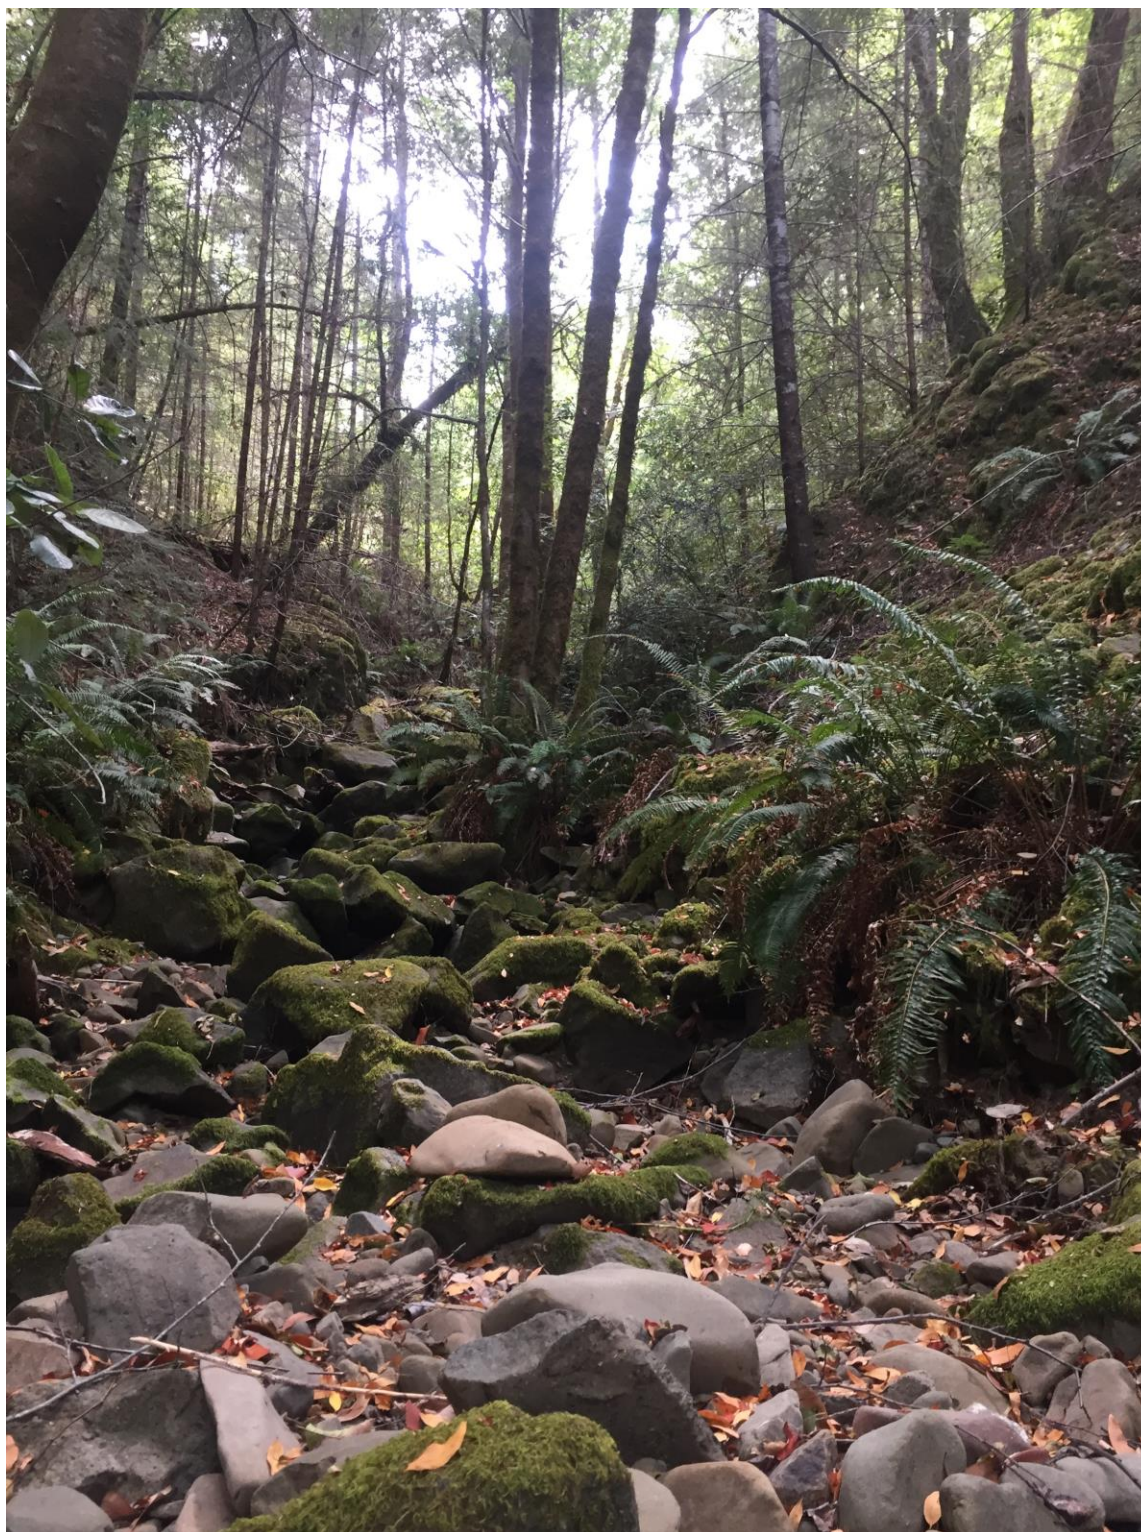
14554 0350.00 End of survey due to 457' of dry channel. The channel is steep and boulder dominated. The last YOY was observed at HU #349, which was a pool located right before the creek ran dry.

Photo 2: End of survey due to dry 457' of dry channel. Photo taken at habitat unit 350, 14,812' upstream of start of survey. (Photo taken 8/22/17)
