## CALIFORNIA DEPARTMENT OF FISH AND WILDLIFE

### STREAM INVENTORY REPORT

#### **Hely Creek**

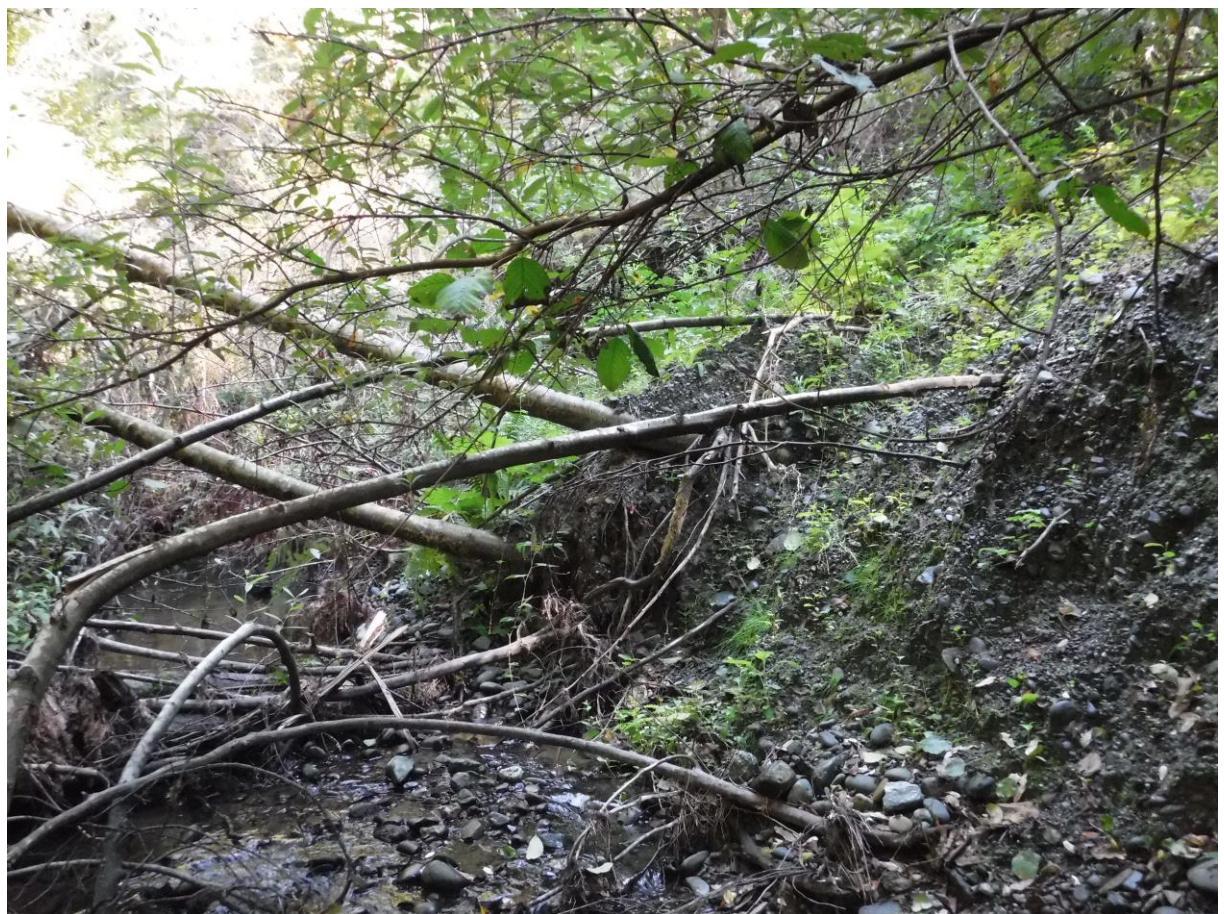
Photo 1: Landslide at unknown distance from start of survey. (Photo taken 9/25/17)

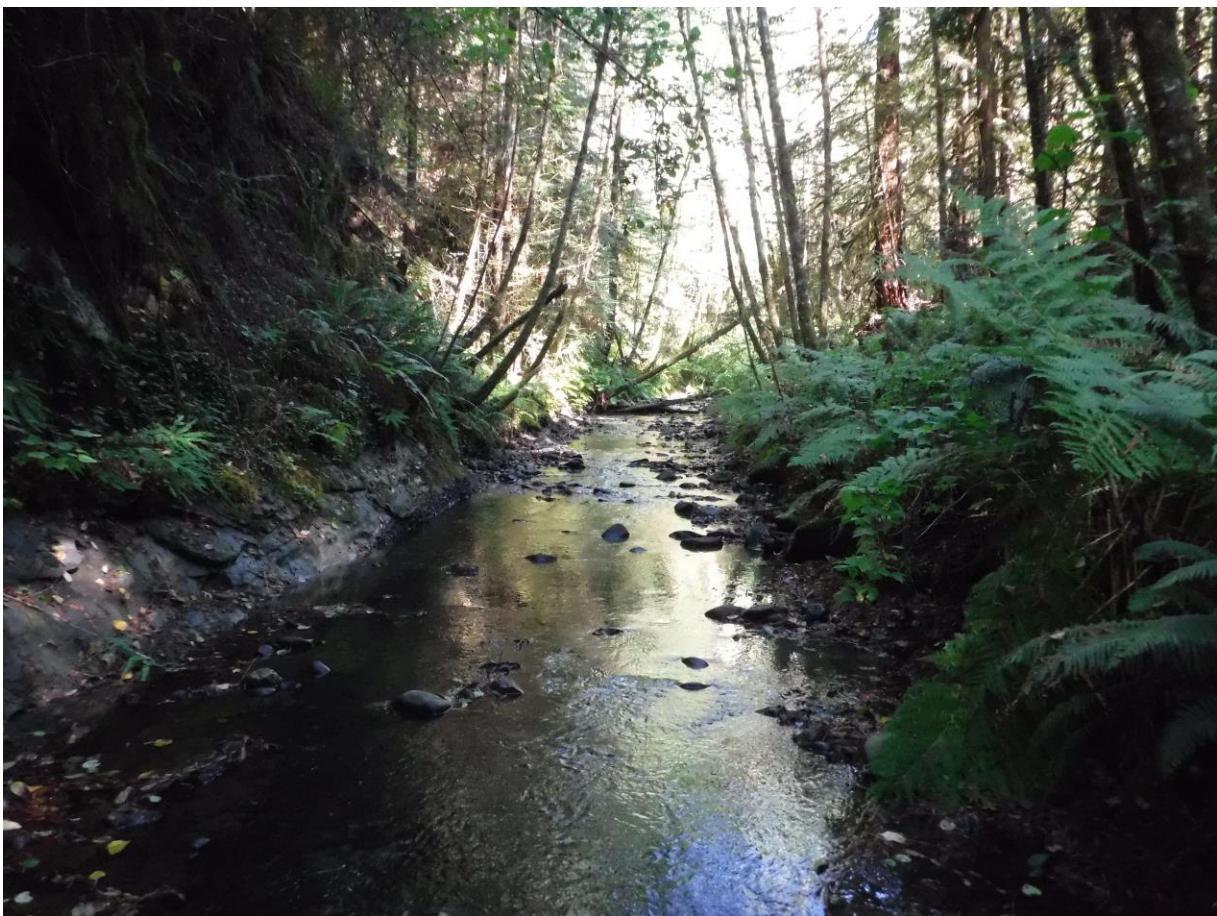
Photo 2: Run unit at unknown distance from start of survey. (Photo taken 9/25/17)
