CALIFORNIA DEPARTMENT OF FISH AND WILDLIFE

STREAM INVENTORY REPORT

Stevens Creek

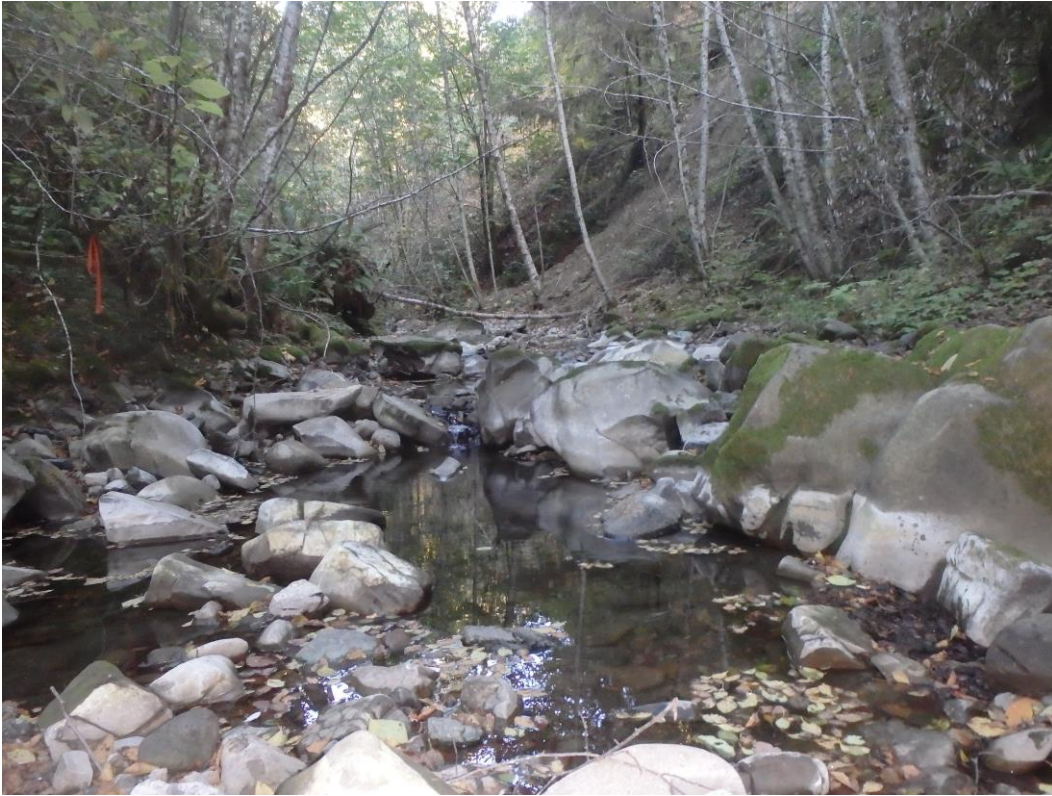
Photo 1: Start of survey at the mouth of Stevens Creek, facing upstream from the confluence with Grizzly Creek. (Photo taken 10/11/17)

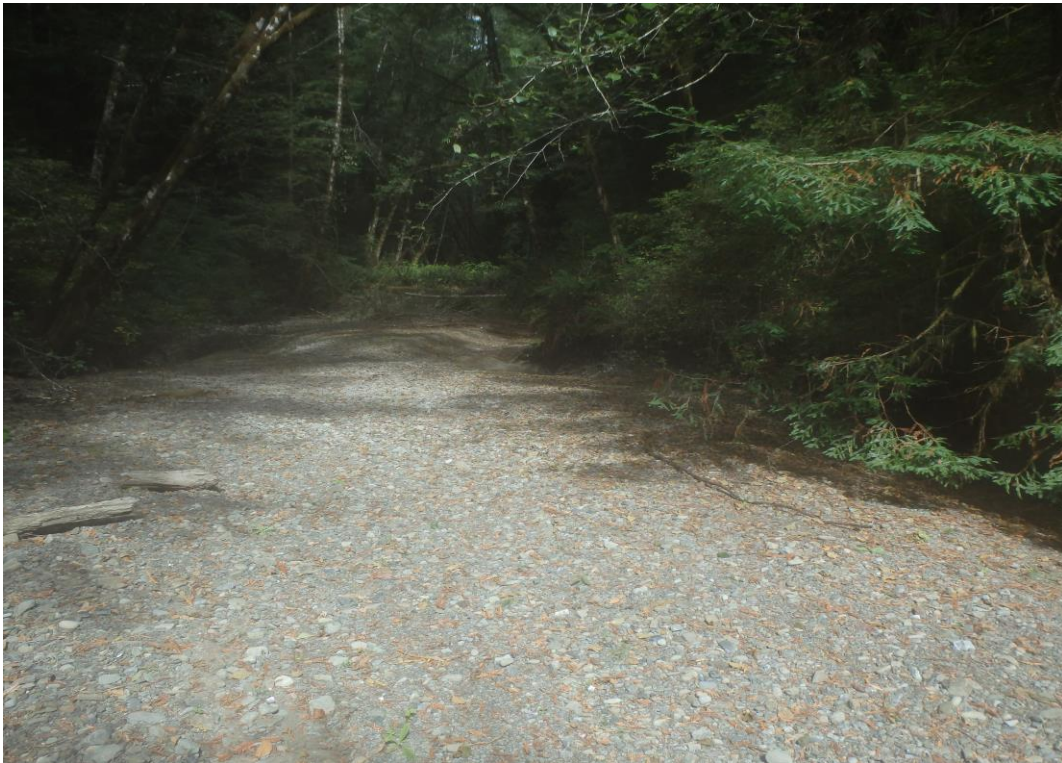
Photo 2: Dry channel above large debris accumulation #1 at habitat unit #047, 2,440' upstream from start of survey. Facing upstream. (Photo taken 10/11/17)

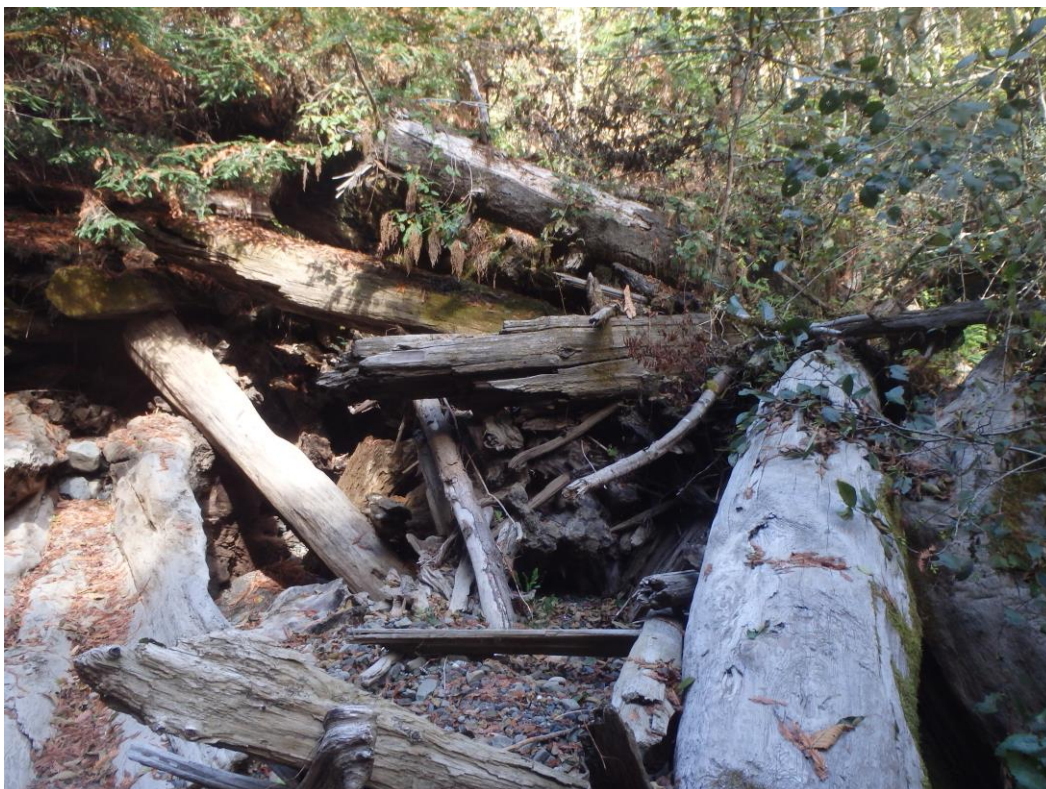
2826	0049.00	YOY.
2886	0051.00	There was heavy logging activity starting at habitat unit 051 and continuing up stream.
4852	0088.00	LDA #2 is 4.5' high, 23' wide, 5' long and contains 4 pieces of LWD. Water flows through the LDA and there are visible gaps in it. Sediment is being retained in the approximate dimensions of 23' wide, 8' long and 1' deep. The sediment ranges in size from gravel to boulders. The LDA is not a possible barrier to. Fish were observed above the LDA.
4929	0090.00	LDA #3 is 11' high, 45' wide, 80' long and contains 20 pieces of LWD. Water does not flow through the LDA and there are no visible gaps in it. Sediment is being retained in the approximate dimensions of 45' wide, 30' long and 5' deep. The sediment ranges in size from silt to gravel. The LDA is a possible barrier to juvenile salmonids as water does not flow through the LDA. The LDA is not a possible barrier to adult salmonids. Fish were observed above the LDA.

Photo 3: Large debris accumulation #2 at habitat unit #088, 5,934' upstream from start of survey. Facing upstream. (Photo taken 10/11/17)

- 4) There are several log debris accumulations present on Stevens Creek that are retaining large quantities of fine sediment and potentially hindering fish passage. The modification of these debris accumulations is desirable, but must be done carefully, over time, to avoid excessive sediment loading in downstream reaches.
