California Department of Fish and Game
Petaluma River Watershed
Stream Habitat Assessment Reports
Lichau Creek
Surveyed 2007

STREAM INVENTORY REPORT

Lichau Creek

Survey conducted summer 2007

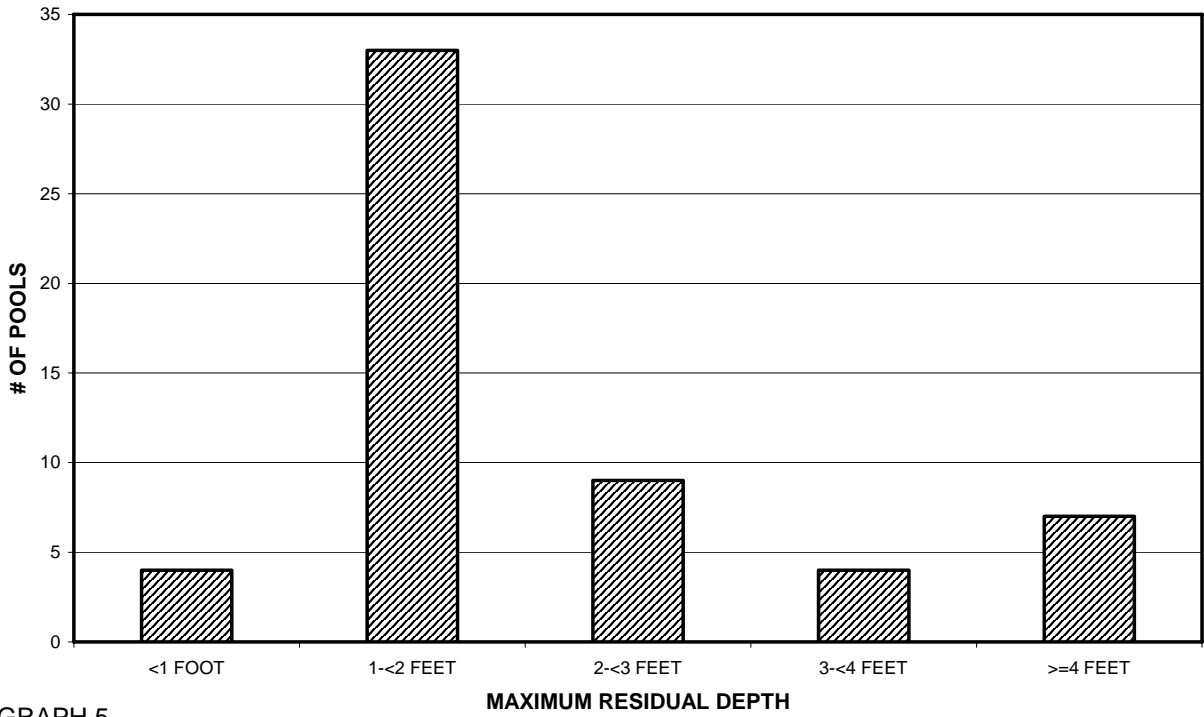
GRAPH 5

Table 4 is a summary of maximum residual pool depths by pool habitat types. Pool quality for salmonids increases with depth. Eleven of the 57 pools (19%) had a residual depth of three feet or greater (Graph 5).

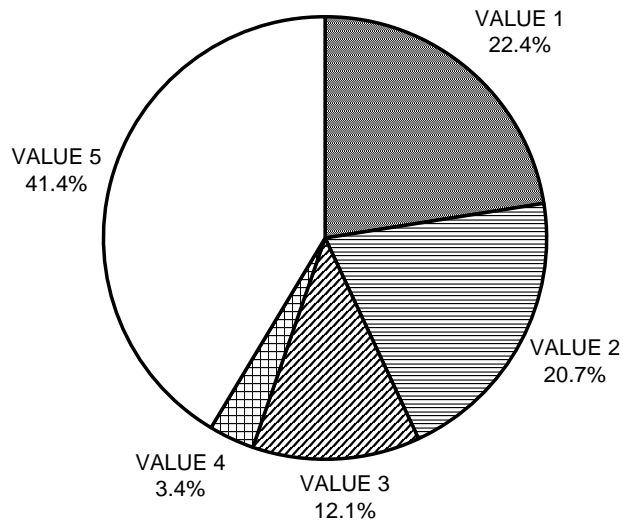
GRAPH 6

The depth of cobble embeddedness was estimated at pool tail-outs. Of the 58 pool tail-outs measured, 13 had a value of 1 (22.4%); 12 had a value of 2 (20.7%); 7 had a value of 3 (12.1%); 2 had a value of 4 (3.4%); and 24 had a value of 5 (41.4%) (Graph 6). On this scale, a value of 1 indicates the best spawning conditions and a value of 4 the worst. Additionally, a value of 5 was assigned to tail-outs deemed unsuited for spawning due to inappropriate substrate such as bedrock, log sills, boulders, or other considerations.

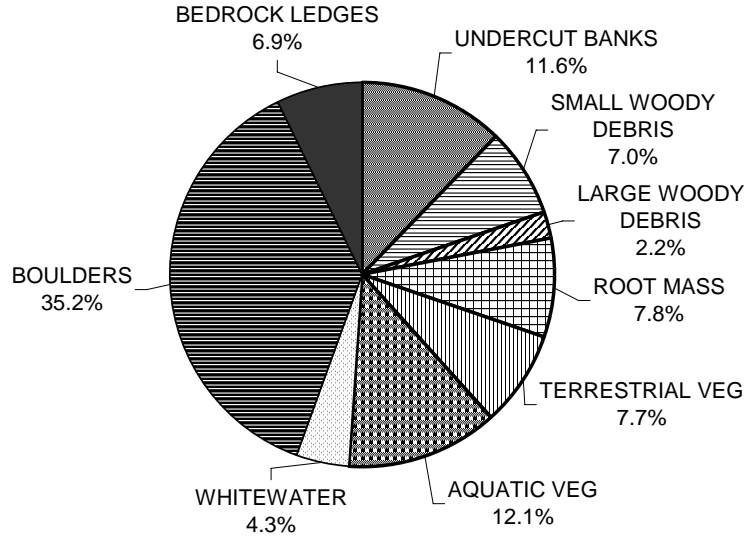
GRAPH 7

Table 5 summarizes mean percent cover by habitat type. Boulders are the dominant cover types in Lichau Creek. Graph 7 describes the pool cover in Lichau Creek. Boulders are the dominant pool cover type followed by aquatic vegetation.

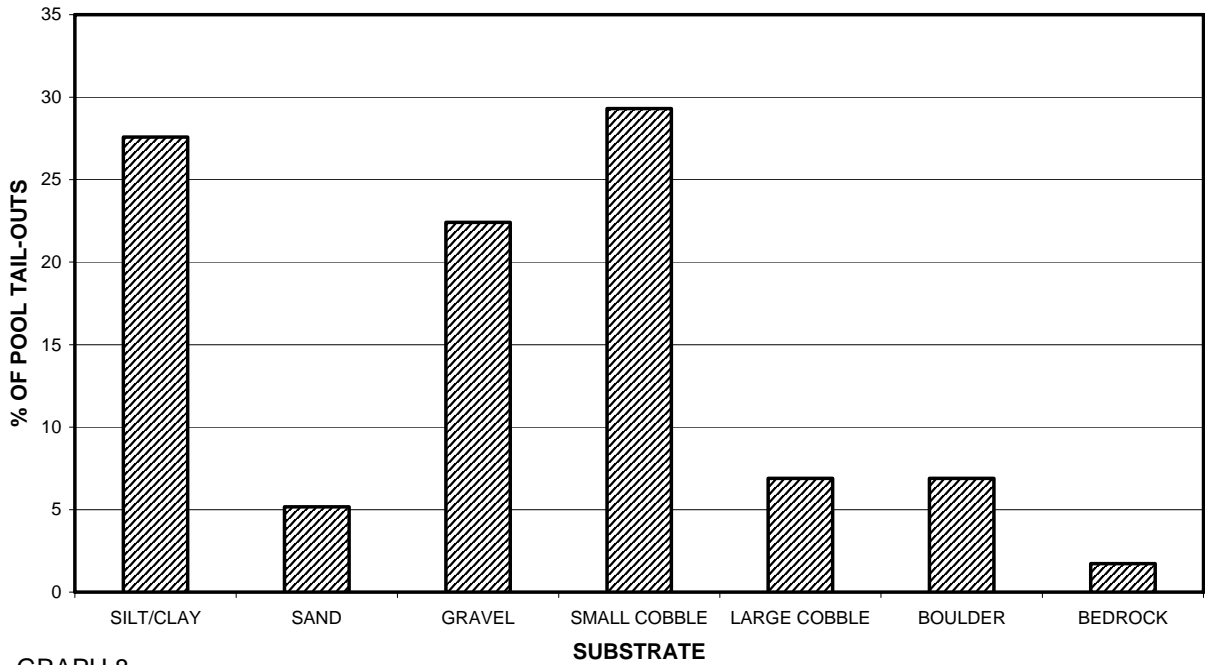
GRAPH 8

Table 6 summarizes the dominant substrate by habitat type. Graph 8 depicts the dominant substrate observed in pool tail-outs. A silt/clay substrate type was observed in 28% of pool tail-outs and small Cobble observed in 29% of pool tail-outs.

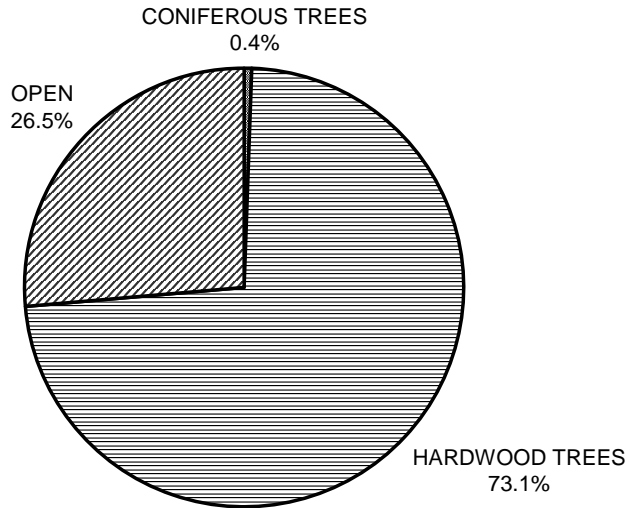
GRAPH 9

percent of the canopy was open. Graph 9 describes the mean percent canopy in Lichau Creek.

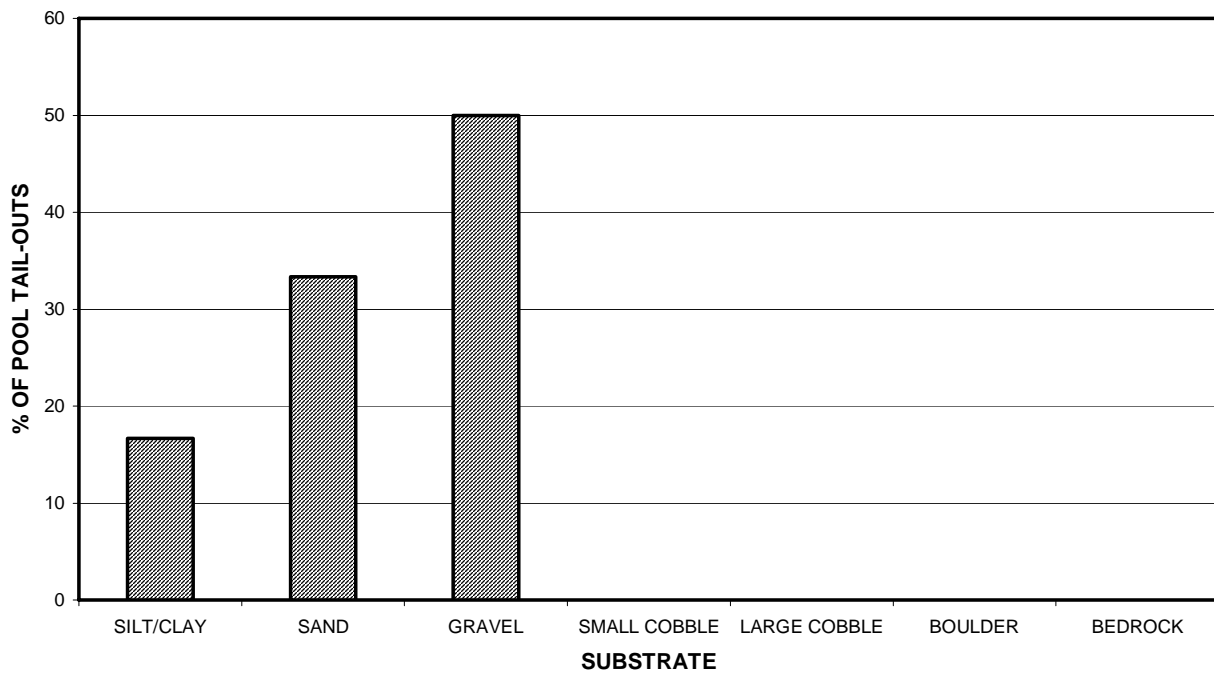
GRAPH 8

Table 6 summarizes the dominant substrate by habitat type. Graph 8 depicts the dominant substrate observed in pool tail-outs. Sand was observed in 33% of pool tail-outs and gravel observed in 50% of pool tail-outs.
