California Department of Fish and Game
Petaluma River Watershed
Stream Habitat Assessment Reports

Ellis Creek

STREAM INVENTORY REPORT

Report Completed March 2008

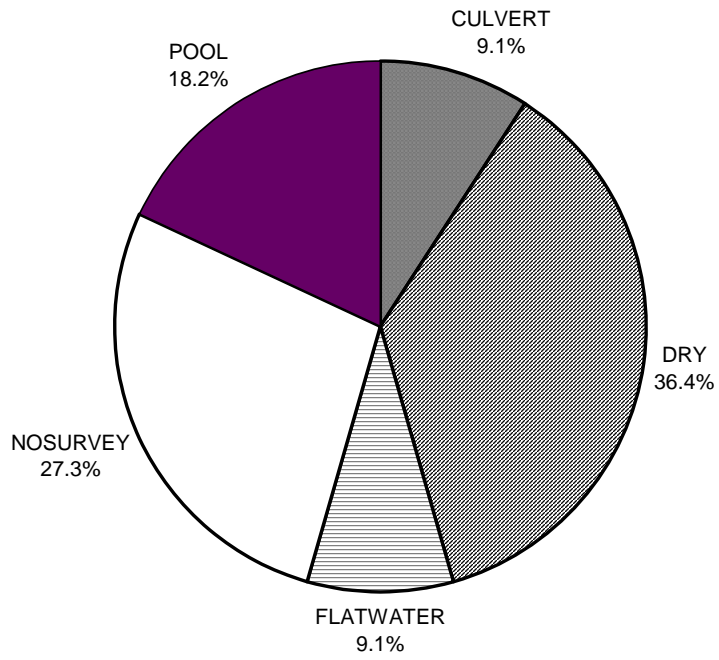
GRAPH 1

Table 1 summarizes the Level II riffle, flatwater, and pool habitat types. Based on frequency of occurrence there were 27% nosurvey units, 36% dry units, 9% flatwater units, 18% pool units and 9% culvert units (Graph 1). Based on total length of Level II habitat types there were 60% nosurvey units, 39% dry units, 0.2% flatwater units, 0.2% pool units and 0.2% culvert units (Graph 2).

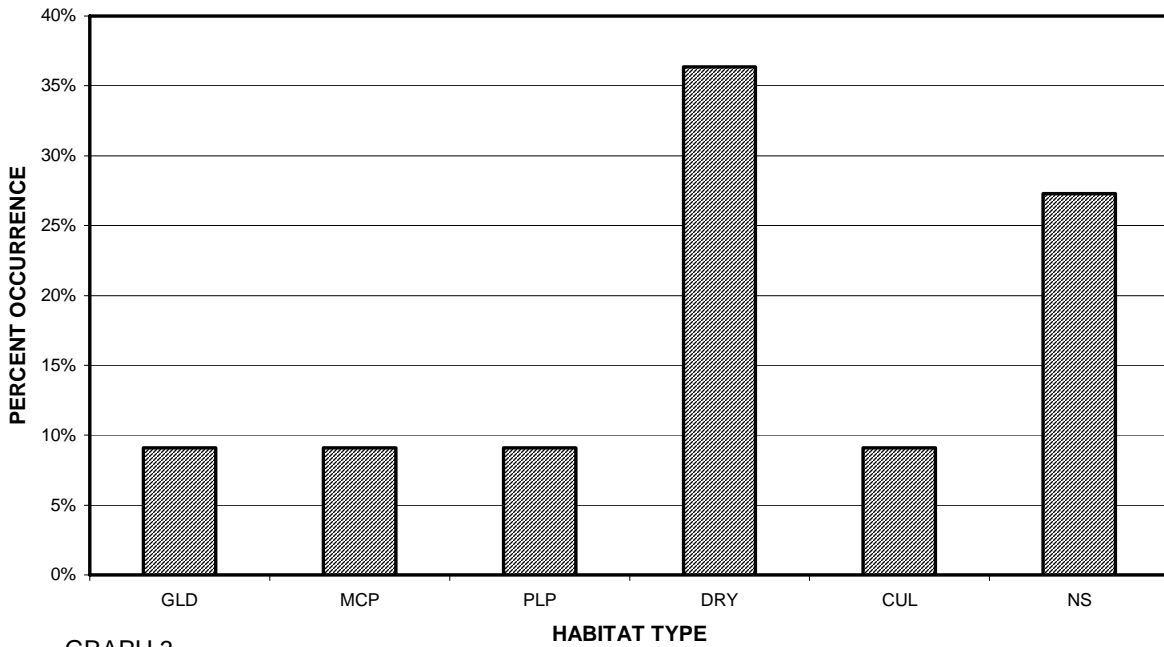
GRAPH 3

Four Level IV habitat types were identified (Table 2). The most frequent habitat types by percent occurrence were 27% Not Surveyed units, 36% Dry units and 9% Glide units (Graph 3). The most frequent habitat types based on percent total length were 60% Not Surveyed units, 39% Dry units and 0.2% glides.

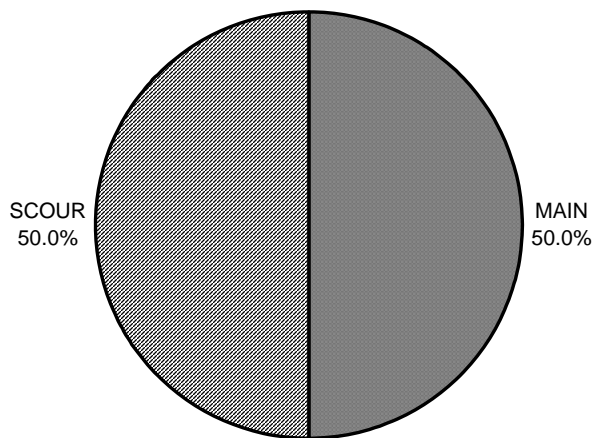
GRAPH 4

A total of 2 pools were identified (Table 3). Main Channel pools were the most frequently encountered, at 50%, and comprised 71% of the total length of all pools (Graph 4).

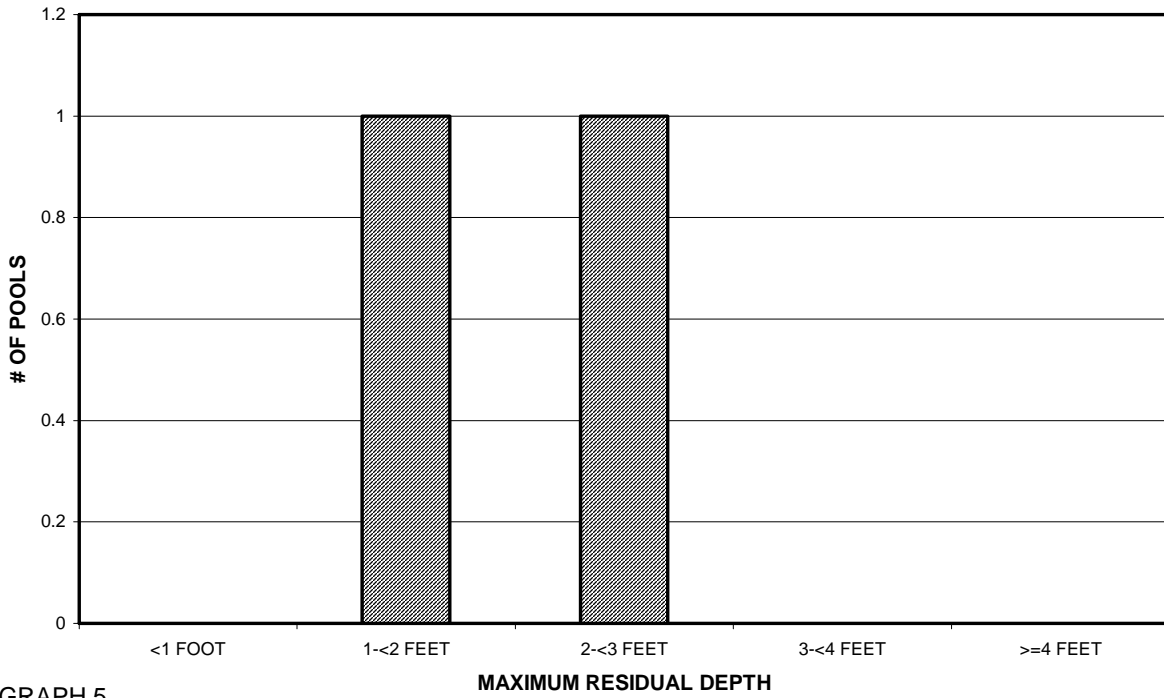
GRAPH 5

Table 4 is a summary of maximum residual pool depths by pool habitat types. Pool quality for salmonids increases with depth. One of the 2 pools (50%) had a residual depth of two feet or greater (Graph 5).

Flatwater habitat types comprised 0.2% of the total length of this survey, riffles 0%, and pools 0.2%. The pools are relatively shallow, with 1 of the 2 (50%) pools having a maximum residual depth greater than 2 feet. In general, pool enhancement projects are considered when primary pools comprise less than 40% of the length of total stream habitat. In first and second order streams, a primary pool is defined to have a maximum residual depth of at least two feet, occupy at least half the width of the low flow channel, and be as long as the low flow channel width. Installing structures that will increase or deepen pool habitat is recommended for locations where their installation will not be threatened by high stream energy, or where their installation will not conflict with the modification of the numerous log debris accumulations (LDA's) in the stream.

- 7) Where feasible, design and engineer pool enhancement structures to increase the number of pools. This must be done where the banks are stable or in conjunction with stream bank armor to prevent erosion.

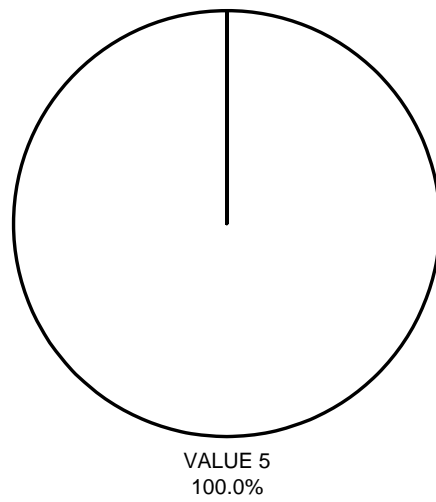
GRAPH 6

The depth of cobble embeddedness was estimated at pool tail-outs. Of the 2 pool tail-outs measured, 2 had a value of 5 (100%) (Graph 6). On this scale, a value of 1 indicates the best spawning conditions and a value of 4 the worst. Additionally, a value of 5 was assigned to tail-outs deemed unsuited for spawning due to inappropriate substrate such as bedrock, log sills, boulders, or other considerations.

None of the 2 pool tail-outs measured had embeddedness ratings of 1 or 2. None of the pool tail-outs had embeddedness ratings of 3 or 4. Two of the pool tail-outs had a rating of 5, which is considered unsuitable for spawning. Cobble embeddedness measured to be 25% or less, a rating of 1, is considered to indicate good quality spawning substrate for salmon and steelhead. Sediment sources in Ellis Creek should be mapped and rated according to their potential sediment yields, and control measures should be taken.

- 4) Inventory and map sources of stream bank erosion and prioritize them according to present and potential sediment yield. Identified sites should then be treated to reduce the amount of fine sediments entering the stream.

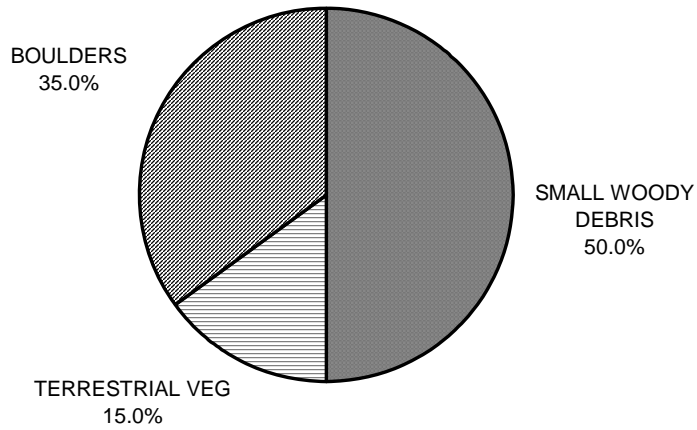
GRAPH 7

Table 5 summarizes mean percent cover by habitat type. Small Woody Debris is the dominant cover types in Ellis Creek. Graph 7 describes the pool cover in Ellis Creek. Small Woody Debris is the dominant pool cover type followed by boulders.

The mean shelter rating for pools was 8. The shelter rating in the flatwater habitats was 0. A pool shelter rating of approximately 100 is desirable. The amount of cover that now exists is being provided primarily by Small Woody Debris in Ellis Creek. Small Woody Debris is the dominant cover type in pools followed by boulders. Log and root wad cover structures in the pool and flatwater habitats would enhance both summer and winter salmonid habitat. Log cover structure provides rearing fry with protection from predation, rest from water velocity, and also divides territorial units to reduce density related competition.

- 6) Increase woody cover in the pools and flatwater habitat units. Most of the existing cover in the pools is from Small Woody Debris. Adding high quality complexity with woody cover in the pools is desirable.

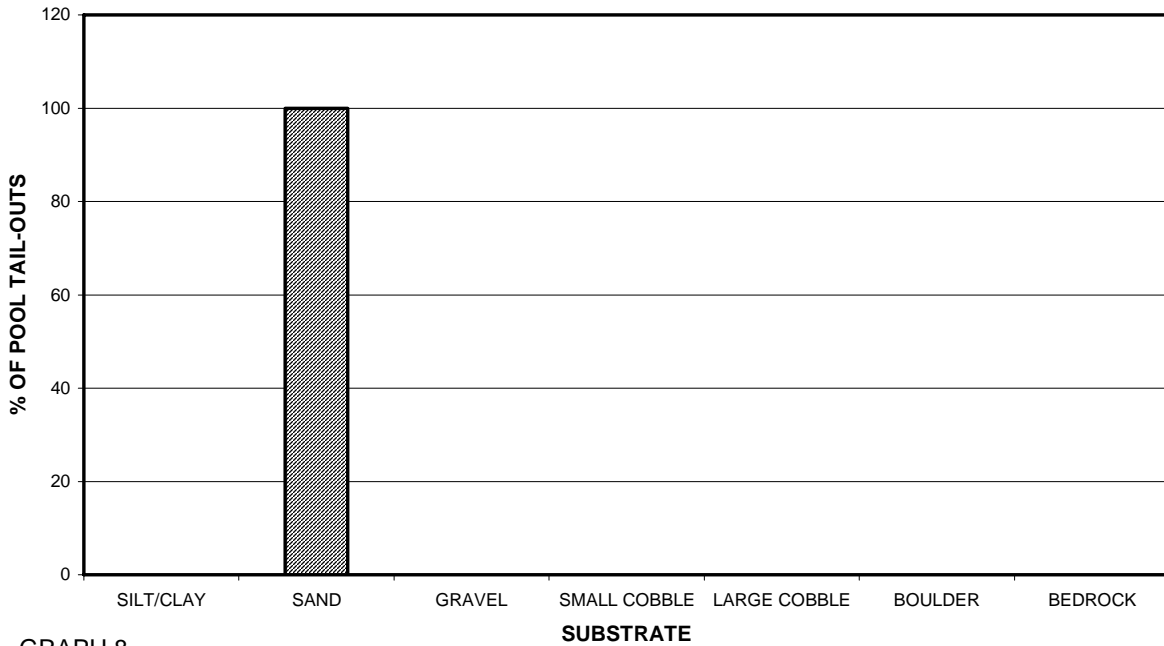
GRAPH 8

Table 6 summarizes the dominant substrate by habitat type. Graph 8 depicts the dominant substrate observed in pool tail-outs and sand was the only substrate observed in 100% of pool tail-outs.

Two of the 2 pool tail-outs had silt, sand, large cobble, boulders or bedrock as the dominant substrate. This is generally considered unsuitable for spawning salmonids.

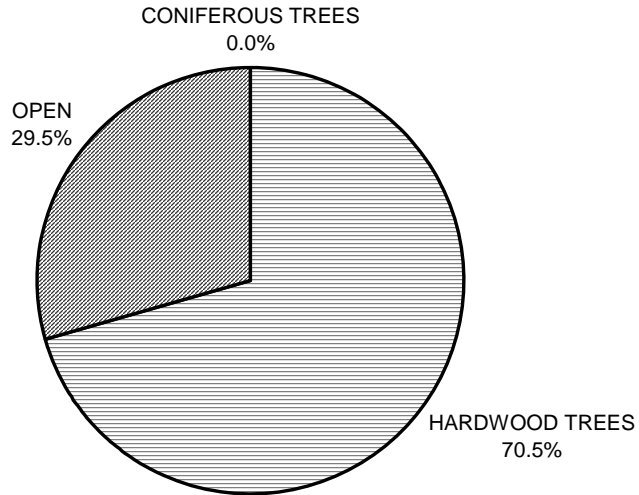
GRAPH 9

The mean percent canopy density for the surveyed length of Ellis Creek was 70.5%. The mean percentages of hardwood and coniferous trees were 100% and 0%, respectively. Thirty percent of the canopy was open. Graph 9 describes the mean percent canopy in Ellis Creek.

The mean percent canopy density for the stream was 70.5%. Reach 1 had a canopy density of 94%, Reach 3 had a canopy density of 94%, Reach 5 had a canopy density of 0. In general, revegetation projects are considered when canopy density is less than 80%.

- 5) Increase the canopy on Ellis Creek by planting appropriate native vegetation like willow, alder, redwood, and Douglas fir along the stream where shade canopy is not at acceptable levels. The reaches above this survey section should be inventoried and treated as well, since the water flowing here is affected from upstream. In many cases, planting will need to be coordinated to follow bank stabilization or upslope erosion control projects.

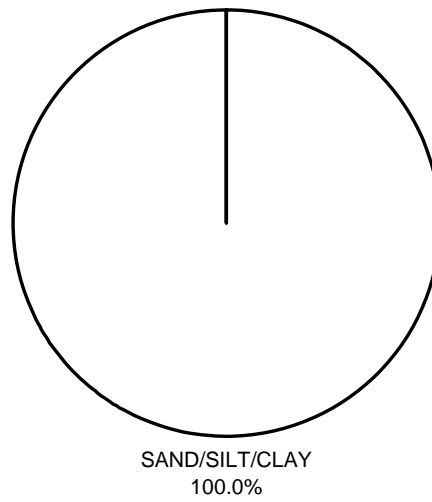
GRAPH 10

For the stream reach surveyed, the mean percent right bank vegetated was 38%. The mean percent left bank vegetated was 47%. The dominant elements composing the structure of the stream banks consisted of 100% sand/silt/clay (Graph 10).

The percentage of right and left bank covered with vegetation was low at 38% and 47%, respectively. In areas of stream bank erosion or where bank vegetation is sparse, planting endemic species of coniferous and hardwood trees, in conjunction with bank stabilization, is recommended.
