**Fish Passage Assessment  
at the State Park Bridge on San Julian Road  
Gaviota Creek, California**

Prepared for:

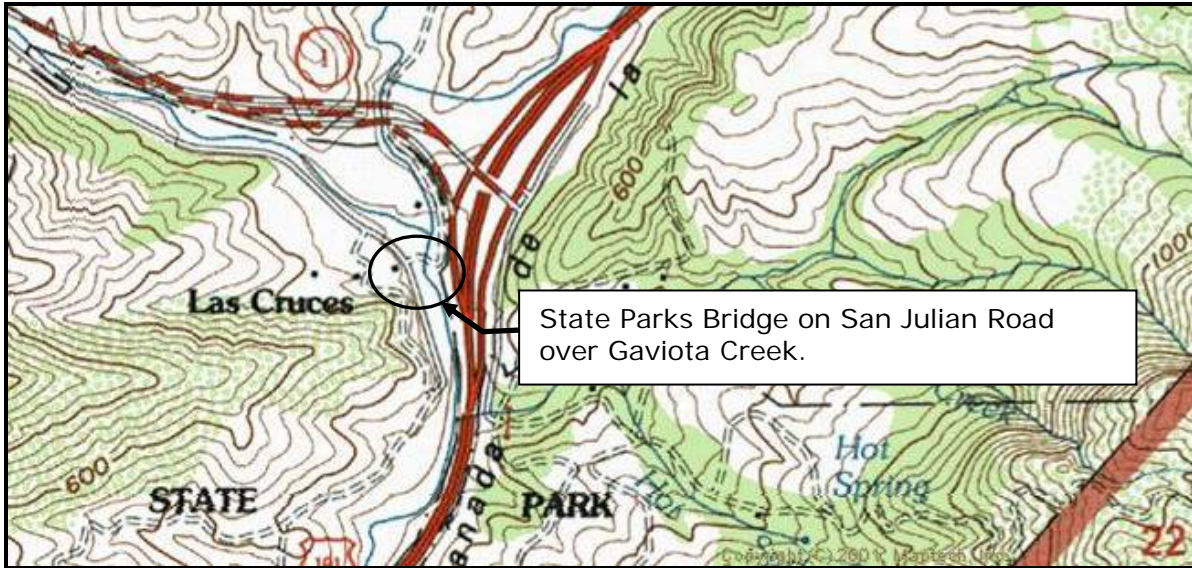
**Figure 1** – Location of the Sate Park Bridge on San Julian Road shown on the USGS 7.5 minute Solvang quadrangle.

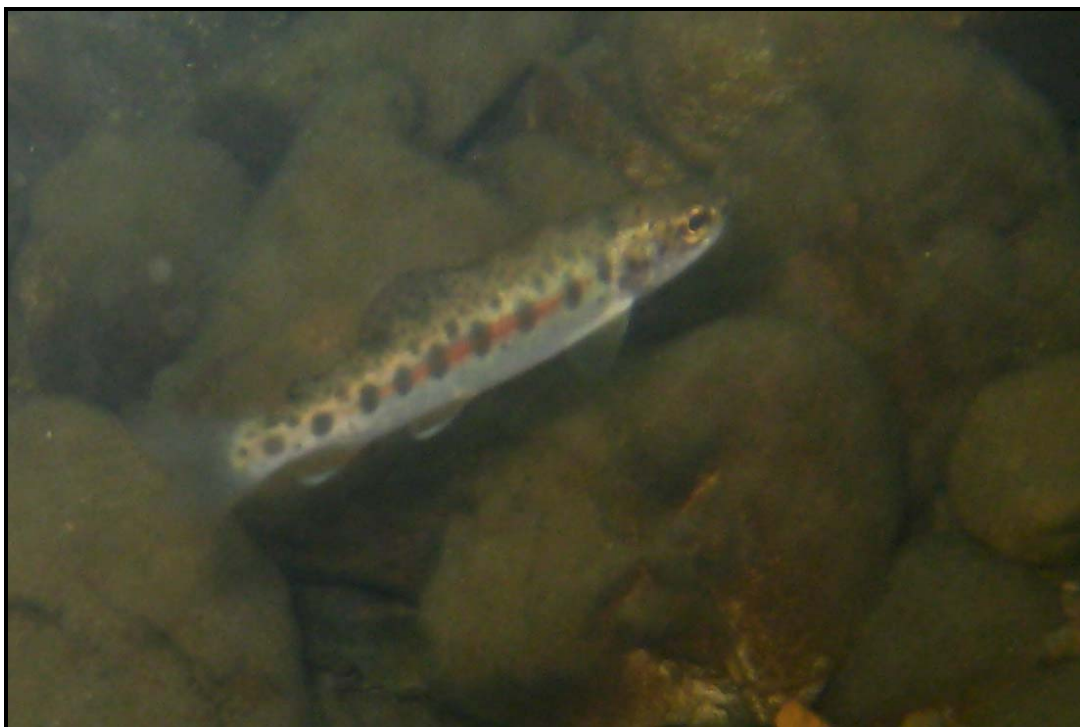
**Figure 5** – One of two juvenile steelhead trout observed in the plunge pool downstream of the bridge apron.
