CALIFORNIA DEPARTMENT OF FISH AND WILDLIFE

STREAM INVENTORY REPORT

Dutch Charlie Creek

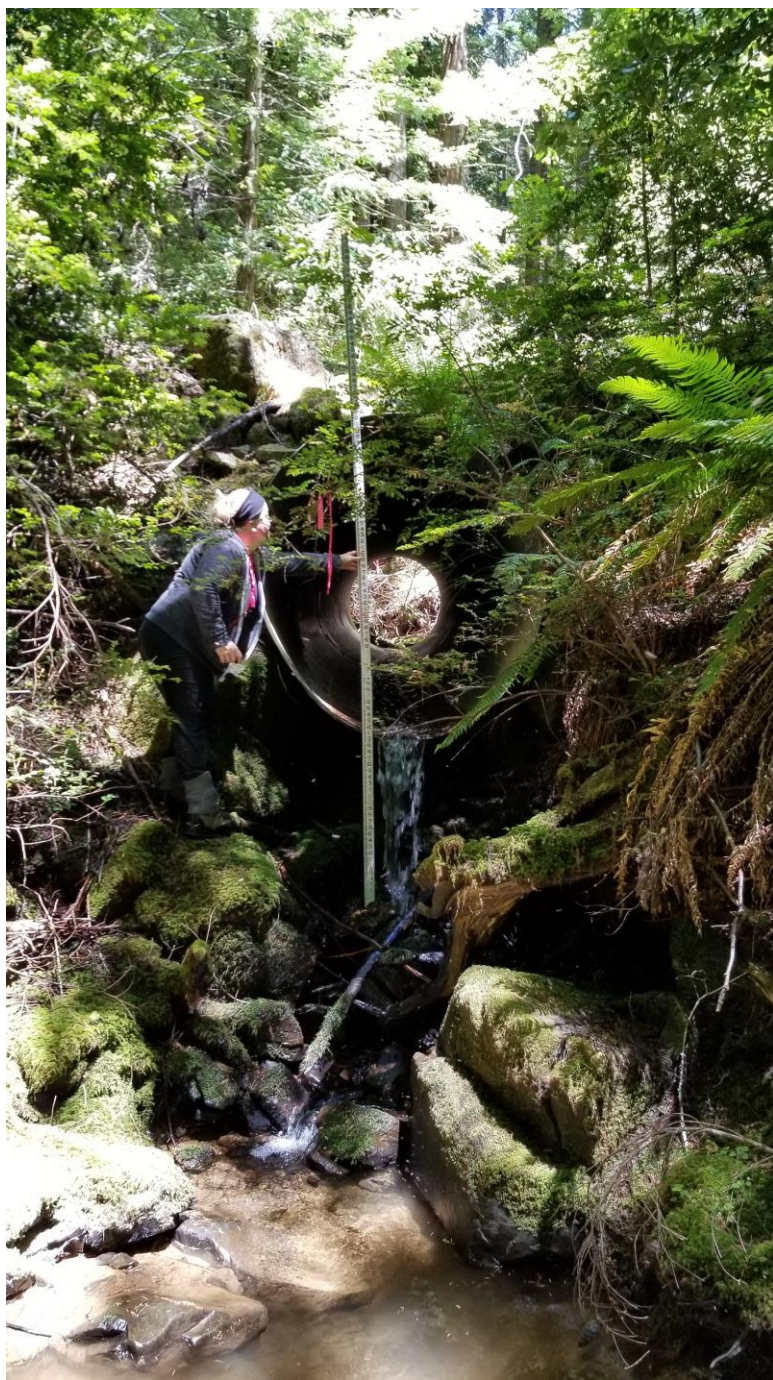
Photo 1. Culvert at Habitat Unit 245, 11,424 feet upstream from start of survey.
Photo taken 6/13/2018

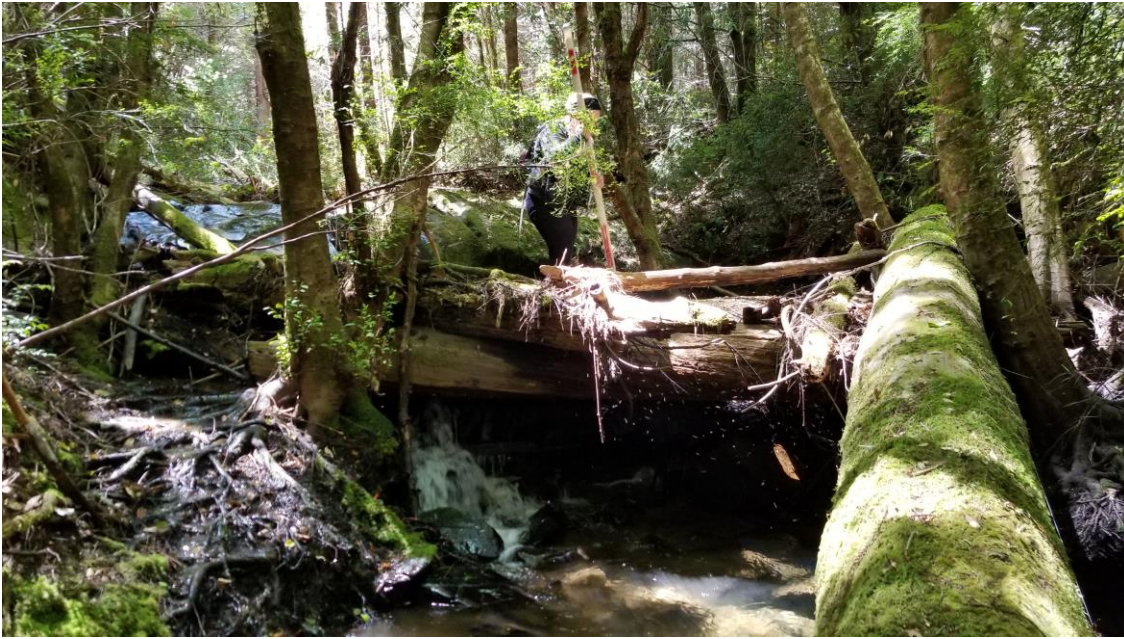
| 11462 | 250 | Log debris accumulation (LDA) # 1 is 5.7' high x 30' wide x 7' long and contains 6 pieces of large woody debris (LWD). Water flows through the LDA and there are no visible gaps in it. Sediment is being retained in the approximate dimensions of 30' wide x 27' long x 6' high. |

Photo 2. Habitat Unit 250, 11,496 feet upstream of start of survey. Photo taken 6/13/2018

- 4) There are several log debris accumulations present on Dutch Charlie Creek that are retaining large quantities of fine sediment. The modification of these debris accumulations is desirable, but must be done carefully, over time, to avoid excessive sediment loading in downstream reaches.

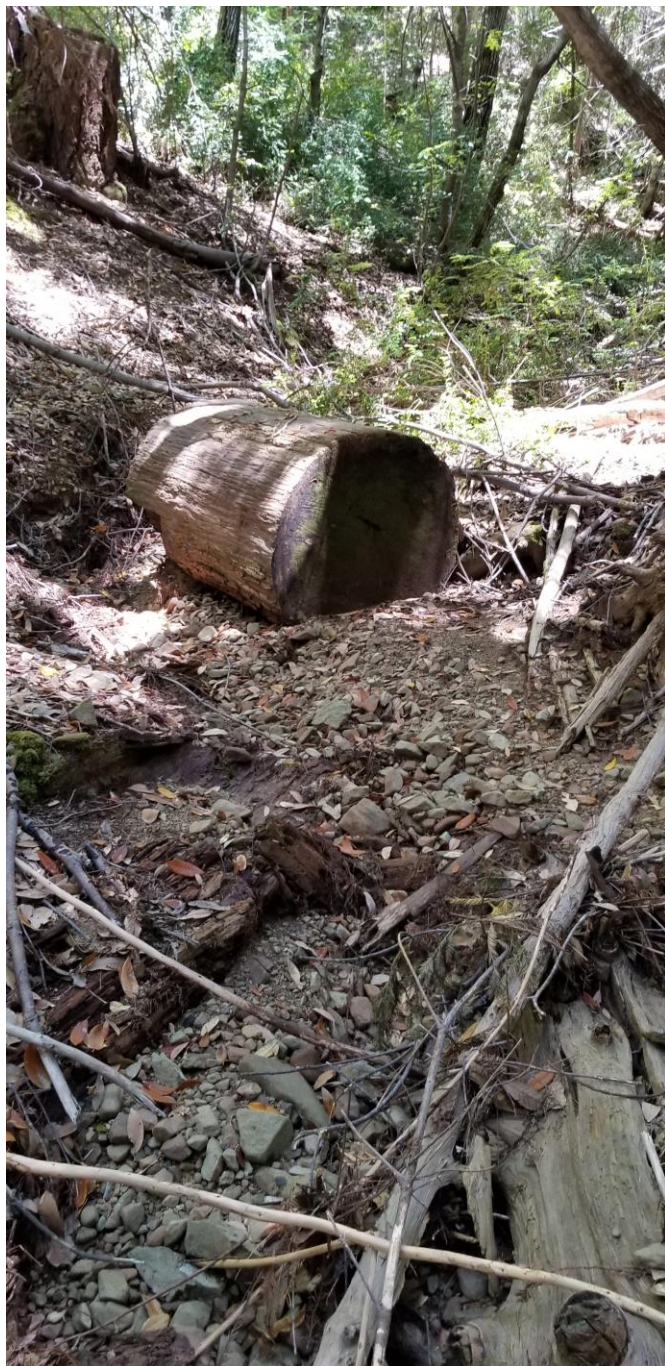
Photo 4. Habitat Unit 477, End of survey, 21,959 feet upstream start of survey.
Photo taken on 6/14/2018.
