# Austin Creek Large Wood Augmentation – Planning & Design *(amended)*

Recipient: Trout Unlimited, Inc.

Project Number: #8006.22.073876

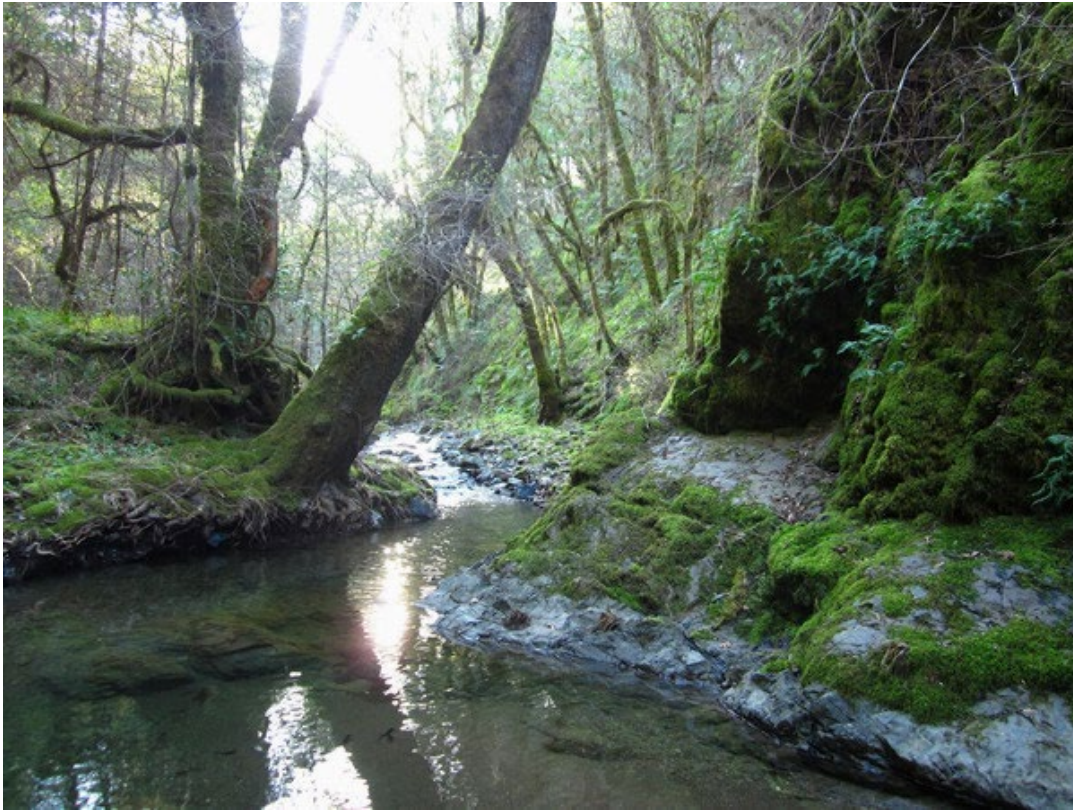
*Figure 1. East Austin Creek - representative photo of creek devoid of wood. Bedrock expressions indicate moderate incision*

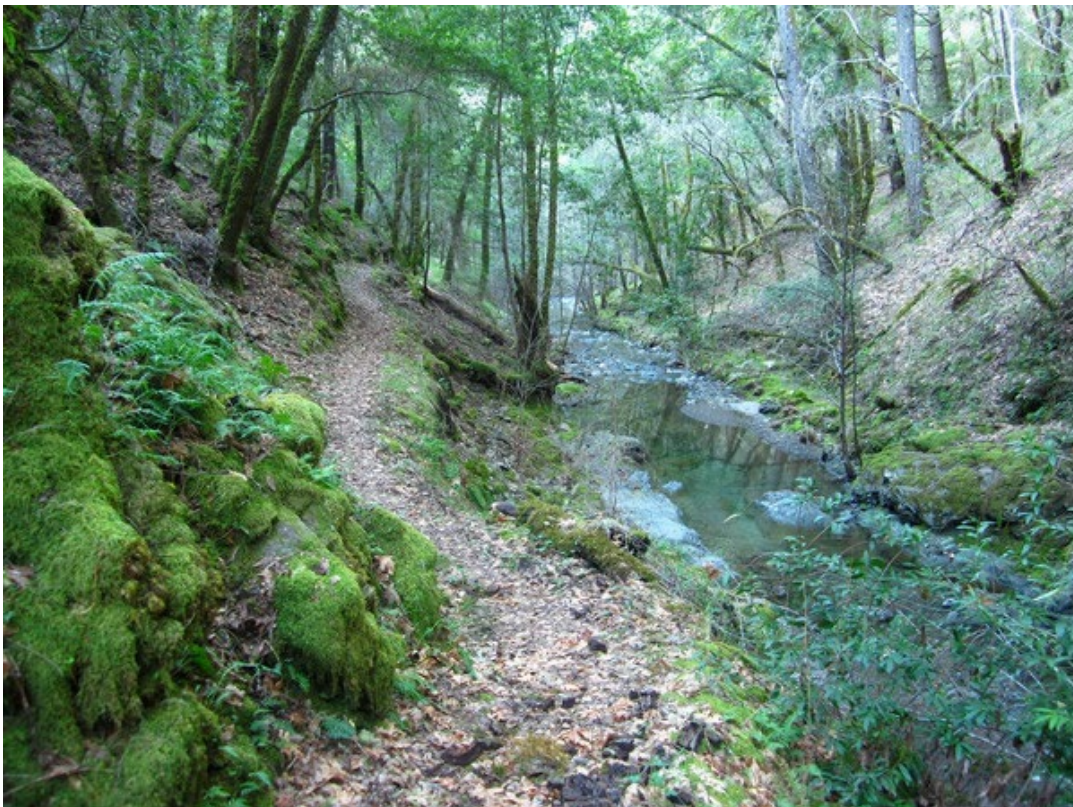
*Figure 2. East Austin Creek - representative photo of creek devoid of wood*

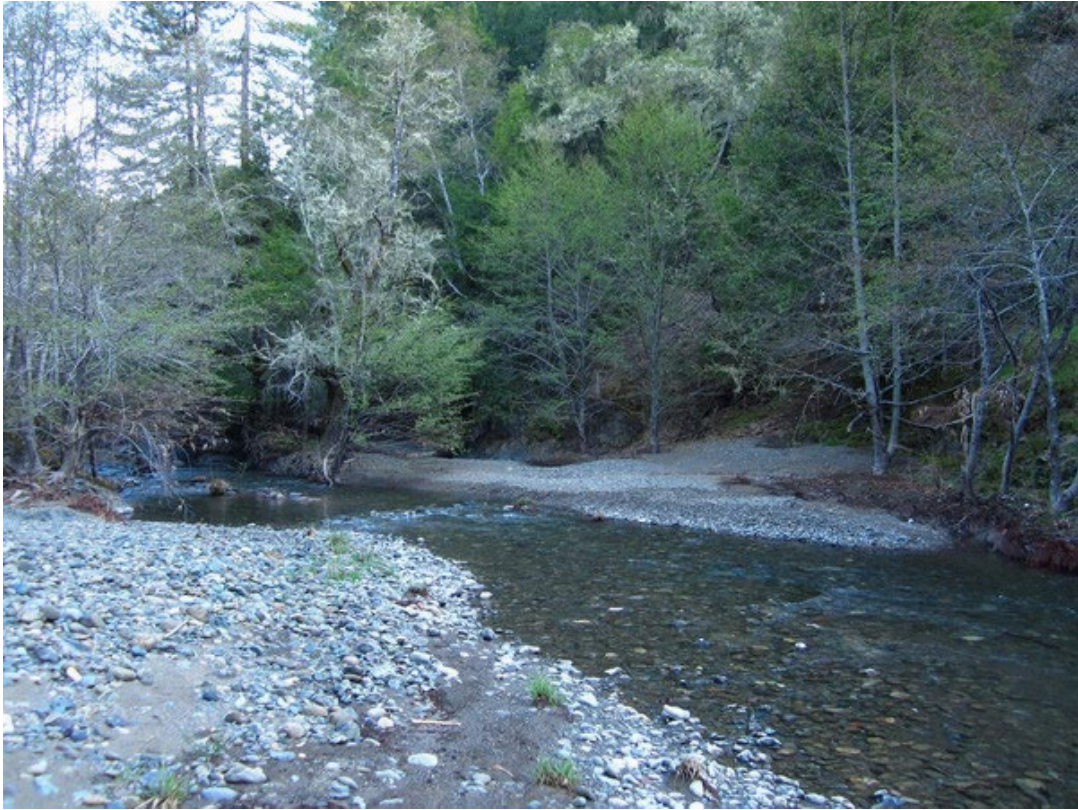
*Figure 3. East Austin Creek - representative photo of creek devoid of wood. Channel is connected to floodplain and alluvial deposits and spawning substrate present*

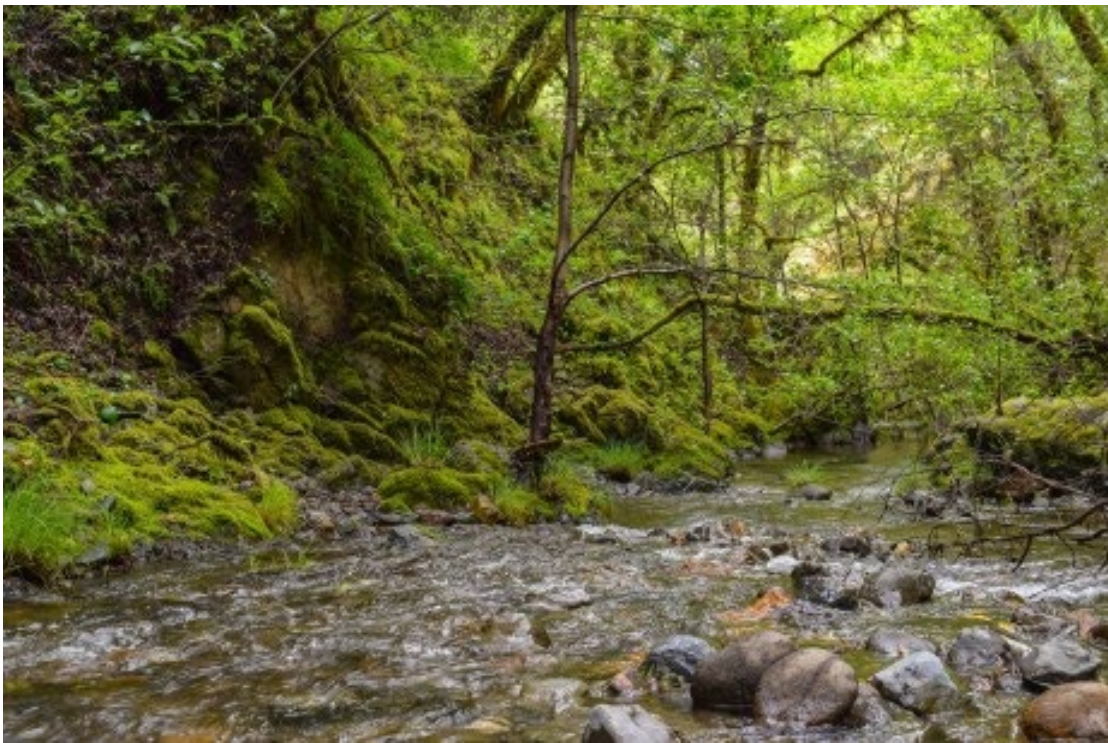
*Figure 4. Gillam Creek - representative photo, channel riffle*

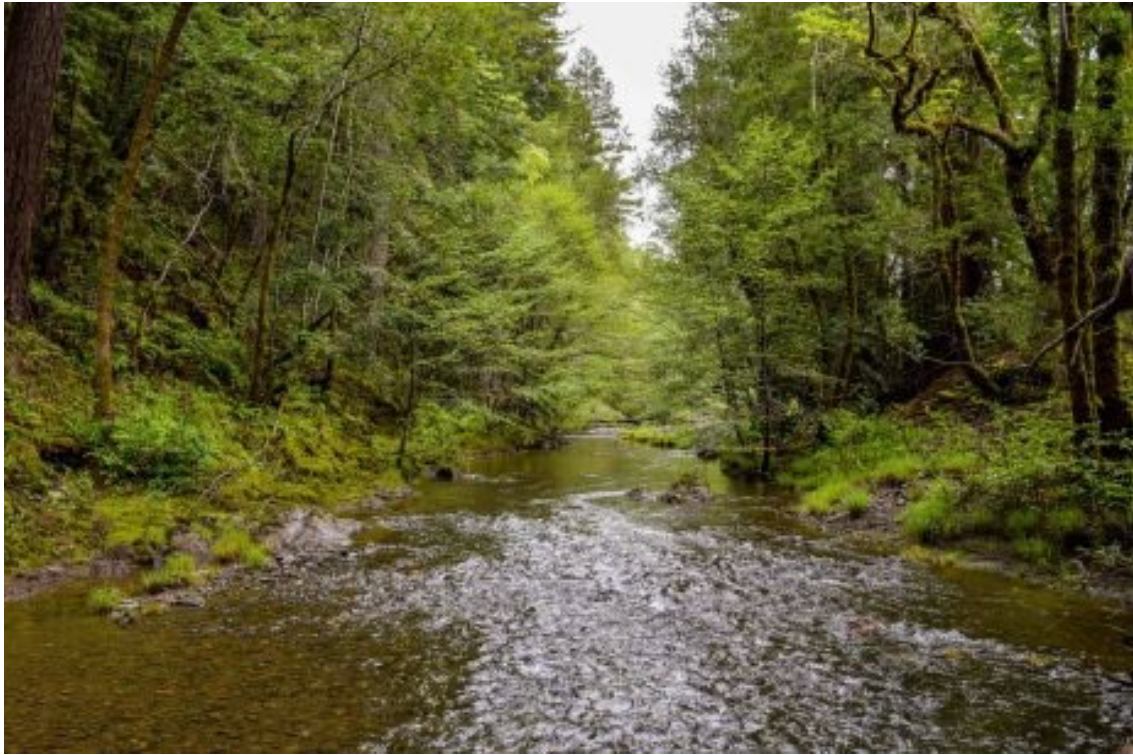
*Figure 5. Gilliam Creek - homogenous channel, devoid of large wood*

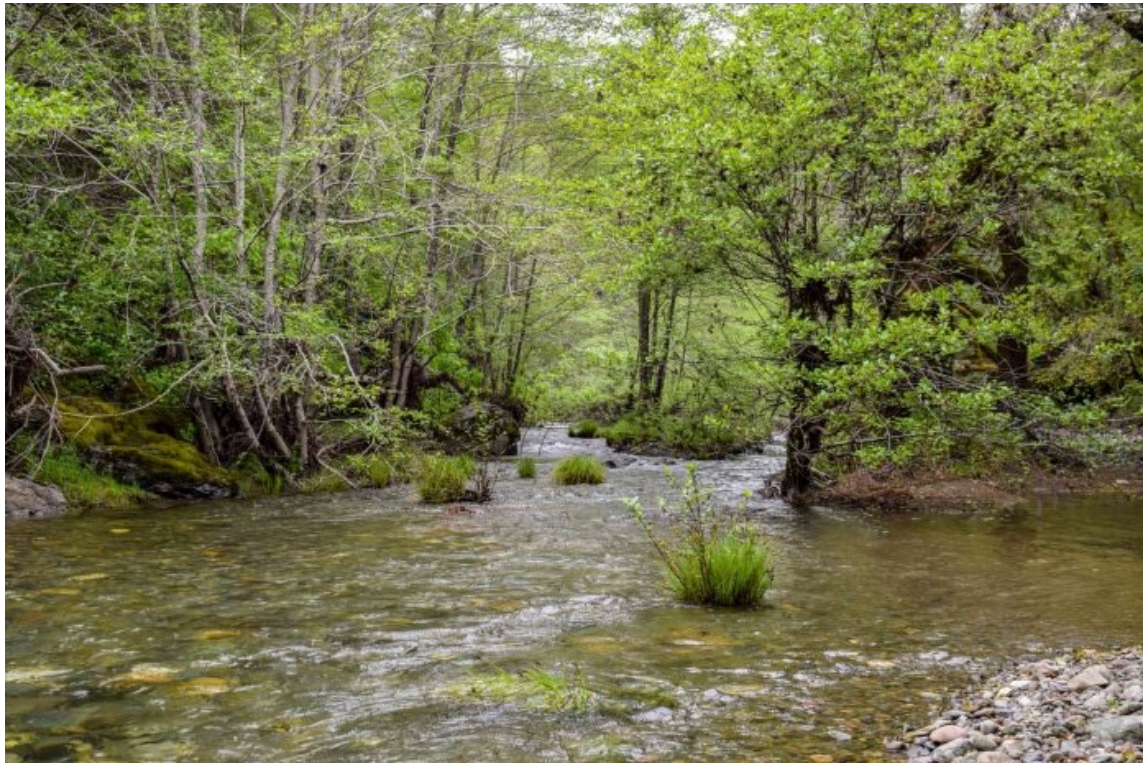
*Figure 7. Gilliam Creek - vegetated island, broad channel devoid of large wood*

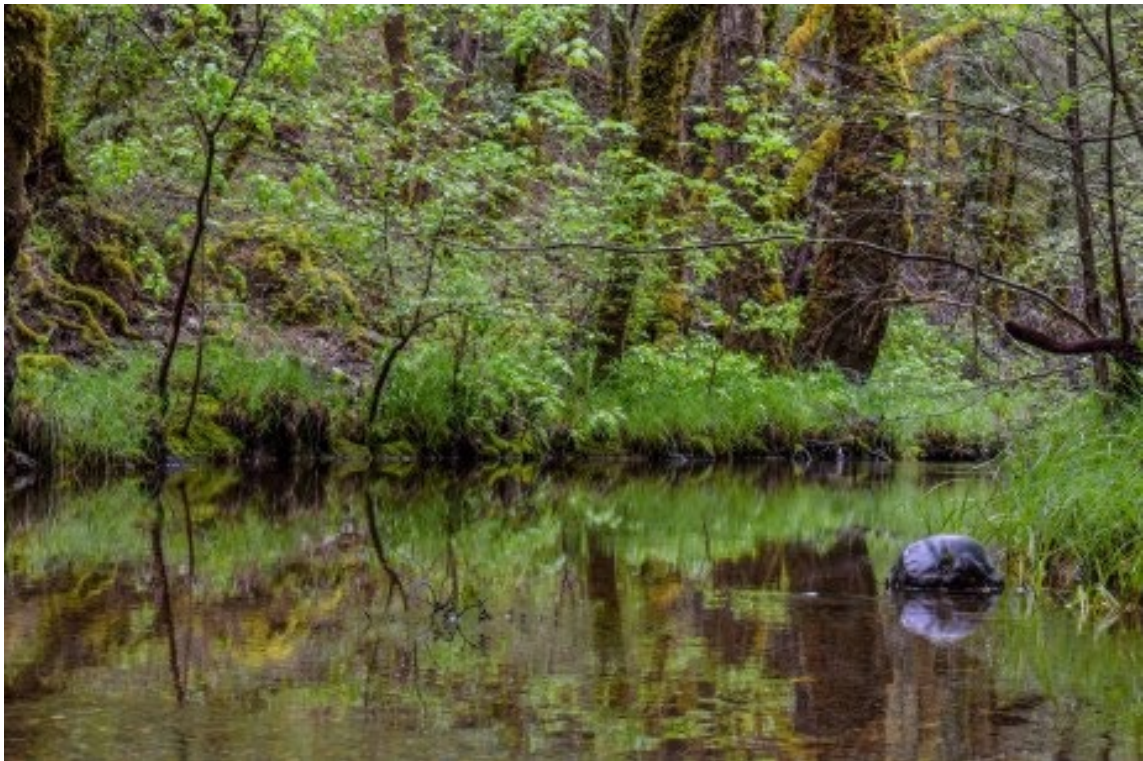
*Figure 8. Gilliam Creek, homogenous glide, lacks complexity and shelter*
