# Mission Creek Habitat Restoration and Monitoring Plan

Mission Canyon Stream Habitat Restoration Project Initial Study/Mitigated Negative Declaration

January 2024 | 01606.00001.024 (EDS-01.10)

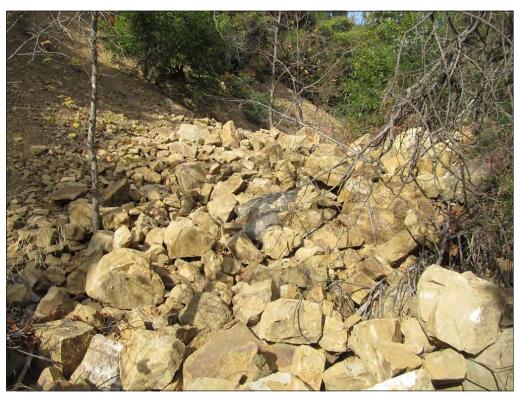
Photo 1. Example of sidecast in Mission Creek.

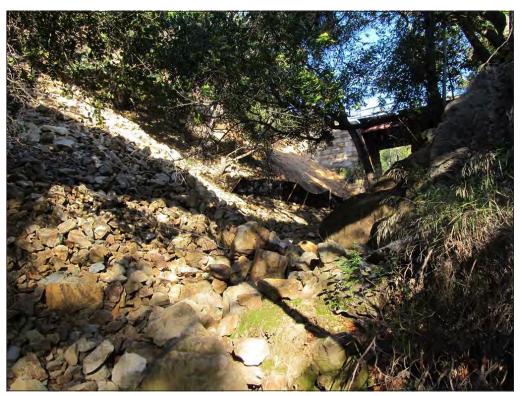
Photo 2. Looking upstream at Creek Site 2 in Mission Creek.

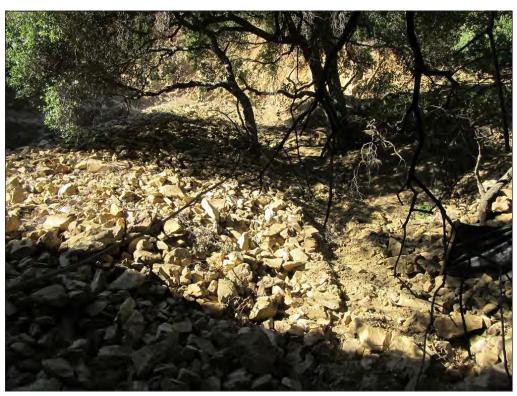
Photo 3. Looking downstream in Mission Creek from Creek Site 2.

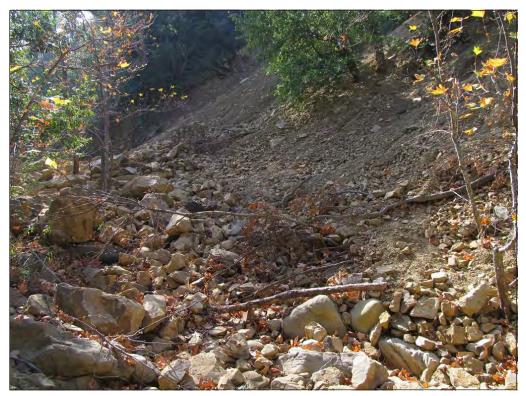
Photo 4. Looking downstream in Mission Creek at Creek Site 3.

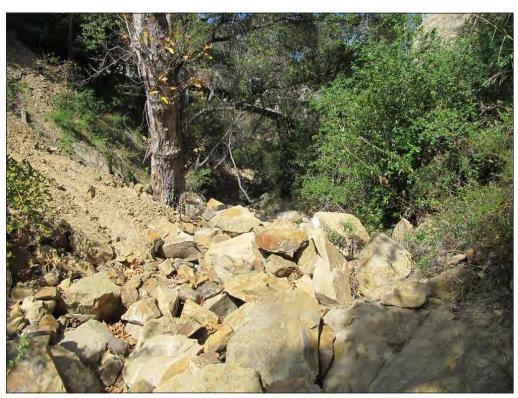
Photo 5. Looking upstream in Mission Creek at Creek Site 4.

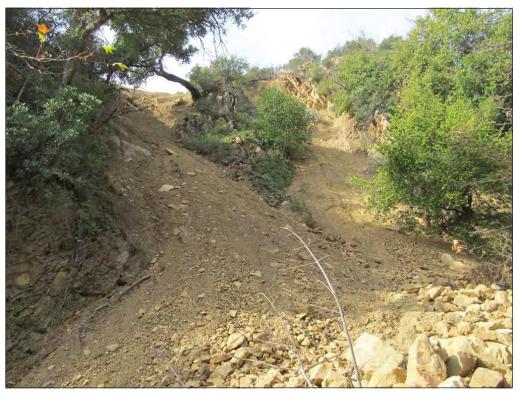
Photo 6. Looking up from Mission Creek toward the road at Creek Site 4.

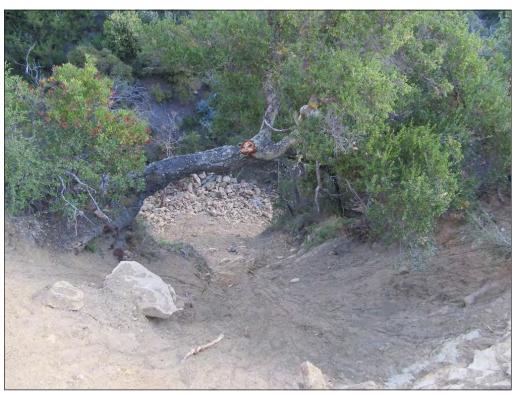
Photo 7. View into Mission Creek from the road at Creek Site 4.

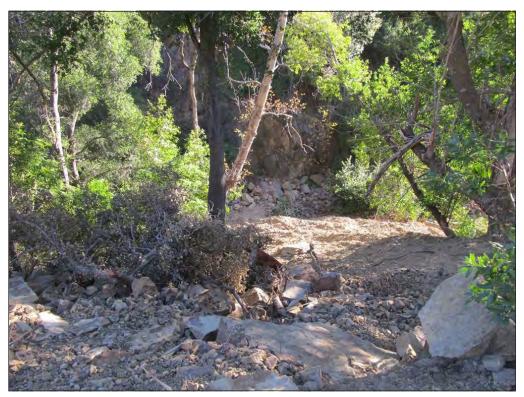
Photo 8. View into Mission Creek from the road at Creek Site 3.

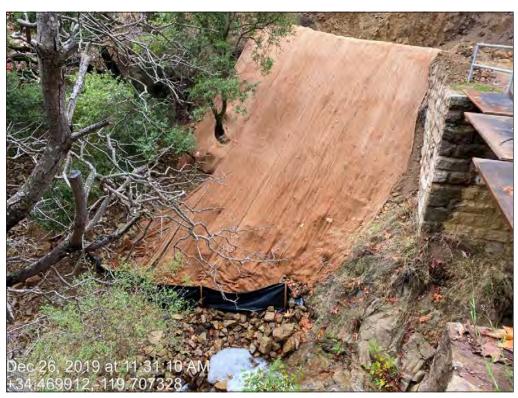
Photo 9. Erosion control matting and silt fence at Creek Site 2.

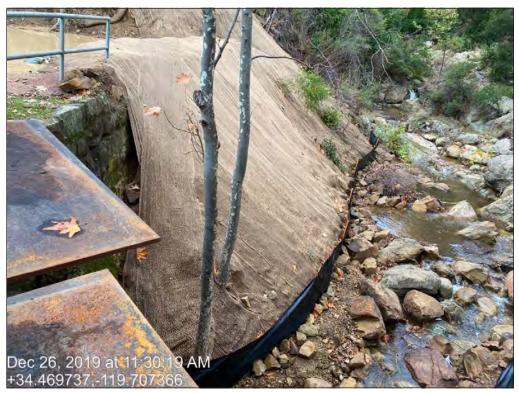
Photo 10. Erosion control matting and silt fence at Creek Site 1.

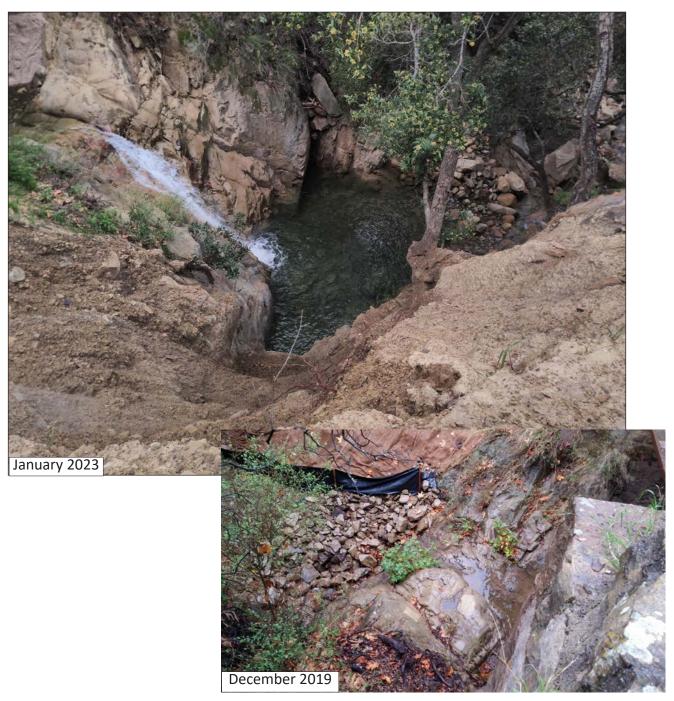
Photograph 1a-b. Creek Site 2, Mission Creek plunge Pool below bridge.

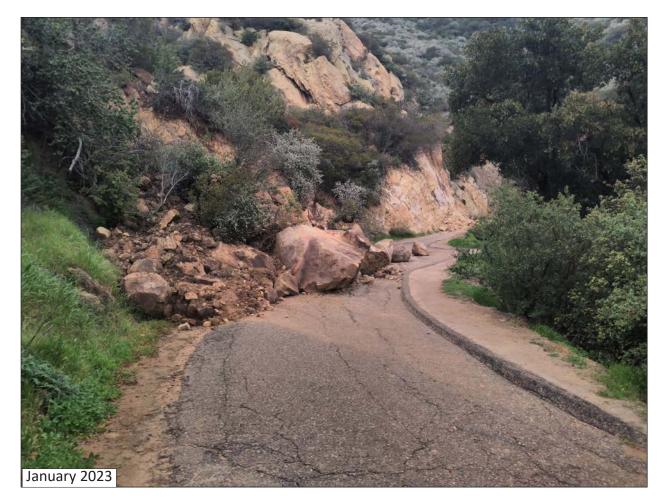
Photograph 3. Spyglass Ridge Road Area 1 with slope failure, looking north.

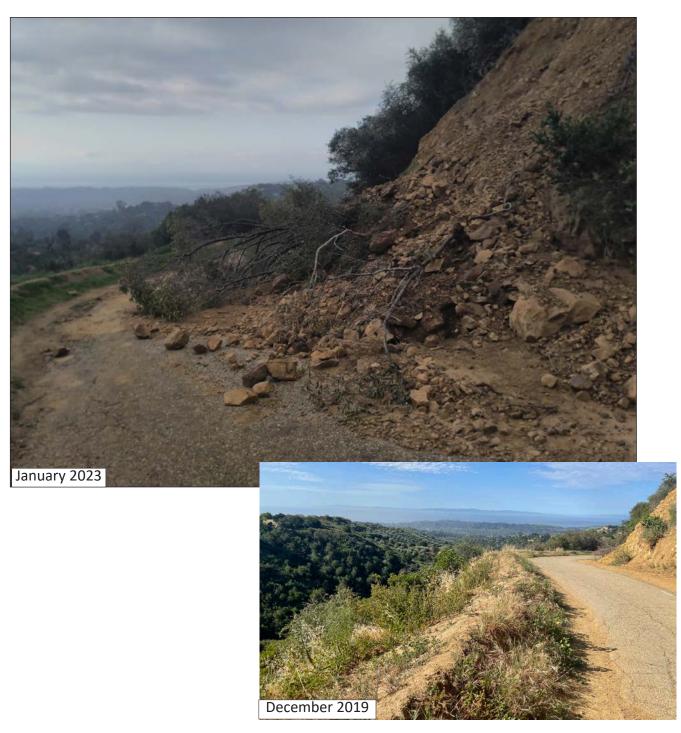
Photograph 4a-b. Spyglass Ridge Road Area 1 slope failure, looking south.

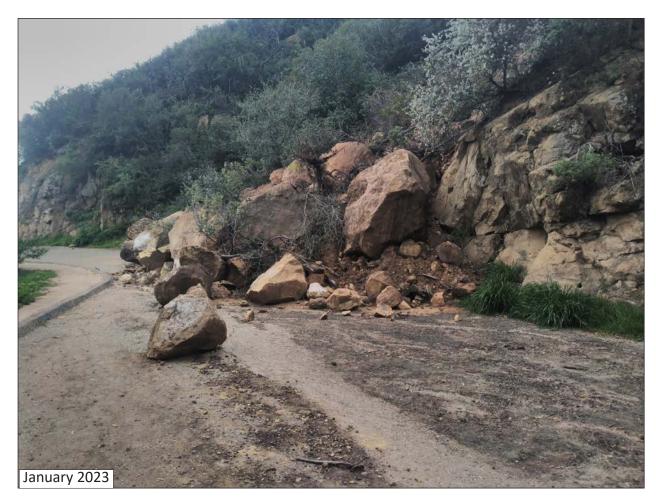
Photograph 5. Spyglass Ridge Road Area 2 with slope failure, looking south.
