**Mission Canyon Stream Habitat Restoration Project
Initial Study/Mitigated Negative Declaration**

Mission Canyon Stream Restoration Project

Supplemental Site Surveys and Comparative
Scoping Analysis

October 2022

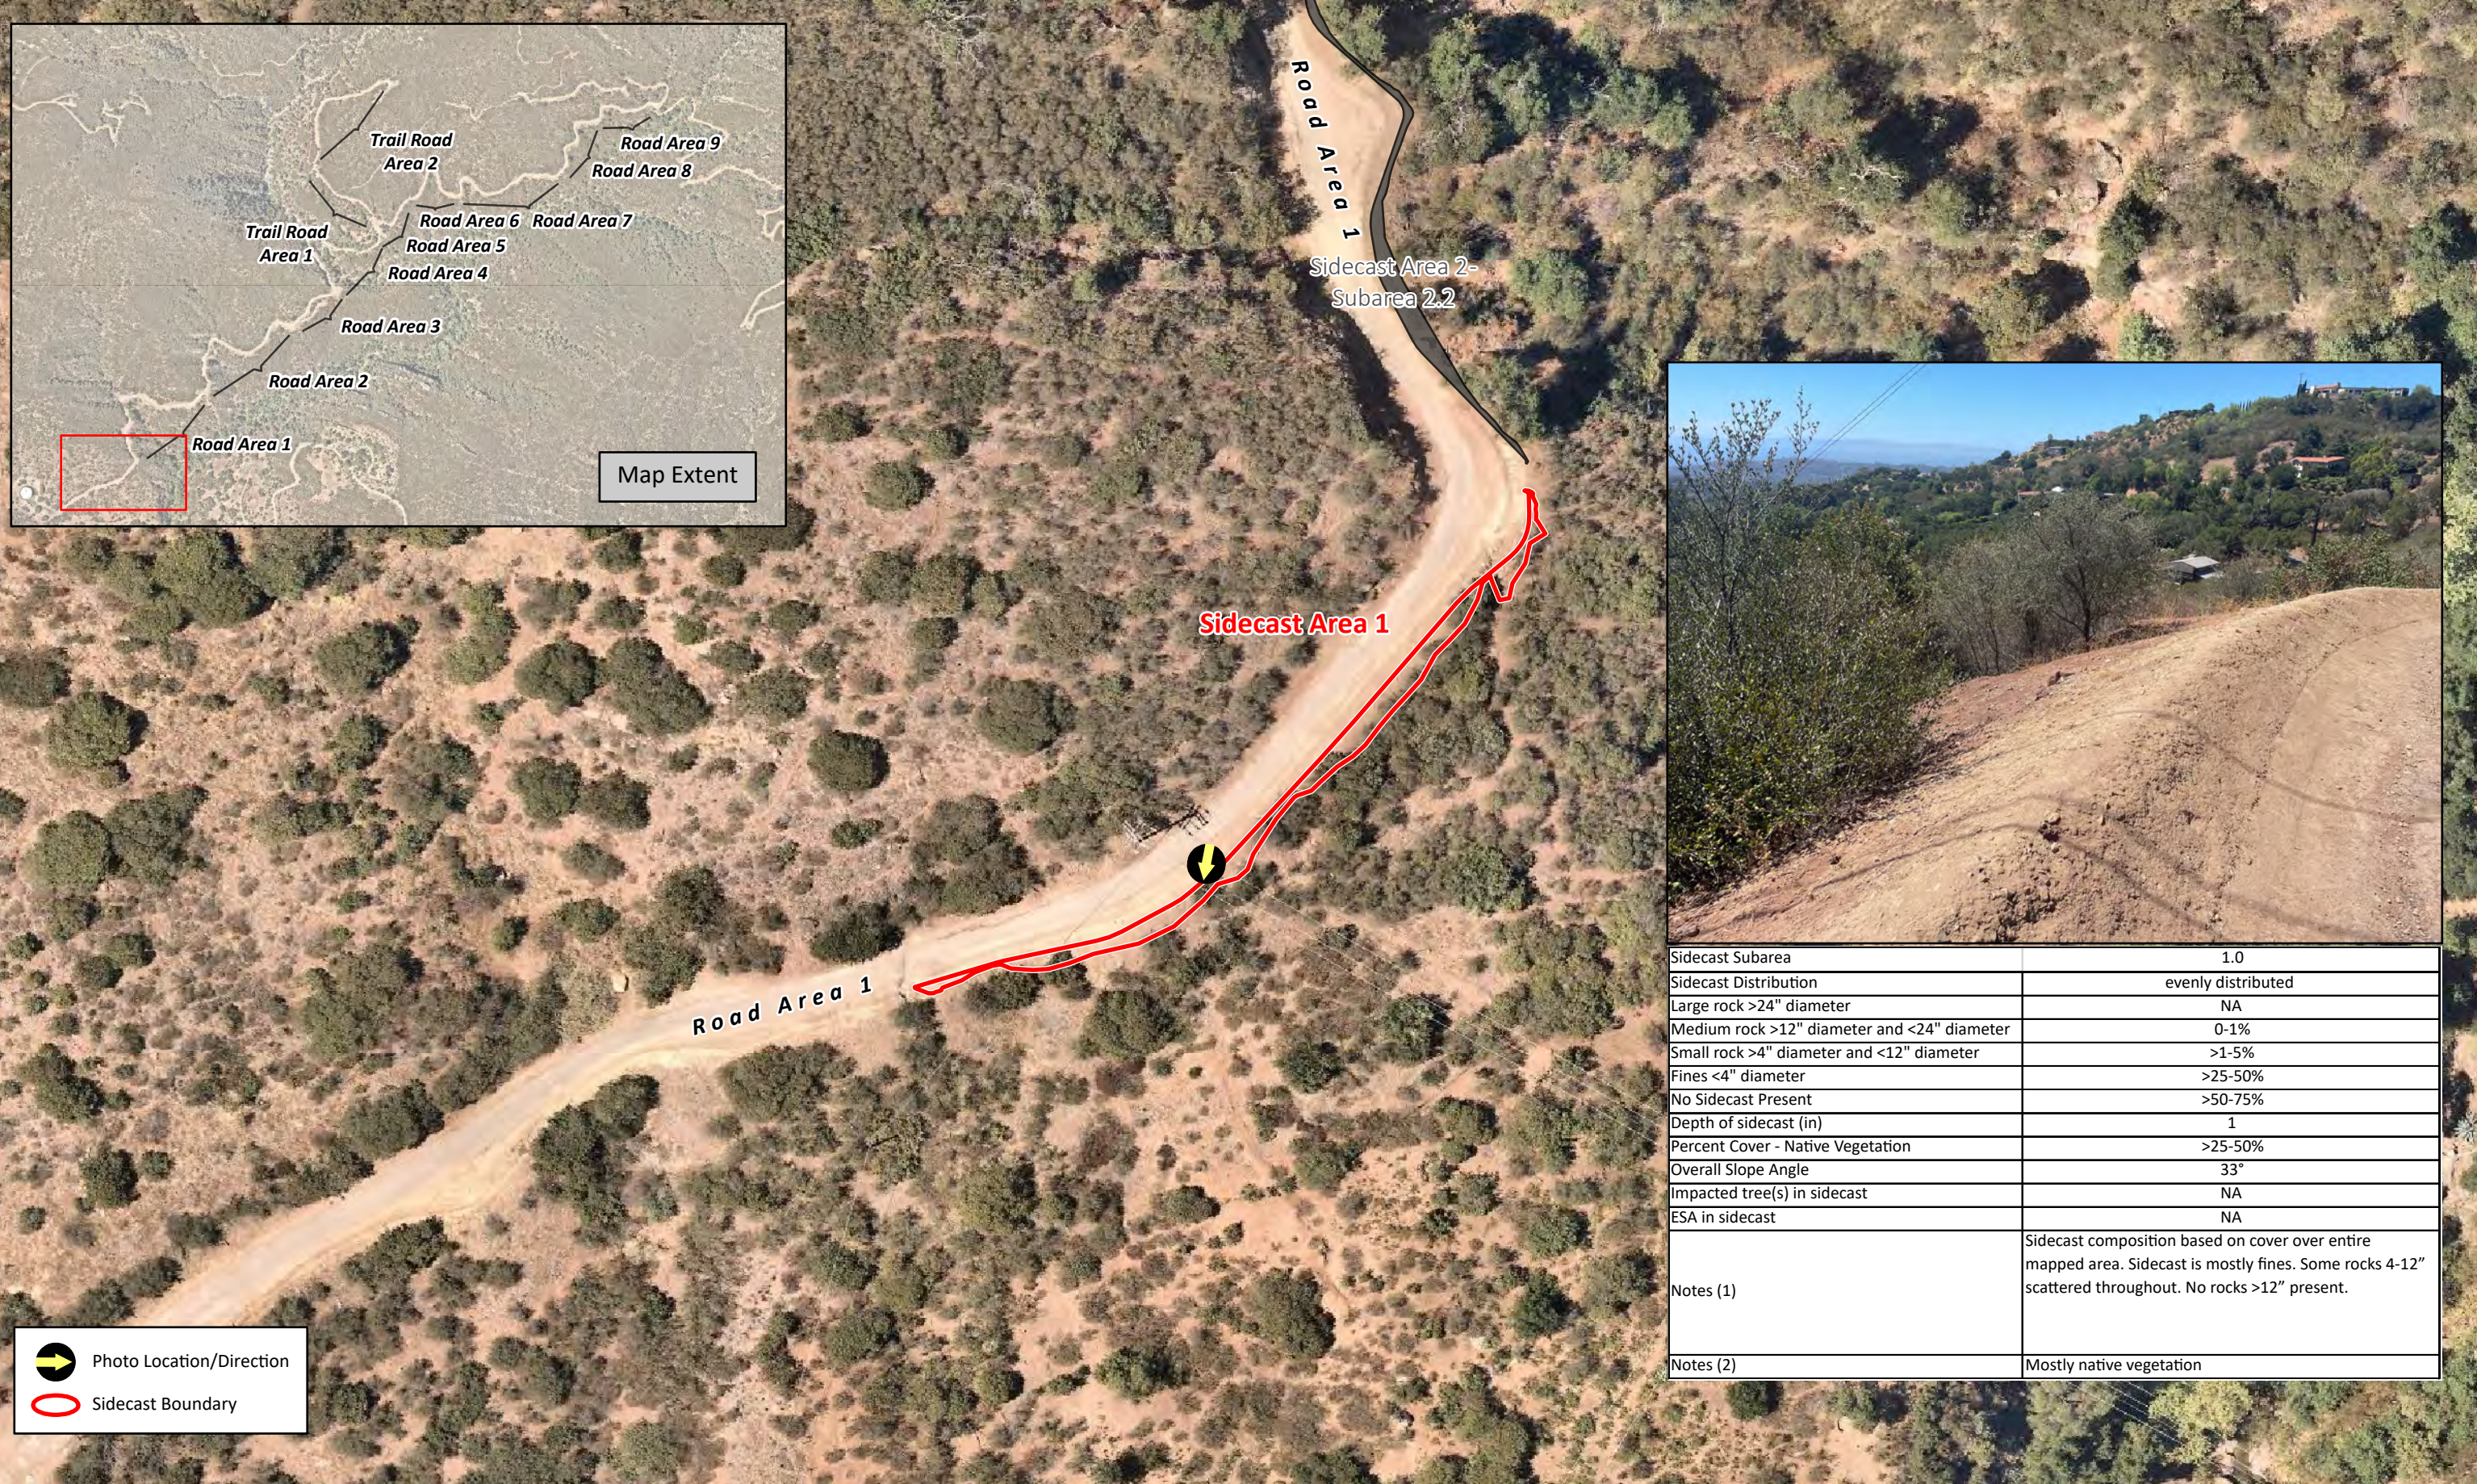
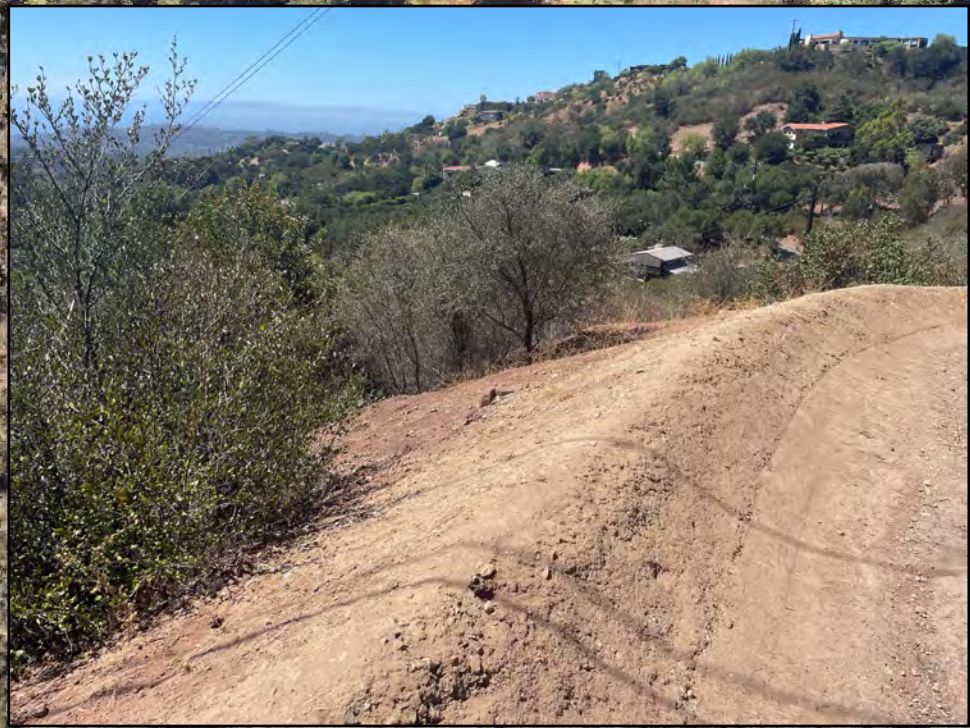
Sidecast Subarea	1.0
Sidecast Distribution	evenly distributed
Large rock >24" diameter	NA
Medium rock >12" diameter and <24" diameter	0-1%
Small rock >4" diameter and <12" diameter	>1-5%
Fines <4" diameter	>25-50%
No Sidecast Present	>50-75%
Depth of sidecast (in)	1
Percent Cover - Native Vegetation	>25-50%
Overall Slope Angle	33°
Impacted tree(s) in sidecast	NA
ESA in sidecast	NA
Notes (1)	Sidecast composition based on cover over entire mapped area. Sidecast is mostly fines. Some rocks 4-12" scattered throughout. No rocks >12" present.
Notes (2)	Mostly native vegetation

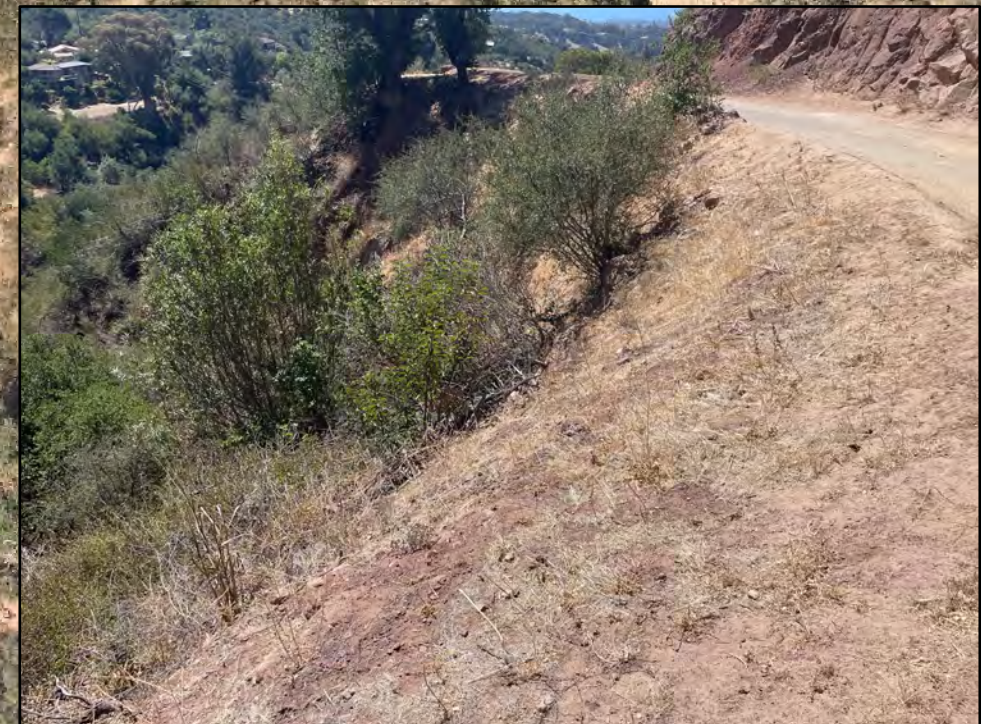
Sidecast Subarea	2.2
Sidecast Distribution	accumulated in portions
Large rock >24" diameter	NA
Medium rock >12" diameter and <24" diameter	NA
Small rock >4" diameter and <12" diameter	NA
Fines <4" diameter	>50-75%
No Sidecast Present	>25-50%
Depth of sidecast (in)	3
Percent Cover - Native Vegetation	>5-25%
Overall Slope Angle	40°
Impacted tree(s) in sidecast	13
ESA in sidecast	NA
Notes (1)	Sidecast composition based on cover over entire mapped area. Very steep slopes, some accumulations of larger rocks >6" at base of shrubs, most of sidecast is fines and rocks <4".
Notes (2)	NA

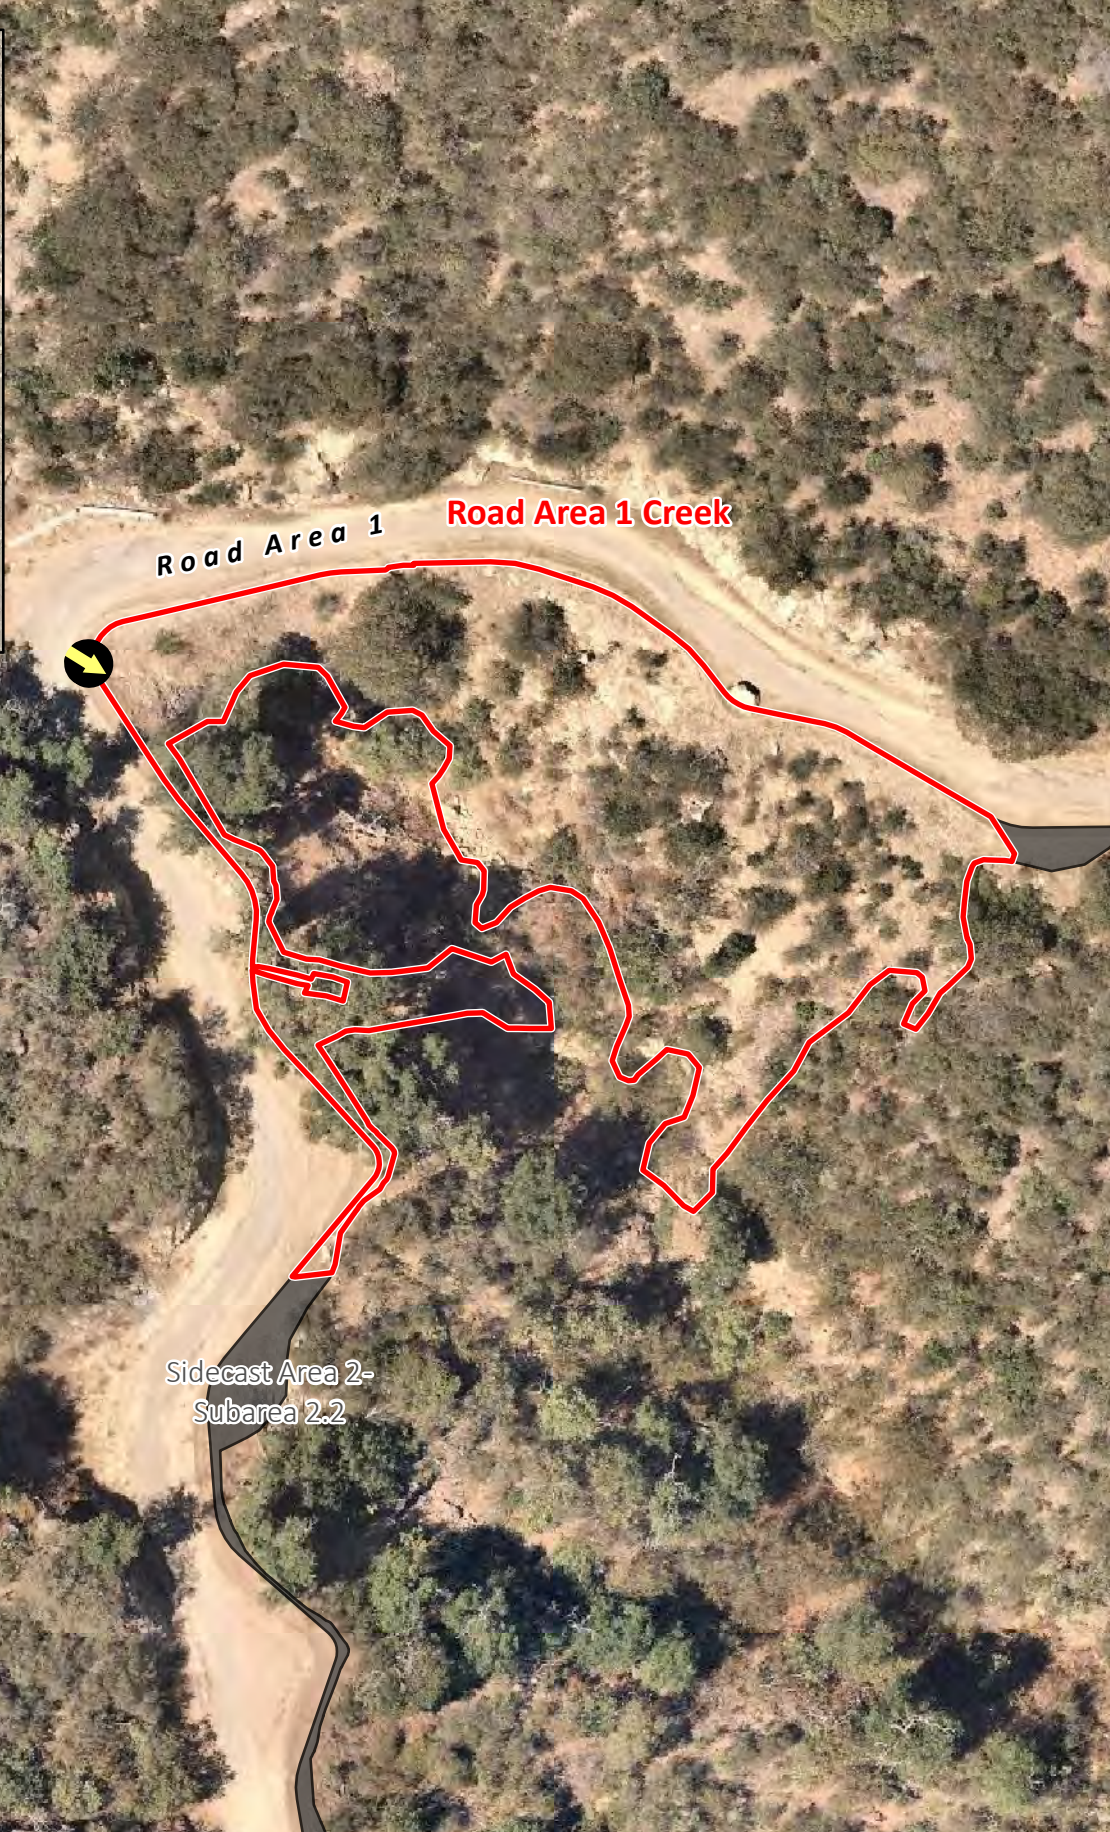
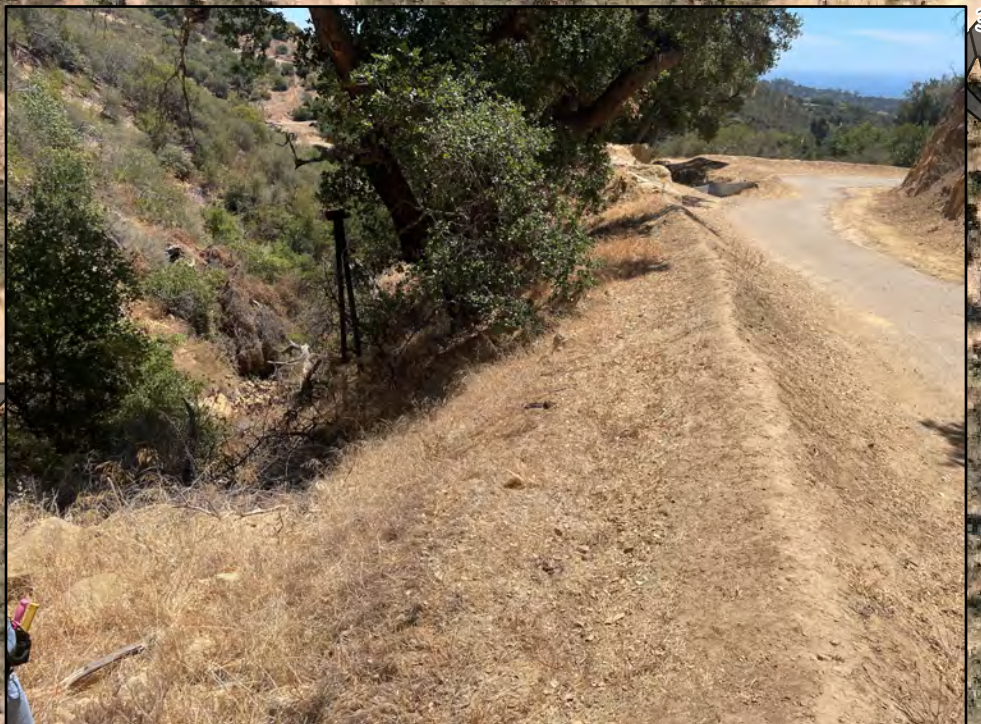
Sidecast Subarea	RA 1 creek
Sidecast Distribution	accumulated in portions
Large rock >24" diameter	>5-25%
Medium rock >12" diameter and <24" diameter	NA
Small rock >4" diameter and <12" diameter	NA
Fines <4" diameter	>25-50%
No Sidecast Present	>25-50%
Depth of sidecast (in)	3
Percent Cover - Native Vegetation	>5-25%
Overall Slope Angle	45°
Impacted tree(s) in sidecast	12
ESA in sidecast	NA
Notes (1)	Sidecast composition based on cover over entire mapped area. Most of sidecast is fines <4". Larger rocks >24" within drainage area.
Notes (2)	NA

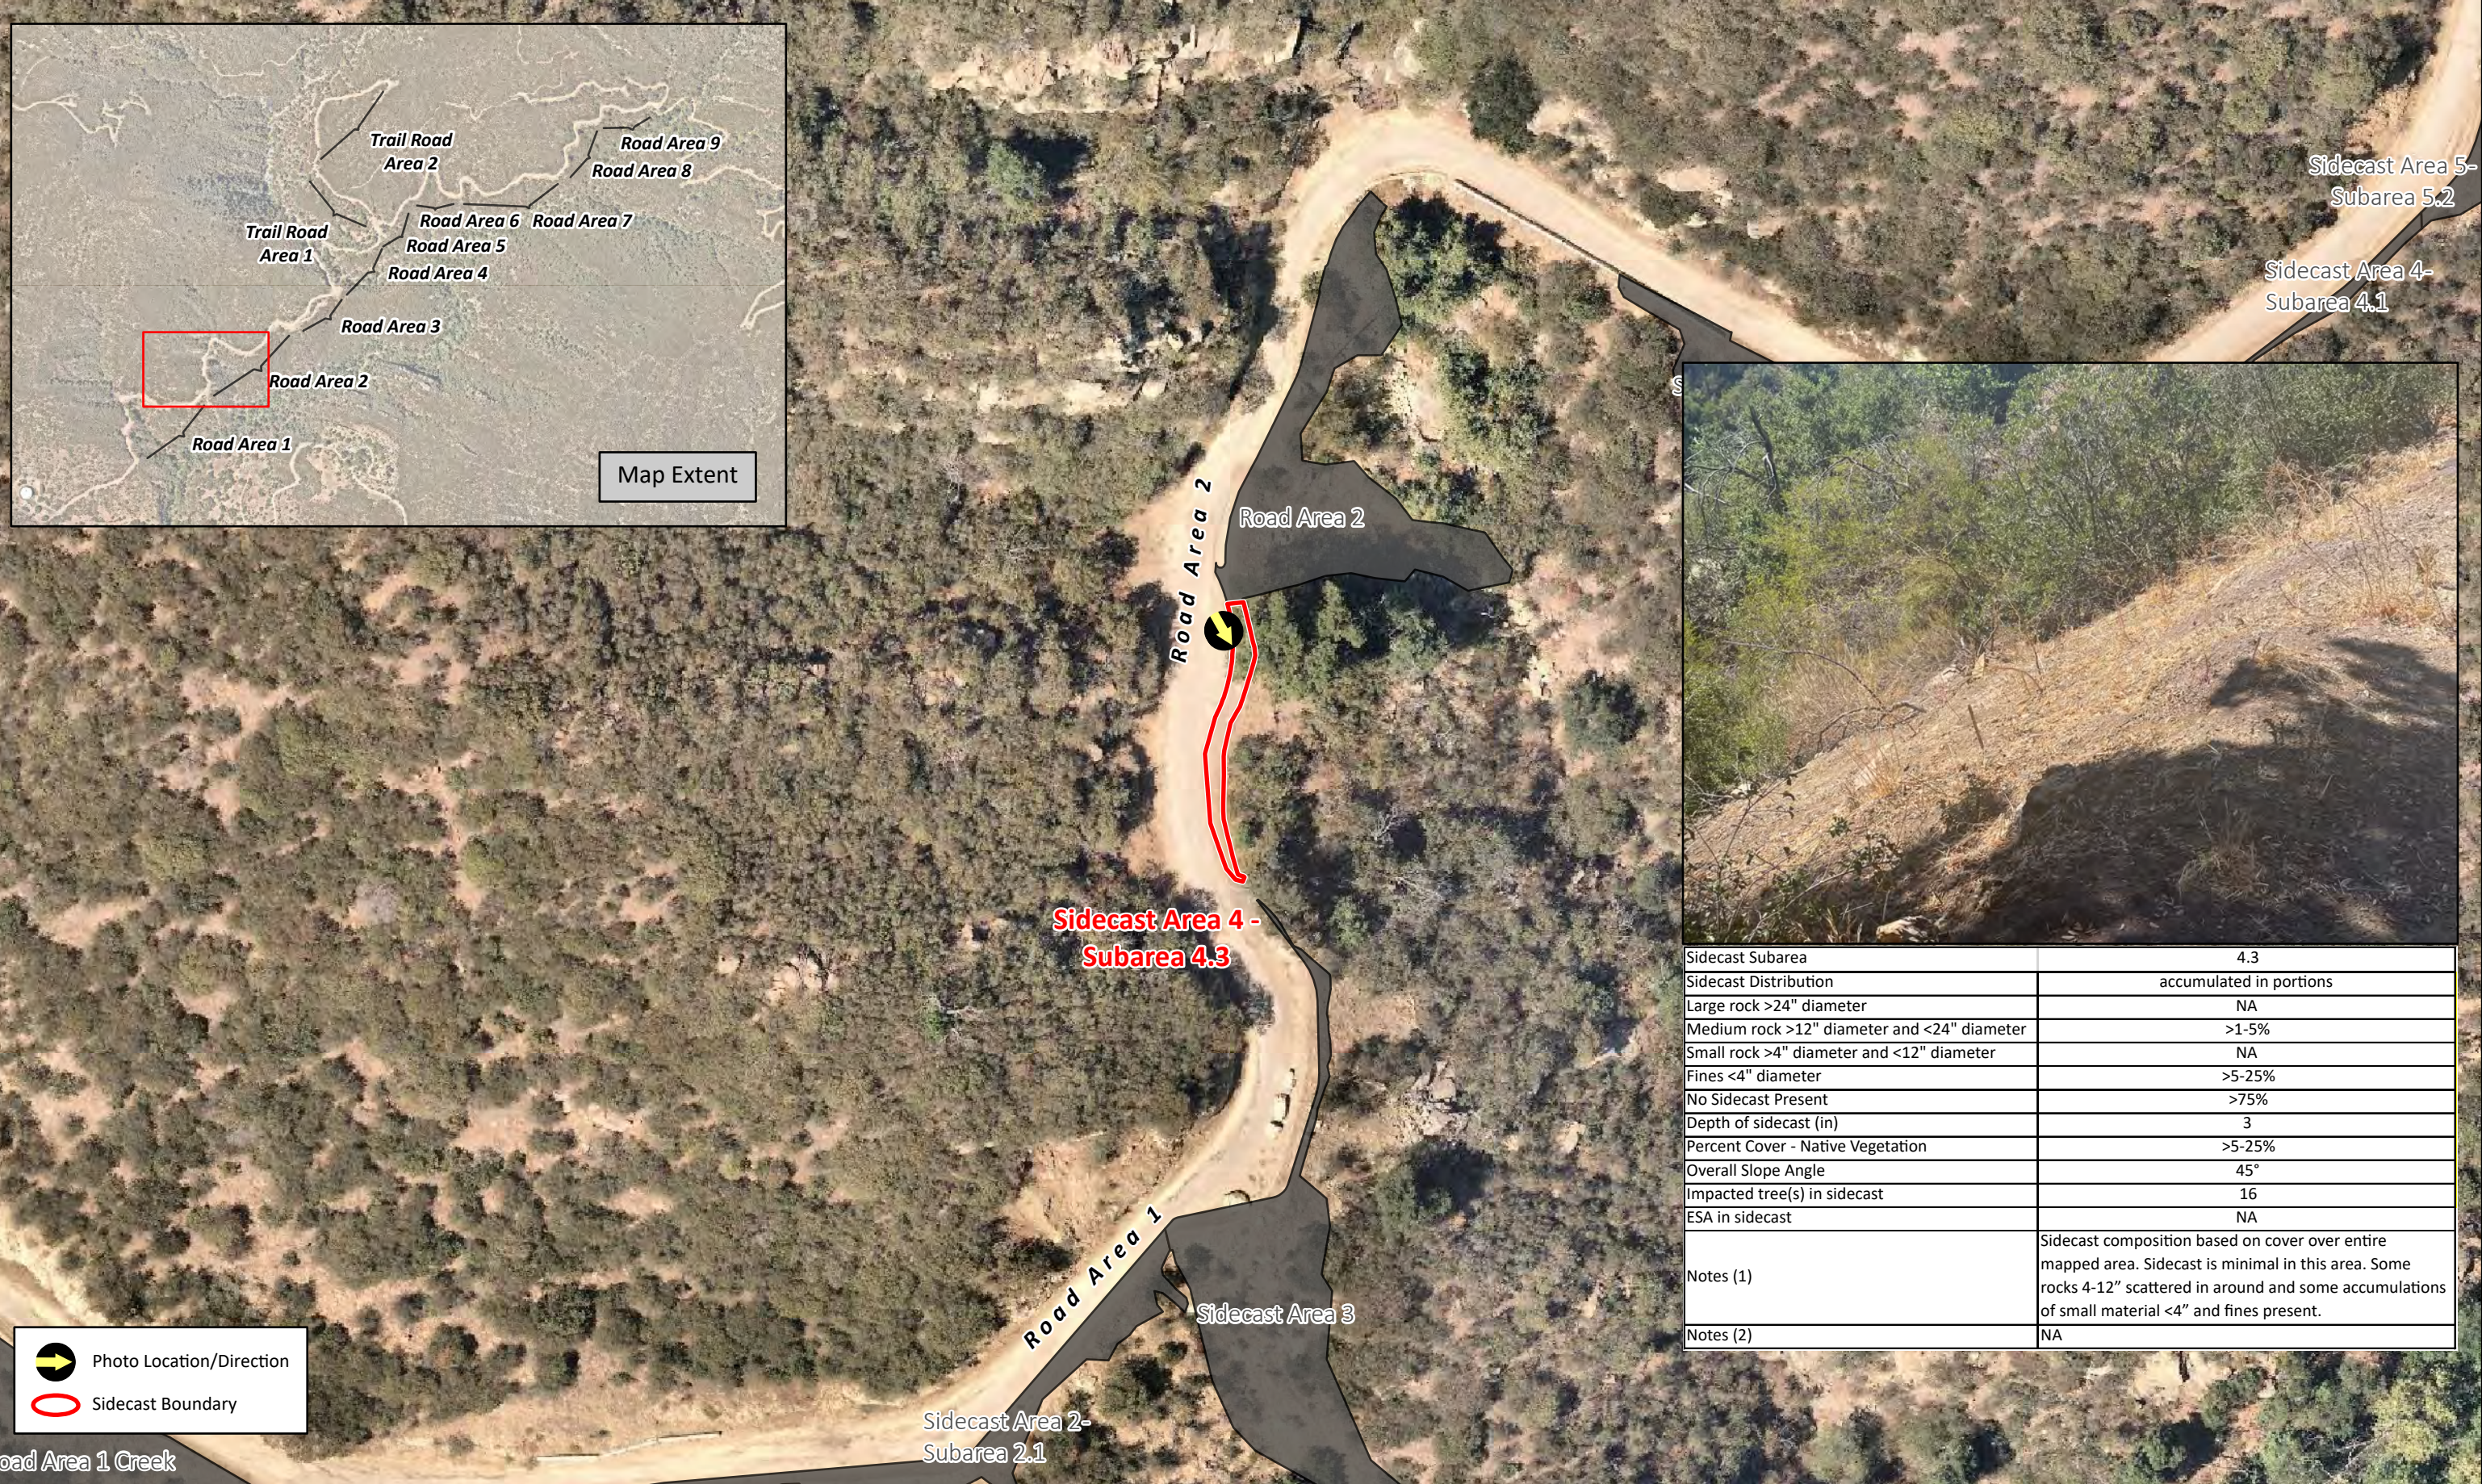
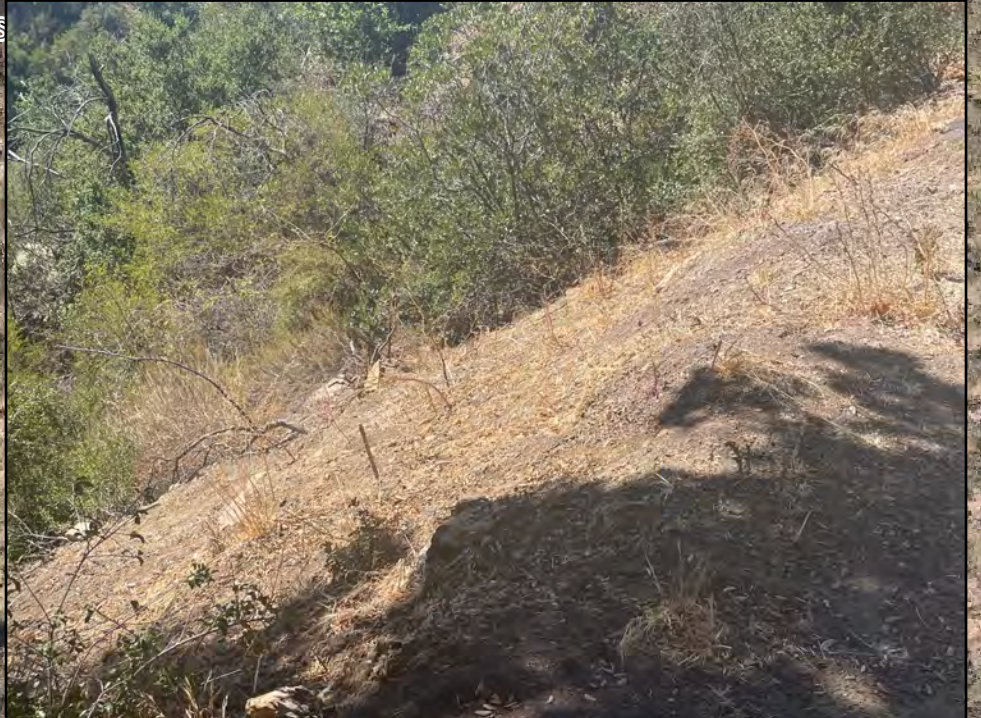
Sidecast Subarea	4.3
Sidecast Distribution	accumulated in portions
Large rock >24" diameter	NA
Medium rock >12" diameter and <24" diameter	>1-5%
Small rock >4" diameter and <12" diameter	NA
Fines <4" diameter	>5-25%
No Sidecast Present	>75%
Depth of sidecast (in)	3
Percent Cover - Native Vegetation	>5-25%
Overall Slope Angle	45°
Impacted tree(s) in sidecast	16
ESA in sidecast	NA
Notes (1)	Sidecast composition based on cover over entire mapped area. Sidecast is minimal in this area. Some rocks 4-12" scattered in around and some accumulations of small material <4" and fines present.
Notes (2)	NA

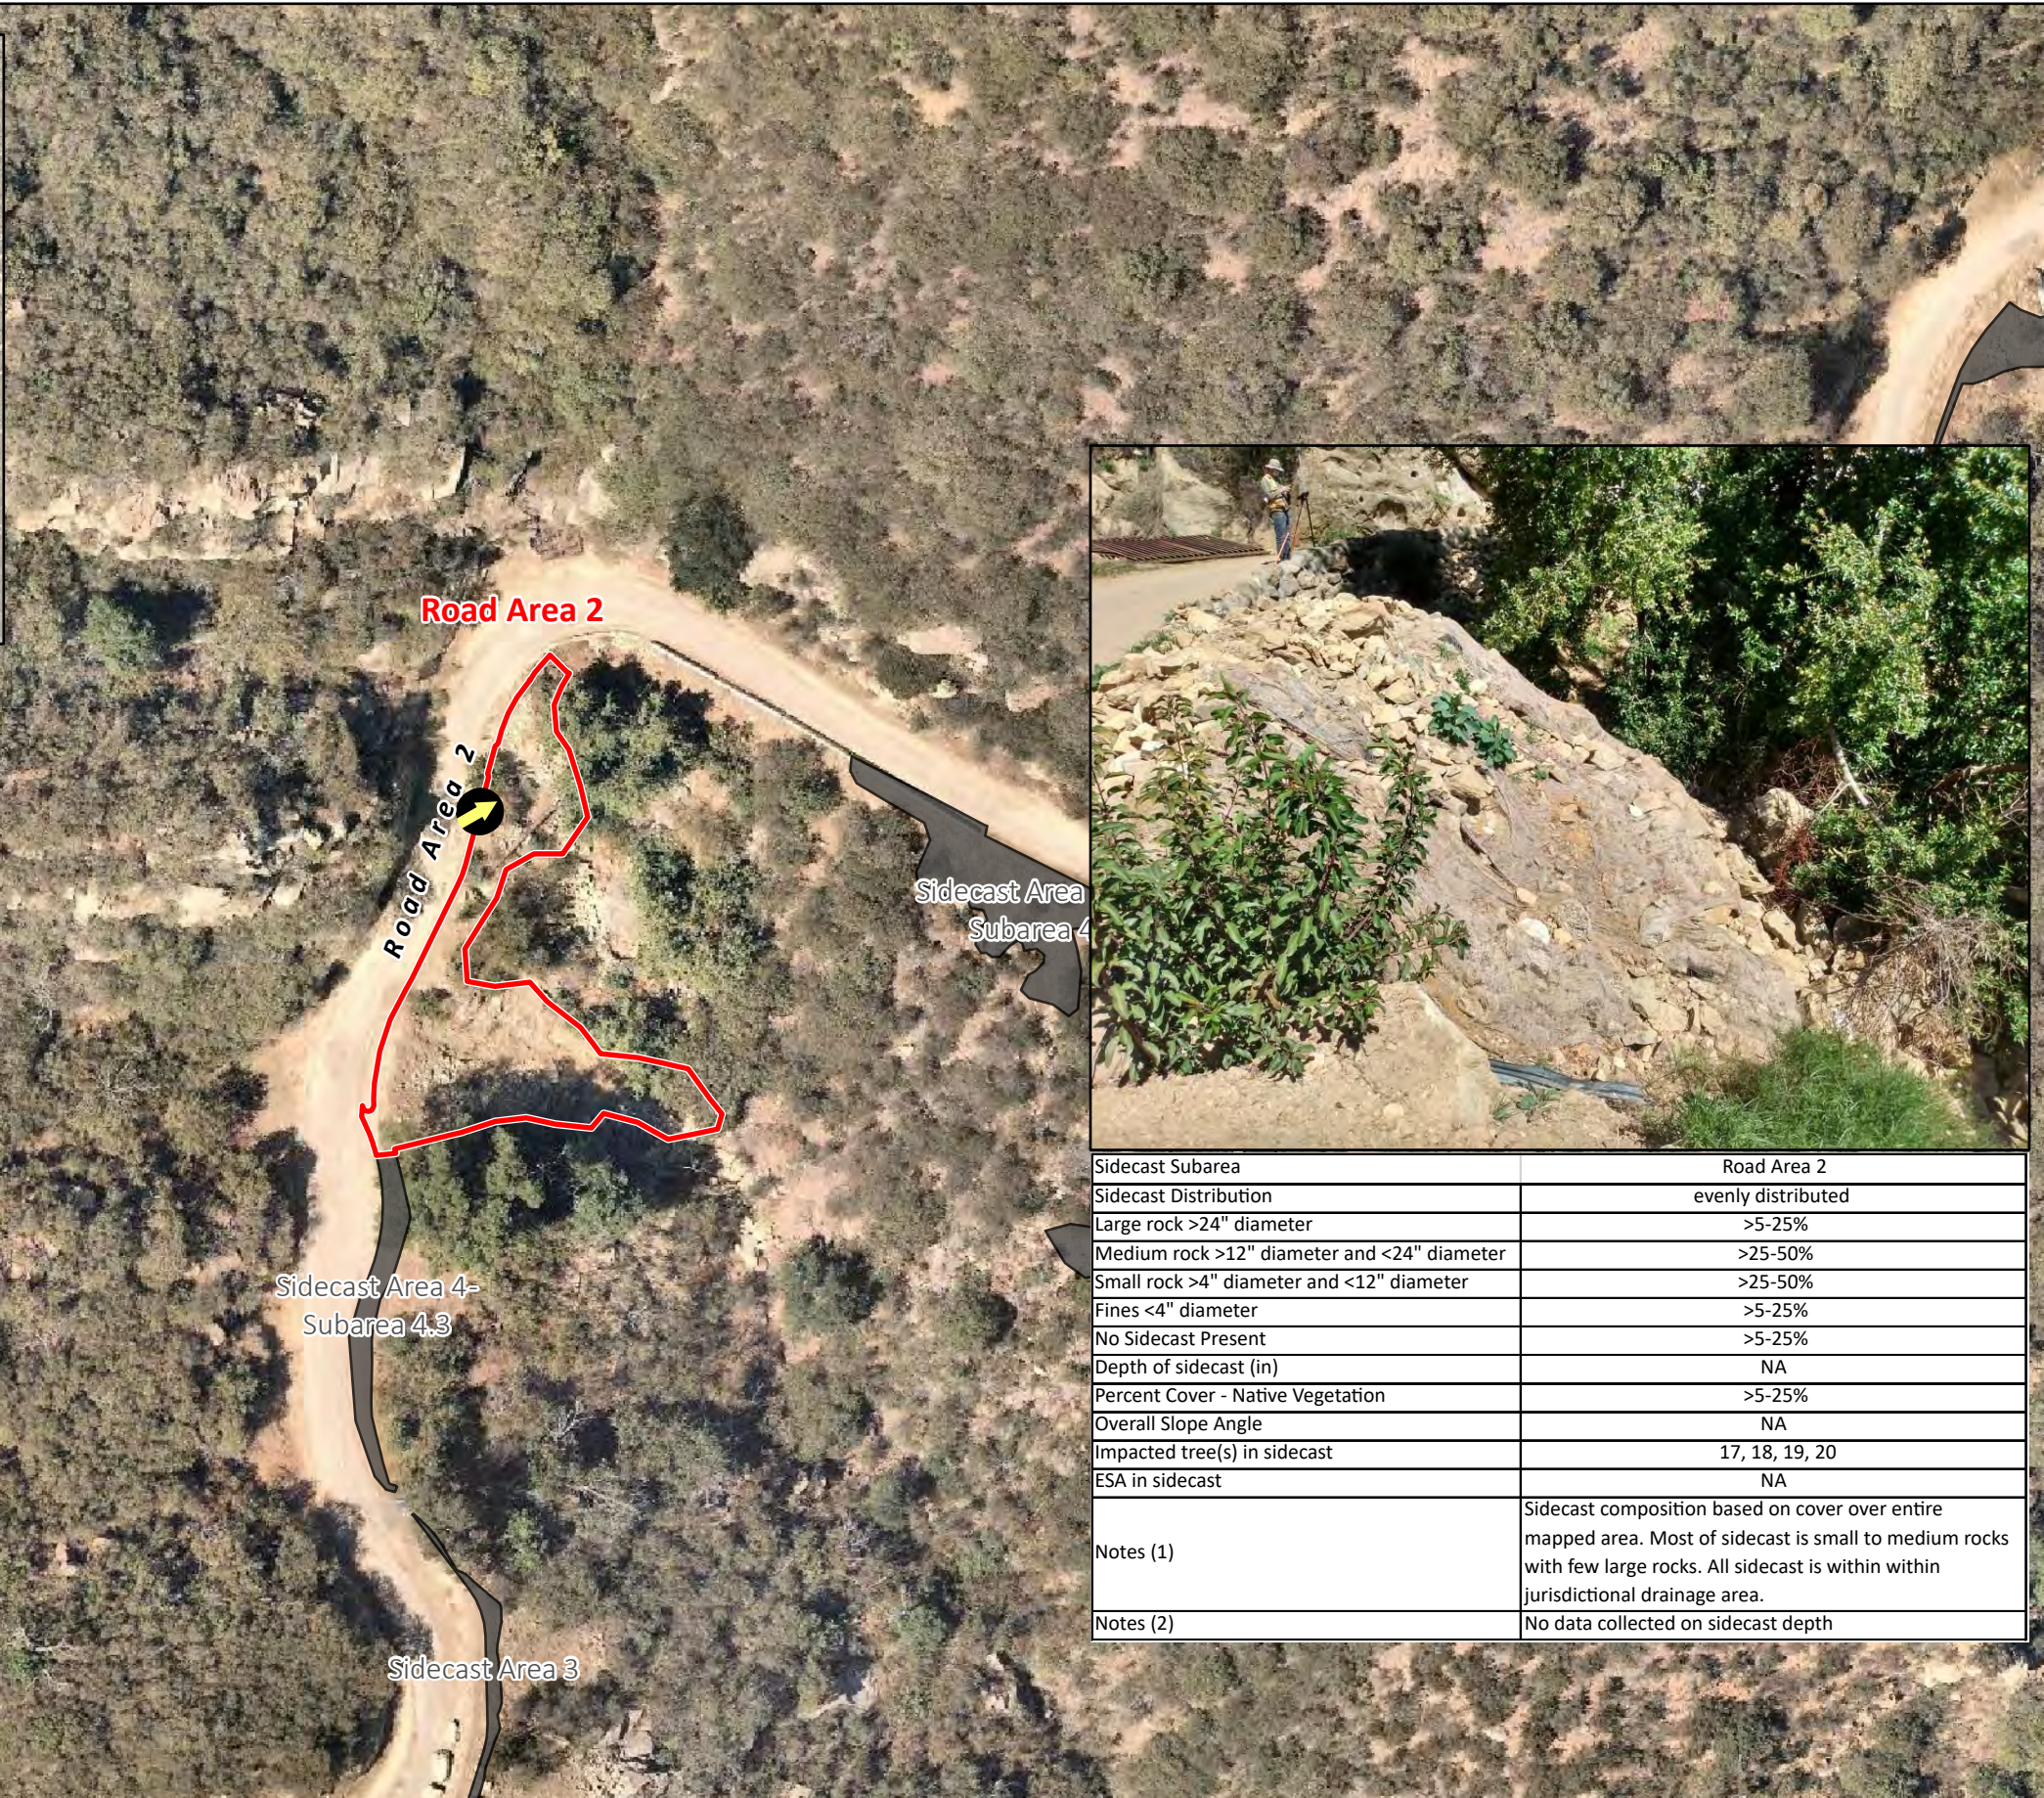
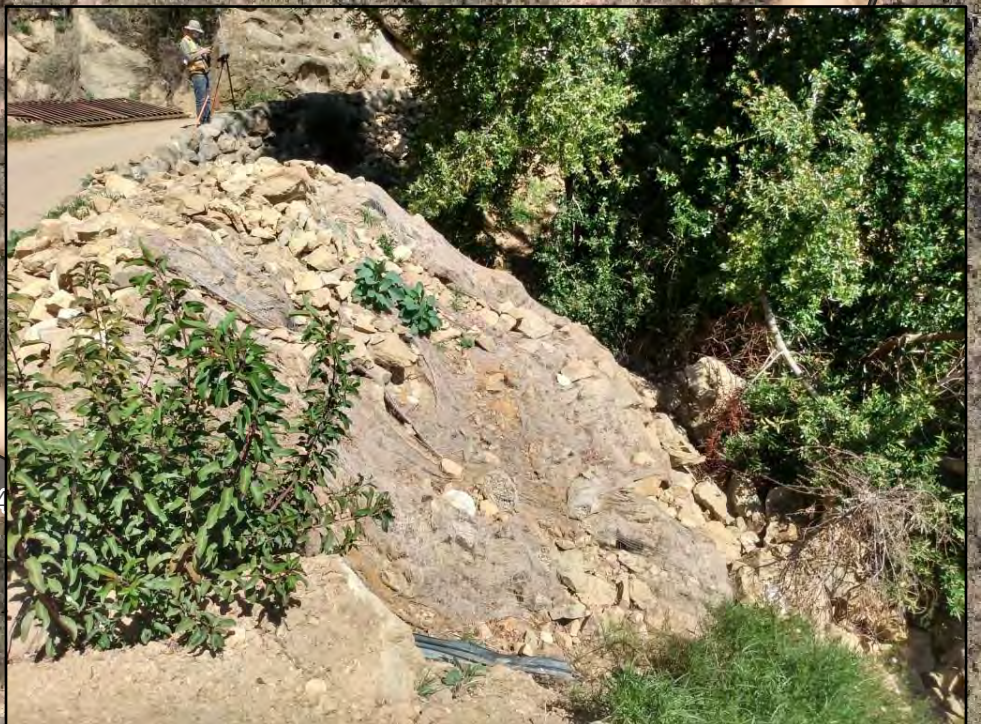
Sidecast Subarea	Road Area 2
Sidecast Distribution	evenly distributed
Large rock >24" diameter	>5-25%
Medium rock >12" diameter and <24" diameter	>25-50%
Small rock >4" diameter and <12" diameter	>25-50%
Fines <4" diameter	>5-25%
No Sidecast Present	>5-25%
Depth of sidecast (in)	NA
Percent Cover - Native Vegetation	>5-25%
Overall Slope Angle	NA
Impacted tree(s) in sidecast	17, 18, 19, 20
ESA in sidecast	NA
Notes (1)	Sidecast composition based on cover over entire mapped area. Most of sidecast is small to medium rocks with few large rocks. All sidecast is within within jurisdictional drainage area.
Notes (2)	No data collected on sidecast depth

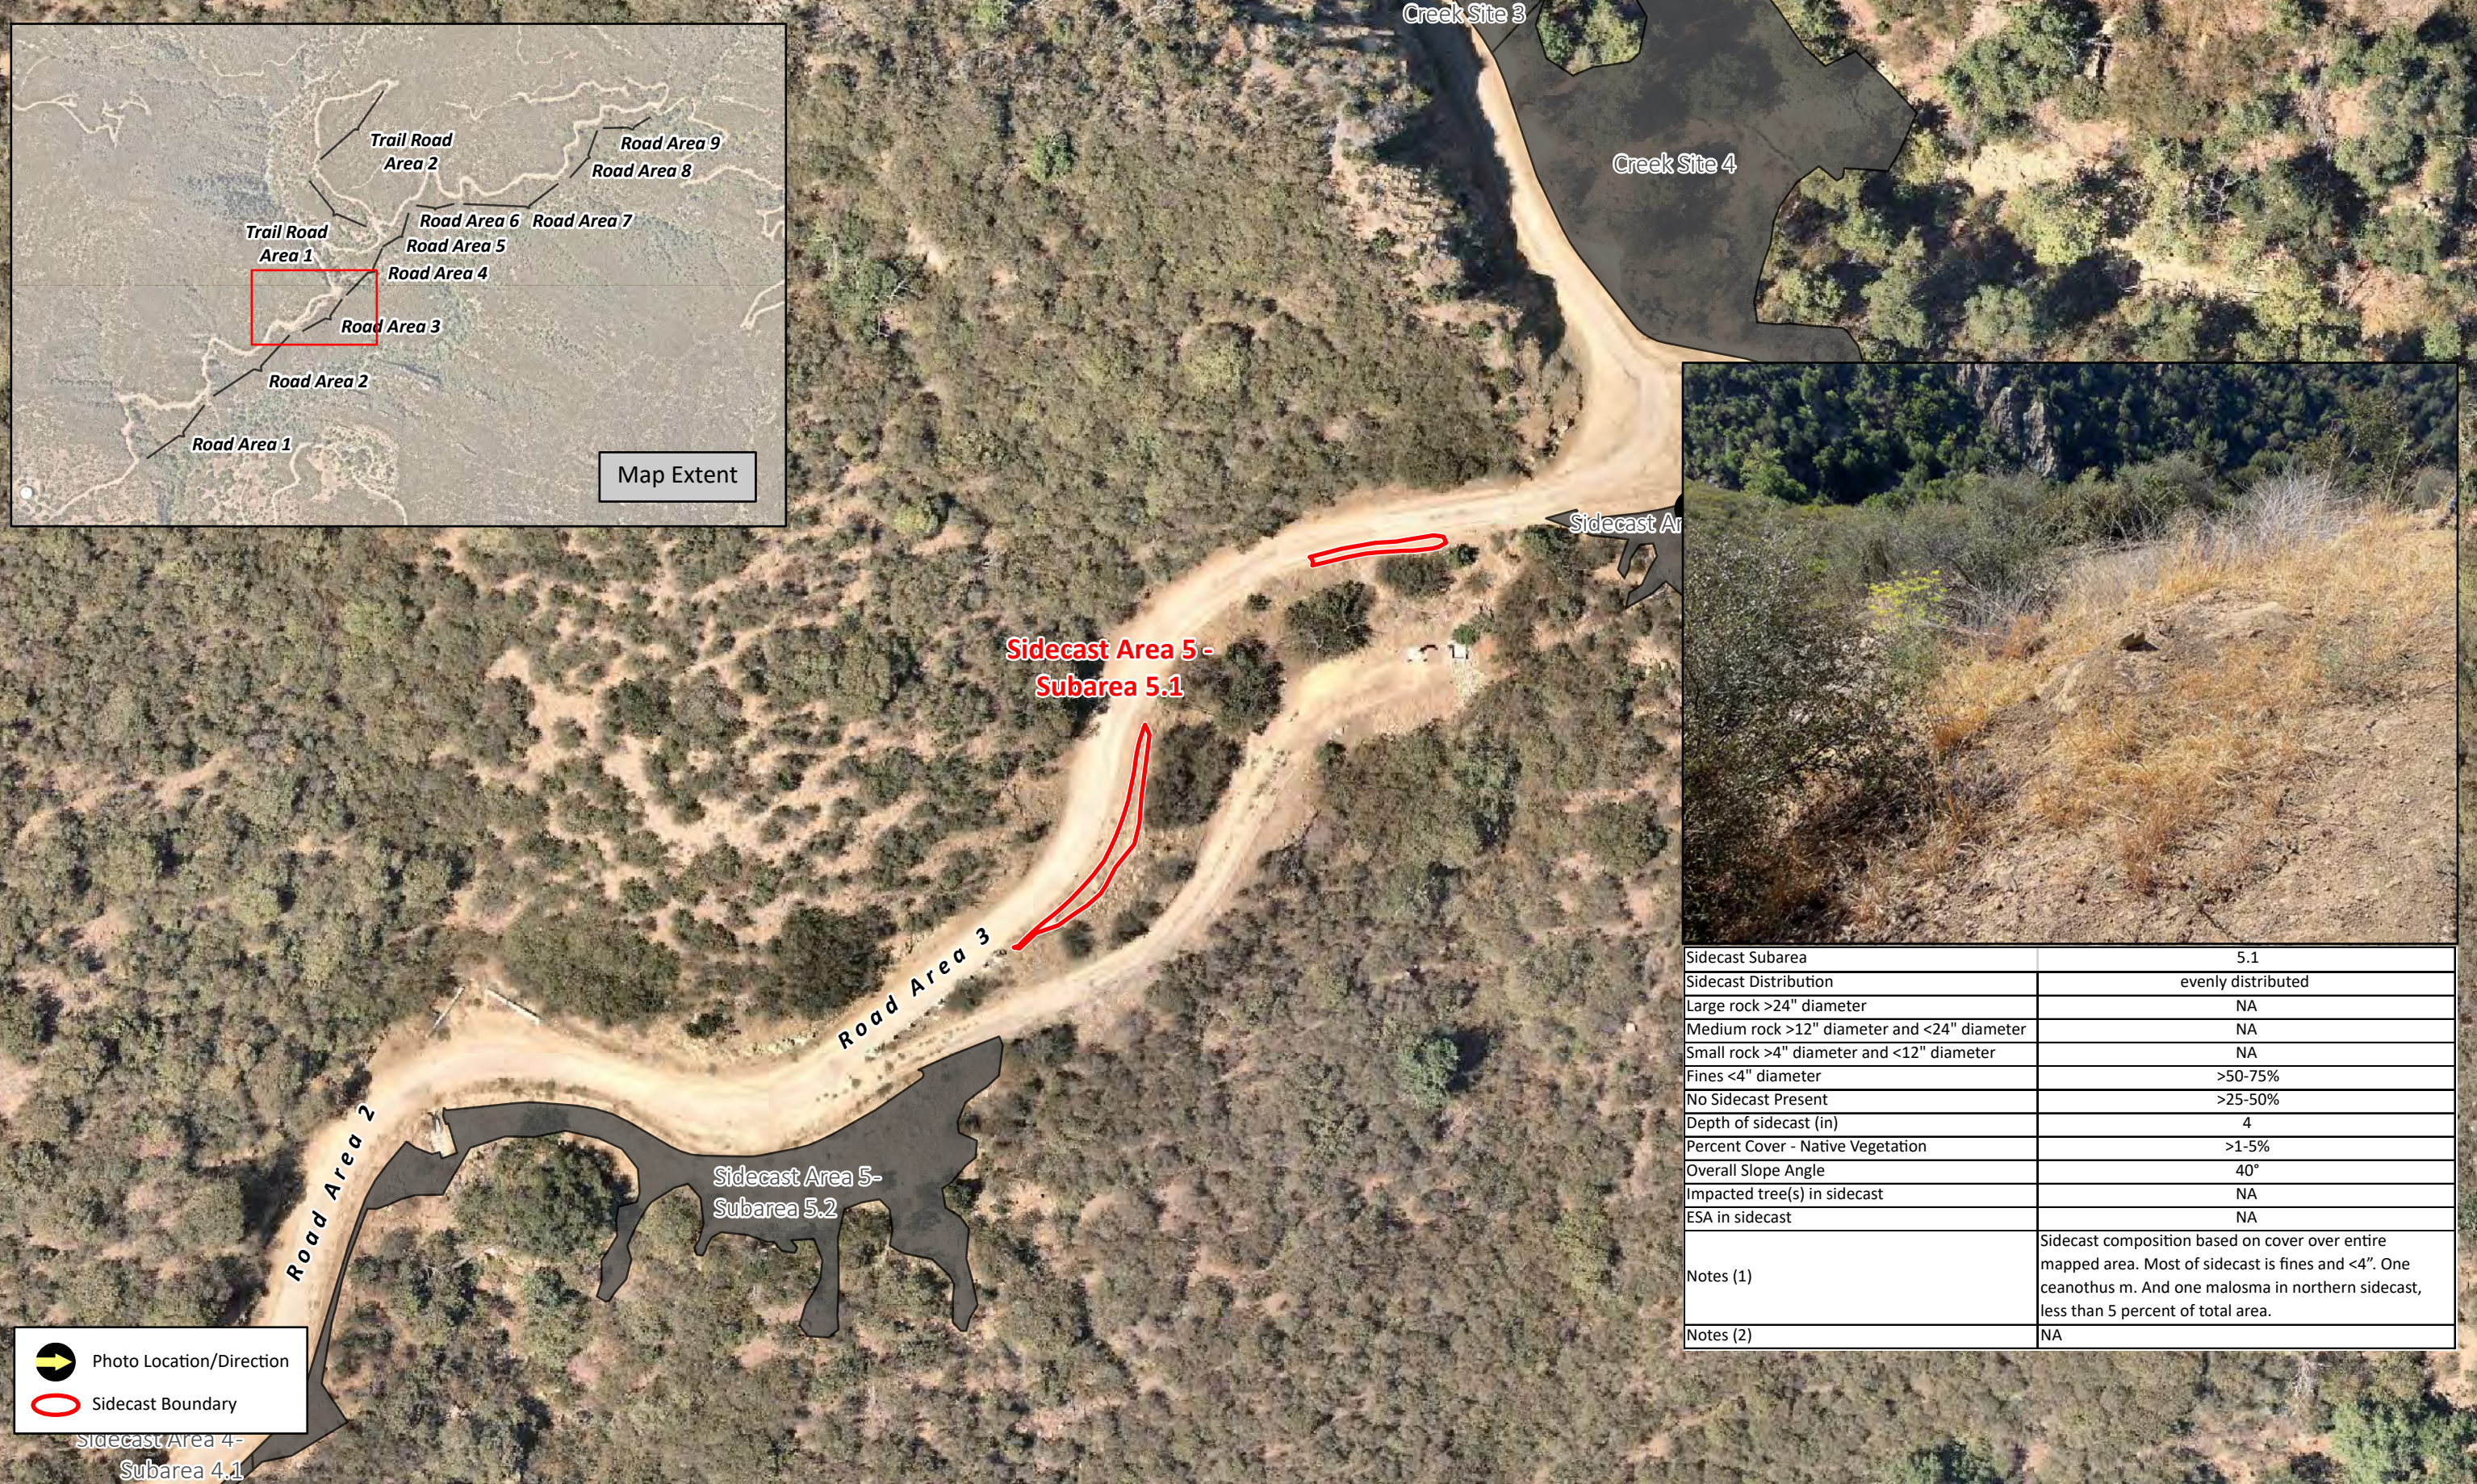
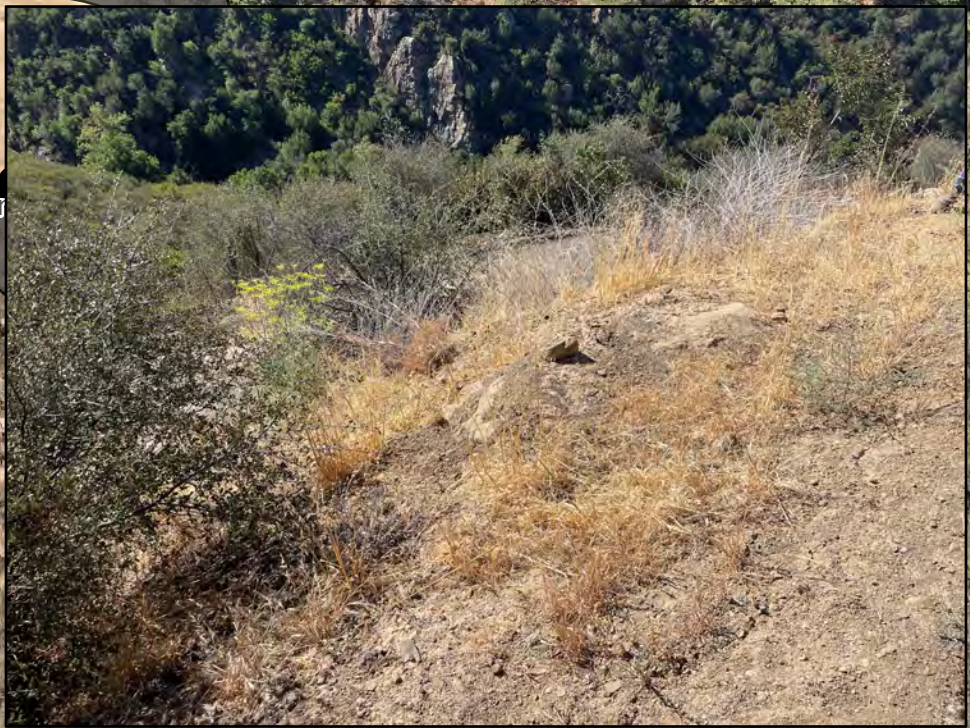
Sidecast Subarea	5.1
Sidecast Distribution	evenly distributed
Large rock >24" diameter	NA
Medium rock >12" diameter and <24" diameter	NA
Small rock >4" diameter and <12" diameter	NA
Fines <4" diameter	>50-75%
No Sidecast Present	>25-50%
Depth of sidecast (in)	4
Percent Cover - Native Vegetation	>1-5%
Overall Slope Angle	40°
Impacted tree(s) in sidecast	NA
ESA in sidecast	NA
Notes (1)	Sidecast composition based on cover over entire mapped area. Most of sidecast is fines and <4". One ceanothus m. And one malosma in northern sidecast, less than 5 percent of total area.
Notes (2)	NA
