**Mission Canyon Stream Habitat Restoration Project
Initial Study/Mitigated Negative Declaration**

Mission Canyon Stream Restoration Project

Supplemental Site Surveys and Comparative
Scoping Analysis

October 2022

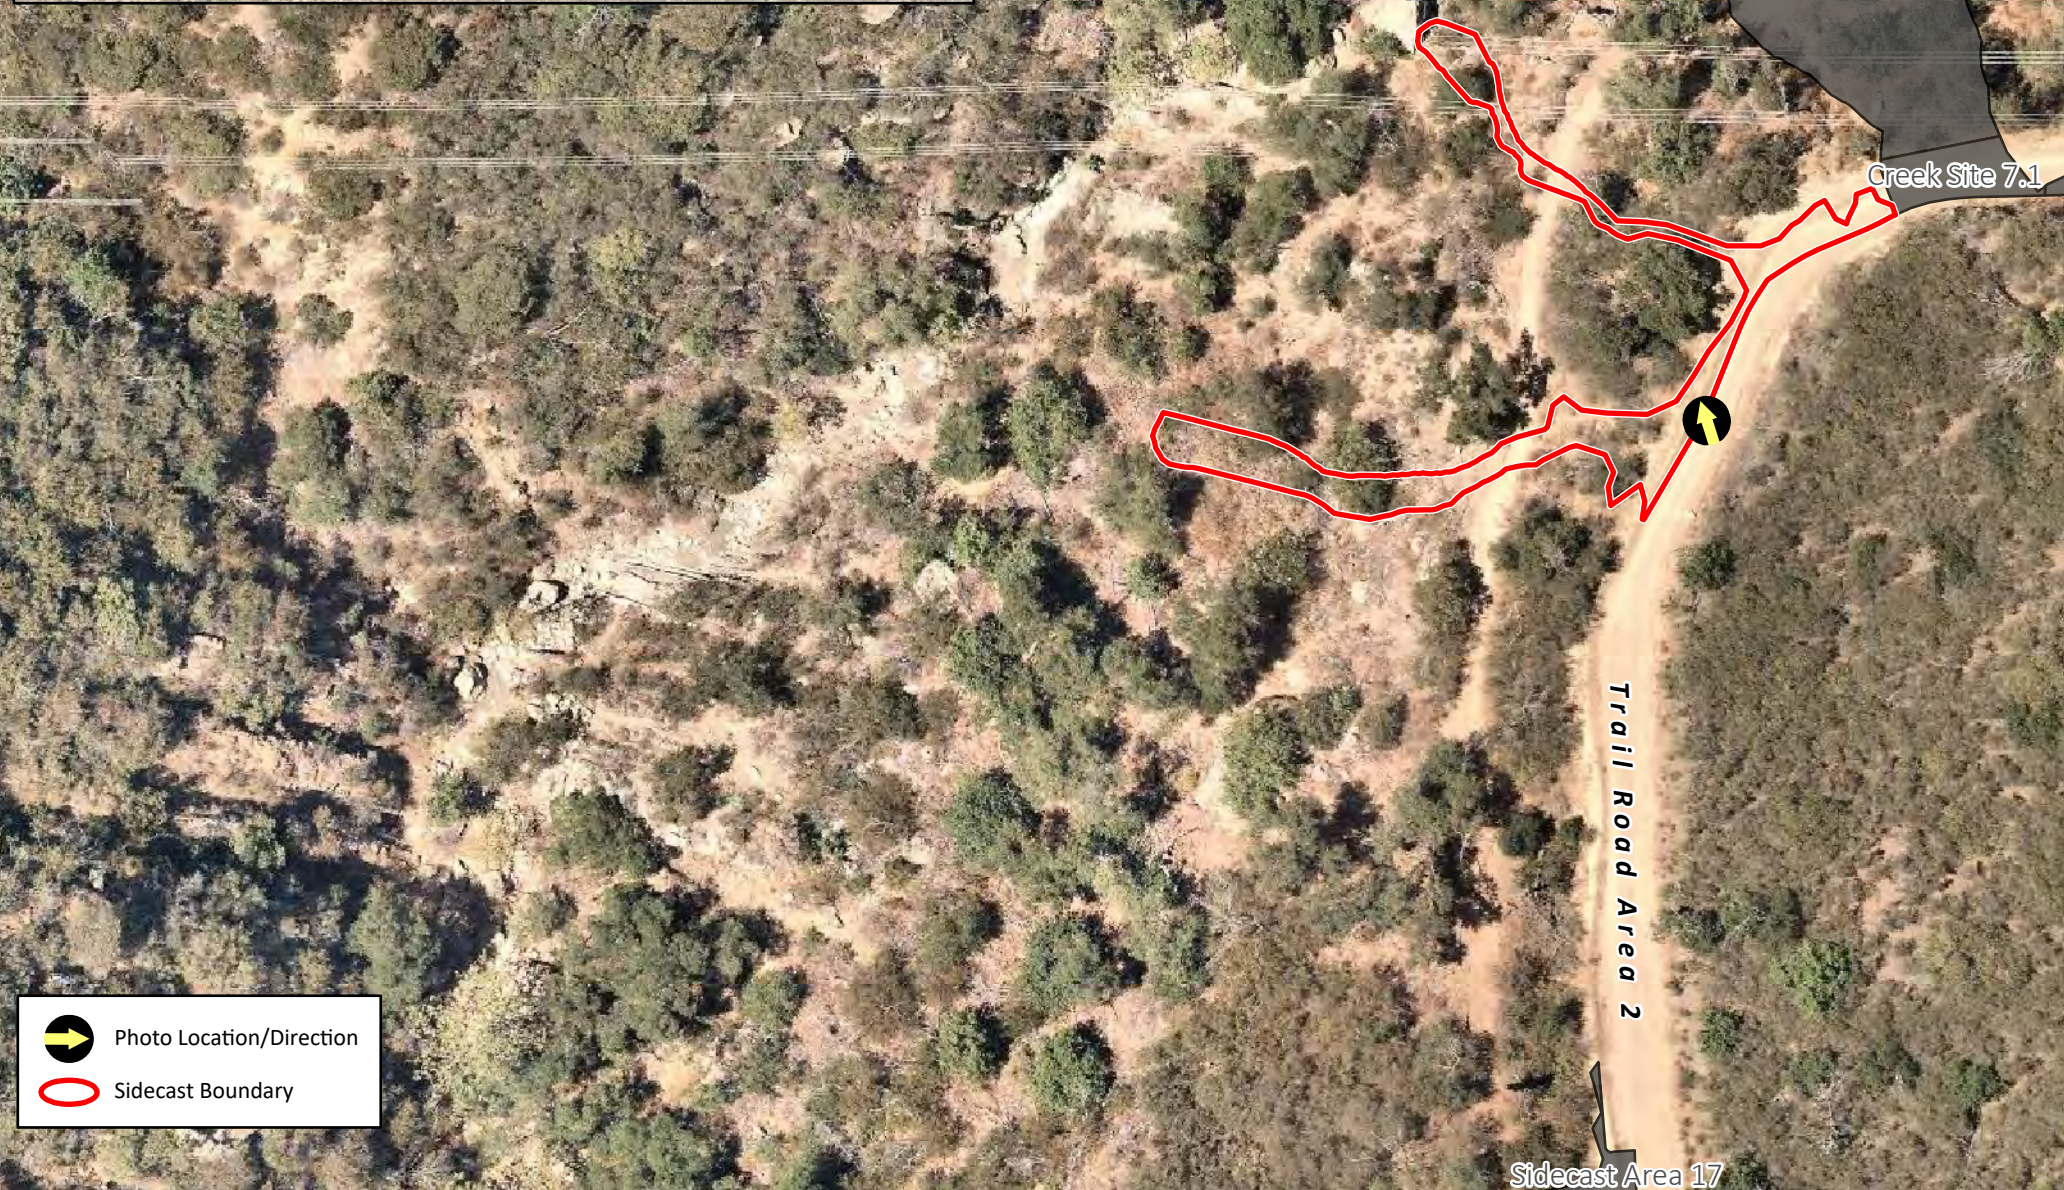
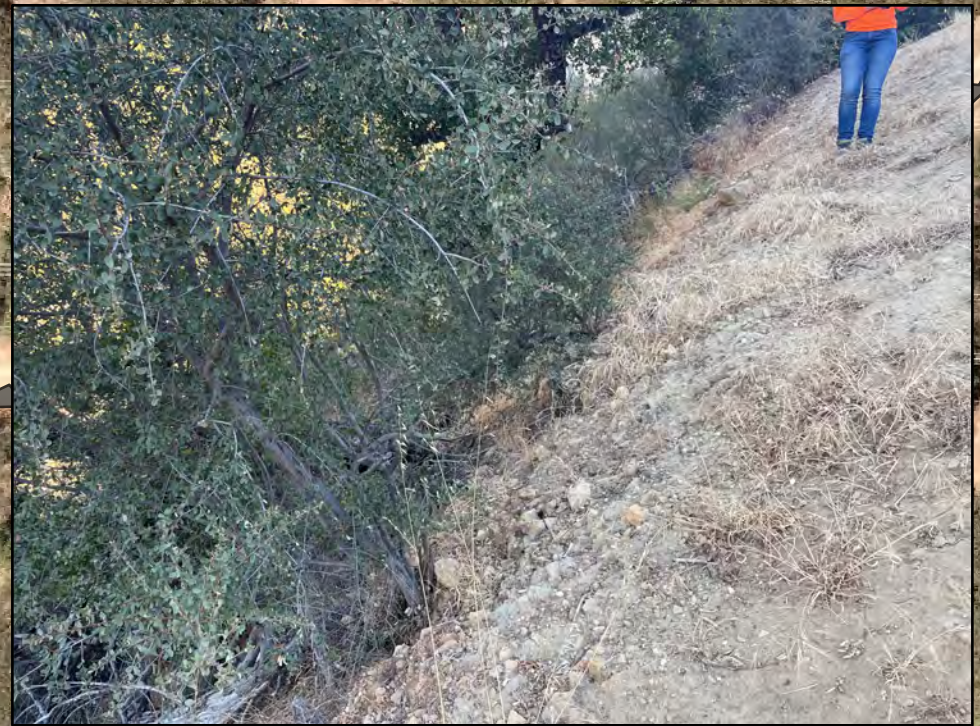
Sidecast Subarea	18.0
Sidecast Distribution	evenly distributed
Large rock >24" diameter	>1-5%
Medium rock >12" diameter and <24" diameter	NA
Small rock >4" diameter and <12" diameter	>25-50%
Fines <4" diameter	>5-25%
No Sidecast Present	>50-75%
Depth of sidecast (in)	2
Percent Cover - Native Vegetation	>5-25%
Overall Slope Angle	35°
Impacted tree(s) in sidecast	109
ESA in sidecast	NA
Notes (1)	Sidecast composition based on cover over entire mapped area. Sidecast is minimal and within 2m of road with a few scattered larger rock downslope. Baccharis plummarae near tree #109. Sidecast fines <4" throughout. Some scattered boulders (2' or greater) present.
Notes (2)	Sensitive species present in sidecast. Sidecast is mainly the berm in this area.

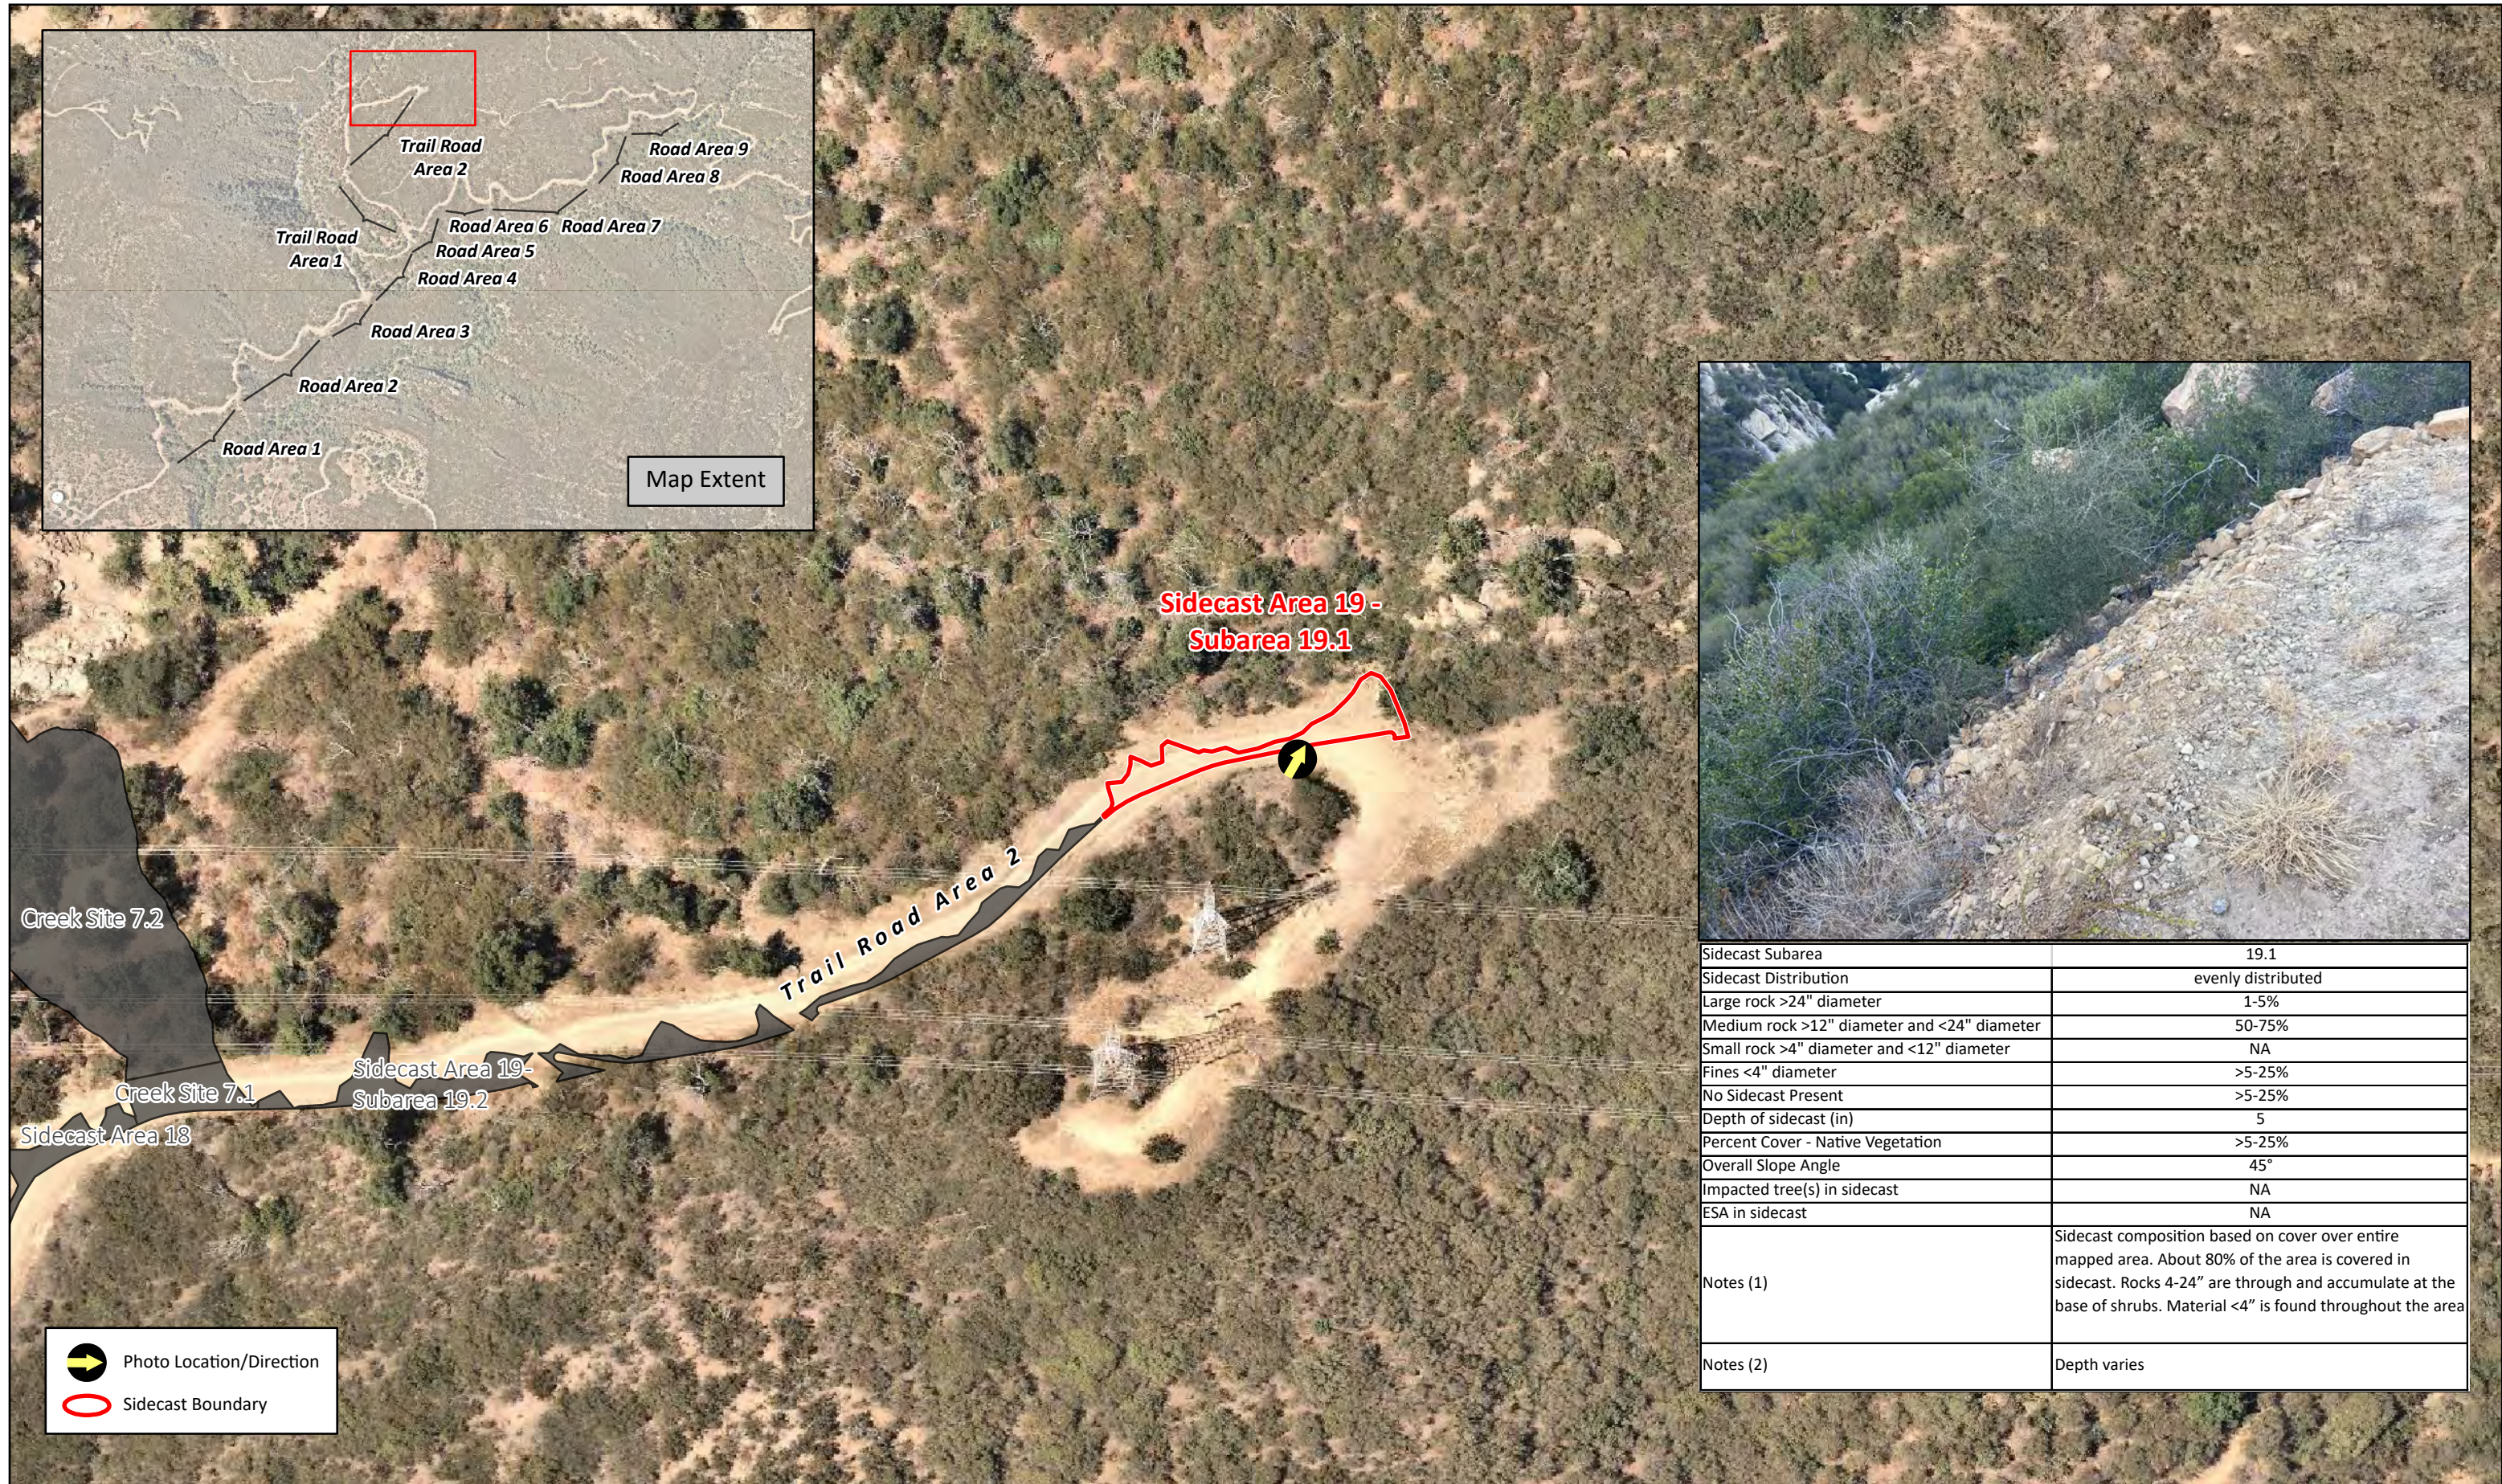
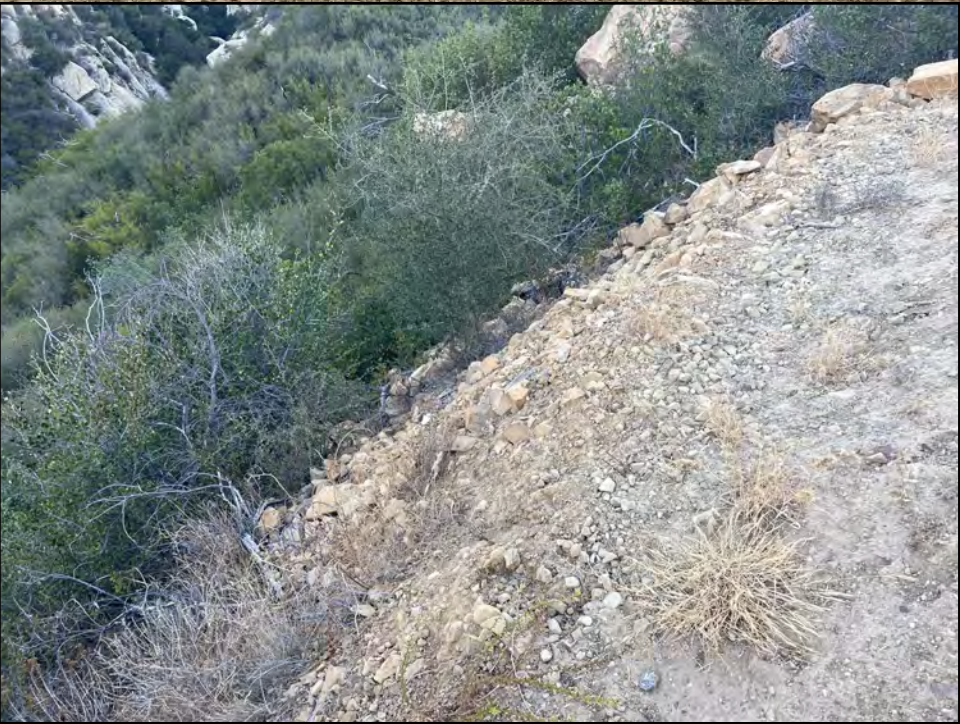
Sidecast Subarea	19.1
Sidecast Distribution	evenly distributed
Large rock >24" diameter	1-5%
Medium rock >12" diameter and <24" diameter	50-75%
Small rock >4" diameter and <12" diameter	NA
Fines <4" diameter	>5-25%
No Sidecast Present	>5-25%
Depth of sidecast (in)	5
Percent Cover - Native Vegetation	>5-25%
Overall Slope Angle	45°
Impacted tree(s) in sidecast	NA
ESA in sidecast	NA
Notes (1)	Sidecast composition based on cover over entire mapped area. About 80% of the area is covered in sidecast. Rocks 4-24" are through and accumulate at the base of shrubs. Material <4" is found throughout the area
Notes (2)	Depth varies

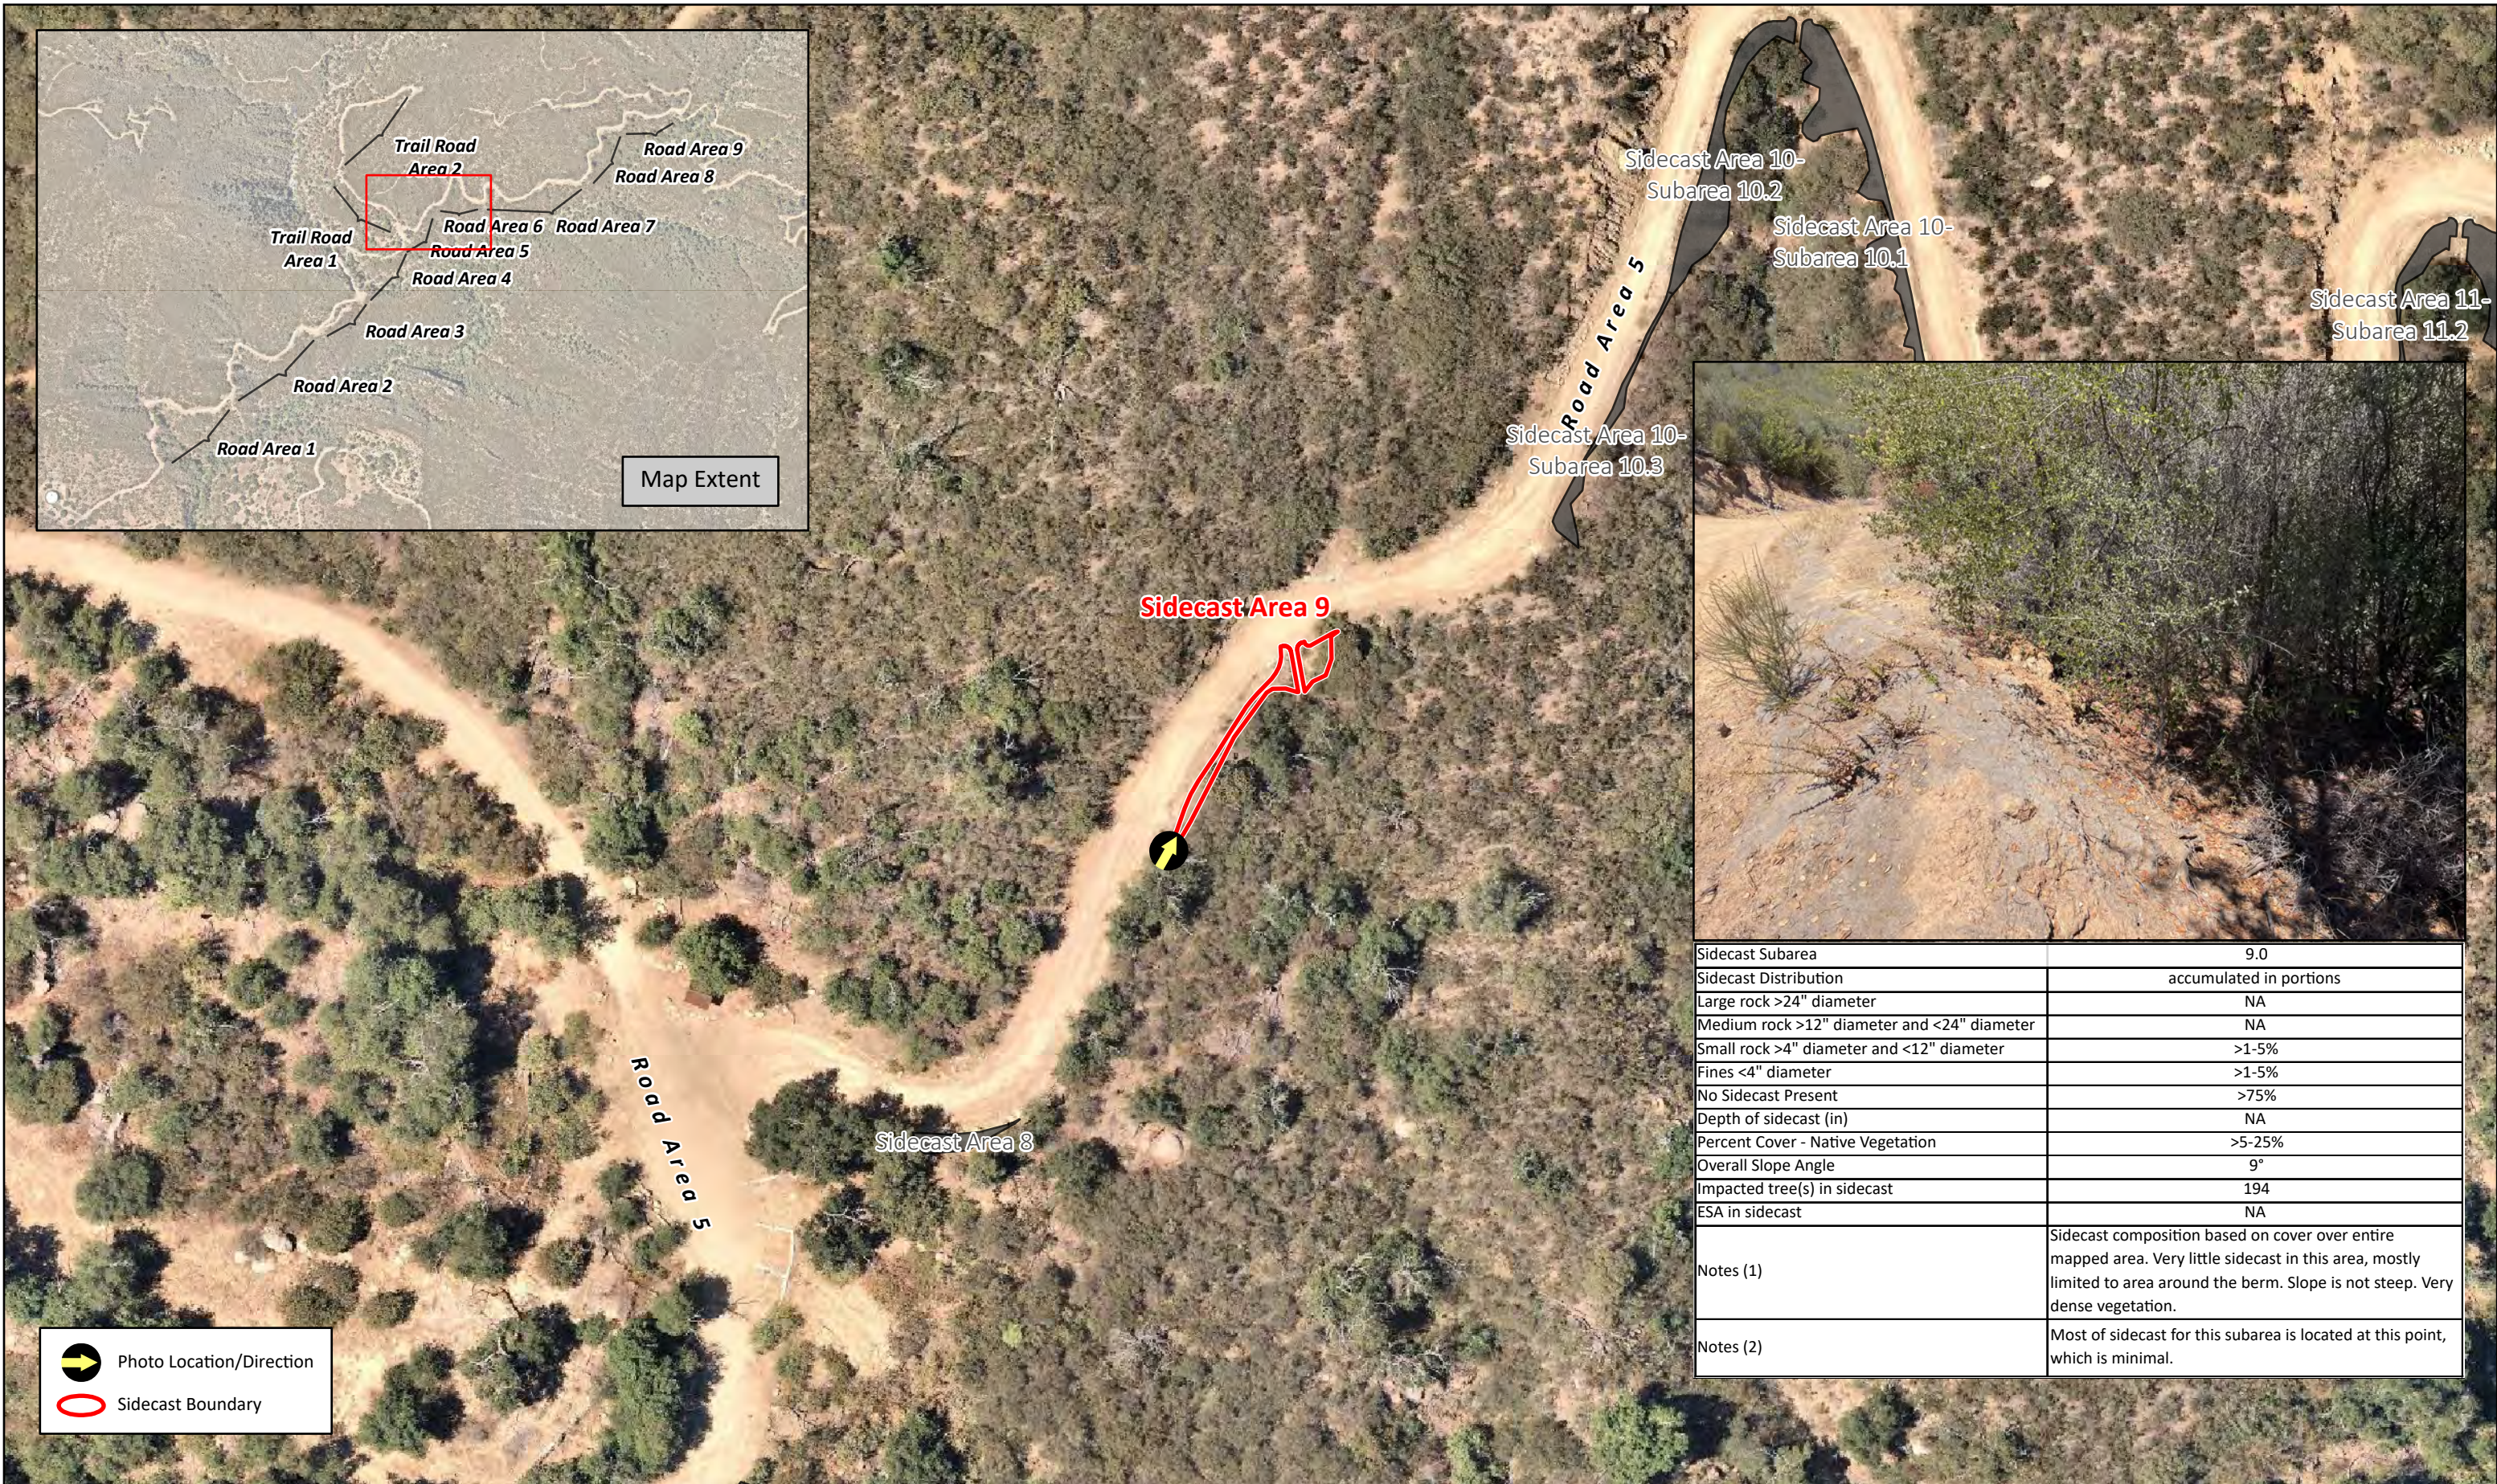
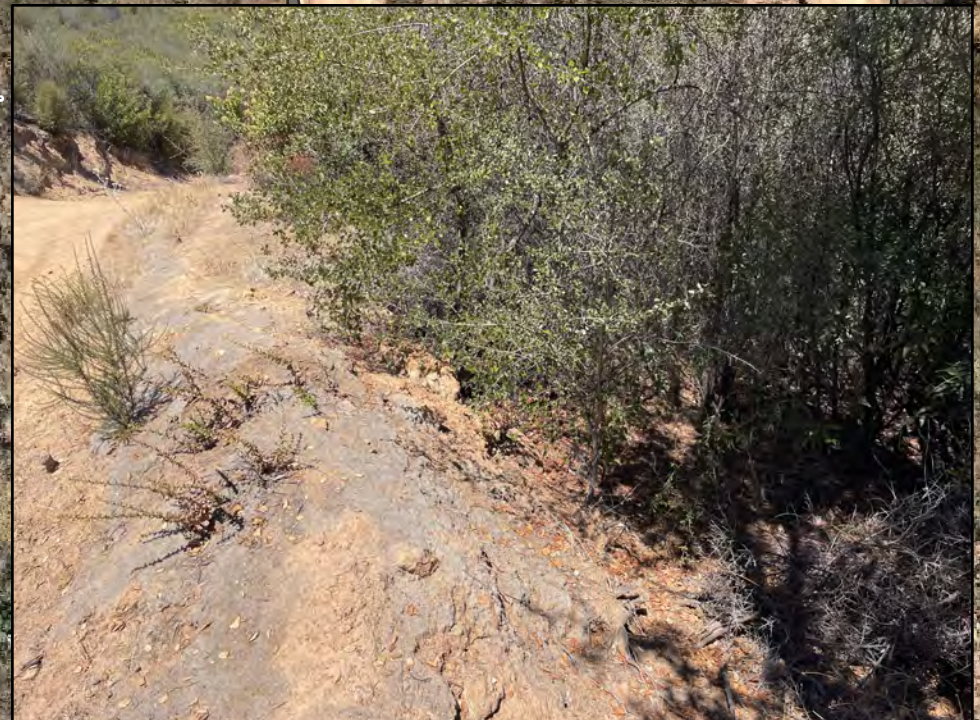
Sidecast Subarea	9.0
Sidecast Distribution	accumulated in portions
Large rock >24" diameter	NA
Medium rock >12" diameter and <24" diameter	NA
Small rock >4" diameter and <12" diameter	>1-5%
Fines <4" diameter	>1-5%
No Sidecast Present	>75%
Depth of sidecast (in)	NA
Percent Cover - Native Vegetation	>5-25%
Overall Slope Angle	9°
Impacted tree(s) in sidecast	194
ESA in sidecast	NA
Notes (1)	Sidecast composition based on cover over entire mapped area. Very little sidecast in this area, mostly limited to area around the berm. Slope is not steep. Very dense vegetation.
Notes (2)	Most of sidecast for this subarea is located at this point, which is minimal.

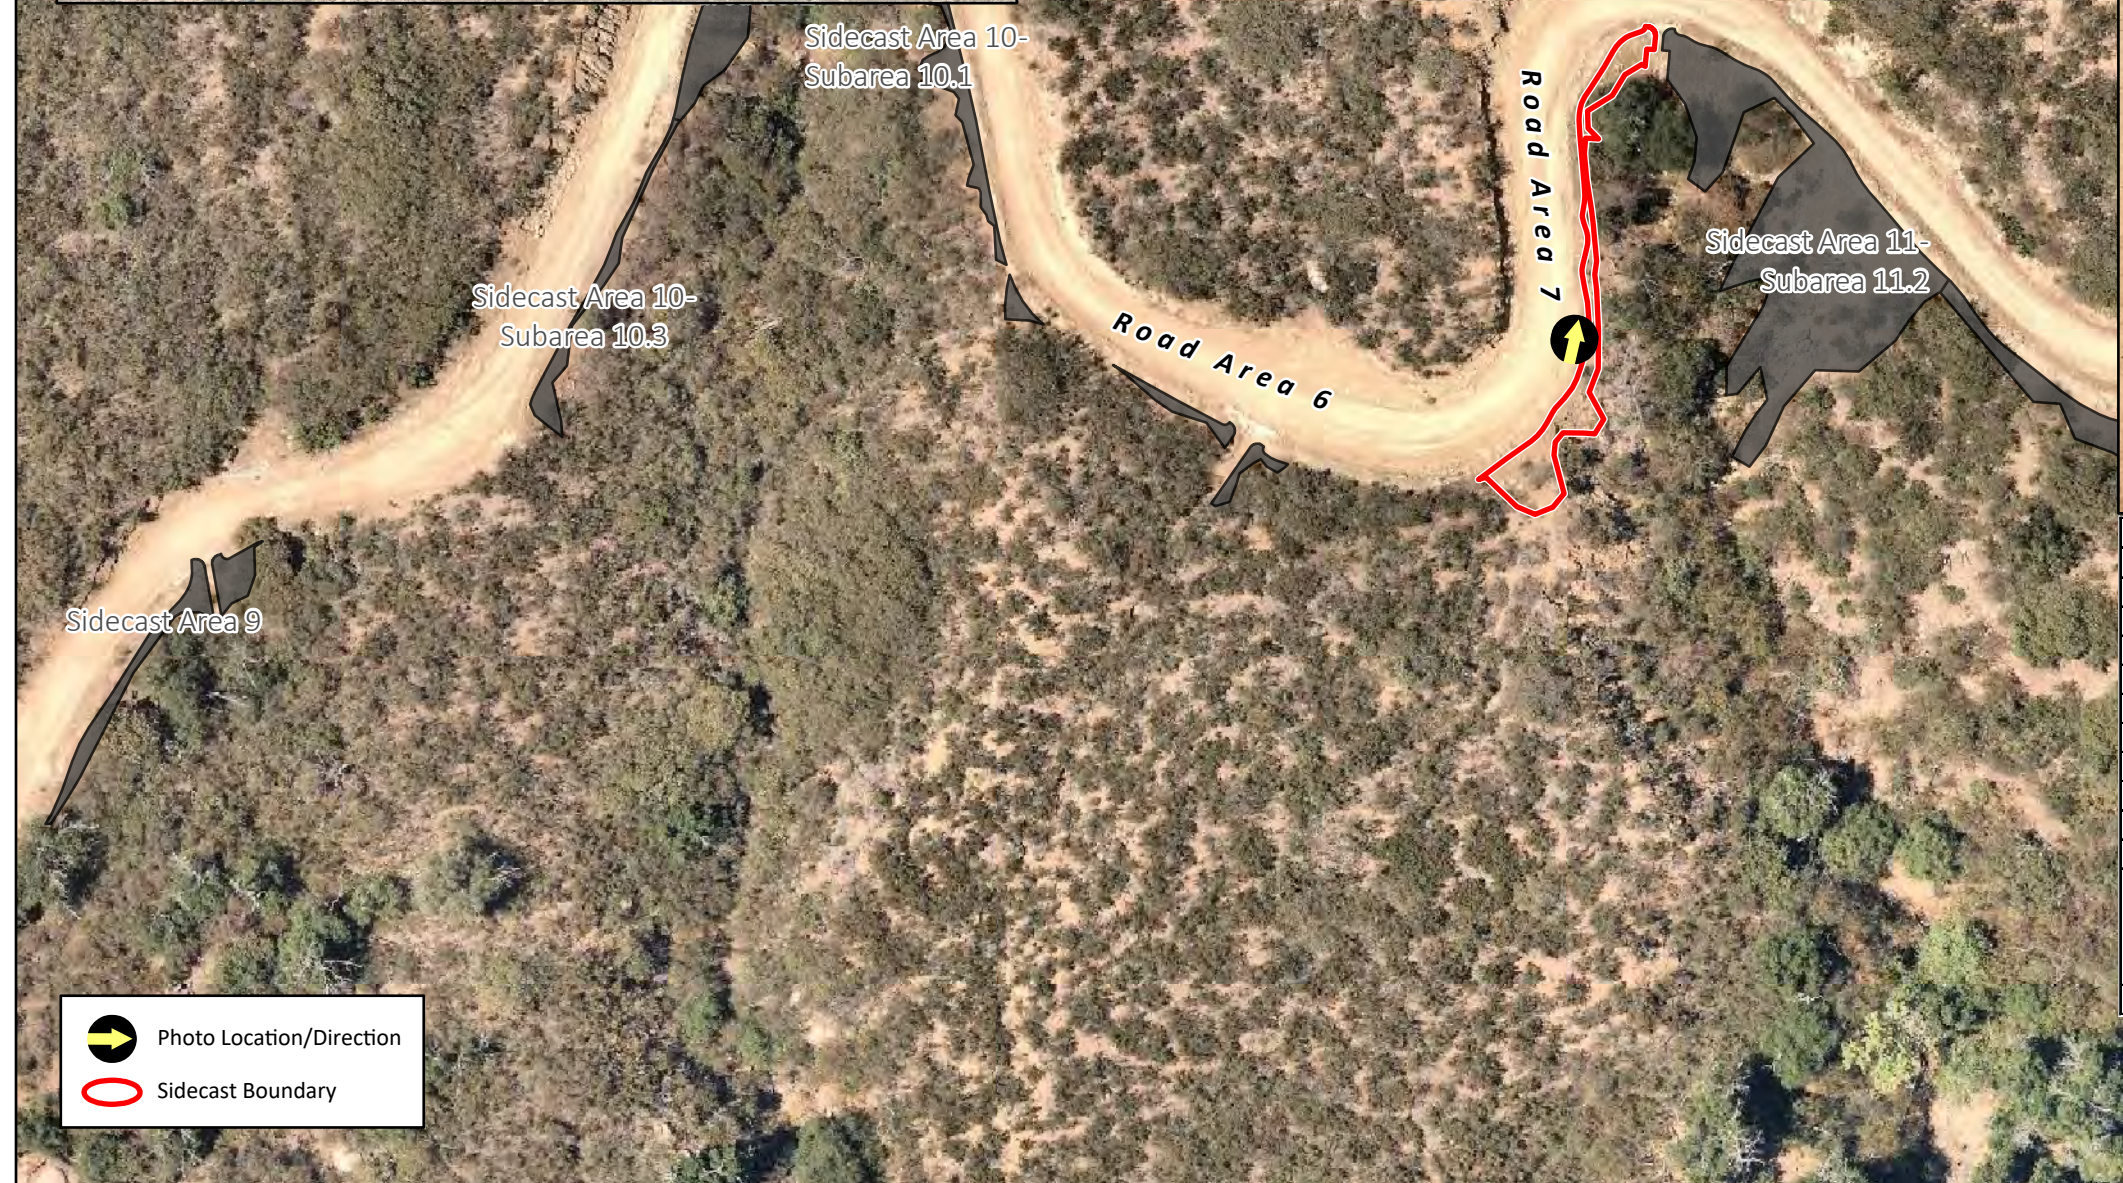
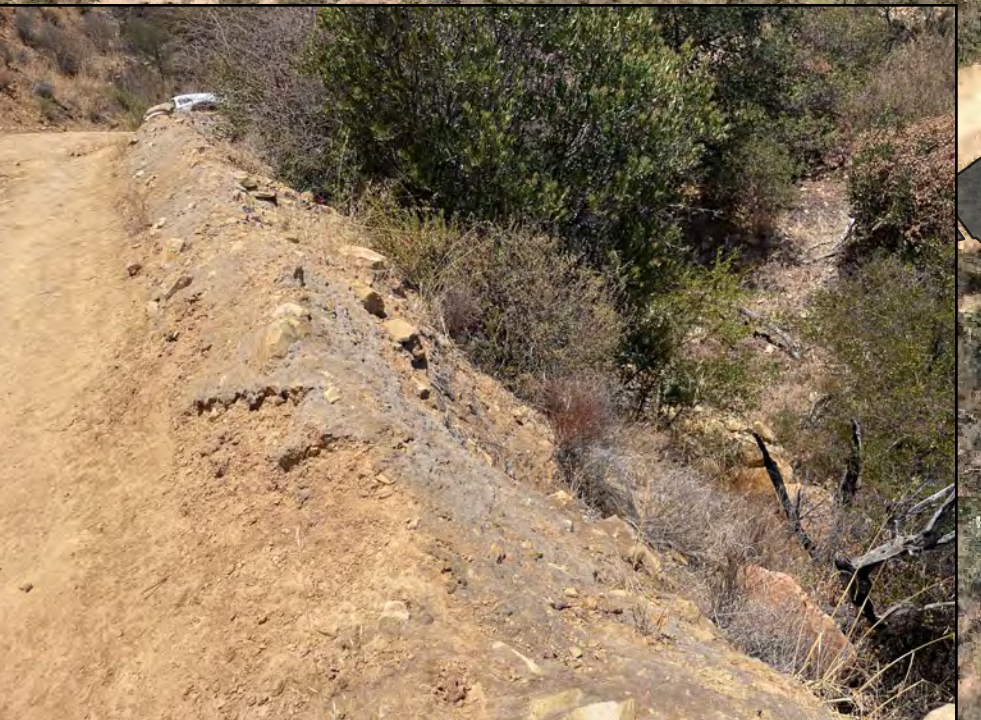
Sidecast Subarea	11.3
Sidecast Distribution	evenly distributed
Large rock >24" diameter	0-1%
Medium rock >12" diameter and <24" diameter	NA
Small rock >4" diameter and <12" diameter	>5-25%
Fines <4" diameter	NA
No Sidecast Present	>75%
Depth of sidecast (in)	NA
Percent Cover - Native Vegetation	>5-25%
Overall Slope Angle	35°
Impacted tree(s) in sidecast	NA
ESA in sidecast	NA
Notes (1)	Sidecast composition based on cover over entire mapped area. Mostly fines throughout, some accumulations at the base of shrubs.
Notes (2)	NA

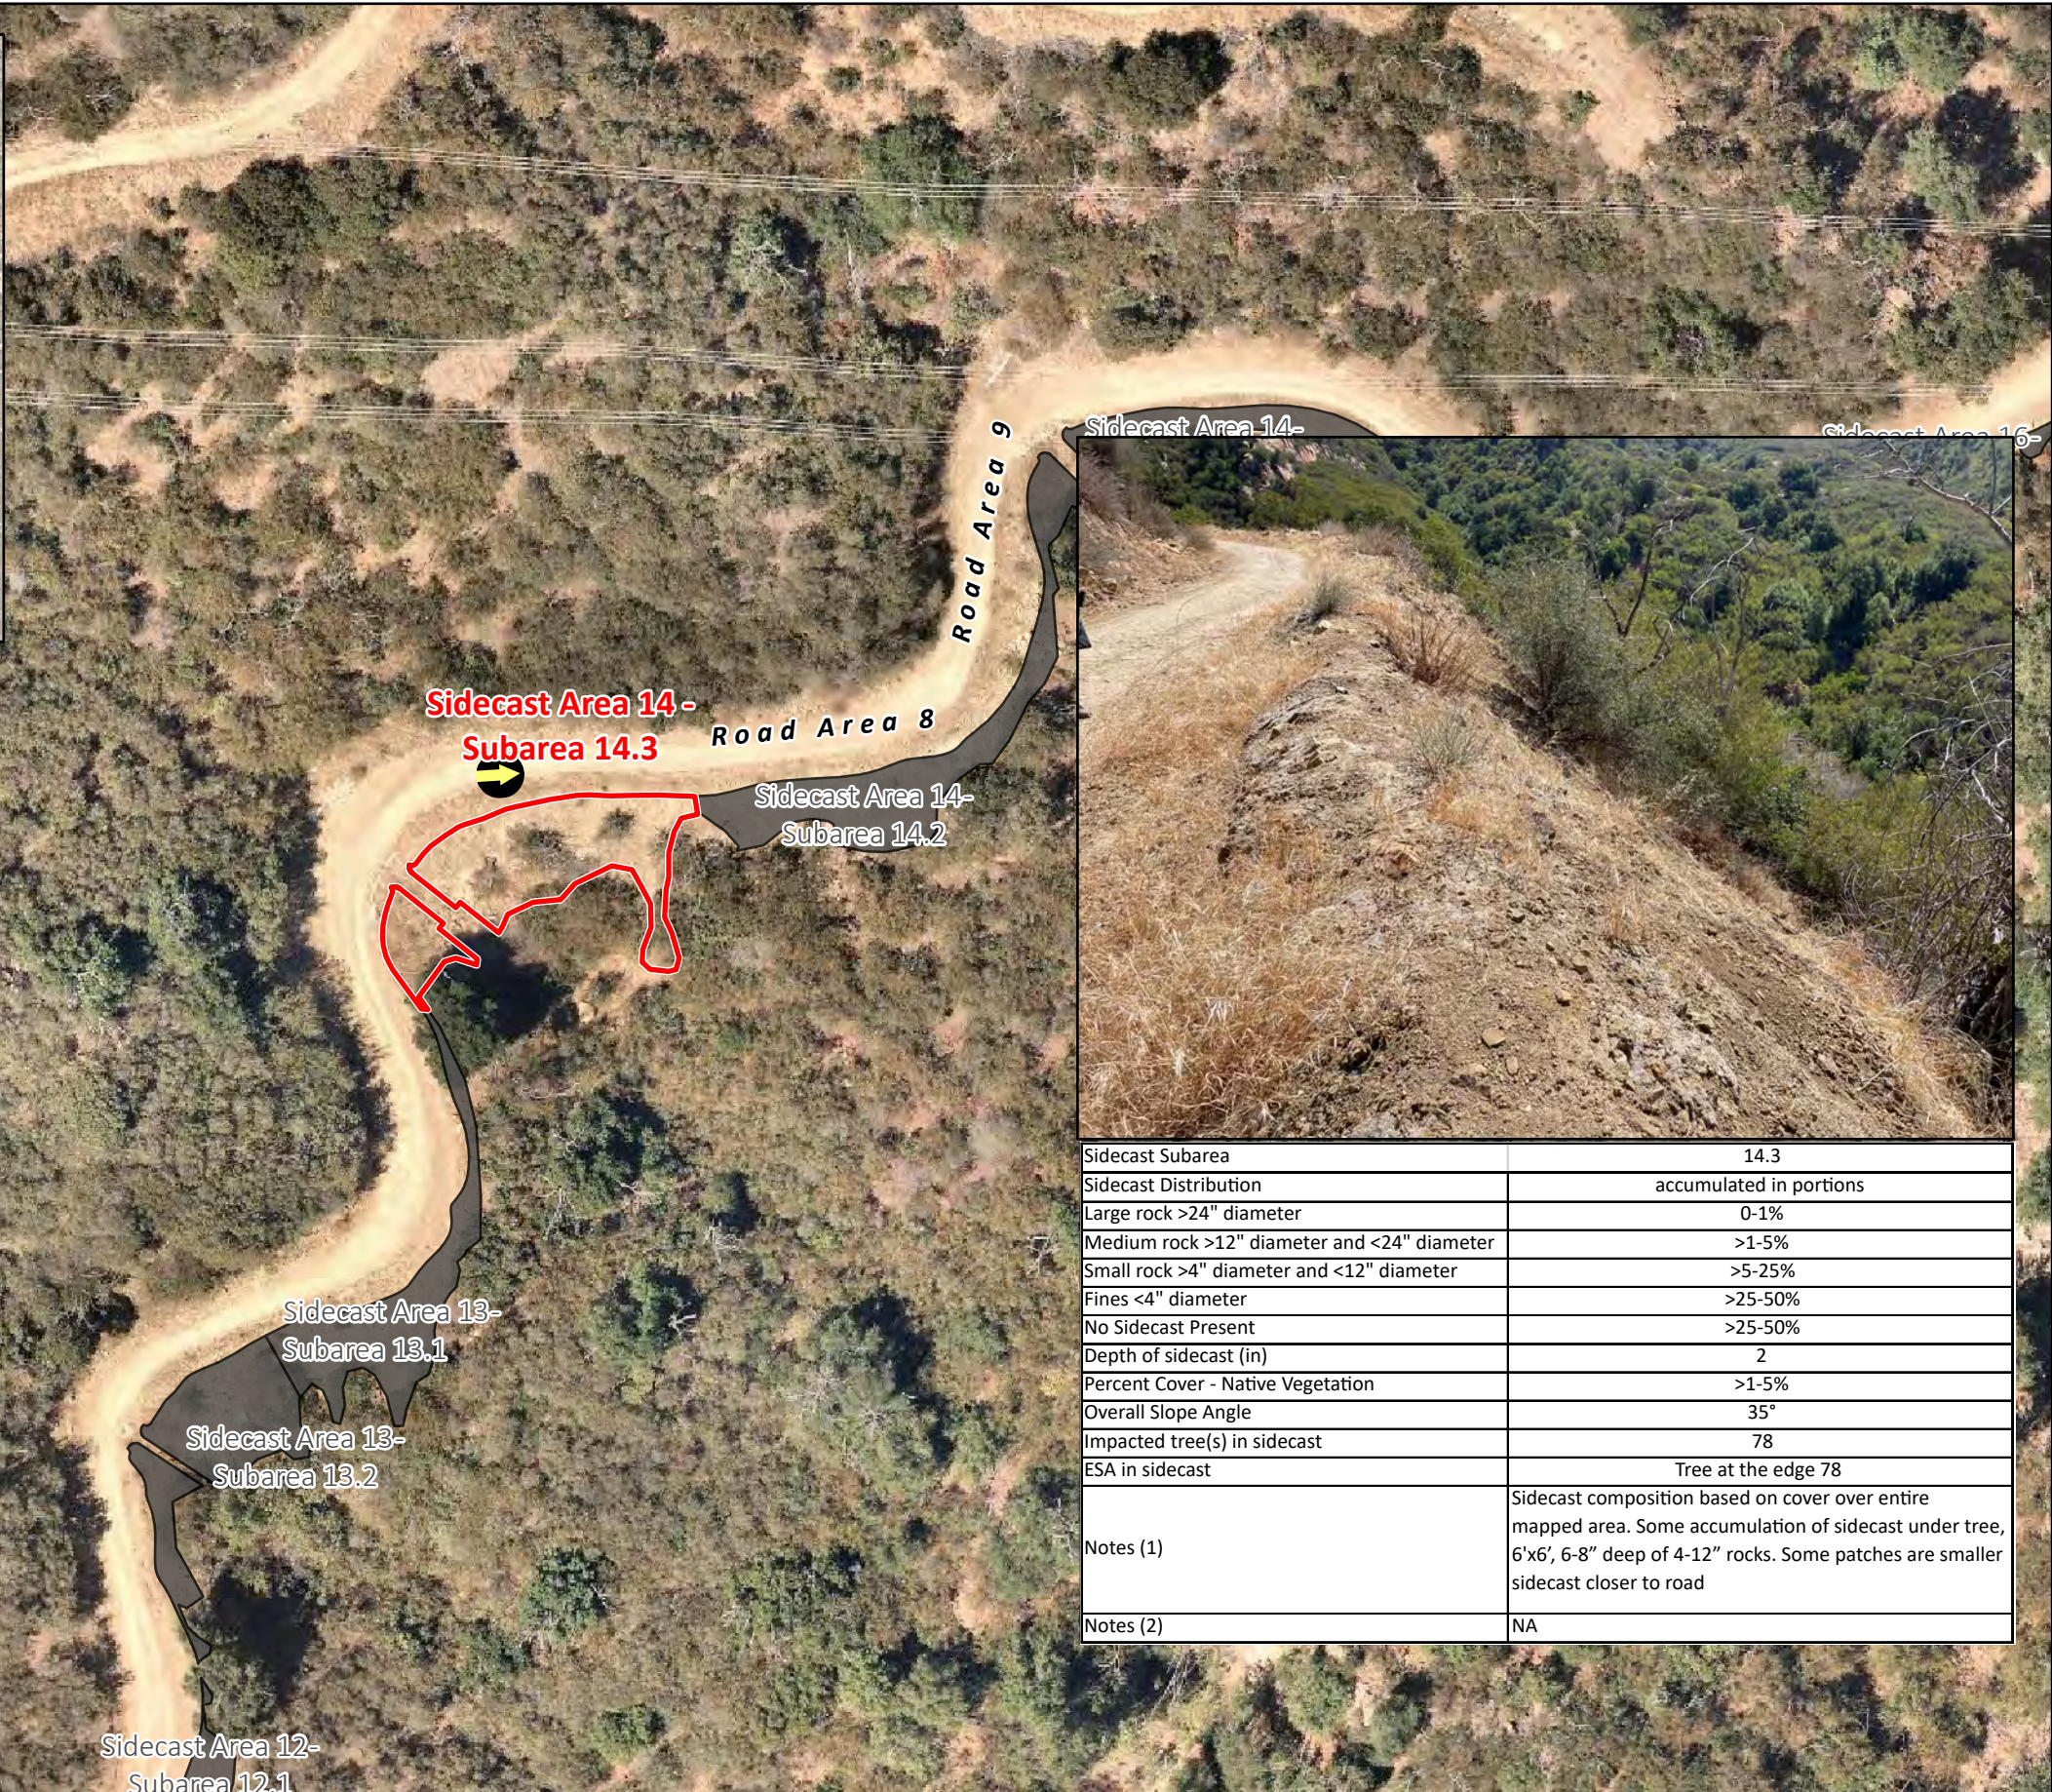
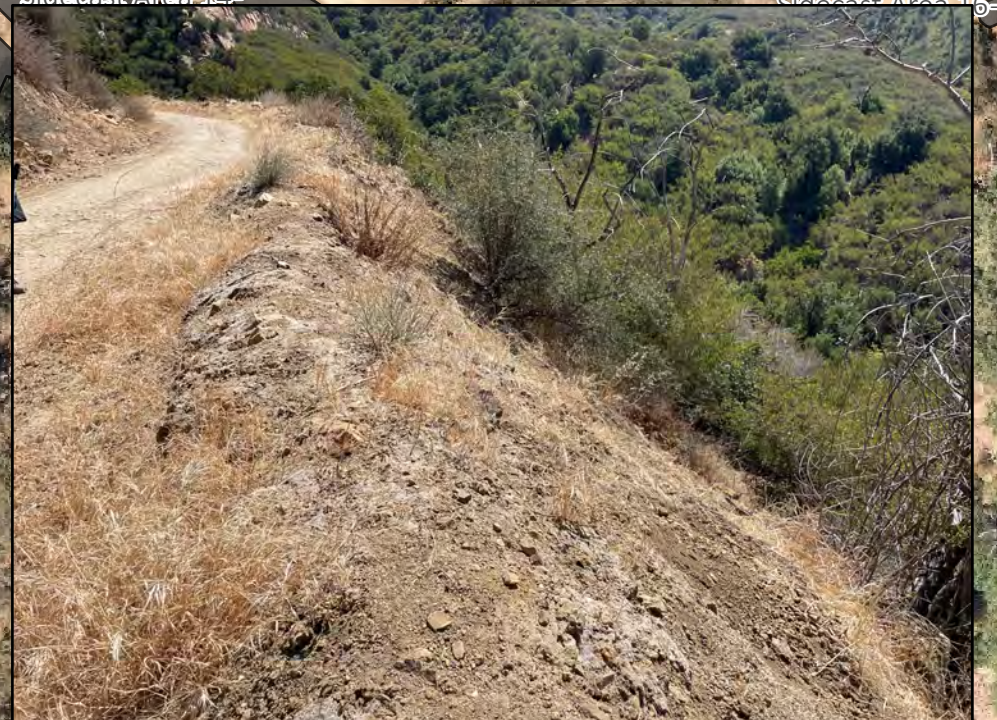
Sidecast Subarea	14.3
Sidecast Distribution	accumulated in portions
Large rock >24" diameter	0-1%
Medium rock >12" diameter and <24" diameter	>1-5%
Small rock >4" diameter and <12" diameter	>5-25%
Fines <4" diameter	>25-50%
No Sidecast Present	>25-50%
Depth of sidecast (in)	2
Percent Cover - Native Vegetation	>1-5%
Overall Slope Angle	35°
Impacted tree(s) in sidecast	78
ESA in sidecast	Tree at the edge 78
Notes (1)	Sidecast composition based on cover over entire mapped area. Some accumulation of sidecast under tree, 6'x6', 6-8" deep of 4-12" rocks. Some patches are smaller sidecast closer to road
Notes (2)	NA
