**Mission Canyon Stream Habitat Restoration Project
Initial Study/Mitigated Negative Declaration**

Mission Canyon Stream Restoration Project

Supplemental Site Surveys and Comparative
Scoping Analysis

October 2022

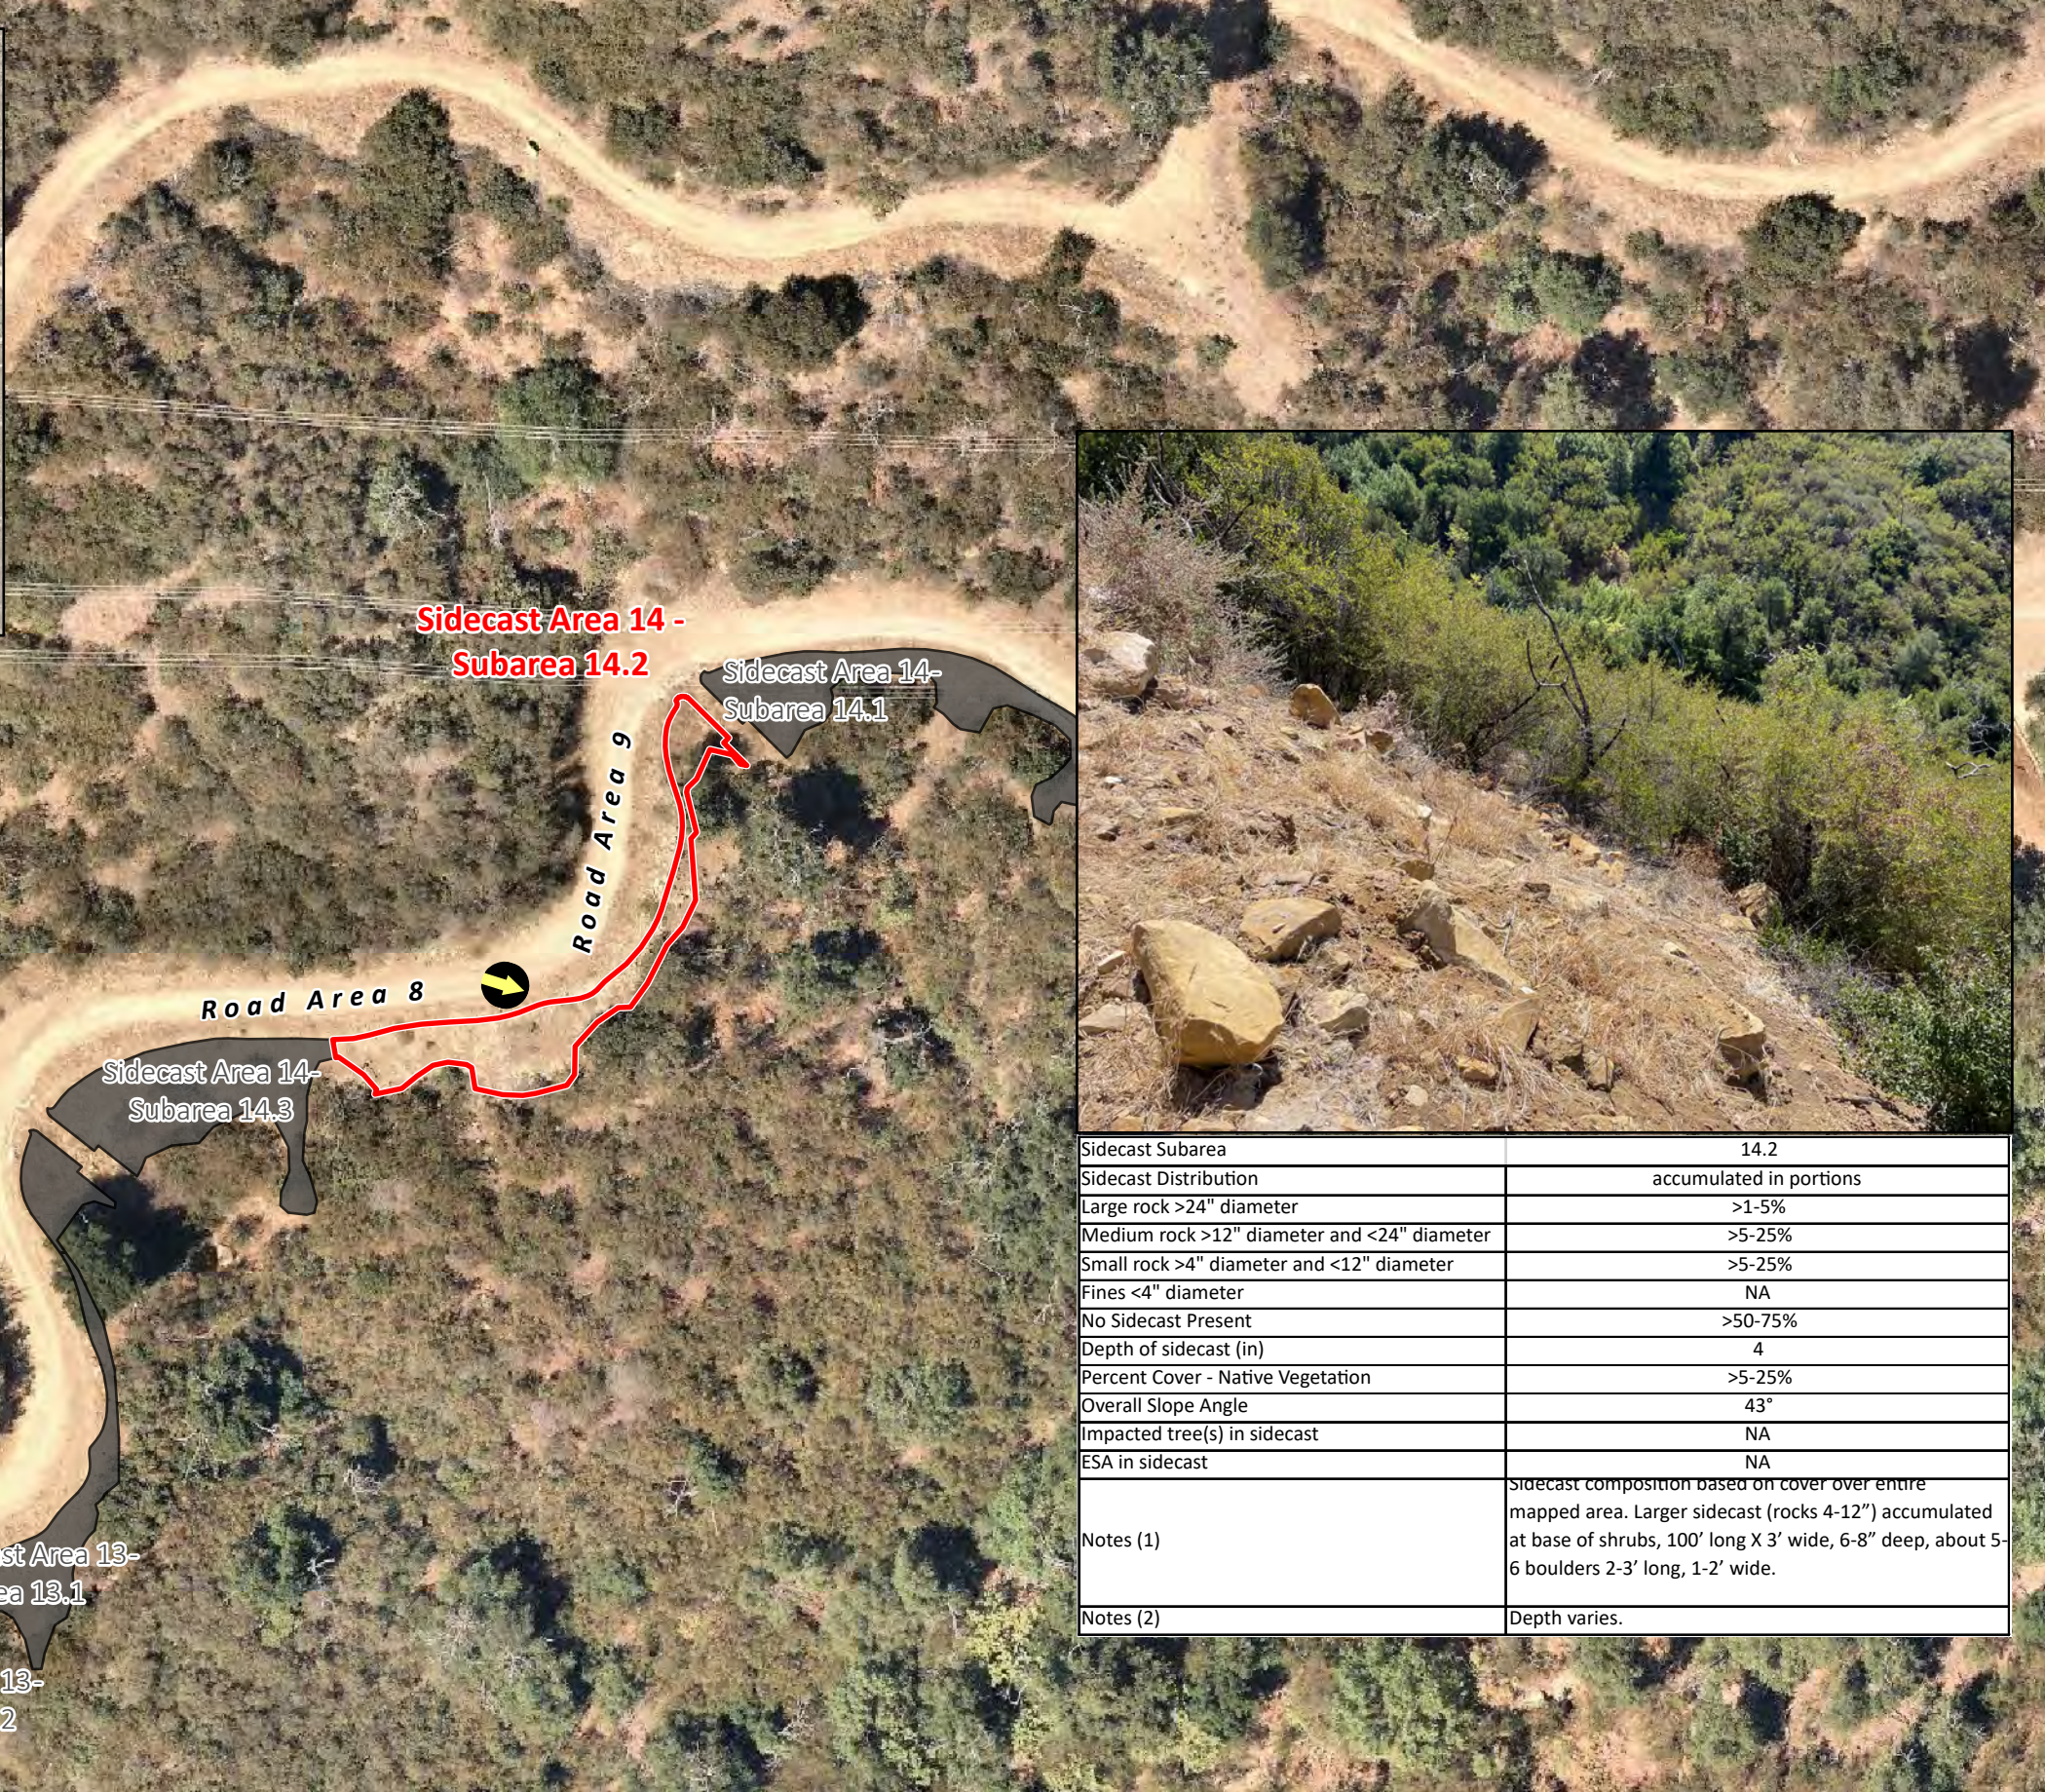
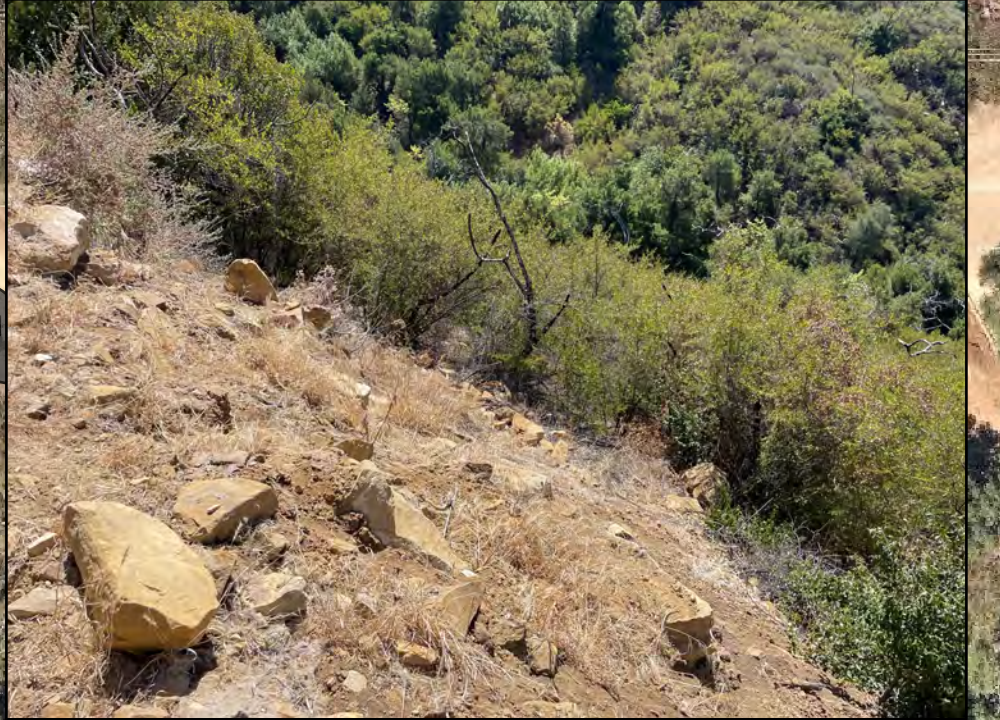
Sidecast Subarea	14.2
Sidecast Distribution	accumulated in portions
Large rock >24" diameter	>1-5%
Medium rock >12" diameter and <24" diameter	>5-25%
Small rock >4" diameter and <12" diameter	>5-25%
Fines <4" diameter	NA
No Sidecast Present	>50-75%
Depth of sidecast (in)	4
Percent Cover - Native Vegetation	>5-25%
Overall Slope Angle	43°
Impacted tree(s) in sidecast	NA
ESA in sidecast	NA
Notes (1)	Sidecast composition based on cover over entire mapped area. Larger sidecast (rocks 4-12") accumulated at base of shrubs, 100' long X 3' wide, 6-8" deep, about 5-6 boulders 2-3' long, 1-2' wide.
Notes (2)	Depth varies.

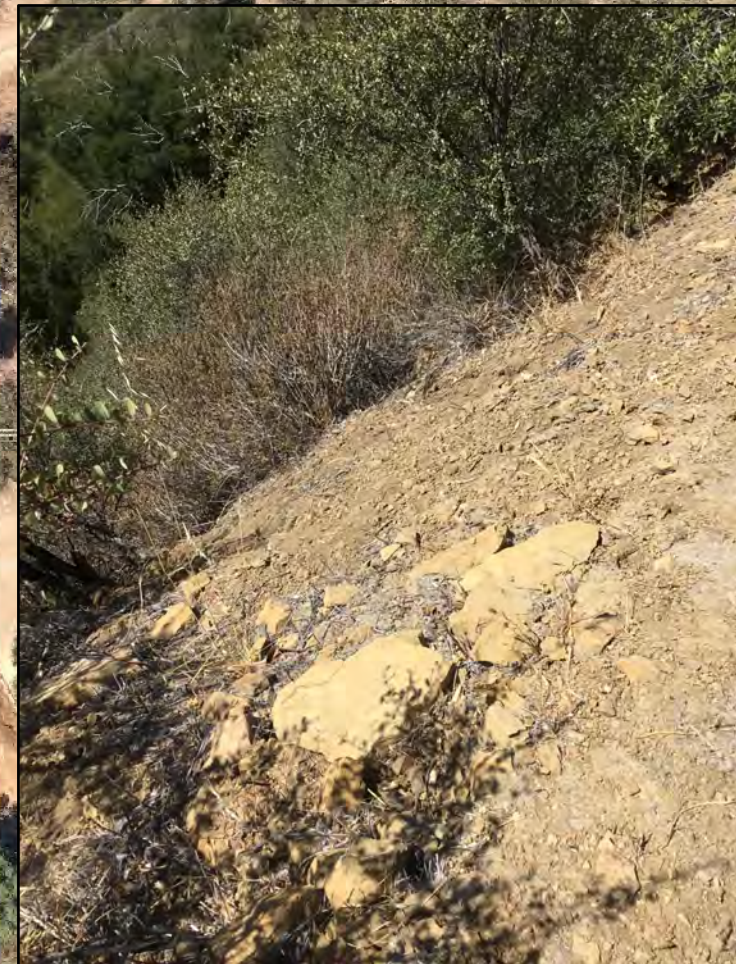
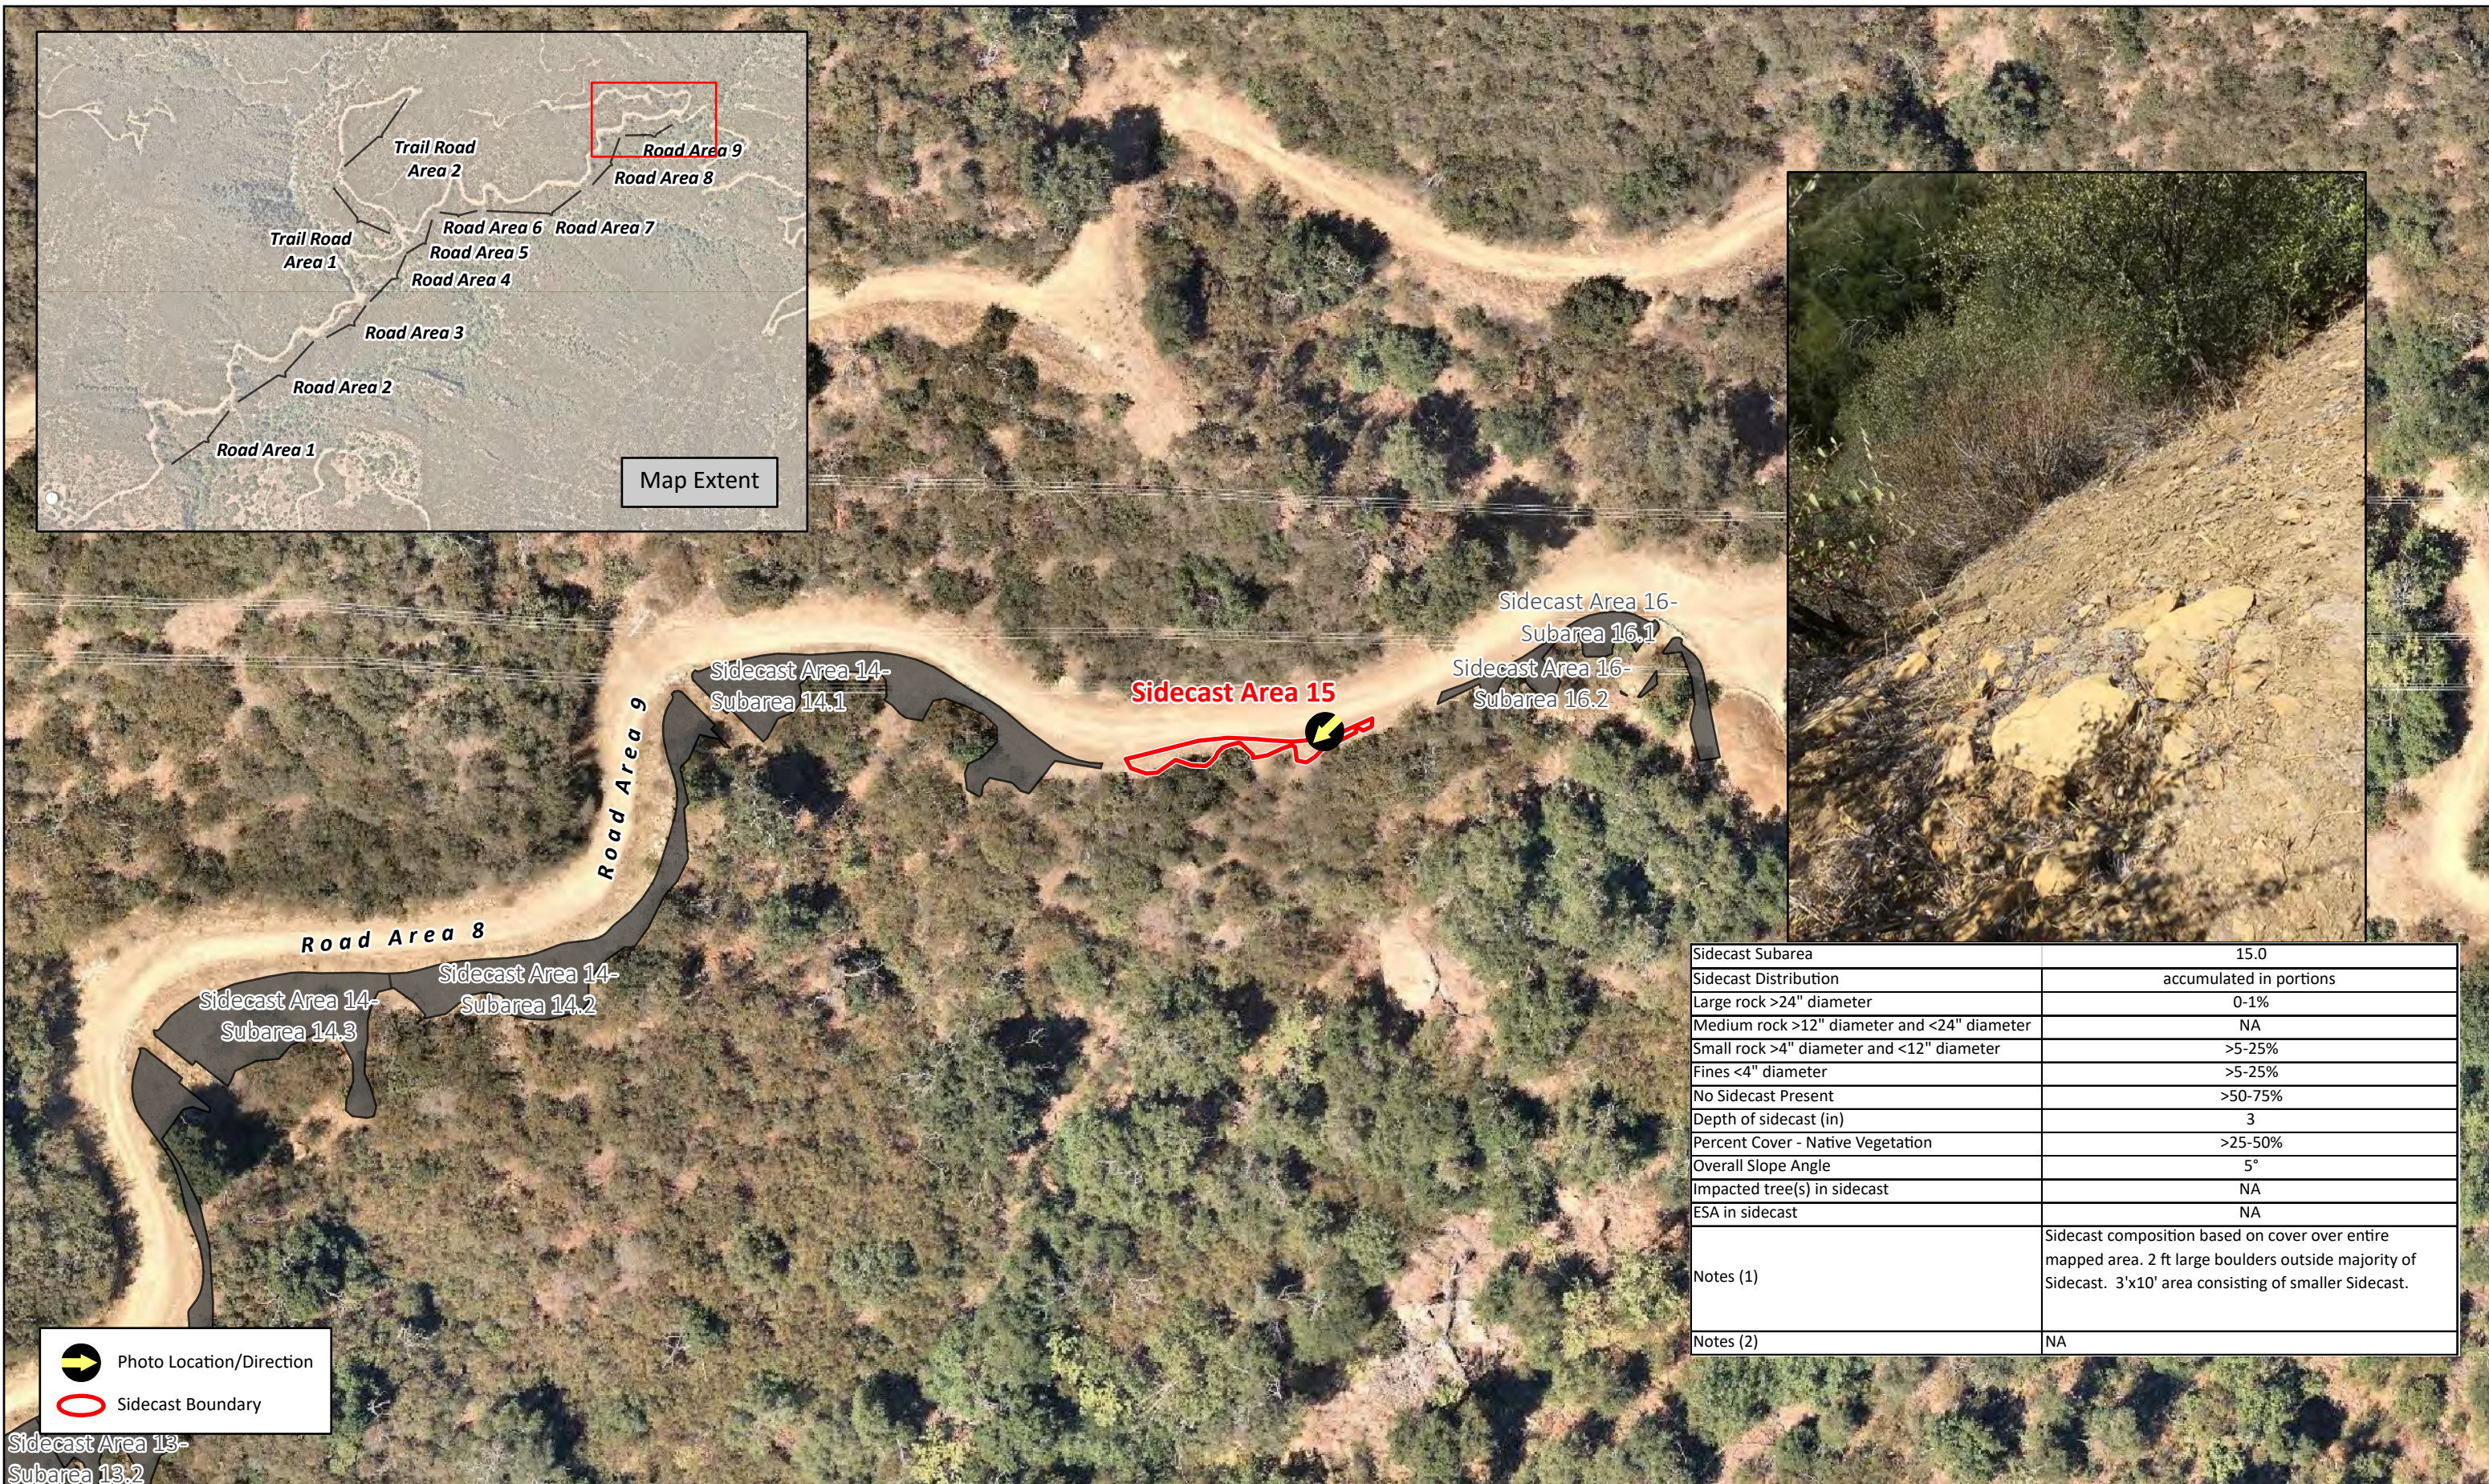
Sidecast Subarea	15.0
Sidecast Distribution	accumulated in portions
Large rock >24" diameter	0-1%
Medium rock >12" diameter and <24" diameter	NA
Small rock >4" diameter and <12" diameter	>5-25%
Fines <4" diameter	>5-25%
No Sidecast Present	>50-75%
Depth of sidecast (in)	3
Percent Cover - Native Vegetation	>25-50%
Overall Slope Angle	5°
Impacted tree(s) in sidecast	NA
ESA in sidecast	NA
Notes (1)	Sidecast composition based on cover over entire mapped area. 2 ft large boulders outside majority of Sidecast. 3'x10' area consisting of smaller Sidecast.
Notes (2)	NA
