The Nipomo Creek Watershed Program

Watershed Characterization Report

The Guadalupe-Nipomo Dunes
Restoration Subcommittee

The Land Conservancy of
San Luis Obispo County

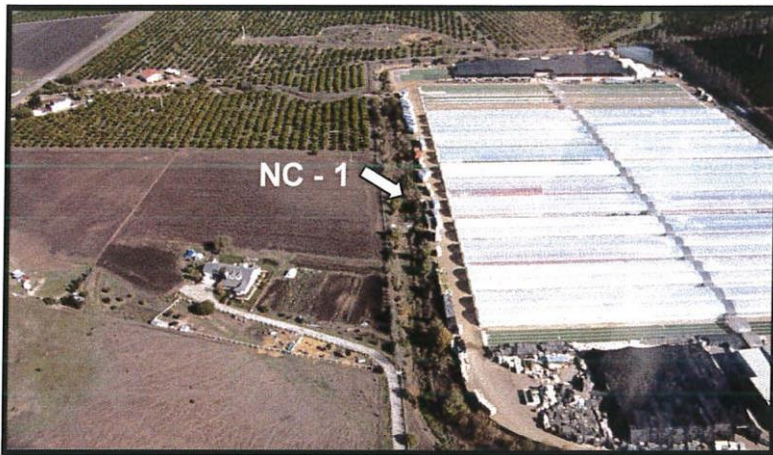
NC- 1: This reach is the uppermost section of the main stem. It begins in an area dominated by new, rural-estate subdivisions with lots ranging between 5 and 15 acres.

The topography is gently rolling. There is little to no riparian vegetation along this reach, with small willows representing what does exist. This reach primarily has the appearance of a swale. At the downstream terminus of this reach, the creek has been straightened in order to accommodate a large greenhouse complex. This

particular area is significantly degraded and features some rock fill.

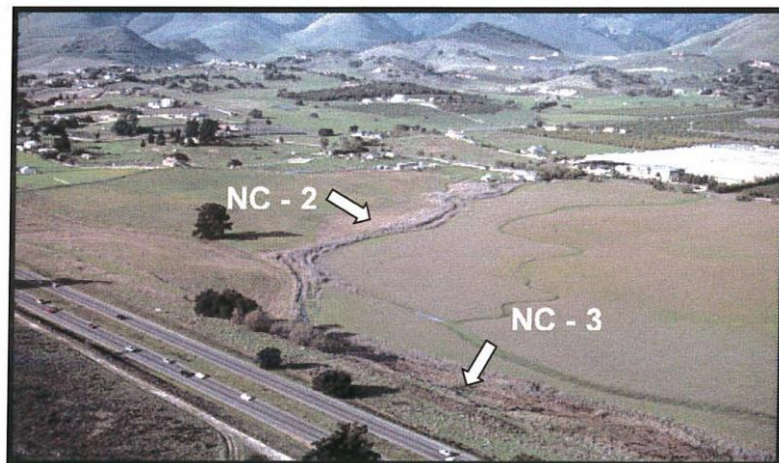
NC - 2 to NC-3:
These reaches are in the lowlands of Nipomo Valley, which are predominately in agricultural use. These reaches have little riparian vegetation and have the appearance of a minor swale. There are a few nice oaks and some smaller willows.

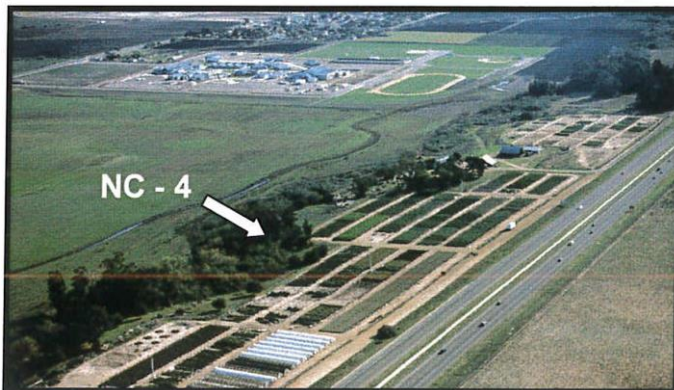
NC-4 to NC-5: These reaches contain healthy and abundant vegetation comprised of

a mature tree canopy and understory associates. Non-native invasive vegetation also exists. Stream channels are shallow with sloped banks at some points and are deep with steep, eroded banks at other points.

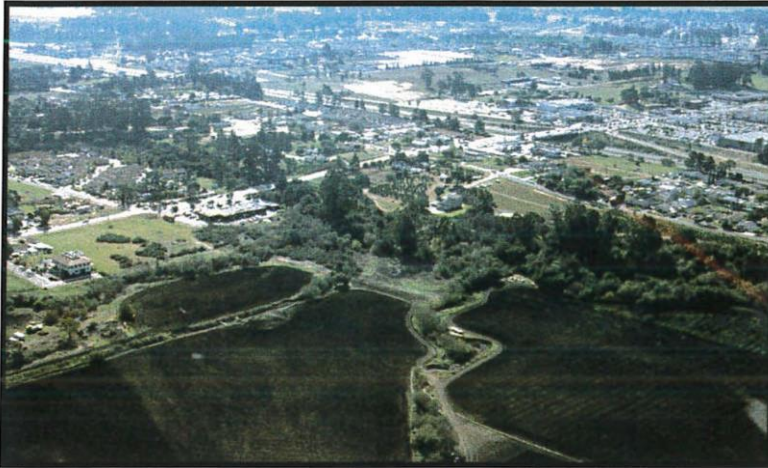
NC - 6: This reach continues with the mature tree canopy and understory associates.

Non-native invasive vegetation also exists. This reach is host to three important confluence areas immediately upstream of the Old Towne Nipomo area. Stream channels are shallow with sloped banks at some points and are deep with steep, eroded banks at other points. There are frequent debris dams present due to the proliferation of willows.

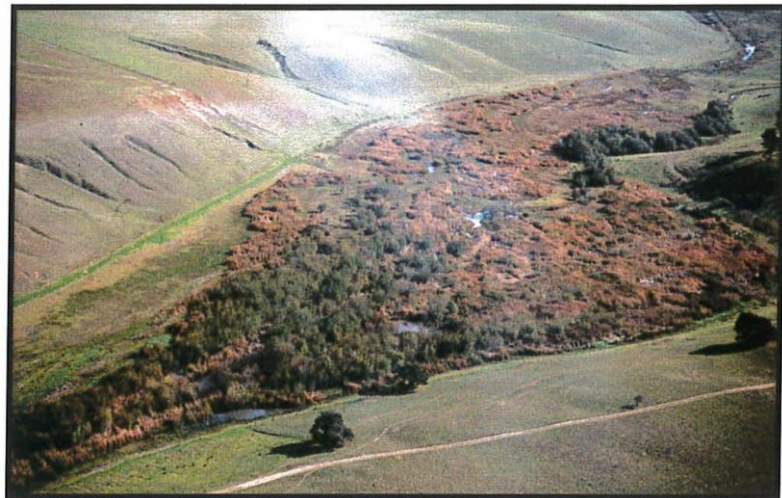
NC - 9 to NC - 11: In these reaches the creek widens out and flows into broad perennial wetlands and pools in several locations. These wetlands provide excellent wildlife habitat, but are threatened by sedimentation transfer from upstream locations. Outside of the wetlands areas, there is little riparian vegetation and the channels are often deeply incised.

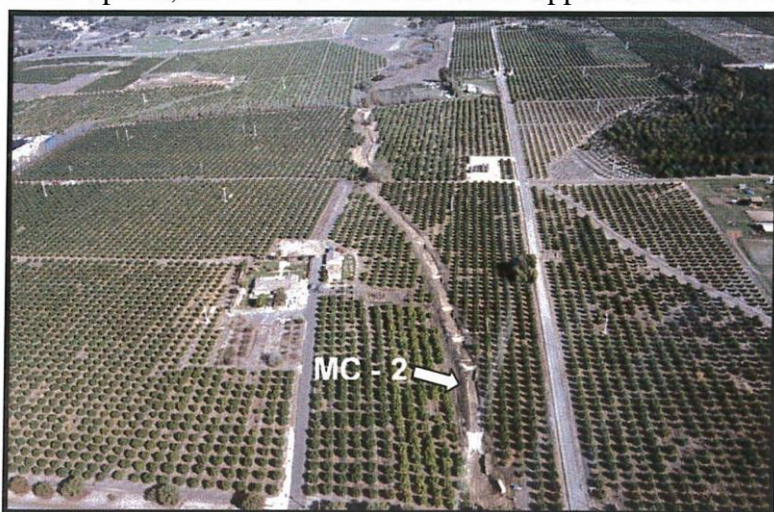
MC-2: This reach does not offer much in the way of native vegetation. There are some sparse, intermittent willows in the upper half of this reach. There is also a retention

pond that has been built into creek channel. At the lower half of this reach, the creek travels through orchards where there is no vegetation at all. Near the end of the reach at Thompson Road, there is a series of concrete steps which stretch across the entire stream channel. It appears that their purpose is for gradient control.

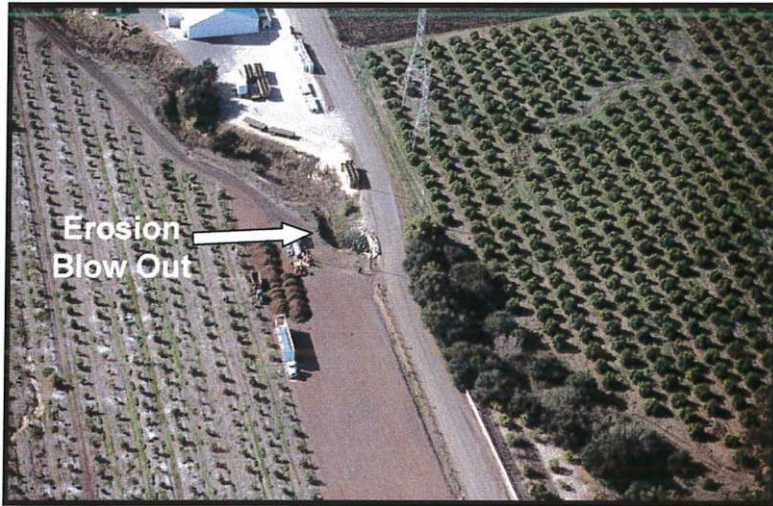
DLC-2: Near the beginning of this reach the creek passes underneath Mehlschau Road. Immediately at the downstream side of the bridge the creek is forced to make a ninety

degree turn. At this location there is a massive erosion problem with the left bank (when looking downstream) being approximately twenty feet high. The right hand bank is filled with rip-rap. There is no vegetation as the ground cover has been entirely graded for agricultural purposes. After this section, the creek continues through orchards where there is no

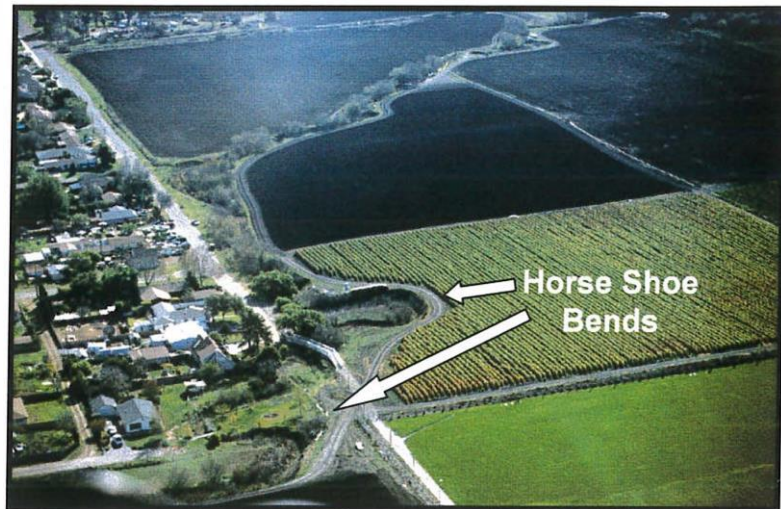
DLC-3: This reach is one of the more problematic in the entire watershed. Immediately after crossing under Thompson Road, the creek interfaces with residential development. Several inadequate flooding solutions have been tried here. The creek then continues for a short, undisturbed period where some intermittent riparian vegetation is present before it again passes by residential development. There is a sharp bend in the creek which is immediately followed by an even sharper bend that forms a horseshoe shape. This area appears to have been one of the causes of flooding damage

suffered by the aforementioned residences in March 2001. The creek continues to flow adjacent to these residences for a stretch before turning right towards the confluence with

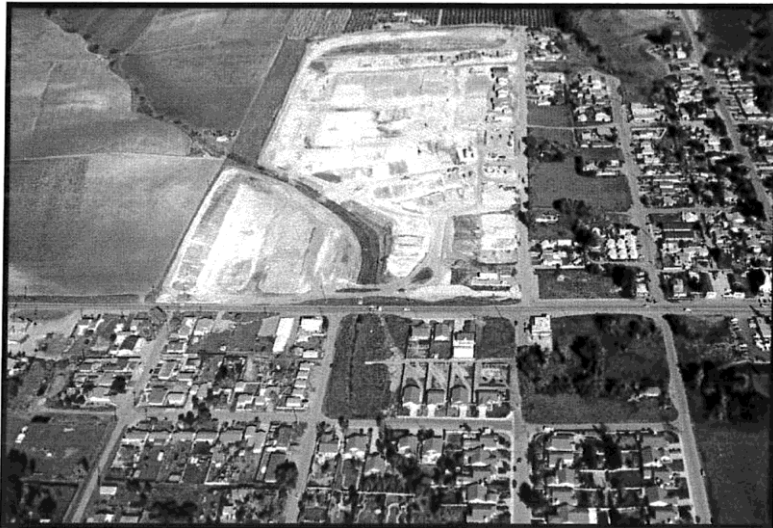
HMC - 1: This reach starts out either flowing through, or adjacent to, orchards and other agriculture. There is little or no vegetation in this area. After this, the creek flows through a graded agriculture field and features some intermittent vegetation. The channel is incised and often has steep, eroded banks. Following this, the creek travels through a new residential subdivision of approximately 100 homes. Currently, this project has not

started construction, but the building pads and roads have been graded. Where the creek flows through, the banks have been fenced off under an Army Corp permit condition to avoid sedimentation filling while construction is under way. The channel has been widened and the banks have been graded back. There is a drainage weir installed at the end of this section right before the

creek crosses under Thompson Road. Continuing downstream, the creek flows through an underground culvert beneath residential development for two city blocks. Upon seeing daylight, the final section of this reach offers little riparian vegetation until right at the confluence area with Nipomo Creek, where there is dense native and non-native vegetation and tree canopy cover. Debris dams tend to accumulate here due to the proliferation of willows in this area. The streambanks are severely eroded in several locations.

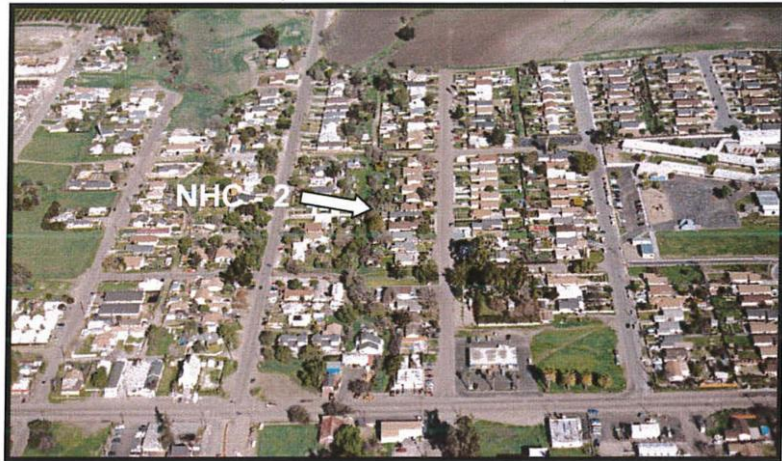
NHC-2: After the above described confluence zone, the vegetation and canopy coverage remains dense for a stretch before reaching more orchards where there is little or no vegetation. The streambanks and channels range from good condition to fair condition. Beyond this, the creek flows through residential and commercial development located in the Old Towne Nipomo area. In this stretch the vegetation is intermittent and dominated by non-natives. The banks are often eroded and the channel is incised. Many residents have attempted makeshift erosion and flood control efforts over the years in order to protect their properties. This reach should be considered a problem area.

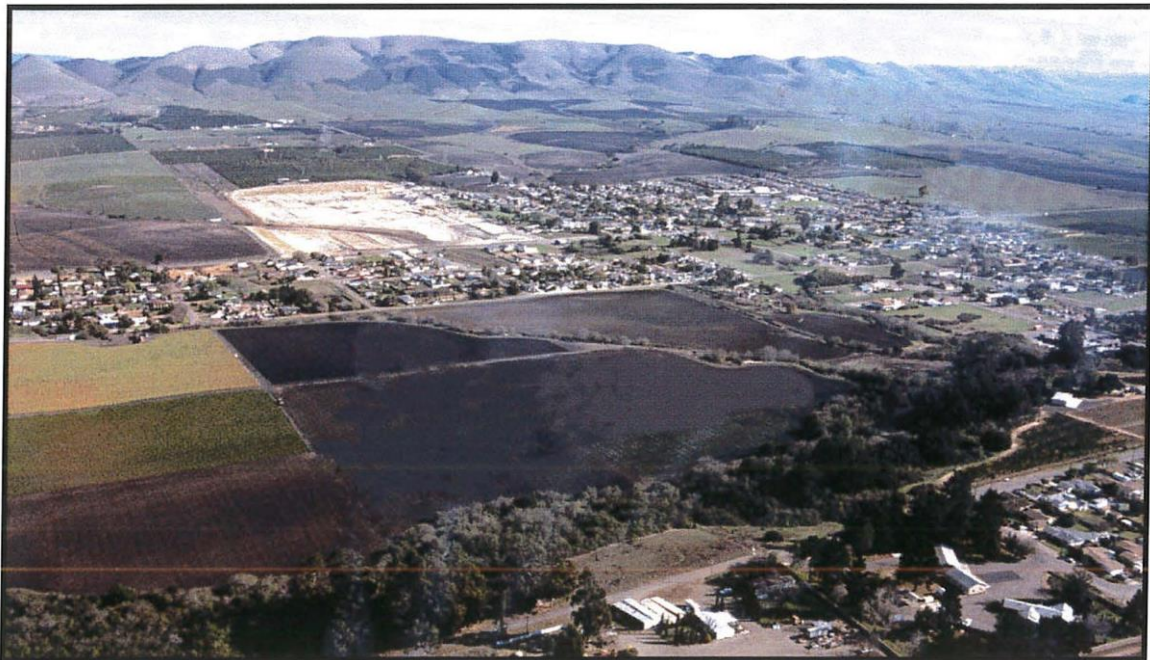
The first focus area is the group of tributaries that start in the foothills and run through the urban core of downtown Nipomo before they enter Nipomo Creek. Over the years these creeks have been impacted by the removal of native vegetation and the resulting loss of stream bank stability has contributed excessive sediment loads to the creek system. These creeks have also been artificially straightened in places and thus during the winter months are subject to high velocity flood events, such as the one that caused significant property damage around Old Towne Nipomo. In order to improve water quality and decrease the sediment loads carried in the creek system, it will be necessary to restore as many parts of the upper Nipomo Creek watershed as possible. More residential development is planned for this area and the increase in impermeable surfaces will also increase rapid surface runoff. Restoration work on these tributaries will increase the ability of upstream areas to hold and slow water during flood events, thus decreasing the damage done to downtown Nipomo.

This photo shows the tributaries that converge upstream from Old Towne Nipomo.

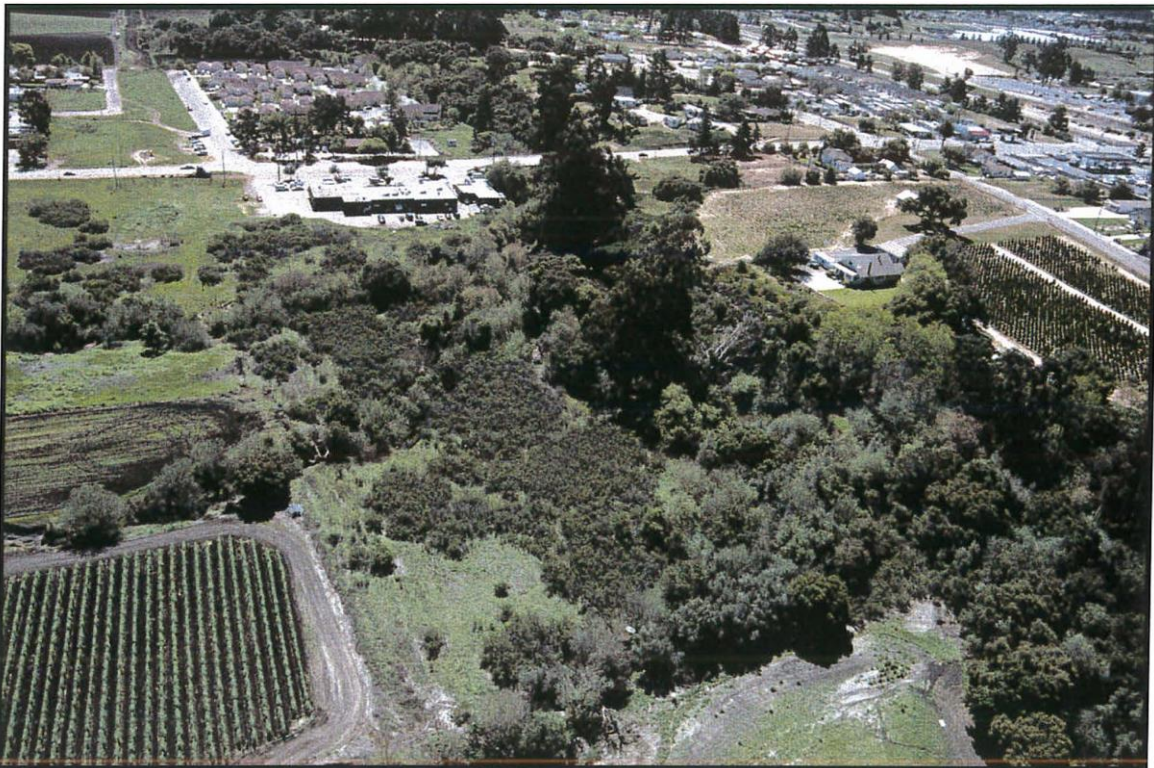
Nipomo Creek at Adobe Plaza

One property that has been identified for acquisition and restoration is a 2.5 acre site which acts as a major confluence area for Haystack Creek and the main stem. The property currently exhibits a mix of healthy riparian vegetation and exotic weeds and it has been observed to be a highly used site for wildlife, especially birds. As a future bonus, the property's proximity to downtown makes it a wonderful site for a public demonstration of riparian restoration.

Another important reason for protecting and restoring this area is the vulnerability of the Tefft Street bridge, which restoration efforts could help reduce. The County of San Luis Obispo Public Works Department has expressed concern that excessive sediment loading on the upstream side of the bridge could jeopardize its integrity in the event of a significant flood event. They estimate the replacement value of this bridge at \$1,200,000.

Adobe Plaza is the building in the upper, middle left of the photo.

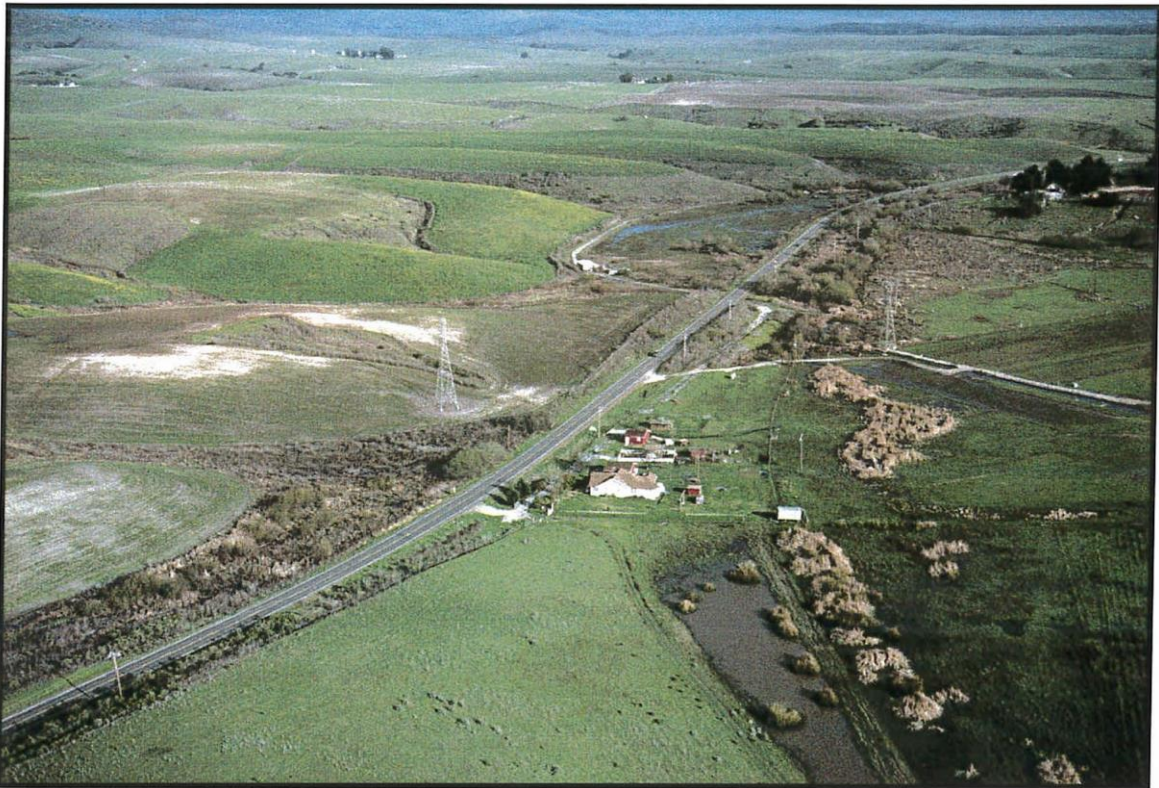
The creek and wetlands in this area are currently impacted by a variety of factors, including agricultural grading and cattle grazing, as well as increasing commercial and residential development. If protected, however, these wetland sites represent incredible restoration opportunities. The remedial restoration of these sites promises an explosion in biological productivity as habitat could be created for special status species like the California red-legged frog and the southwestern pond turtle.

Representative examples of the downstream wetlands.

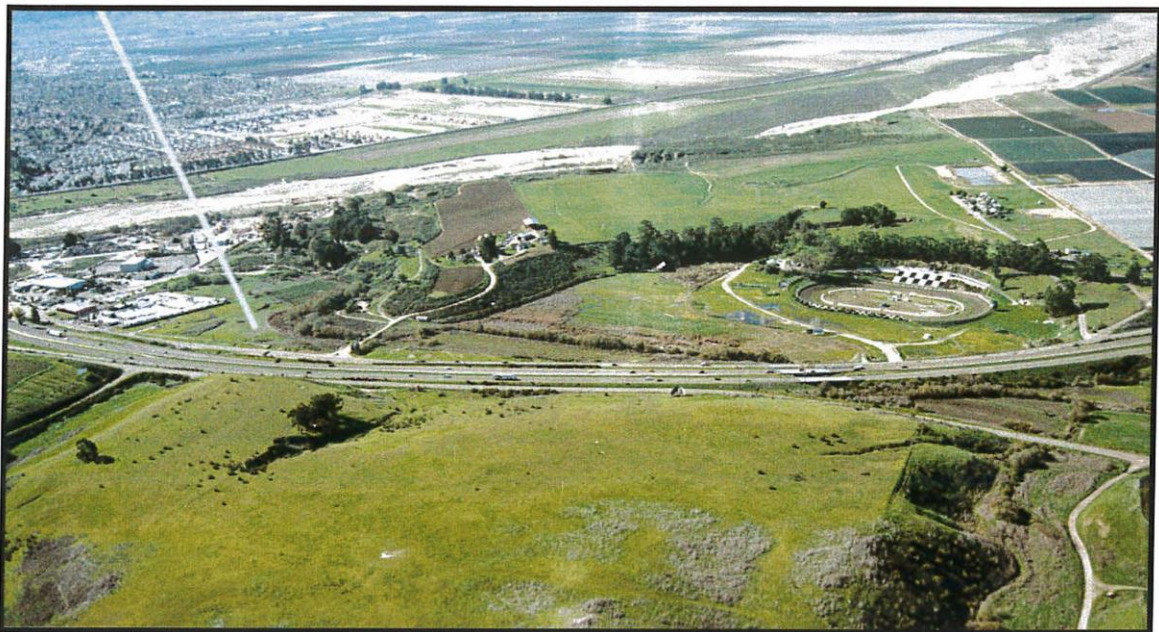
The fourth area that the Land Conservancy will be focusing on for protection is the wetlands complex along the last half mile of Nipomo Creek, near its confluence with the Santa Maria River. Because of its position at the mouth of the watershed, this portion of the creek and its perennial wetland complex represent possibly the most important restoration opportunity in the Nipomo Creek Watershed. The overall health and functionality of Nipomo Creek will depend upon the success of restoration efforts in this area. Currently two flood flow blockages exist in this area, one at the confluence of Nipomo Creek and the Santa Maria River, and the other less than a quarter mile upstream. Additionally, the mixed landownership and zoning pattern in this area are both a current and future threat to the viability of the creek and wetland ecosystem. Agricultural and industrial activities have improperly graded and filled outlying sections of the wetland. The possibility of expanded commercial and residential development in this area also threaten to add additional polluted runoff to the creek.

The final confluence area with the Santa Maria River. The industrial development is to the left and the racetrack is on the right.
