STREAM INVENTORY REPORT

Left Bank Tributary One to Alder Creek

A stream inventory was conducted on August 25, 2003 on Left Bank Tributary One. The survey began at the confluence with Alder Creek and extended upstream 4,964 feet.

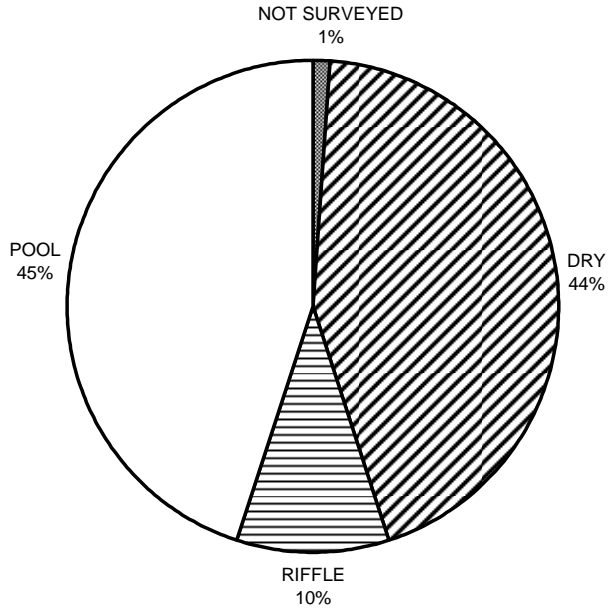
GRAPH 1

Table 1 summarizes the Level II riffle, flatwater, and pool habitat types. Based on frequency of occurrence there were 45% pool units, 10% riffle units, 0% flatwater units, with 44% dry (Graph 1). Based on total length of Level II habitat types there were 21% pool units, 14% riffle units, 0% flatwater units, with 65% dry (Graph 2).

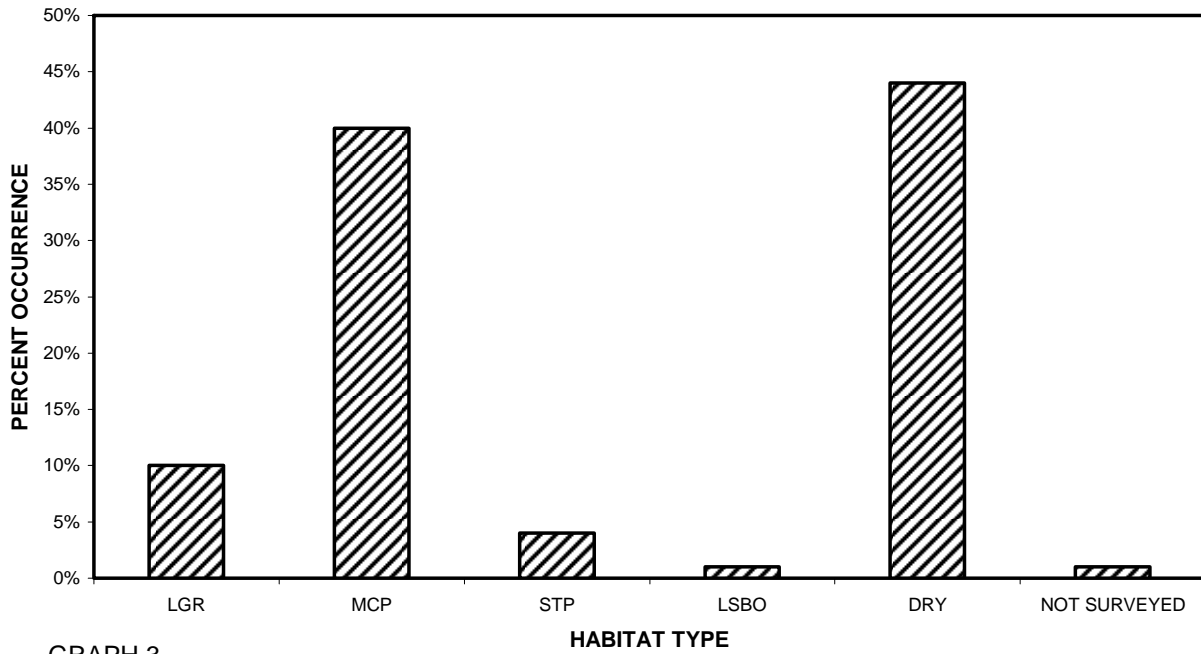
GRAPH 3

Six Level IV habitat types were identified (Table 2). The most frequent habitat types by percent occurrence were dry, 44%; mid-channel pools, 40%; and low-gradient riffles, 10% (Graph 3). Based on percent total length, dry made up 65%, mid-channel pools 15%, and low-gradient riffles 14%.

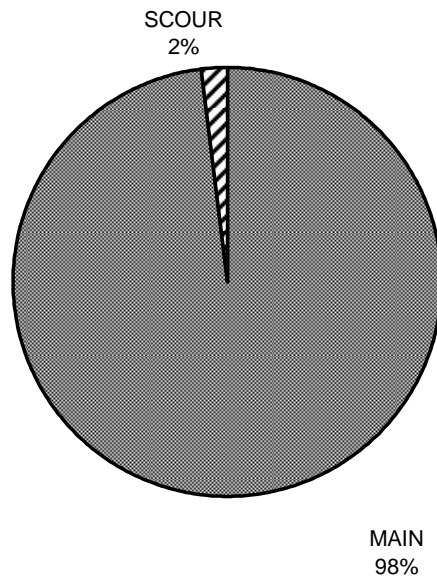
GRAPH 4

A total of 45 pools were identified (Table 3). Main-channel pools were the most frequently encountered, at 98%, and comprised 98% of the total length of all pools (Graph 4).

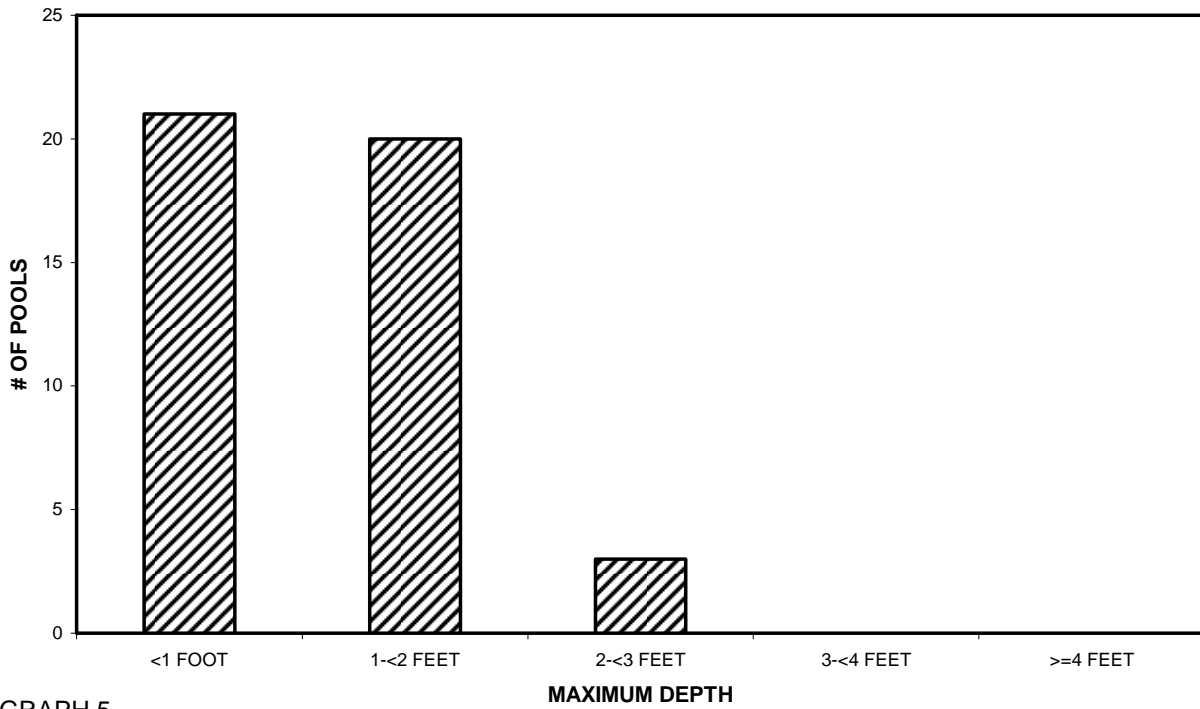
GRAPH 5

Table 4 is a summary of maximum pool depths by pool habitat types. Pool quality for salmonids increases with depth. Three of the 44 measured pools (7%) had a depth of two feet or greater (Graph 5).

Pool habitat types comprised 21% of the total length of this survey and riffles 14%. The pools are relatively shallow, with only 3 of the 44 (7%) measured pools having a maximum depth greater than 2 feet. In general, pool enhancement projects are considered when primary pools comprise less than 40% of the length of total stream habitat. In first and second order streams, a primary pool is defined to have a maximum depth of at least two feet, occupy at least half the width of the low flow channel, and be as long as the low flow channel width. Installing structures that will increase or deepen pool habitat is recommended for locations where their installation will not be threatened by high stream energy, or where their installation will not

- 3) Where feasible, design and engineer pool enhancement structures to increase the number of pools. This must be done where the banks are stable or in conjunction with stream bank armor to prevent erosion.

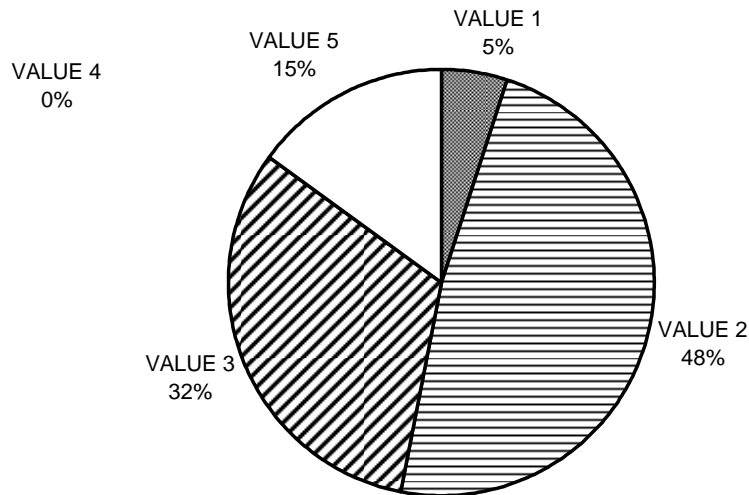
GRAPH 6

The depth of cobble embeddedness was estimated at pool tail-outs. Of the 44 pool tail-outs measured, 2 had a value of 1 (5%); 21 had a value of 2 (48%); 14 had a value of 3 (32%); 0 had a value of 4 (0%); and 7 had a value of 5 (16%) (Graph 6). On this scale, a value of 1 indicates the highest quality of spawning substrate.

Twenty-two of the 44 pool tail-outs measured had embeddedness ratings of 1 or 2. Fourteen of the pool tail-outs had embeddedness ratings of 3 or 4. Seven of the pool tail-outs had a rating of 5, which is considered unsuitable for spawning. Cobble embeddedness measured to be 25% or less, a rating of 1, is considered to indicate good quality spawning substrate for salmon and steelhead.

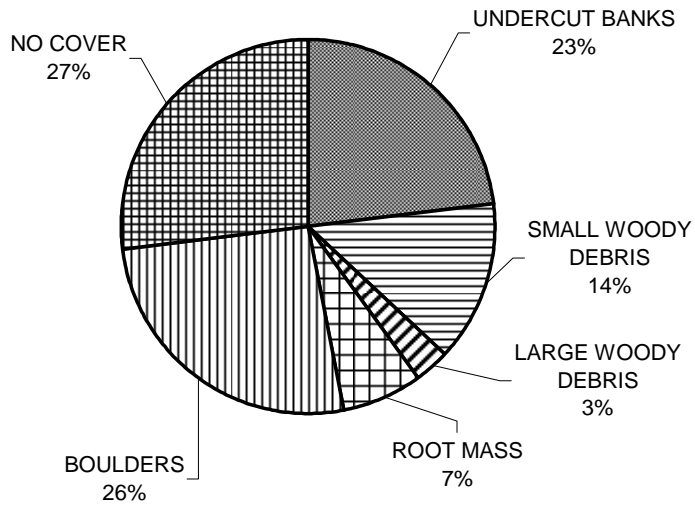
GRAPH 7

Table 5 summarizes mean percent cover by habitat type. Boulders are the dominant cover types in Left Bank Tributary One. Graph 7 describes the pool cover in Left Bank Tributary One. Boulders are the dominant pool cover types followed by undercut banks.

The mean shelter rating for pools was 22. A pool shelter rating of approximately 100 is desirable. The amount of cover that now exists is being provided primarily by boulders in all habitat types. Additionally, undercut banks contribute a small amount. Log and root wad cover structures in the pool and flatwater habitats would enhance both summer and winter salmonid habitat. Log cover structure provides rearing fry with protection from predation, rest from water velocity, and also divides territorial units to reduce density related competition.

- 4) Increase woody cover in the pools and flatwater habitat units. Most of the existing cover is from boulders. Adding high quality complexity with log and root wad cover is desirable.

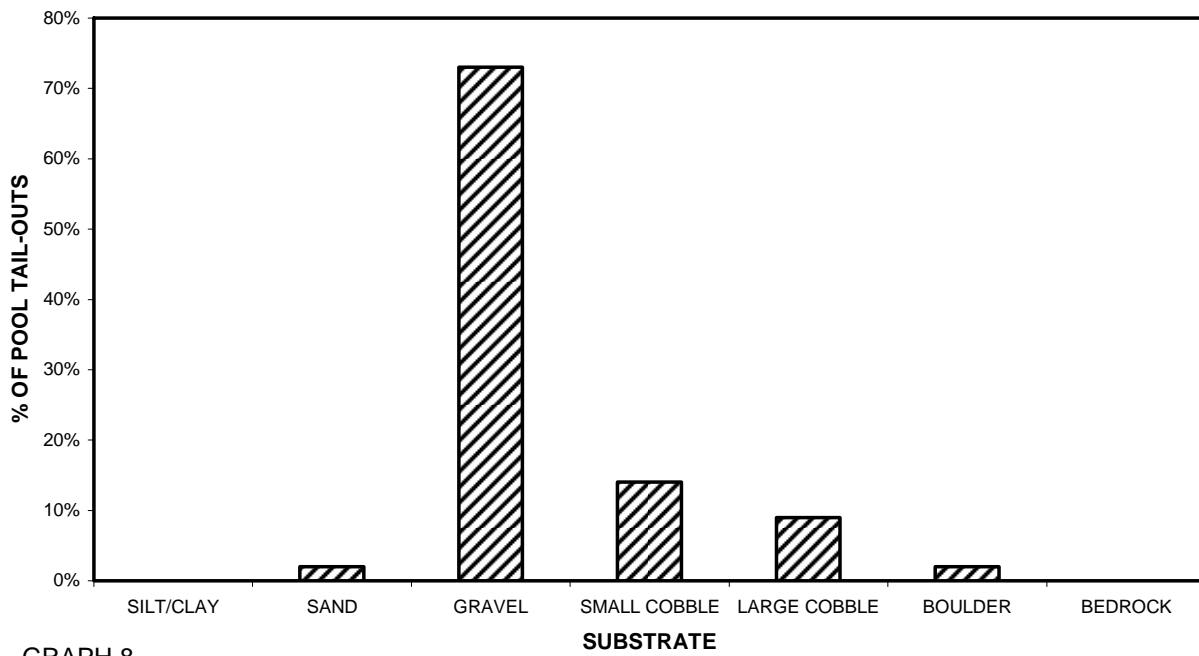
GRAPH 8

Table 6 summarizes the dominant substrate by habitat type. Graph 8 depicts the dominant substrate observed in pool tail-outs. Gravel was the dominant substrate observed in 73% of pool tail-outs while small cobble was the next most frequently observed substrate type, at 41%.

Thirty-eight of the 44 pool tail-outs measured had gravel or small cobble as the dominant substrate. This is generally considered good for spawning salmonids.

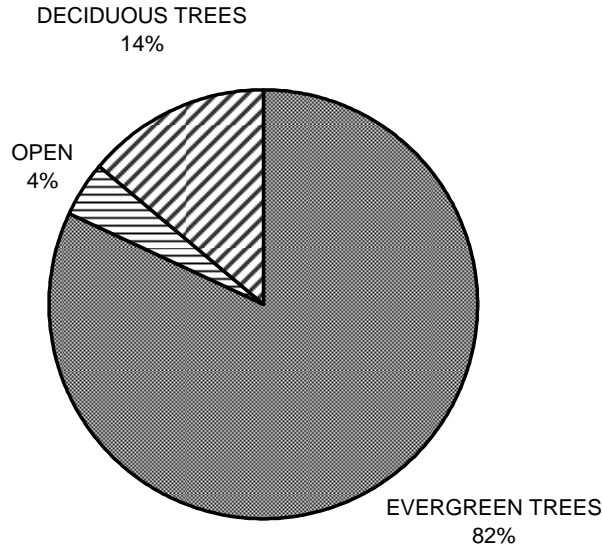
GRAPH 9

The mean percent canopy density for the surveyed length of Left Bank Tributary One was 96%. The mean percentages of evergreen and deciduous trees were 82% and 14%, respectively with 4% of the canopy open. Graph 9 describes the mean percent canopy in Left Bank Tributary One.

The mean percent canopy density for the stream was 96%. Reach 1 had a canopy density of 89% while Reach 2 had a canopy density of 97%.

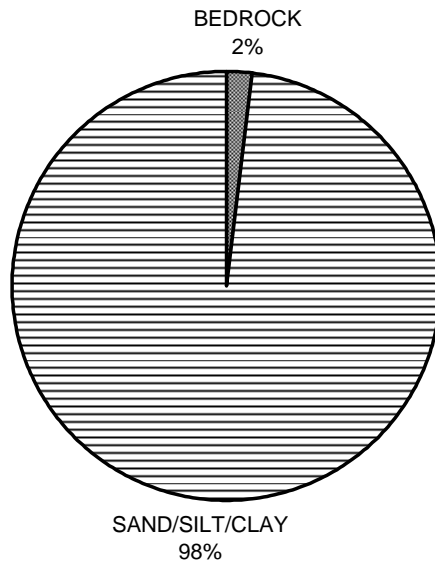
GRAPH 10

For the stream reach surveyed, the mean percent right bank vegetated was 53%. The mean percent left bank vegetated was 52%. The dominant elements composing the structure of the stream banks consisted of 98% sand/silt/clay and 2% bedrock (Graph 10). Coniferous trees were the dominant vegetation type observed in 82% of the units surveyed. Additionally, 18% of the units surveyed had deciduous trees as the dominant vegetation type (Graph 11).

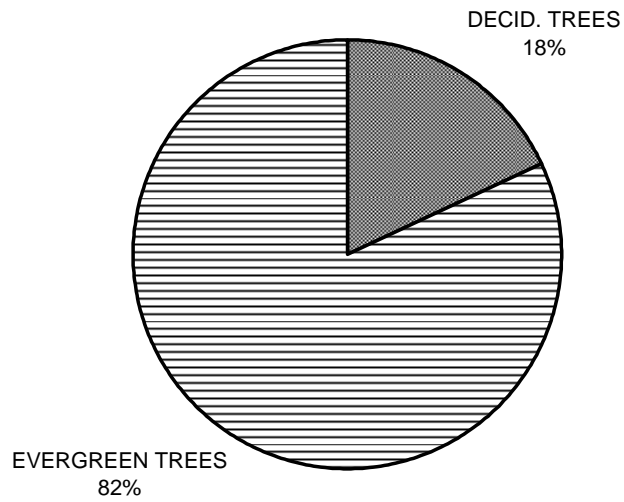
GRAPH 11

The percentage of right and left bank covered with vegetation was low at 53% and 52%, respectively. In areas of stream bank erosion or where bank vegetation is not at acceptable levels, planting endemic trees species, in conjunction with bank stabilization, is recommended.
