STREAM INVENTORY REPORT

Left Bank Tributary Two to Alder Creek

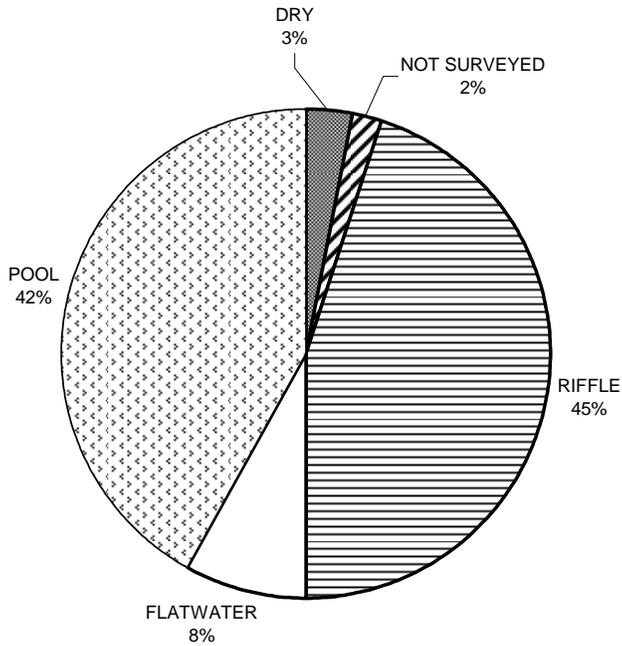
GRAPH 1

Table 1 summarizes the Level II riffle, flatwater, and pool habitat types. Based on frequency of occurrence there were 45% riffle units, 8% flatwater units, and 42% pool units (Graph 1). Based on total length of Level II habitat types there were 73% riffle units, 11% flatwater units, and 13% pool units (Graph 2).

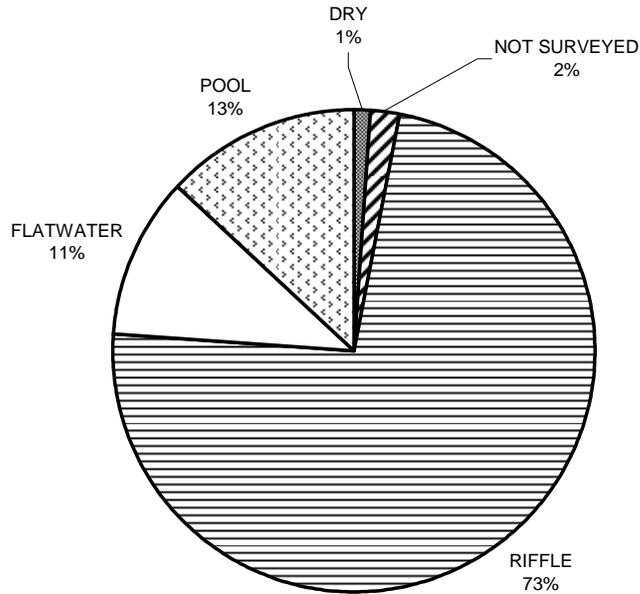
GRAPH 2

Riffle habitat types comprised 73% of the total length of this survey, pools 13%, and flatwater 11%. The pools are relatively shallow, with only 3 of the 25 (12%) measured pools having a maximum depth greater than 2 feet. In general, pool enhancement projects are considered when primary pools comprise less than 40% of the length of total stream habitat. In first and second order streams, a primary pool is defined to have a maximum depth of at least two feet, occupy at least half the width of the low flow channel, and be as long as the low flow channel width.

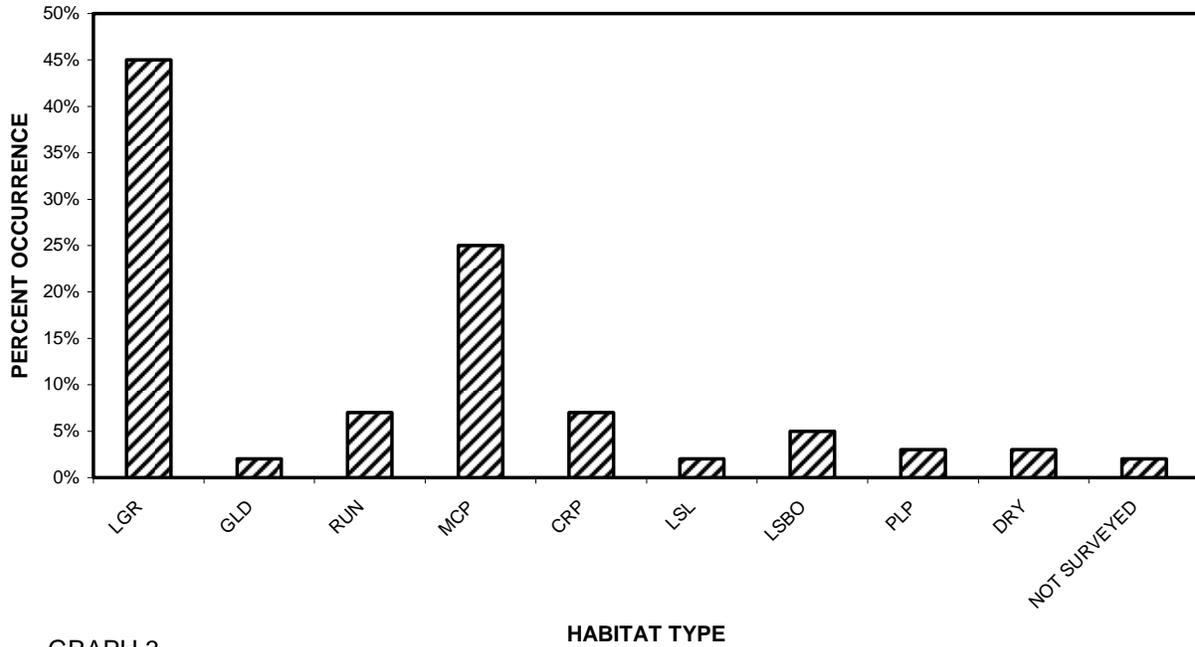
GRAPH 3

Ten Level IV habitat types were identified (Table 2). The most frequent habitat types by percent occurrence were low-gradient riffles, 45%; mid-channel pools, 25%; and runs and corner pools, each at 7% (Graph 3). Based on percent total length, low-gradient riffles made up 45%, runs 10%, and mid-channel pools 8%.

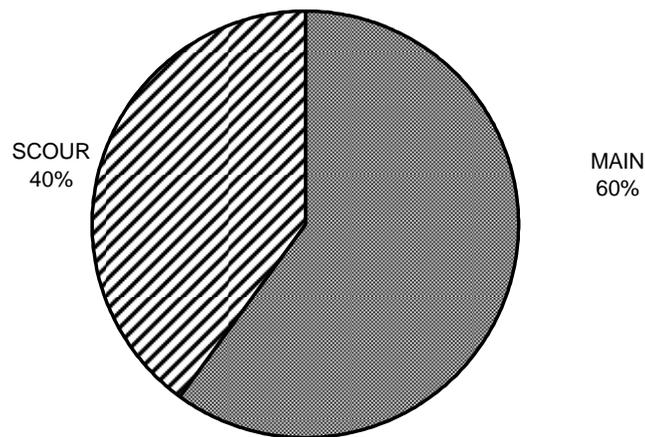
GRAPH 4

A total of 25 pools were identified (Table 3). Main-channel pools were the most frequently encountered, at 60%, and comprised 65% of the total length of all pools (Graph 4).

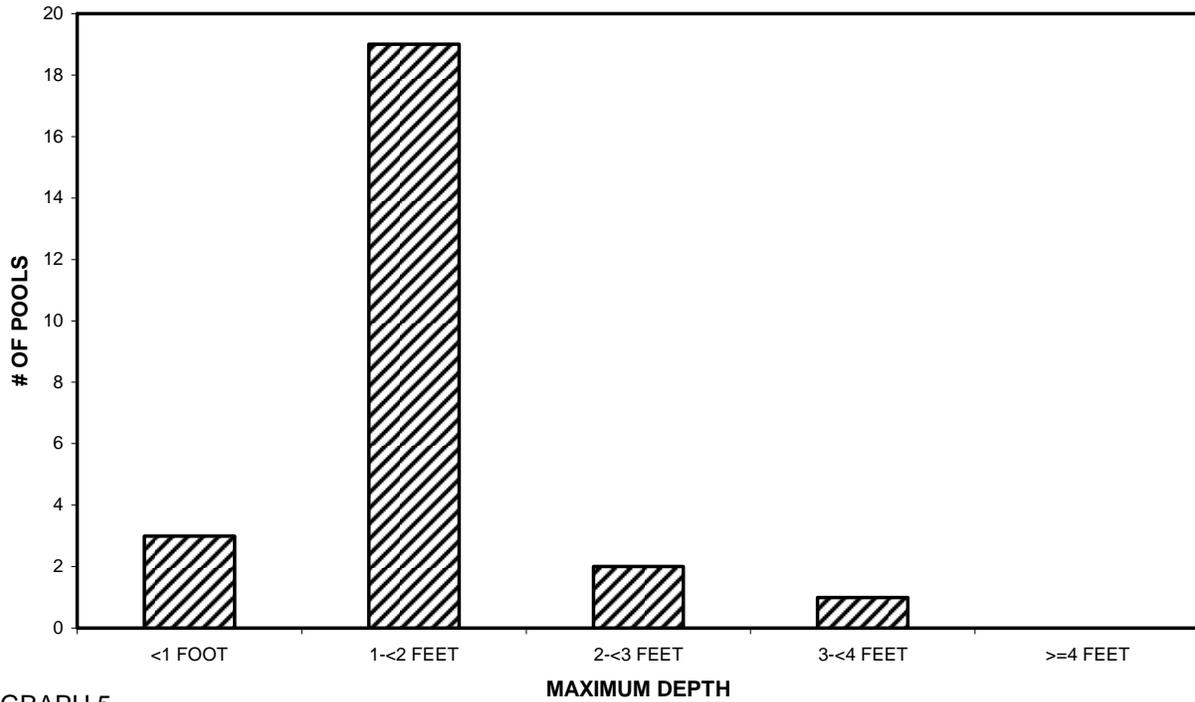
GRAPH 5

Table 4 is a summary of maximum pool depths by pool habitat types. Pool quality for salmonids increases with depth. Three of the 25 measured pools (12%) had a depth of two feet or greater (Graph 5).

Installing structures that will increase or deepen pool habitat is recommended for locations where their installation will not be threatened by high stream energy, or where their installation will not conflict with the modification of the numerous log debris accumulations (LDA's) in the stream.

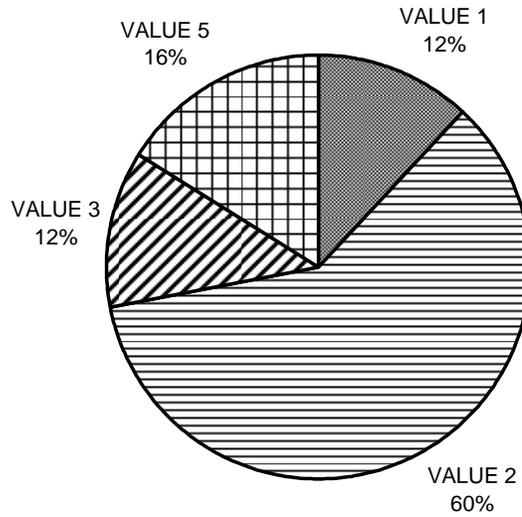
GRAPH 6

The depth of cobble embeddedness was estimated at pool tail-outs. Of the 25 pool tail-outs measured, 3 had a value of 1 (12%); 15 had a value of 2 (60%); 3 had a value of 3 (12%); 0 had a value of 4 (0%); and 4 had a value of 5 (16%) (Graph 6). On this scale, a value of 1 indicates the highest quality of spawning substrate.

Eighteen of the 25 pool tail-outs measured had embeddedness ratings of 1 or 2. Three of the pool tail-outs had embeddedness ratings of 3 or 4. Four of the pool tail-outs had a rating of 5, which is considered unsuitable for spawning. Cobble embeddedness measured to be 25% or less, a rating of 1, is considered to indicate good quality spawning substrate for salmon and steelhead.

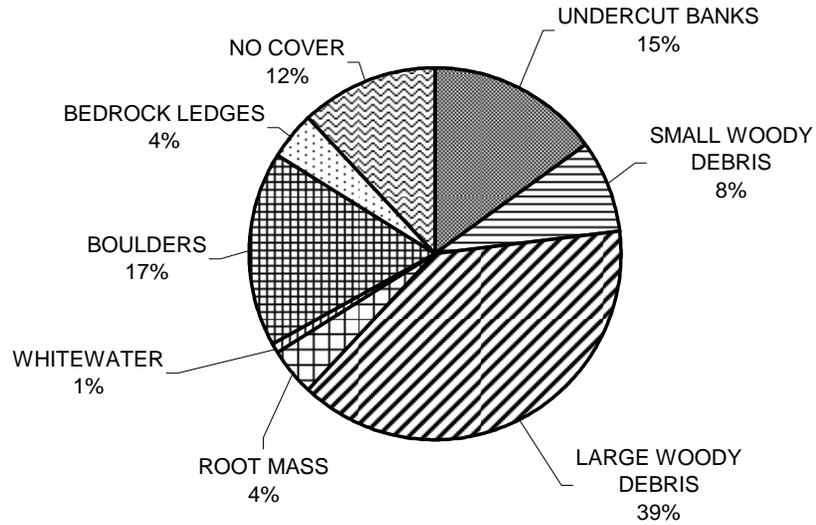
GRAPH 7

Table 5 summarizes mean percent cover by habitat type. Large woody debris is the dominant cover type in Left Bank Tributary Two. Graph 7 describes the pool cover in Left Bank Tributary Two. Large woody debris is the dominant pool cover type followed by boulders.

The mean shelter for flatwater was 13. The mean shelter rating for pools was 40. A pool shelter rating of approximately 100 is desirable. The amount of cover that now exists is being provided primarily by large woody debris in all habitat types. Additionally, boulders contribute a small amount.

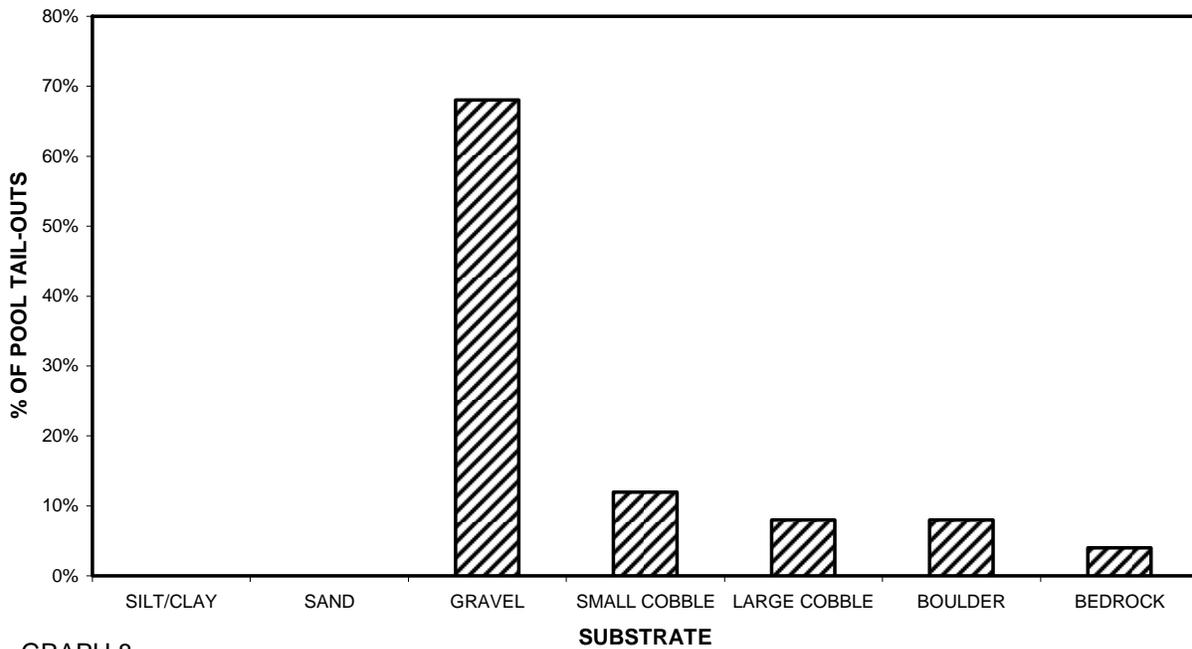
GRAPH 8

Table 6 summarizes the dominant substrate by habitat type. Graph 8 depicts the dominant substrate observed in pool tail-outs. Gravel was the dominant substrate observed in 68% of pool tail-outs while small cobble was the next most frequently observed substrate type, at 12%.

Twenty of the 25 pool tail-outs measured had gravel or small cobble as the dominant substrate. This is generally considered good for spawning salmonids.

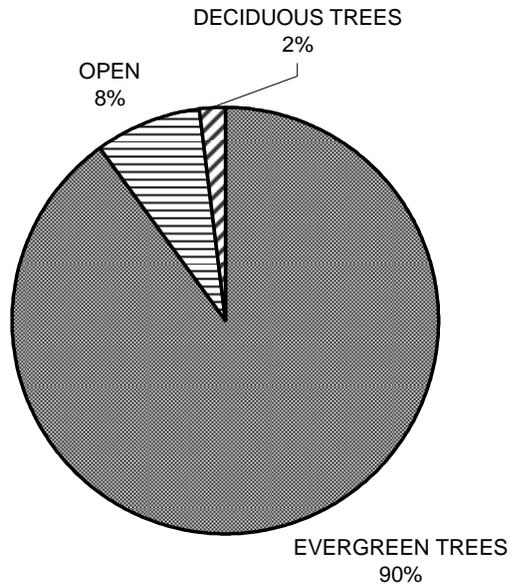
GRAPH 9

The mean percent canopy density for the surveyed length of Left Bank Tributary Two was 92%. The mean percentages of evergreen and deciduous trees were 90% and 2%, respectively with 8% of the canopy open. Graph 9 describes the mean percent canopy in Left Bank Tributary Two.

The mean percent canopy density for the stream was 92%. Reach 1 had a canopy density of 92% while Reach 2 had canopy density of 95%.

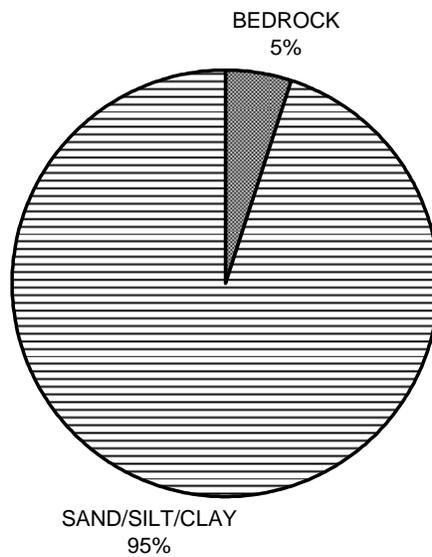
GRAPH 10

For the stream reach surveyed, the mean percent right bank vegetated was 40%. The mean percent left bank vegetated was 38%. The dominant elements composing the structure of the stream banks consisted of 95% sand/silt/clay and 5% bedrock (Graph 10). Coniferous trees were the dominant vegetation type observed in 89% of the units surveyed. Additionally, 11% of the units surveyed had brush as the dominant vegetation type (Graph 11).

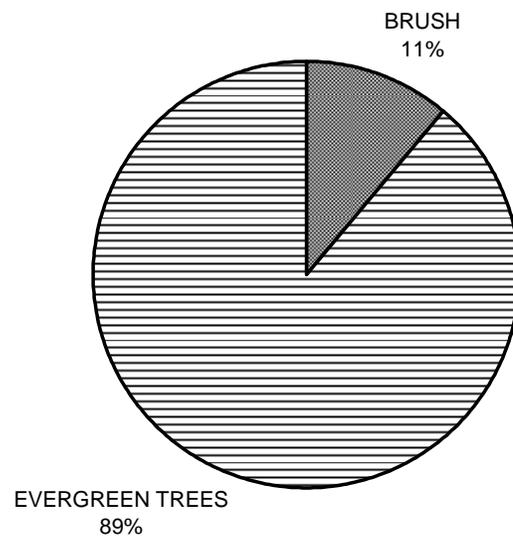
GRAPH 11

The percentage of right and left bank covered with vegetation was low at 40% and 38%, respectively. In areas of stream bank erosion or where bank vegetation is not at acceptable levels, planting endemic trees species, in conjunction with bank stabilization, is recommended.
