# STREAM INVENTORY REPORT

## Left Bank Tributary Three to Alder Creek

A stream inventory was conducted on September 18, 2003 on Left Bank Tributary Three. The survey began at the confluence with Alder Creek and extended upstream 1,043 feet.

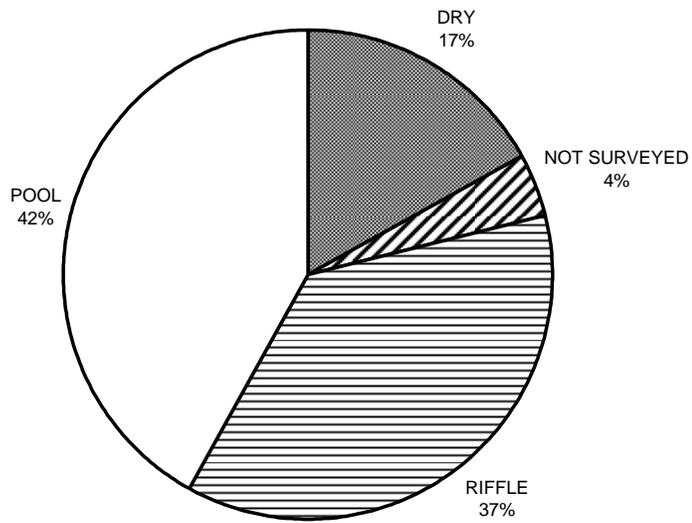
GRAPH 1

Table 1 summarizes the Level II riffle, flatwater, and pool habitat types. Based on frequency of occurrence there were 38% riffle units, 0% flatwater units, and 42% pool units (Graph 1). Based on total length of Level II habitat types there were 43% riffle units, 0% flatwater units, and 6% pool units (Graph 2).

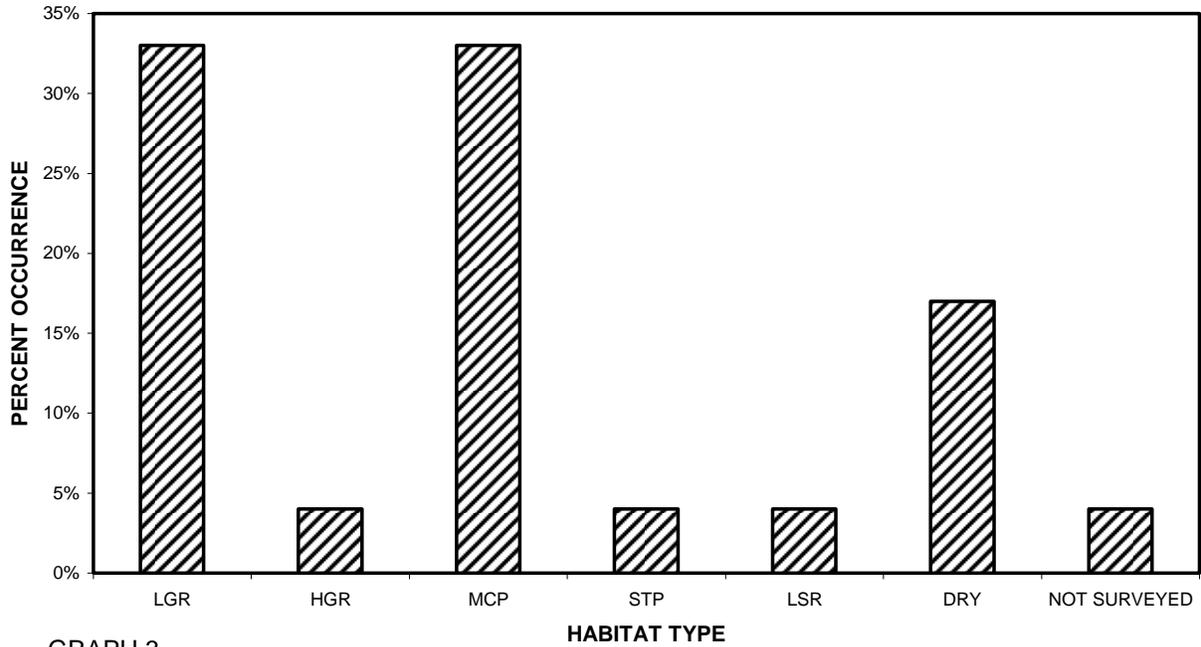
Seven Level IV habitat types were identified (Table 2). The most frequent habitat types by percent occurrence were low-gradient riffles, 33%; mid-channel pools, 33%; and dry, 17% (Graph 3). Based on percent total length, low-gradient riffles made up 42%, dry 41%, and mid-channel pools 10%.

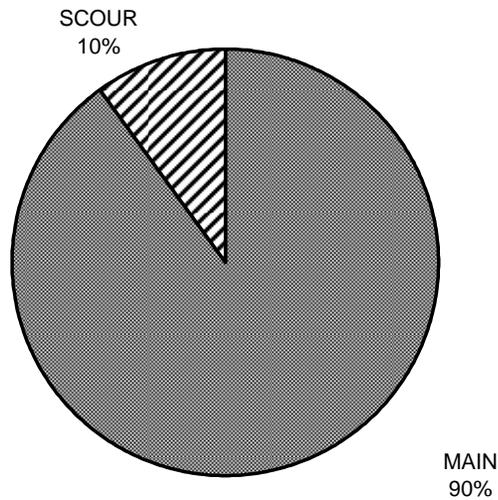
GRAPH 4

A total of 10 pools were identified (Table 3). Main-channel pools were the most frequently encountered, at 90%, and comprised 93% of the total length of all pools (Graph 4).

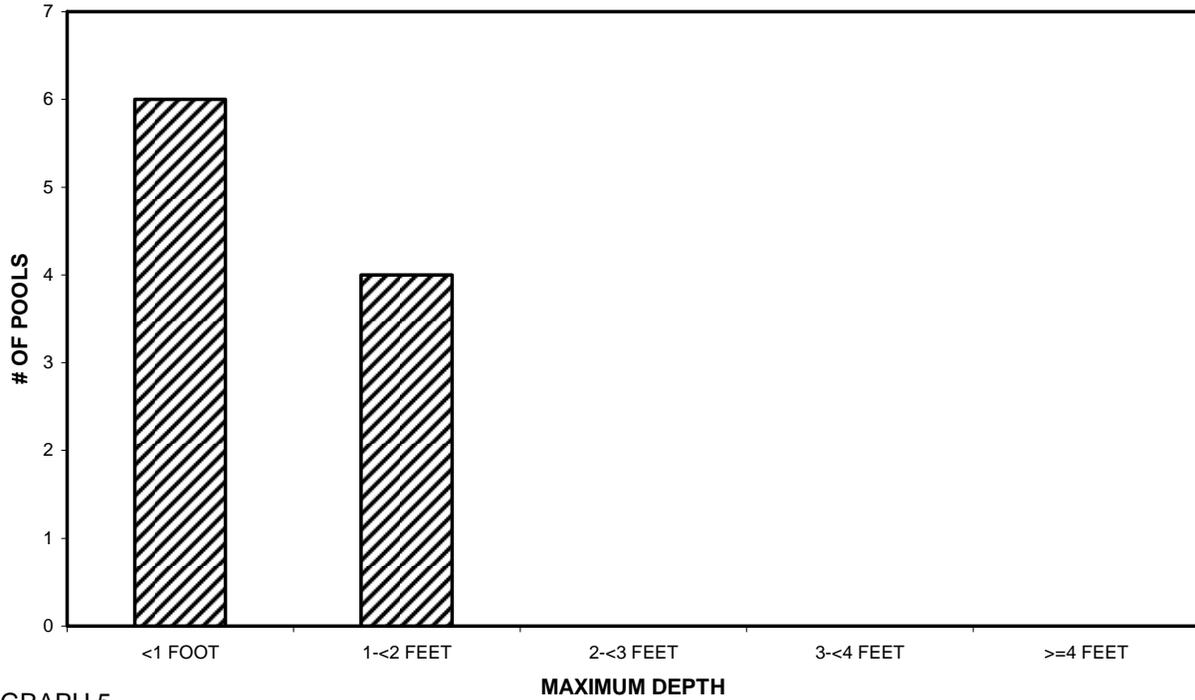
GRAPH 5

Table 4 is a summary of maximum pool depths by pool habitat types. Pool quality for salmonids increases with depth. None of the 10 measured pools had a depth of two feet or greater (Graph 5).

Riffle habitat types comprised 43% of the total length of this survey and pools 13%. The pools are relatively shallow, with only none of the 10 measured pools having a maximum depth greater than 2 feet. In general, pool enhancement projects are considered when primary pools comprise less than 40% of the length of total stream habitat. In first and second order streams, a primary pool is defined to have a maximum depth of at least two feet, occupy at least half the width of the low flow channel, and be as long as the low flow channel width. Installing structures that will increase or deepen pool habitat is recommended for locations where their installation will not be threatened by high stream energy, or where their installation will not conflict with the modification of the numerous log debris accumulations (LDA's) in the stream.

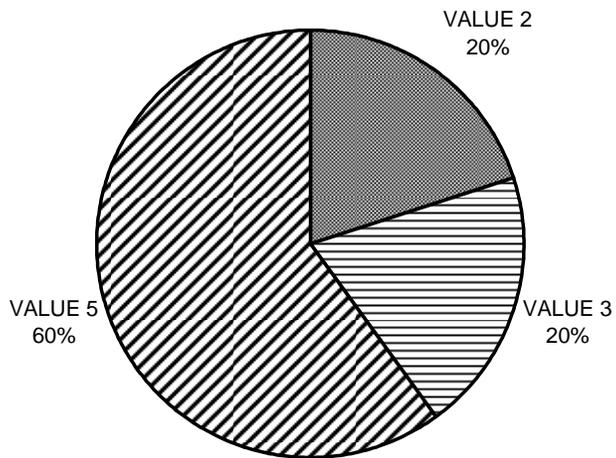
GRAPH 6

The depth of cobble embeddedness was estimated at pool tail-outs. Of the 10 pool tail-outs measured, 0 had a value of 1 (0%); 2 had a value of 2 (20%); 2 had a value of 3 (20%); 0 had a value of 4 (0%); and 6 had a value of 5 (60%) (Graph 6). On this scale, a value of 1 indicates the highest quality of spawning substrate.

Two of the 10 pool tail-outs measured had embeddedness ratings of 1 or 2. Two of the pool tail-outs had embeddedness ratings of 3 or 4. Six of the pool tail-outs had a rating of 5, which is considered unsuitable for spawning. Cobble embeddedness measured to be 25% or less, a rating of 1, is considered to indicate good quality spawning substrate for salmon and steelhead. Sediment sources in Left Bank Tributary Three should be mapped and rated according to their

potential sediment yields, and control measures should be taken.

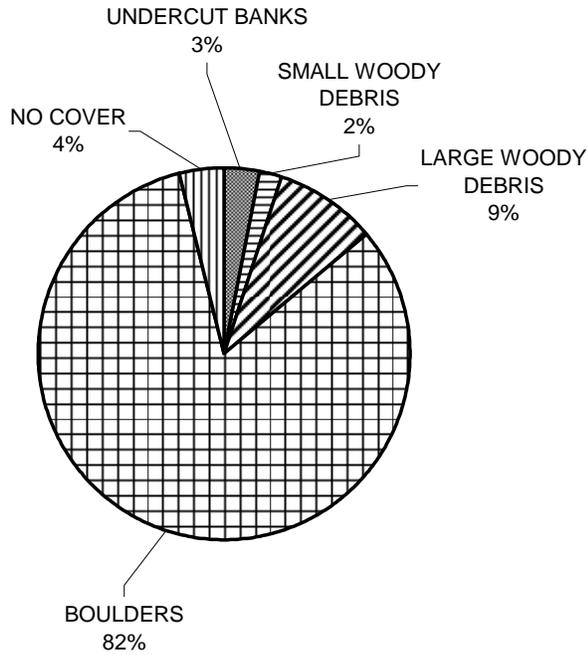
GRAPH 7

Table 5 summarizes mean percent cover by habitat type. Boulders are the dominant cover types in Left Bank Tributary Three. Graph 7 describes the pool cover in Left Bank Tributary Three. Boulders are the dominant pool cover types followed by large woody debris.

The mean shelter rating for pools was 26. A pool shelter rating of approximately 100 is desirable. The amount of cover that now exists is being provided primarily by boulders in all habitat types. Additionally, large woody debris contributes a small amount. Log and root wad cover structures in the pool and flatwater habitats would enhance both summer and winter salmonid habitat. Log cover structure provides rearing fry with protection from predation, rest from water velocity, and also divides territorial units to reduce density related competition.

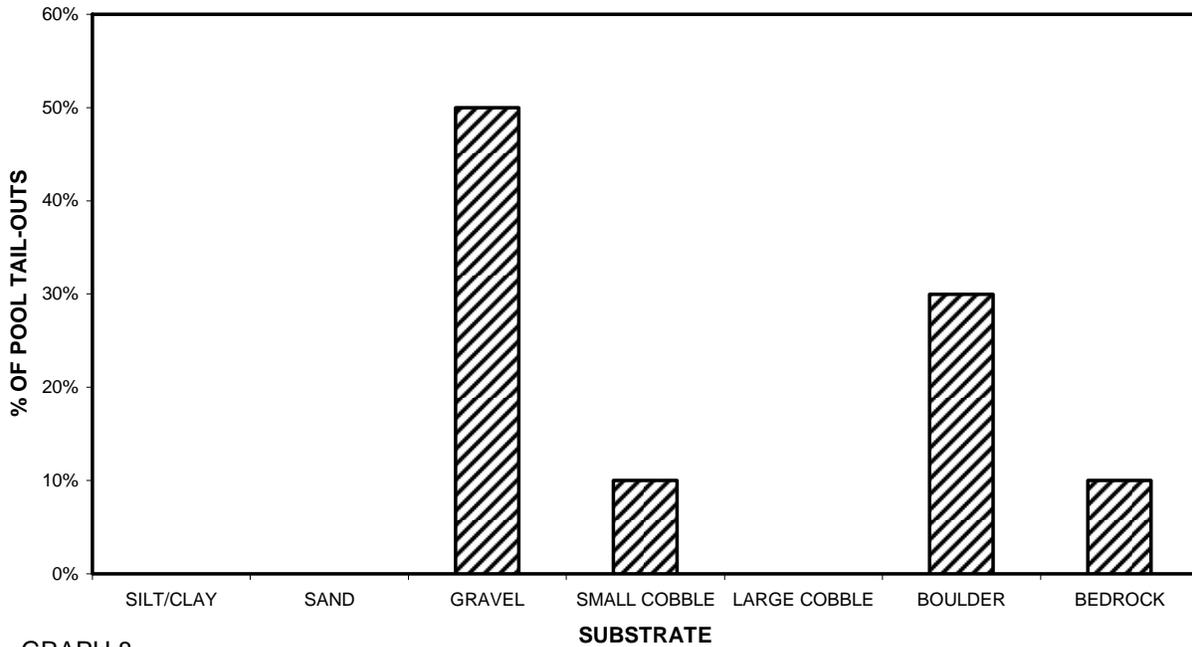
GRAPH 8

Table 6 summarizes the dominant substrate by habitat type. Graph 8 depicts the dominant substrate observed in pool tail-outs. Gravel was the dominant substrate observed in 50% of pool tail-outs while boulders were the next most frequently observed substrate type, at 30%.

Six of the 10 pool tail-outs measured had gravel or small cobble as the dominant substrate. This is generally considered good for spawning salmonids.

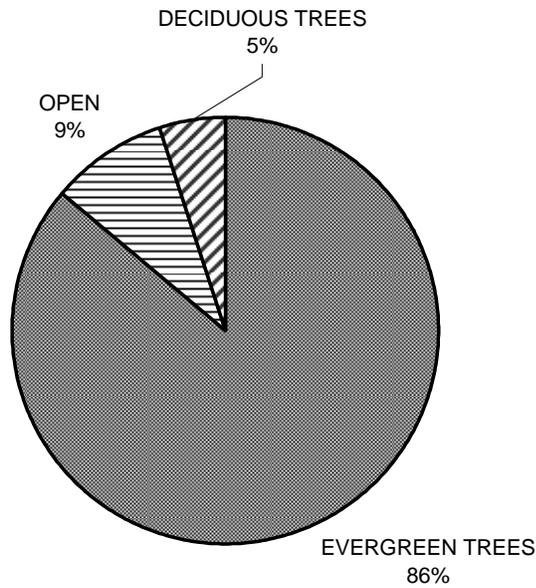
GRAPH 9

The mean percent canopy density for the surveyed length of Left Bank Tributary Three was 91%. The mean percentages of evergreen and deciduous trees were 86% and 5%, respectively with 9% of the canopy open. Graph 9 describes the mean percent canopy in Left Bank Tributary Three.

The mean percent canopy density for the stream was 91%. Reach 1 had a canopy density of 88% while Reach 2 had a canopy density of 98%.

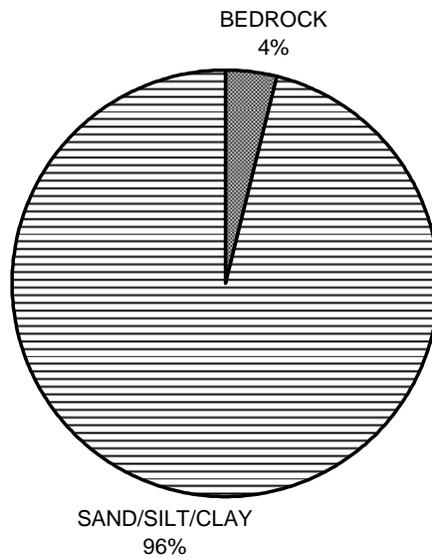
GRAPH 10

For the stream reach surveyed, the mean percent right bank vegetated was 41%. The mean percent left bank vegetated was 45%. The dominant elements composing the structure of the stream banks consisted of 4% bedrock and 96% sand/silt/clay (Graph 10). Coniferous trees were the dominant vegetation type observed in 100% of the units surveyed (Graph 11).

The percentage of right and left bank covered with vegetation was low at 41% and 45%, respectively. In areas of stream bank erosion or where bank vegetation is not at acceptable levels, planting endemic trees species, in conjunction with bank stabilization, is recommended.
