STREAM INVENTORY REPORT

“Panther Creek”

A stream inventory was conducted on August 21, 2003 on an unnamed tributary to Alder Creek locally known as, and herein after referred to as, Panther Creek. The survey began at the confluence with Alder Creek and extended upstream 3,096 feet.

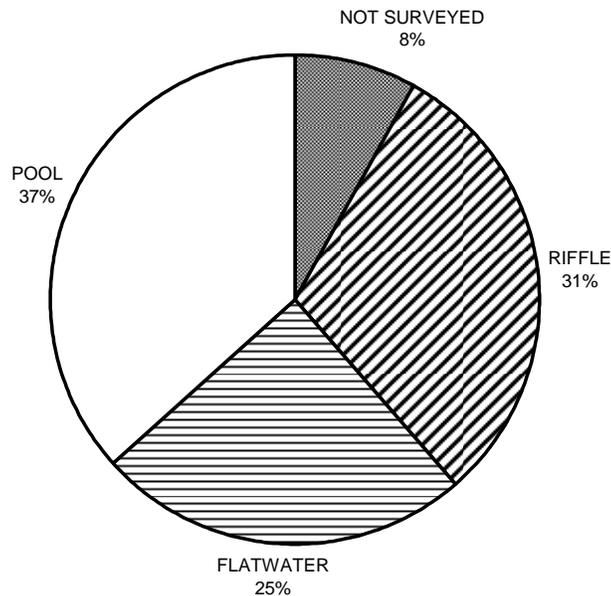
GRAPH 1

Table 1 summarizes the Level II riffle, flatwater, and pool habitat types. Based on frequency of occurrence there were 37% pool units, 31% riffle units, and 25% flatwater units (Graph 1). Based on total length of Level II habitat types there were 49% riffle units, 37% flatwater units, and 10% pool units (Graph 2).

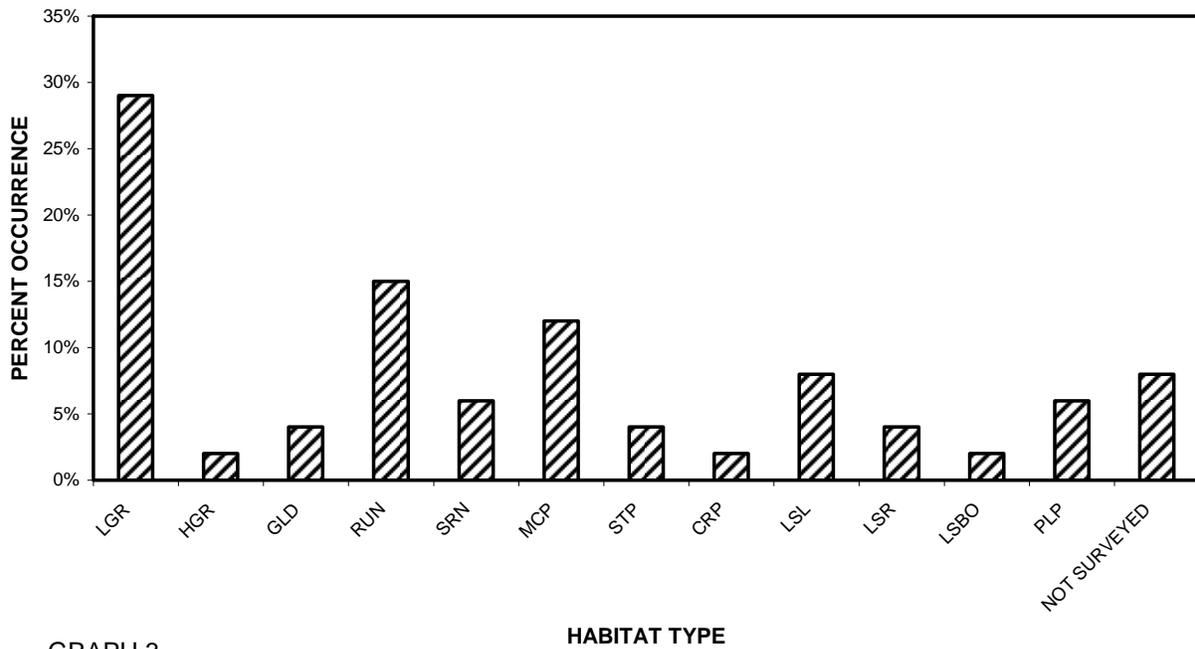
GRAPH 3

Thirteen Level IV habitat types were identified (Table 2). The most frequent habitat types by percent occurrence were low-gradient riffles, 29%; runs, 15%; and mid-channel pools, 12% (Graph 3). Based on percent total length, low-gradient rifles made up 49%, runs 28%, and step-runs 4%.

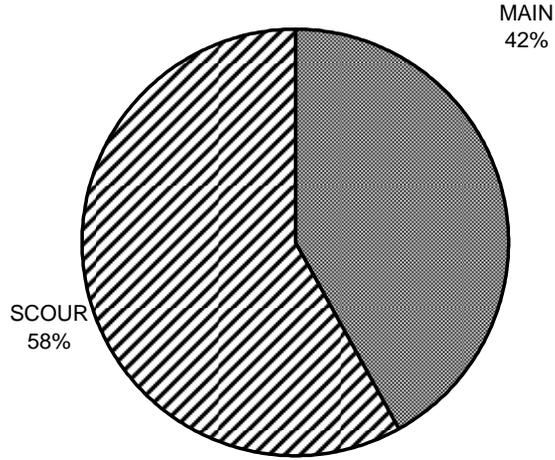
GRAPH 4

A total of 19 pools were identified (Table 3). Scour pools were the most frequently encountered, at 58%, and comprised 51% of the total length of all pools (Graph 4).

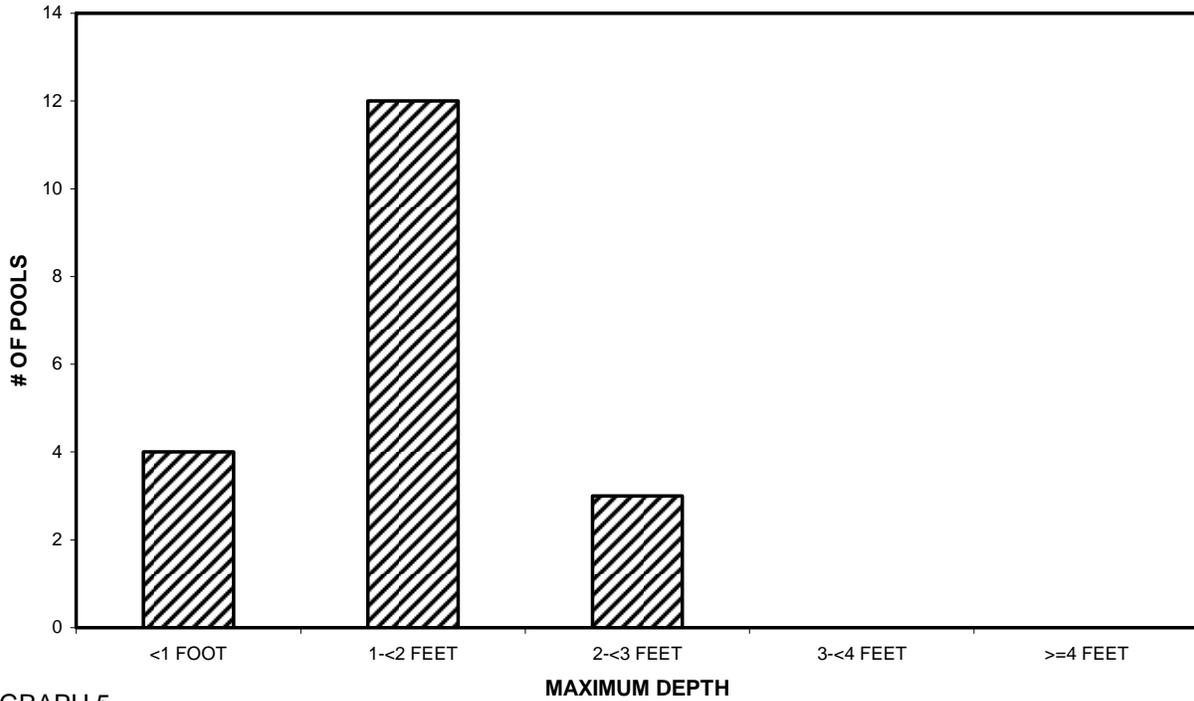
GRAPH 5

Table 4 is a summary of maximum pool depths by pool habitat types. Pool quality for salmonids increases with depth. Three of the 19 measured pools (16%) had a depth of two feet or greater (Graph 5).

Riffle habitat types comprised 49% of the total length of this survey, flatwater 37%, and pools 10%. The pools are relatively shallow, with only 3 of the 19 (16%) measured pools having a maximum depth greater than 2 feet. In general, pool enhancement projects are considered when primary pools comprise less than 40% of the length of total stream habitat. In first and second order streams, a primary pool is defined to have a maximum depth of at least two feet, occupy at least half the width of the low flow channel, and be as long as the low flow channel width. Installing structures that will increase or deepen pool habitat is recommended for locations where their installation will not be threatened by high stream energy, or where their installation will not conflict with the modification of the numerous log debris accumulations (LDA's) in the stream.

- 4) Where feasible, design and engineer pool enhancement structures to increase the number of pools. This must be done where the banks are stable or in conjunction with stream bank armor to prevent erosion.
- 5) Increase woody cover in the pools and flatwater habitat units. Most of the existing cover is from boulders. Adding high quality complexity with log and root wad cover is desirable.
- 6) Inventory and map sources of stream bank erosion and prioritize them according to present and potential sediment yield. Identified sites should then be treated to reduce the amount of fine sediments entering the stream.

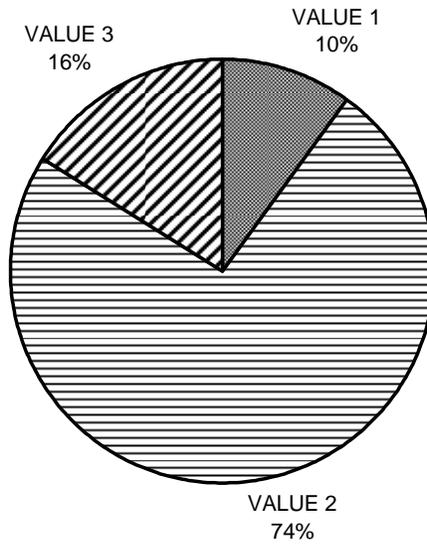
GRAPH 6

The depth of cobble embeddedness was estimated at pool tail-outs. Of the 19 pool tail-outs measured, 2 had a value of 1 (11%); 14 had a value of 2 (74%); 3 had a value of 3 (16%); 0 had a value of 4 (0%); and 0 had a value of 5 (0%) (Graph 6). On this scale, a value of 1 indicates the highest quality of spawning substrate.

Sixteen of the 19 pool tail-outs measured had embeddedness ratings of 1 or 2. Three of the pool tail-outs had embeddedness ratings of 3 or 4. None of the pool tail-outs had a rating of 5, which is considered unsuitable for spawning. Cobble embeddedness measured to be 25% or less, a rating of 1, is considered to indicate good quality spawning substrate for salmon and steelhead.

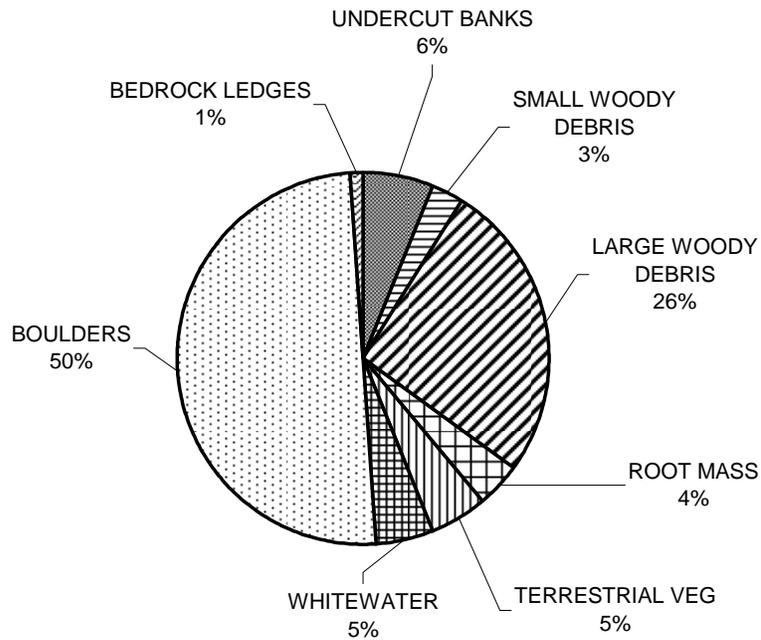
GRAPH 7

Table 5 summarizes mean percent cover by habitat type. Boulders are the dominant cover types in Panther Creek. Graph 7 describes the pool cover in Panther Creek. Boulders are the

dominant pool cover types followed by large woody debris.

The mean shelter for flatwater was 57. The mean shelter rating for pools was 52. A pool shelter rating of approximately 100 is desirable. The amount of cover that now exists is being provided primarily by boulders in all habitat types. Additionally, large woody debris contributes a small amount. Log and root wad cover structures in the pool and flatwater habitats would enhance both summer and winter salmonid habitat. Log cover structure provides rearing fry with protection from predation, rest from water velocity, and also divides territorial units to reduce density related competition.

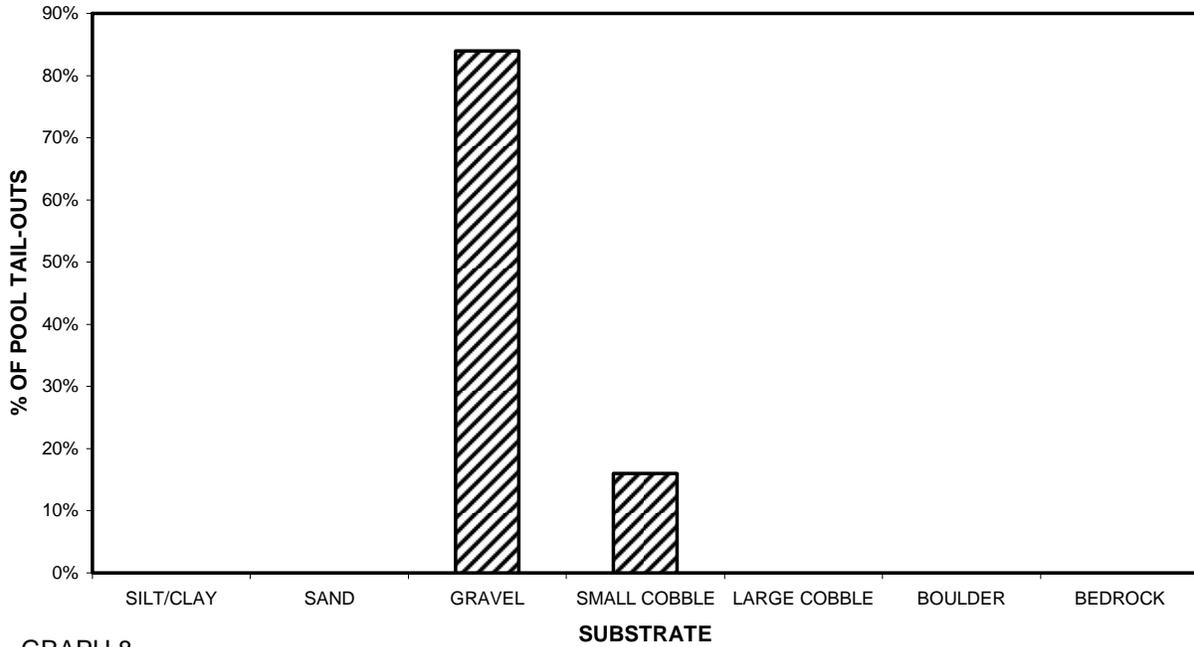
GRAPH 8

Table 6 summarizes the dominant substrate by habitat type. Graph 8 depicts the dominant substrate observed in pool tail-outs. Gravel was the dominant substrate observed in 84% of pool tail-outs while small cobble was the next most frequently observed substrate type, at 16%.

All of the pool tail-outs measured had gravel or small cobble as the dominant substrate. This is generally considered good for spawning salmonids.

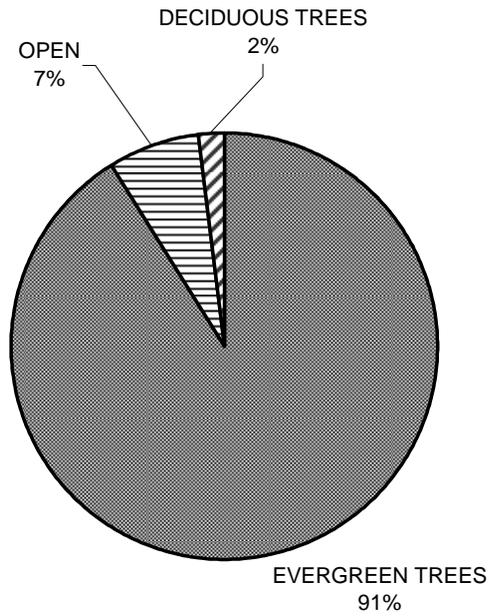
GRAPH 9

The mean percent canopy density for the surveyed length of Panther Creek was 98%. The mean percentages of evergreen and deciduous trees were 91% and 2%, respectively with 7% of the canopy open. Graph 9 describes the mean percent canopy in Panther Creek.

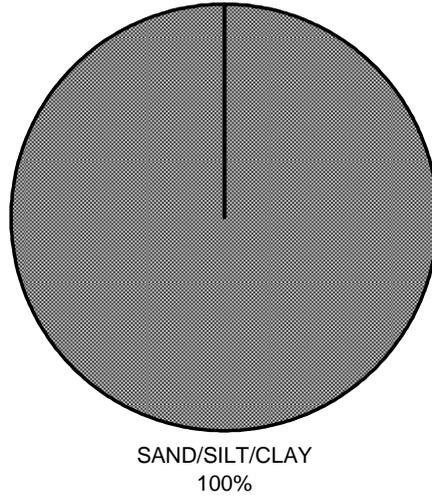
GRAPH 10

For the stream reach surveyed, the mean percent right bank vegetated was 41%. The mean percent left bank vegetated was 38%. The dominant element composing the structure of the stream banks consisted of 100% sand/silt/clay (Graph 10). Coniferous trees were the dominant vegetation type observed in 94% of the units surveyed. Additionally, 6% of the units surveyed had brush as the dominant vegetation type (Graph 11).

The percentage of right and left bank covered with vegetation was low at 41% and 38%, respectively. In areas of stream bank erosion or where bank vegetation is not at acceptable levels, planting endemic trees species, in conjunction with bank stabilization, is recommended.
