STREAM INVENTORY REPORT

Right Bank Tributary One to Alder Creek

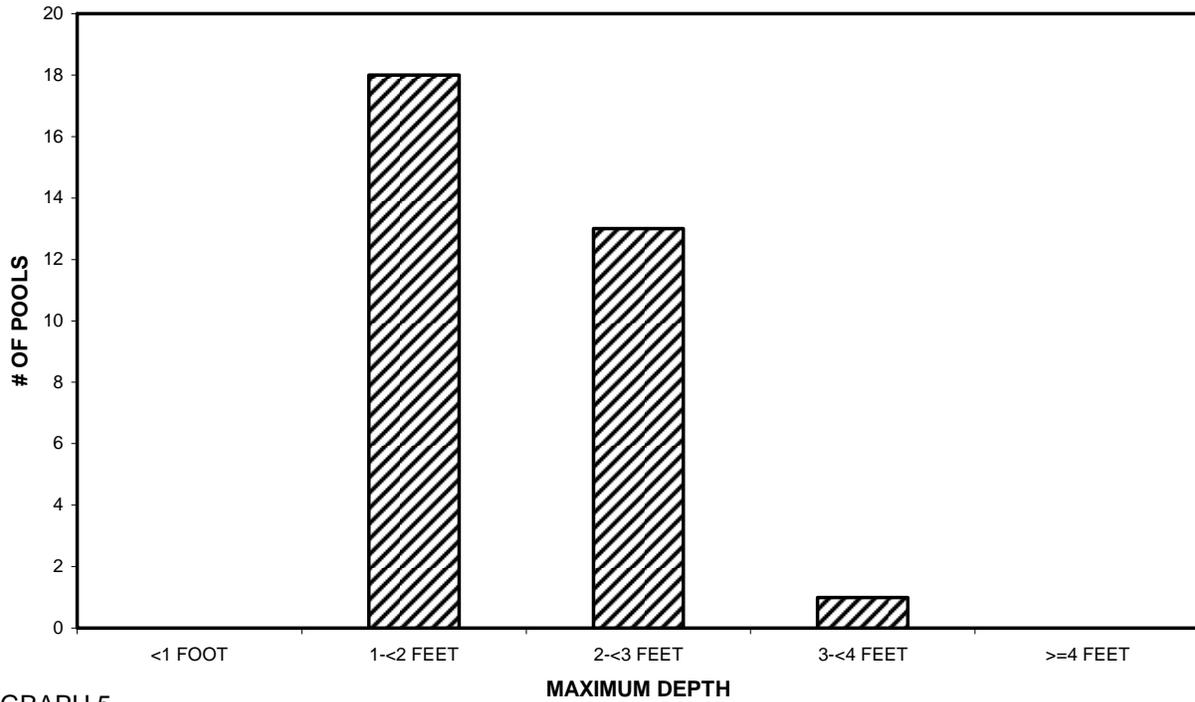
GRAPH 5

Table 4 is a summary of maximum pool depths by pool habitat types. Pool quality for salmonids increases with depth. Fourteen of the 32 measured pools (44%) had a depth of two feet or greater (Graph 5).

Riffle habitat types comprised 61% of the total length of this survey, flatwater 19%, and pools 17%. The pools are relatively shallow, with only 14 of the 32 (44%) measured pools having a maximum depth greater than 2 feet. In general, pool enhancement projects are considered when primary pools comprise less than 40% of the length of total stream habitat. In first and second order streams, a primary pool is defined to have a maximum depth of at least two feet, occupy at least half the width of the low flow channel, and be as long as the low flow channel width. Installing structures that will increase or deepen pool habitat is recommended for locations where their installation will not be threatened by high stream energy, or where their installation will not conflict with the modification of the numerous log debris accumulations (LDA's) in the stream.

- 3) Where feasible, design and engineer pool enhancement structures to increase the number of pools. This must be done where the banks are stable or in conjunction with stream bank armor to prevent erosion.

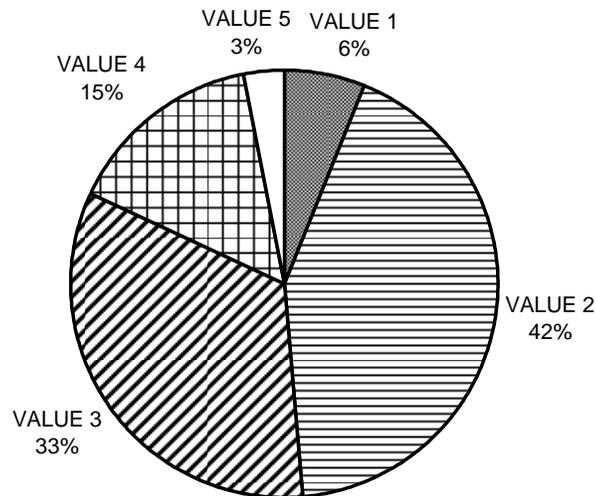
GRAPH 6

The depth of cobble embeddedness was estimated at pool tail-outs. Of the 33 pool tail-outs measured, 2 had a value of 1 (6%); 14 had a value of 2 (42%); 11 had a value of 3 (33%); 5 had a value of 4 (15%); and 1 had a value of 5 (3%) (Graph 6). On this scale, a value of 1 indicates the highest quality of spawning substrate.

Sixteen of the 33 pool tail-outs measured had embeddedness ratings of 1 or 2. Fifteen of the pool tail-outs had embeddedness ratings of 3 or 4. One of the pool tail-outs had a rating of 5, which is considered unsuitable for spawning. Cobble embeddedness measured to be 25% or less, a rating of 1, is considered to indicate good quality spawning substrate for salmon and steelhead.

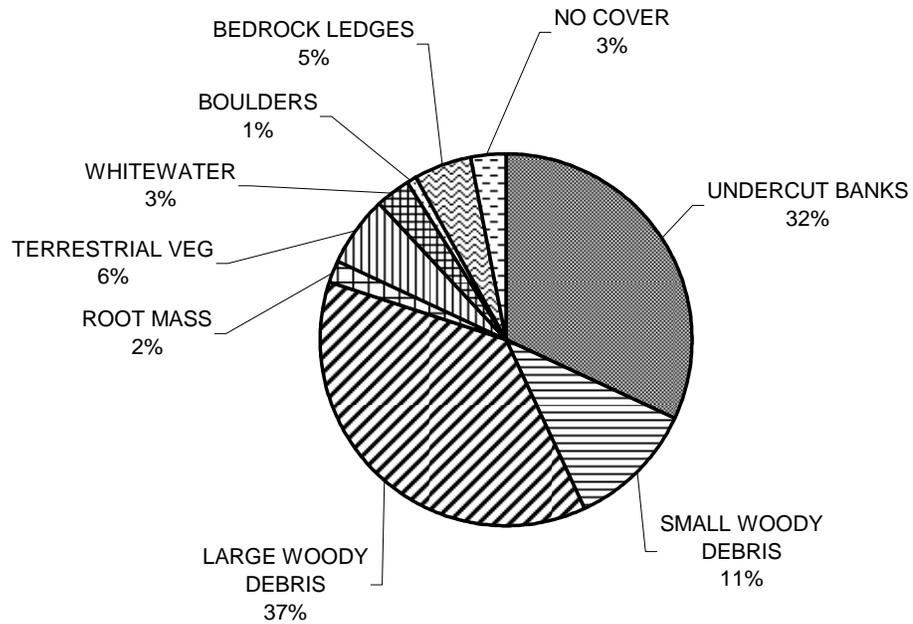
GRAPH 7

Table 5 summarizes mean percent cover by habitat type. Undercut banks are the dominant cover types in Right Bank Tributary One. Graph 7 describes the pool cover in Right Bank Tributary One. Large woody debris is the dominant pool cover type followed by undercut banks.

The mean shelter for flatwater was 20. The mean shelter rating for pools was 50. A pool shelter rating of approximately 100 is desirable. The amount of cover that now exists is being provided primarily by undercut banks in all habitat types. Additionally, large woody debris contributes a small amount. Log and root wad cover structures in the pool and flatwater habitats would enhance both summer and winter salmonid habitat. Log cover structure provides rearing fry with protection from predation, rest from water velocity, and also divides territorial units to reduce density related competition.

- 4) Increase woody cover in the pools and flatwater habitat units. Most of the existing cover is from undercut banks. Adding high quality complexity with log and root wad cover is desirable.

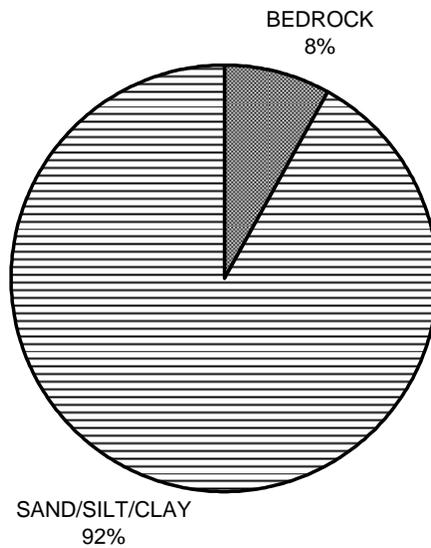
GRAPH 10

For the stream reach surveyed, the mean percent right bank vegetated was 41%. The mean percent left bank vegetated was 47%. The dominant elements composing the structure of the stream banks consisted of 92% sand/silt/clay and 8% bedrock (Graph 10). Coniferous trees were the dominant vegetation type observed in 87% of the units surveyed. Additionally, 12% of the units surveyed had brush as the dominant vegetation type, and 1% had deciduous trees as the dominant vegetation (Graph 11).

- 5) Inventory and map sources of stream bank erosion and prioritize them according to present and potential sediment yield. Identified sites should then be treated to reduce the amount of fine sediments entering the stream.

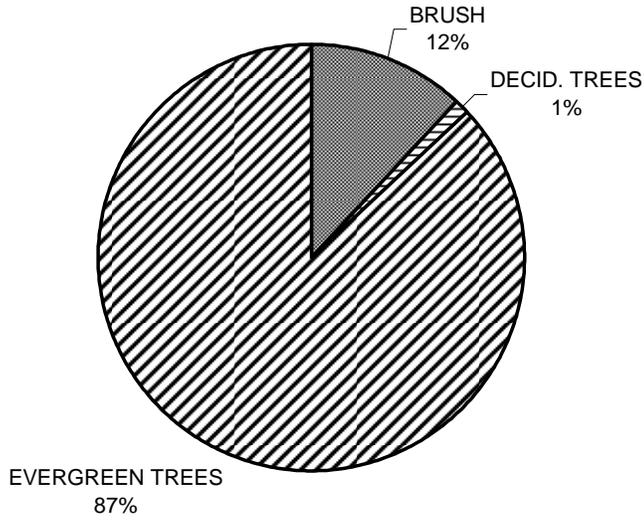
GRAPH 11

The percentage of right and left bank covered with vegetation was low at 41% and 47%, respectively. In areas of stream bank erosion or where bank vegetation is not at acceptable levels, planting endemic trees species, in conjunction with bank stabilization, is recommended.
