STREAM INVENTORY REPORT

Chamberlain Creek

A stream inventory was conducted June 6 to June 22, 2011 on Chamberlain Creek. The survey began at the confluence with North Fork Big River and extended upstream 5.3 miles. Stream inventories and reports were also completed for six tributaries to Chamberlain Creek.

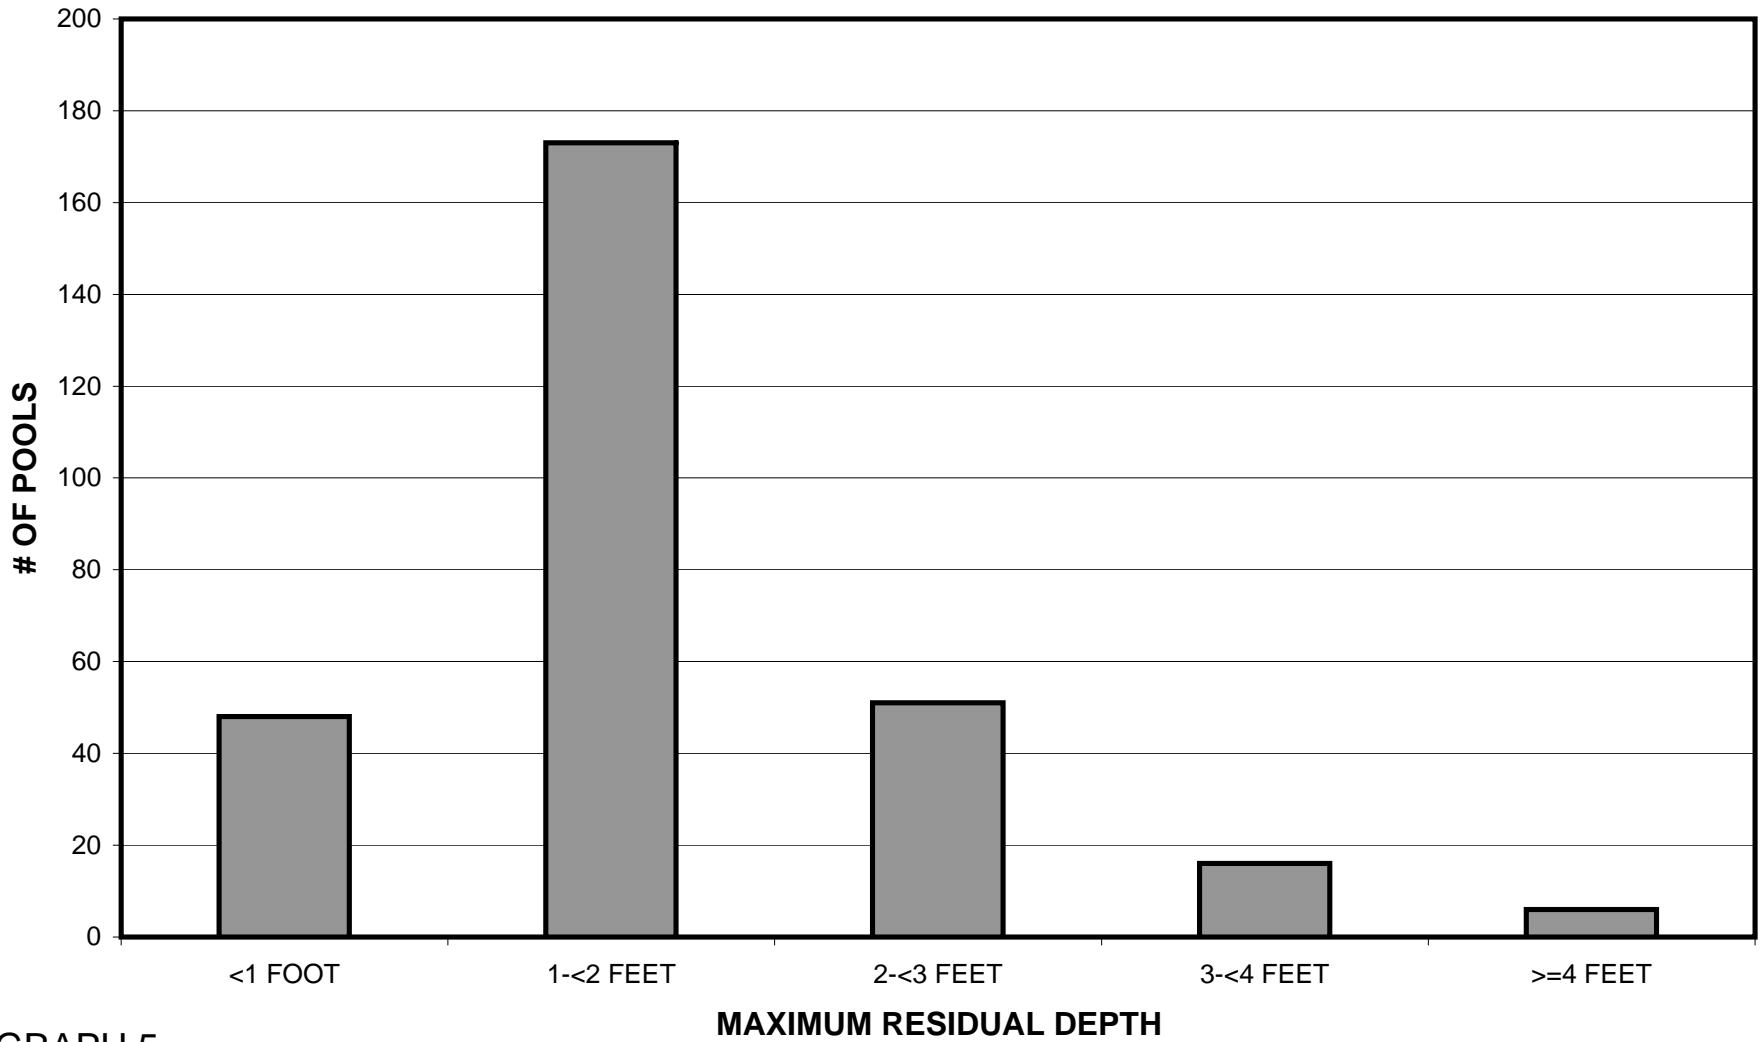
GRAPH 5

Table 4 is a summary of maximum residual pool depths by pool habitat types. Pool quality for salmonids increases with depth. Twenty-two of the 294 pools (7%) had a residual depth of three feet or greater (Graph 5).

Flatwater habitat types comprised 57% of the total length of this survey, riffles 9%, and pools 31%. Twenty-two of the 294 pools (7%) had a residual depth greater than three feet. In general, pool enhancement projects are considered when primary pools comprise less than 40% of the length of total stream habitat. In third and fourth order streams, a primary pool is defined to have a maximum residual depth of at least three feet, occupy at least half the width of the low flow channel, and be as long as the low flow channel width. Installing structures that will increase or deepen pool habitat is recommended in reach 1 and 2.

- 3) Where feasible, design and engineer pool enhancement structures to increase the number of pools. This must be done where the banks are stable or in conjunction with stream bank armor to prevent erosion.

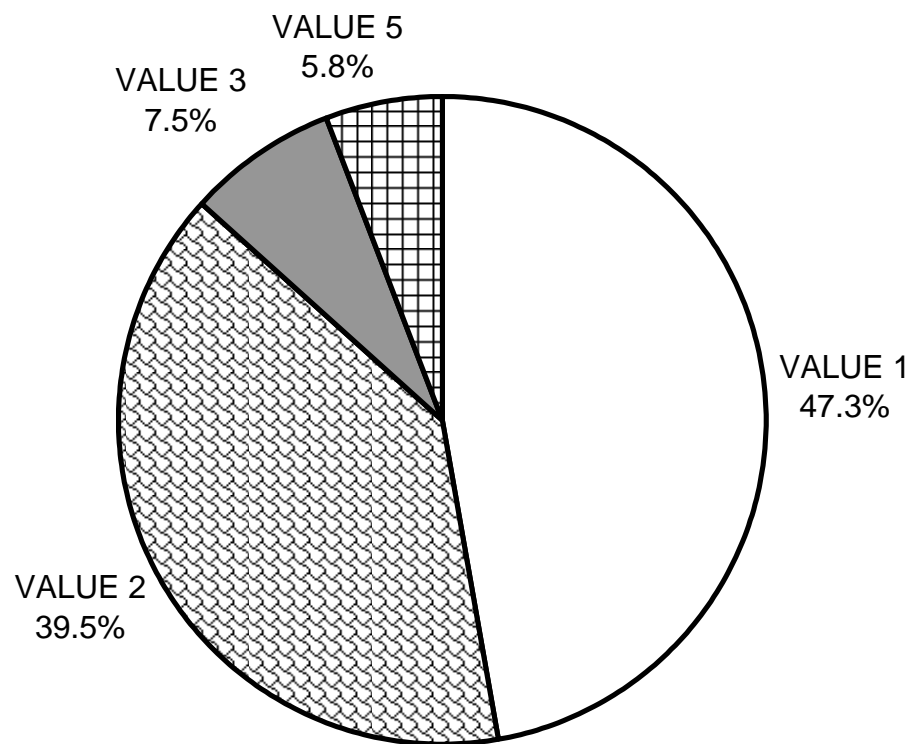
GRAPH 6

The depth of cobble embeddedness was estimated at pool tail-outs. Of the 294 pool tail-outs measured, 139 had a value of 1 (47.3%); 116 had a value of 2 (39.5%); 22 had a value of 3 (7.5%); 17 had a value of 5 (5.8%) (Graph 6). On this scale, a value of 1 indicates the best spawning conditions and a value of 4 the worst. Additionally, a value of 5 was assigned to tail-outs deemed not suitable for spawning due to inappropriate substrate such as bedrock, log sills, boulders, or other considerations.

Two hundred fifty-five of the 294 pool tail-outs measured had embeddedness ratings of 1 or 2. Twenty-two of the pool tail-outs had embeddedness ratings of 3 or 4. Seventeen of the pool tail-outs had a rating of 5, which is considered unsuitable for spawning. Cobble embeddedness measured to be 25% or less, a rating of 1, is considered to indicate good quality spawning substrate for salmon and steelhead.

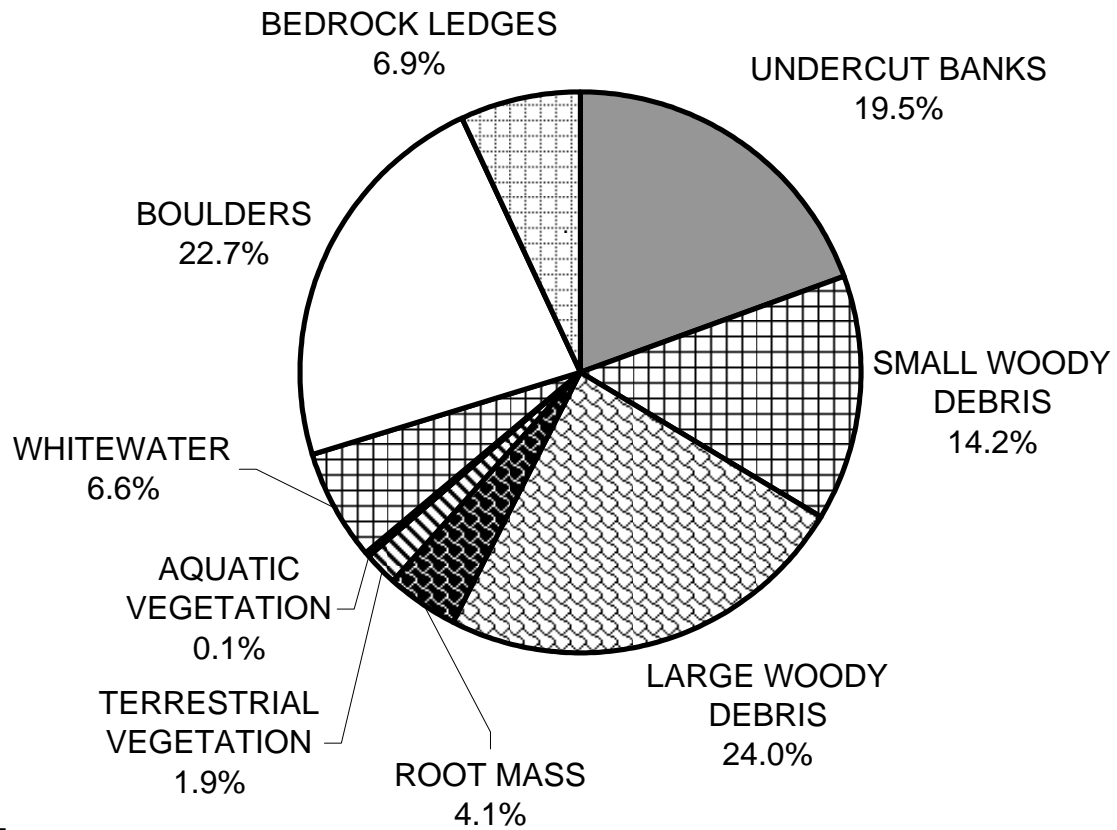
GRAPH 7

Table 5 summarizes mean percent cover by habitat type. Boulders are the dominant cover type in Chamberlain Creek. Graph 7 describes the pool cover in Chamberlain Creek. Large woody debris is the dominant pool cover type followed by boulders.

The mean shelter rating for pools is 20. The shelter rating in the flatwater habitats is 8. A pool shelter rating of approximately 100 is desirable. The amount of cover that now exists is being provided primarily by boulders in Chamberlain Creek. Large woody debris is the dominant cover type in pools followed by boulders. Log and root wad cover structures in the pool and flatwater habitats would enhance both summer and winter salmonid habitat. Log cover structures provide rearing fry with protection from predation, rest from water velocity, and also divide territorial units to reduce density related competition.

- 4) Increase woody cover in the pools and flatwater habitat units. Most of the existing cover in the pools is from large woody debris. Adding high quality complexity with woody cover in the pools is desirable.

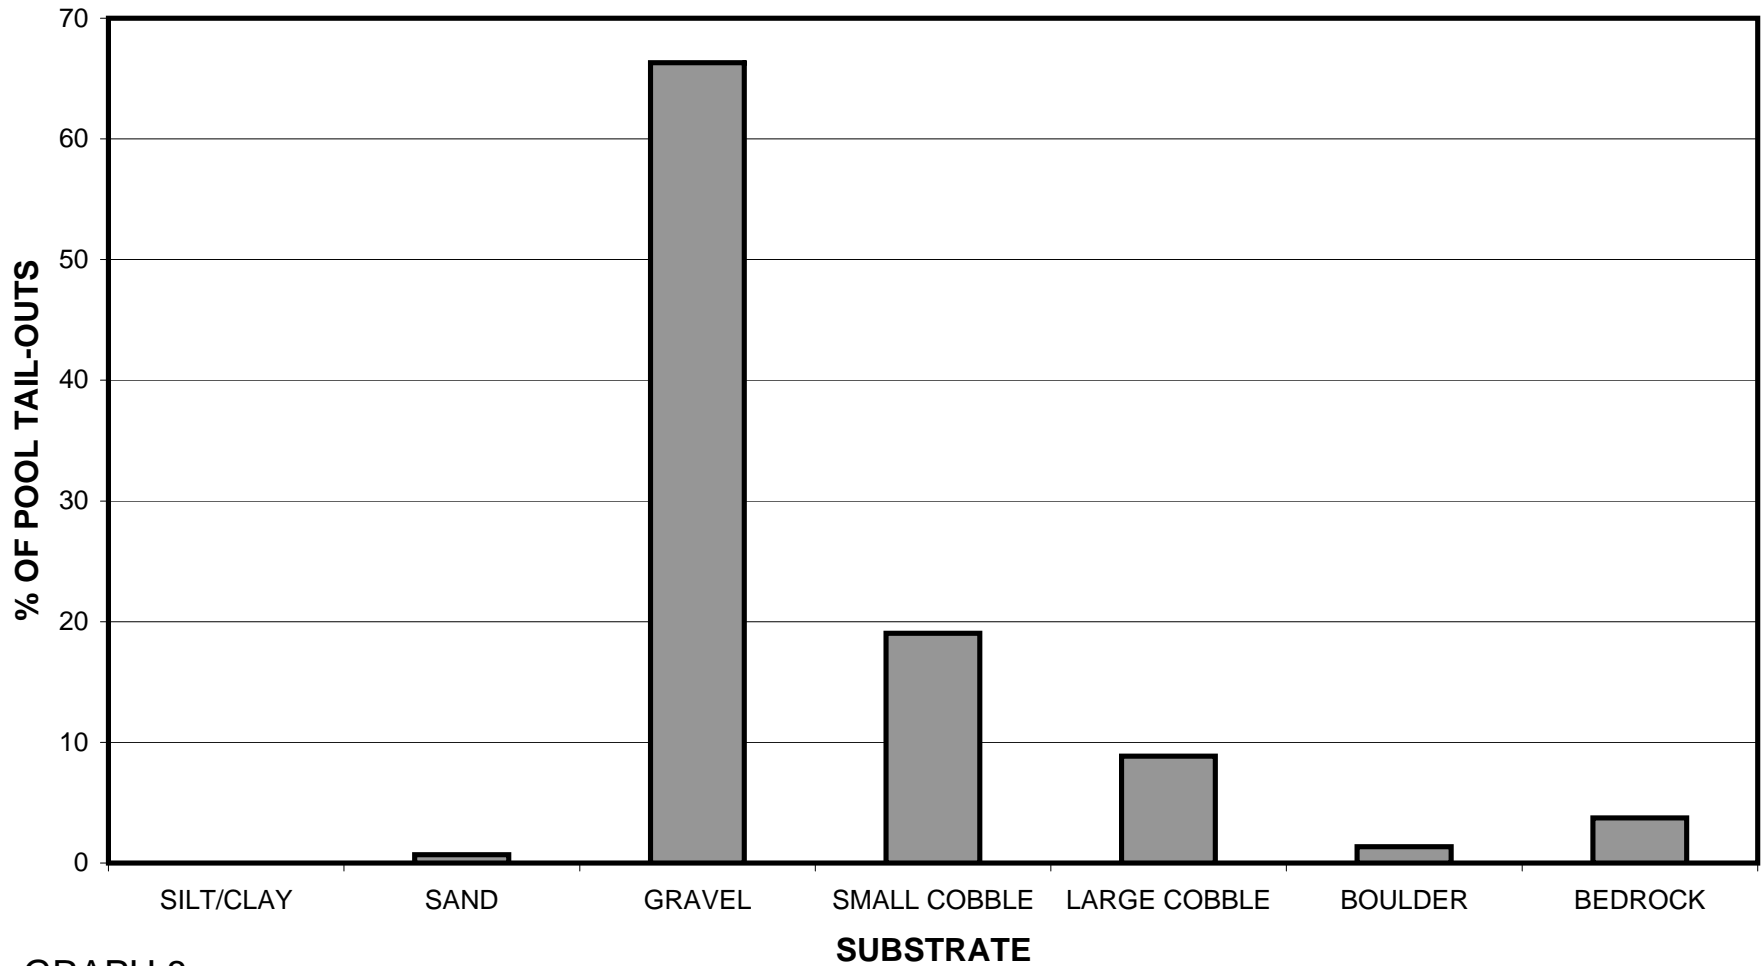
GRAPH 8

Table 6 summarizes the dominant substrate by habitat type. Graph 8 depicts the dominant substrate observed in pool tail-outs. Gravel was the dominant substrate observed in 66% of the pool tail-outs. Small cobble was the next most frequently observed dominant substrate type and occurred in 19% of the pool tail-outs.

Two hundred fifty-one of the 294 pool tail-outs measured had gravel or small cobble as the dominant substrate. This is generally considered good for spawning salmonids.

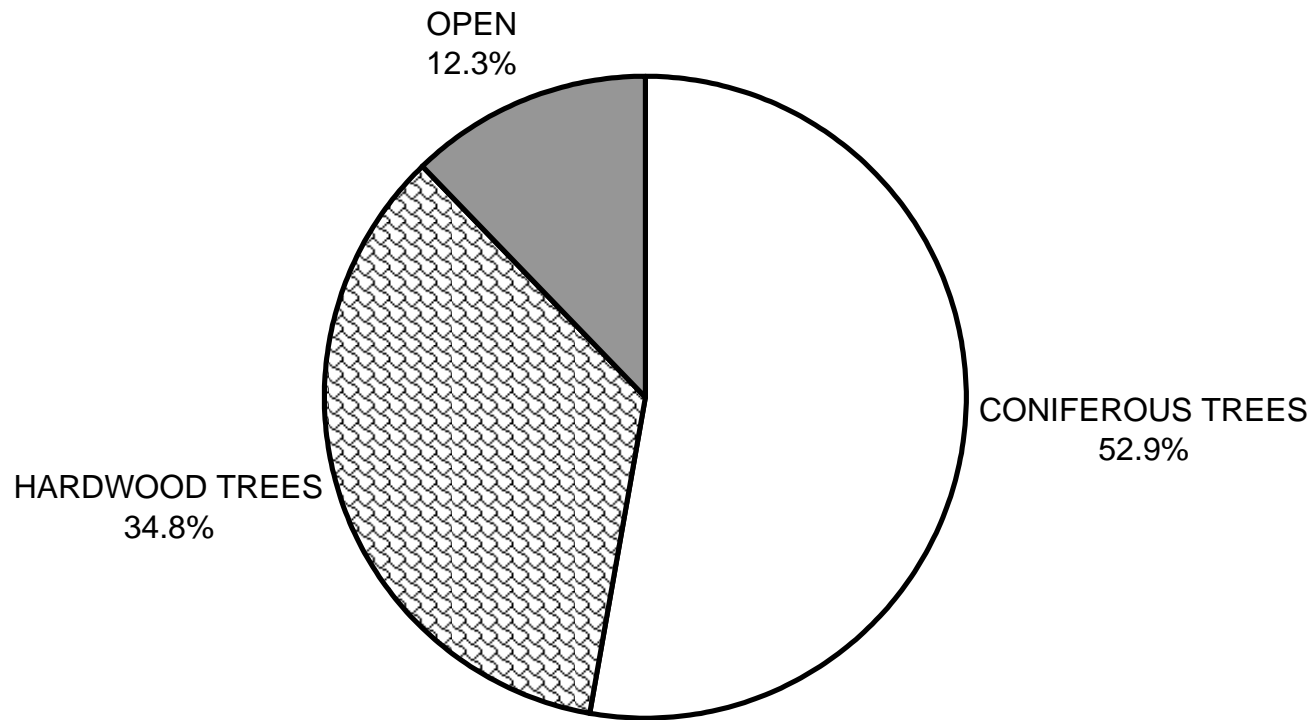
GRAPH 9

The mean percent canopy density for the surveyed length of Chamberlain Creek was 88%. Twelve percent of the canopy was open. Of the canopy present, the mean percentages of hardwood and coniferous trees were 40% and 60%, respectively. Graph 9 describes the mean percent canopy in Chamberlain Creek.

The mean percent canopy density for the stream was 88%. Reach 1 had a canopy density of 81%, Reach 2 had a canopy density of 94%, and Reach 3 had a canopy density of 95%. In general, revegetation projects are considered when canopy density is less than 80%.

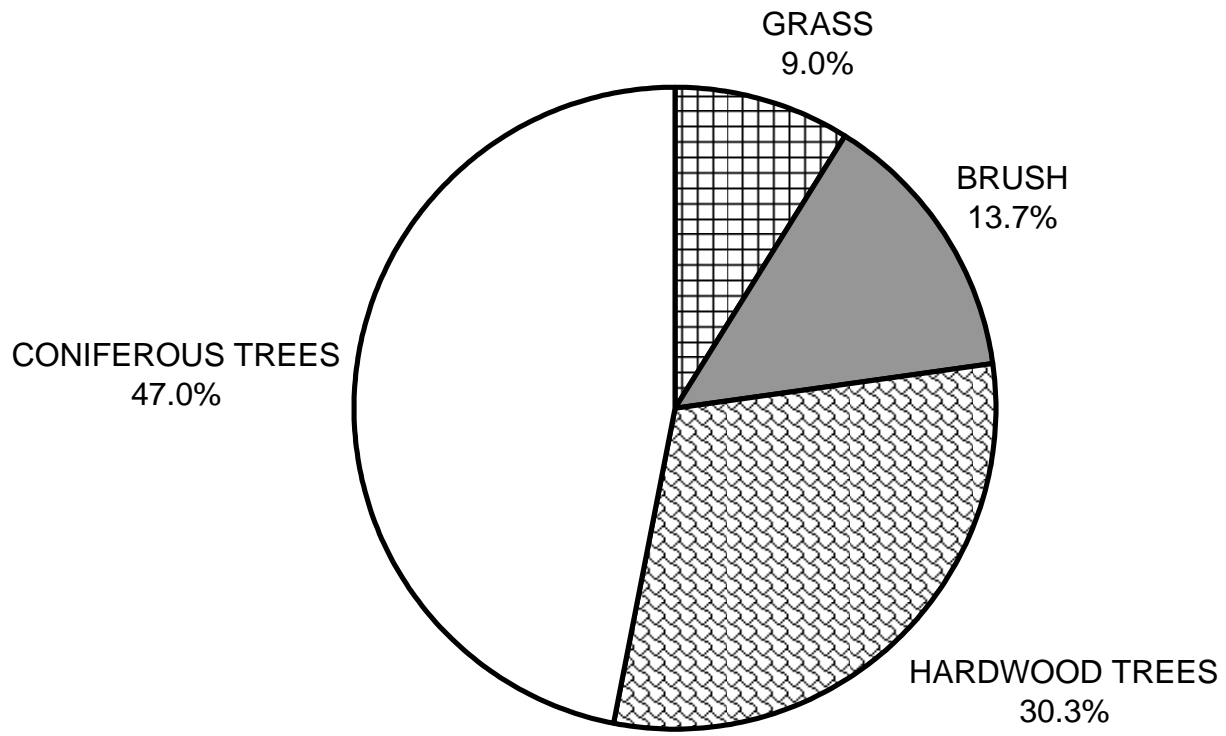
GRAPH 11

For the stream reach surveyed, the mean percent right bank vegetated was 97%. The mean percent left bank vegetated was 97%. The dominant elements composing the structure of the stream banks consisted of 42% cobble/gravel, 35% sand/silt/clay, 20% bedrock, and 4% boulder (Graph 10). Coniferous trees were the dominant vegetation type observed in 47% of the units surveyed. Additionally, 30% of the units surveyed had deciduous as the dominant vegetation type, and 14% had brush as the dominant vegetation type (Graph 11).

The percentage of right and left bank covered with vegetation was 97% and 97%, respectively. In areas of stream bank erosion or where bank vegetation is sparse, planting endemic species of coniferous and hardwood trees, in conjunction with bank stabilization, is recommended.
