STREAM INVENTORY REPORT

Chamberlain Creek

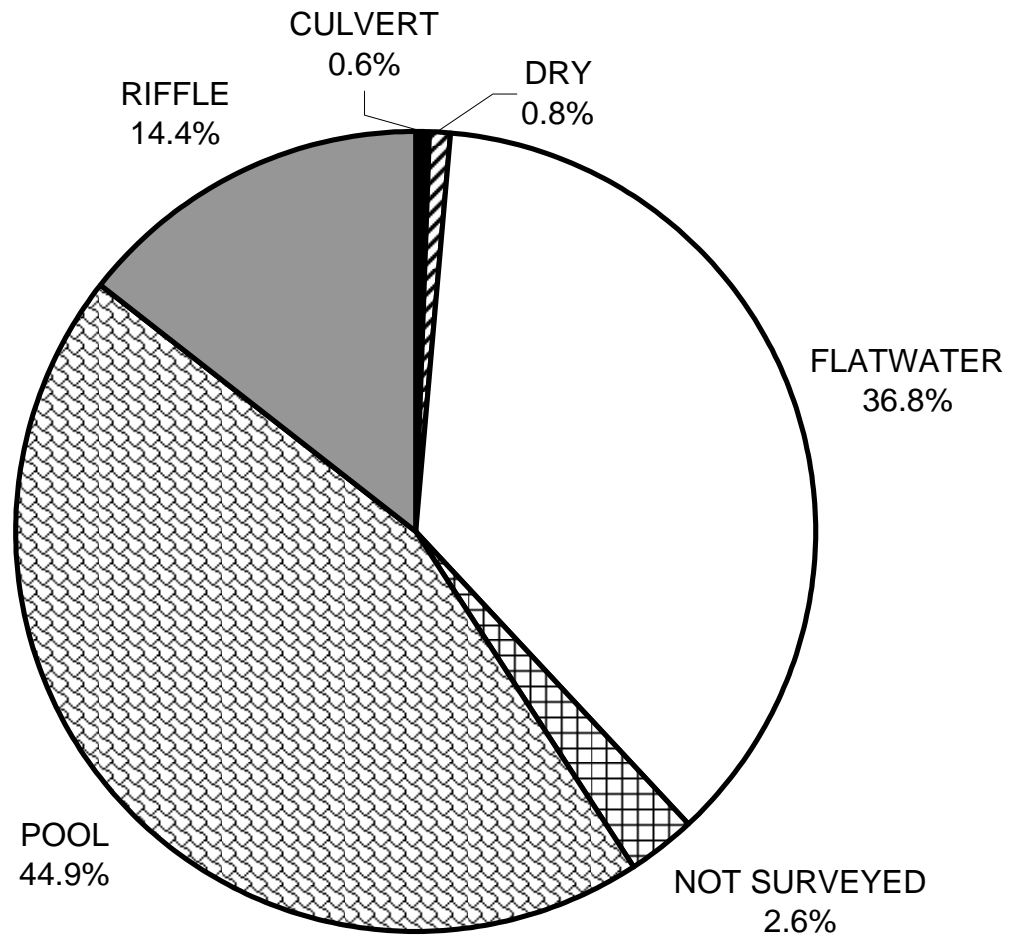
GRAPH 1

Table 1 summarizes the Level II riffle, flatwater, and pool habitat types. Based on frequency of occurrence there were 45% pool units, 37% flatwater units, 14% riffle units, 3% no survey units, 1% culvert units, and 1% dry units (Graph 1). Based on total length of Level II habitat types there were 57% flatwater units, 31% pool units, 9% riffle units, 1% no survey units, and 1% culvert units (Graph 2).

CHAMBERLAIN CREEK 2011 HABITAT TYPES BY PERCENT OCCURRENCE

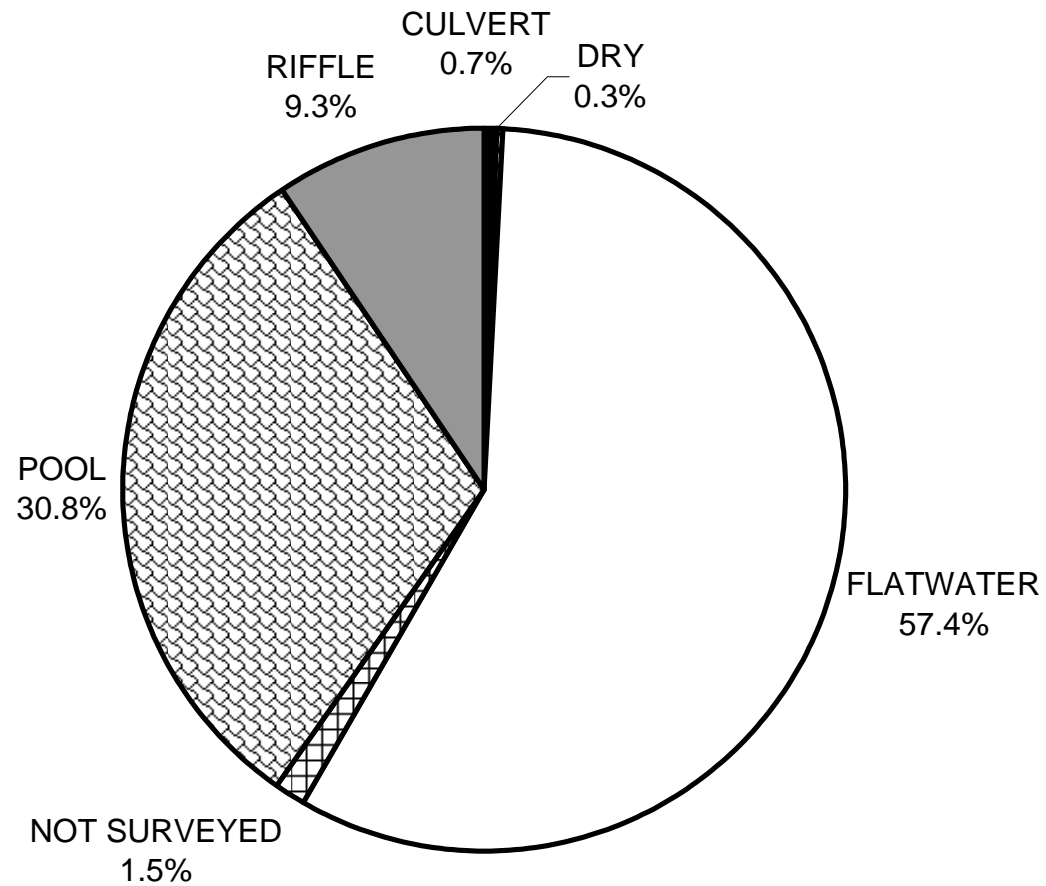
GRAPH 2

CHAMBERLAIN CREEK 2011 HABITAT TYPES BY PERCENT TOTAL LENGTH

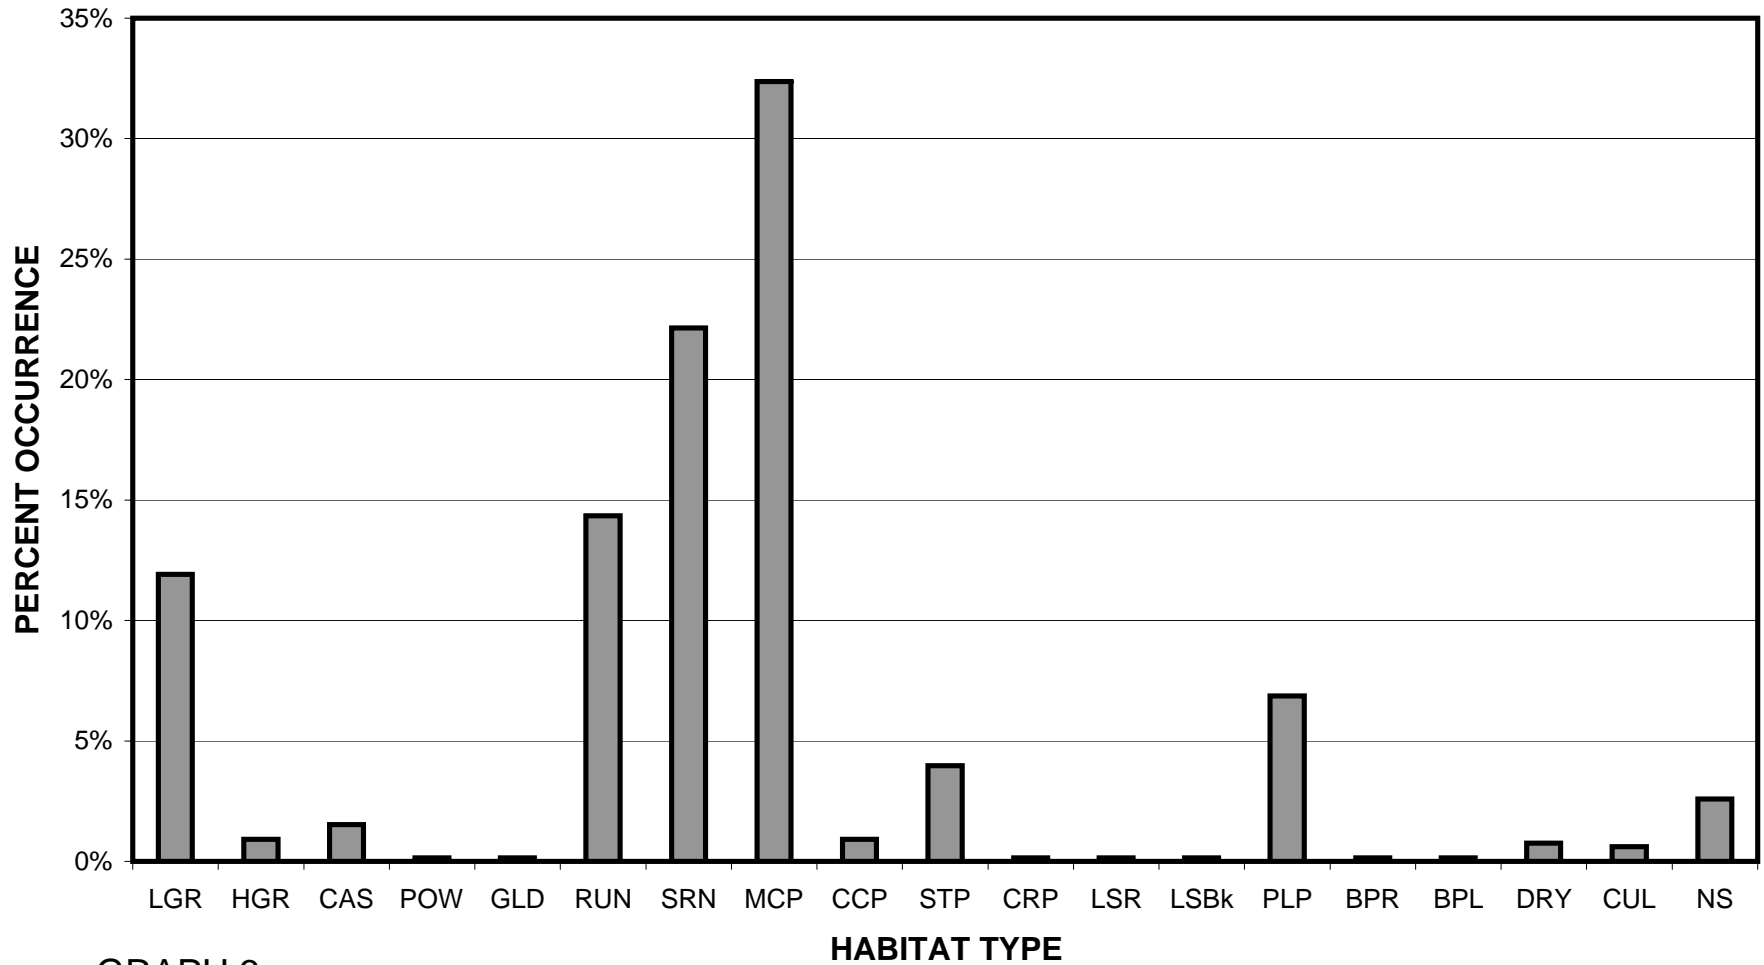
GRAPH 3

Seventeen Level IV habitat types were identified (Table 2). The most frequent habitat types by percent occurrence were mid-channel pool units, 32%; step run units, 22%; and run units, 14% (Graph 3). Based on percent total length, step run units made up 40%; mid-channel pool units 24%, and run units 17%.

HABITAT TYPES BY PERCENT OCCURRENCE

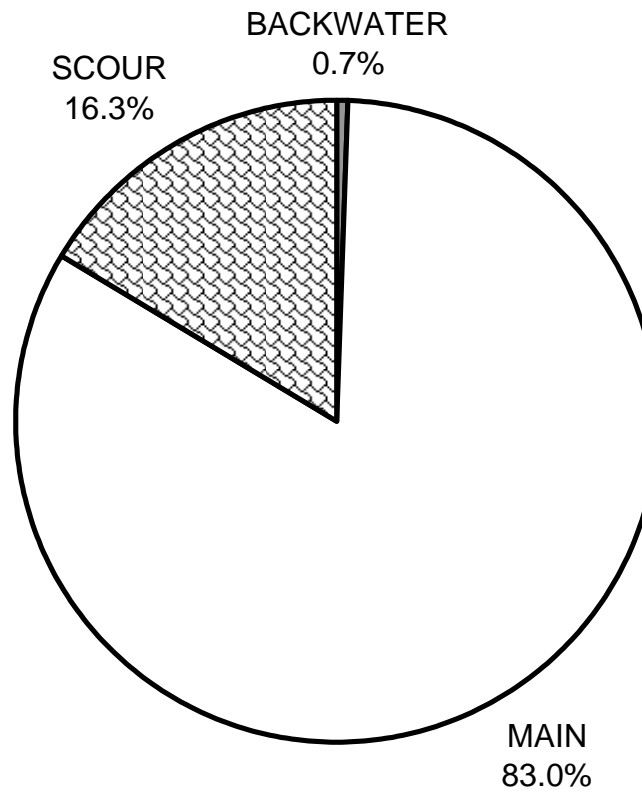
GRAPH 4

A total of 294 pools were identified (Table 3). Main channel pools were the most frequently encountered at 83% (Graph 4), and comprised 91% of the total length of all pools (Table 3).

CHAMBERLAIN CREEK 2011 POOL TYPES BY PERCENT OCCURRENCE

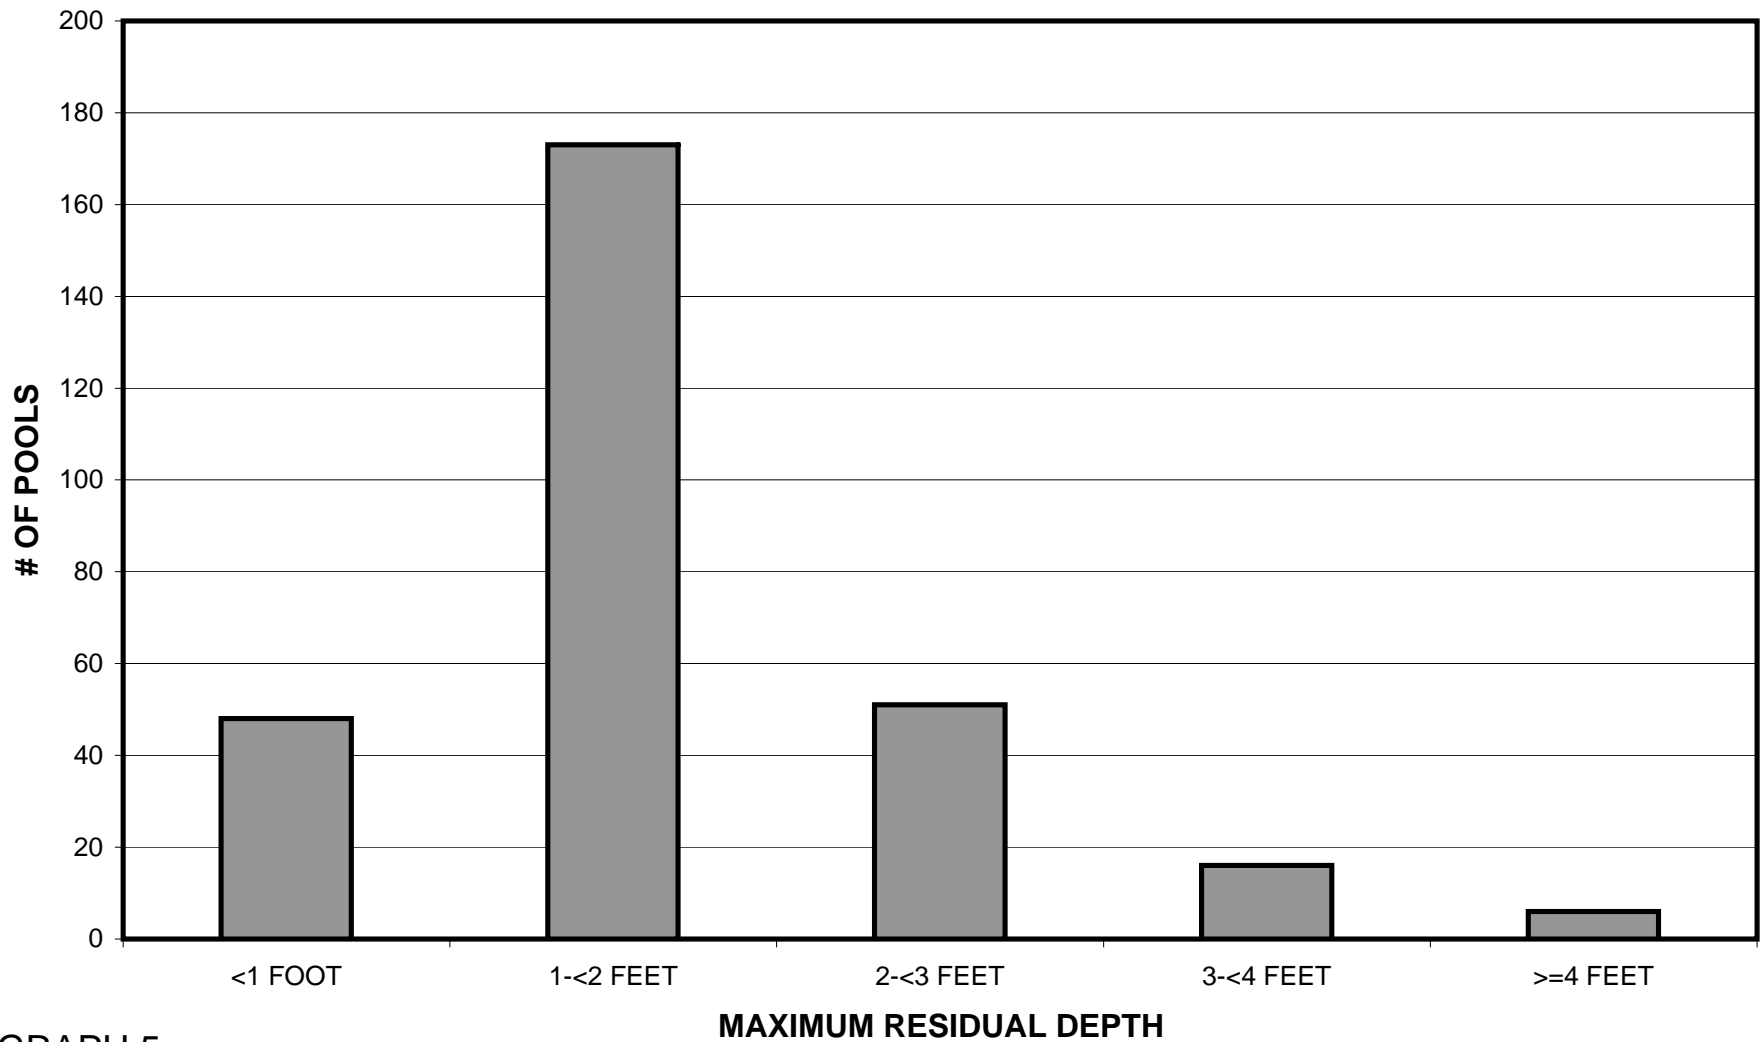
GRAPH 5

Table 4 is a summary of maximum residual pool depths by pool habitat types. Pool quality for salmonids increases with depth. Twenty-two of the 294 pools (7%) had a residual depth of three feet or greater (Graph 5).

Flatwater habitat types comprised 57% of the total length of this survey, riffles 9%, and pools 31%. Twenty-two of the 294 pools (7%) had a residual depth greater than three feet. In general, pool enhancement projects are considered when primary pools comprise less than 40% of the length of total stream habitat. In third and fourth order streams, a primary pool is defined to have a maximum residual depth of at least three feet, occupy at least half the width of the low flow channel, and be as long as the low flow channel width. Installing structures that will increase or deepen pool habitat is recommended in reach 1 and 2.

CHAMBERLAIN CREEK 2011 MAXIMUM DEPTH IN POOLS

- 3) Where feasible, design and engineer pool enhancement structures to increase the number of pools. This must be done where the banks are stable or in conjunction with stream bank armor to prevent erosion.

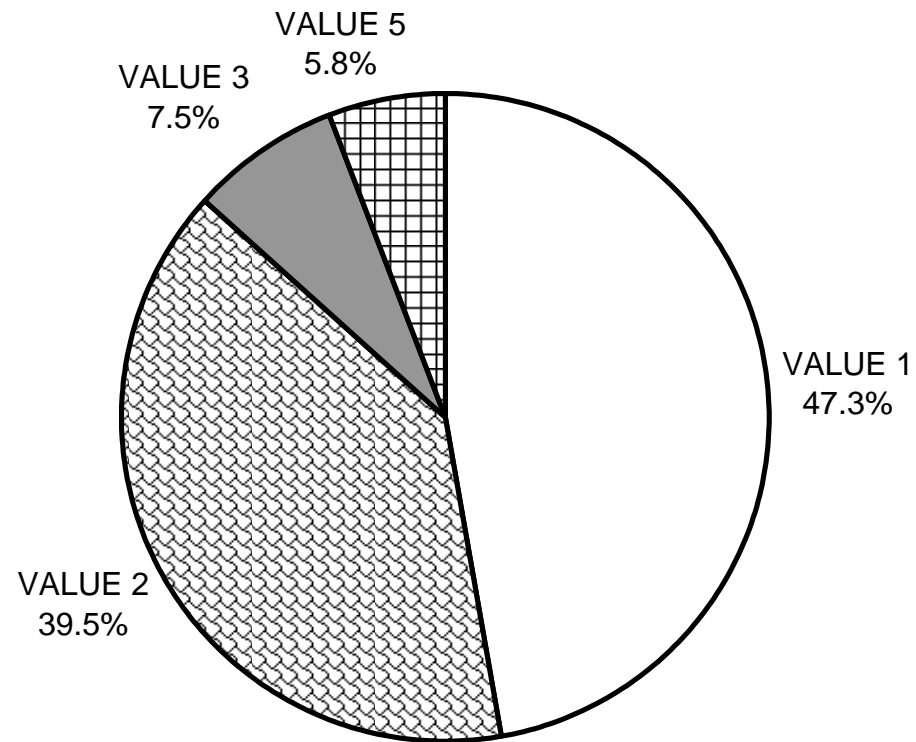
GRAPH 6

The depth of cobble embeddedness was estimated at pool tail-outs. Of the 294 pool tail-outs measured, 139 had a value of 1 (47.3%); 116 had a value of 2 (39.5%); 22 had a value of 3 (7.5%); 17 had a value of 5 (5.8%) (Graph 6). On this scale, a value of 1 indicates the best spawning conditions and a value of 4 the worst. Additionally, a value of 5 was assigned to tail-outs deemed not suitable for spawning due to inappropriate substrate such as bedrock, log sills, boulders, or other considerations.

Two hundred fifty-five of the 294 pool tail-outs measured had embeddedness ratings of 1 or 2. Twenty-two of the pool tail-outs had embeddedness ratings of 3 or 4. Seventeen of the pool tail-outs had a rating of 5, which is considered unsuitable for spawning. Cobble embeddedness measured to be 25% or less, a rating of 1, is considered to indicate good quality spawning substrate for salmon and steelhead.

CHAMBERLAIN CREEK 2011 PERCENT EMBEDDEDNESS

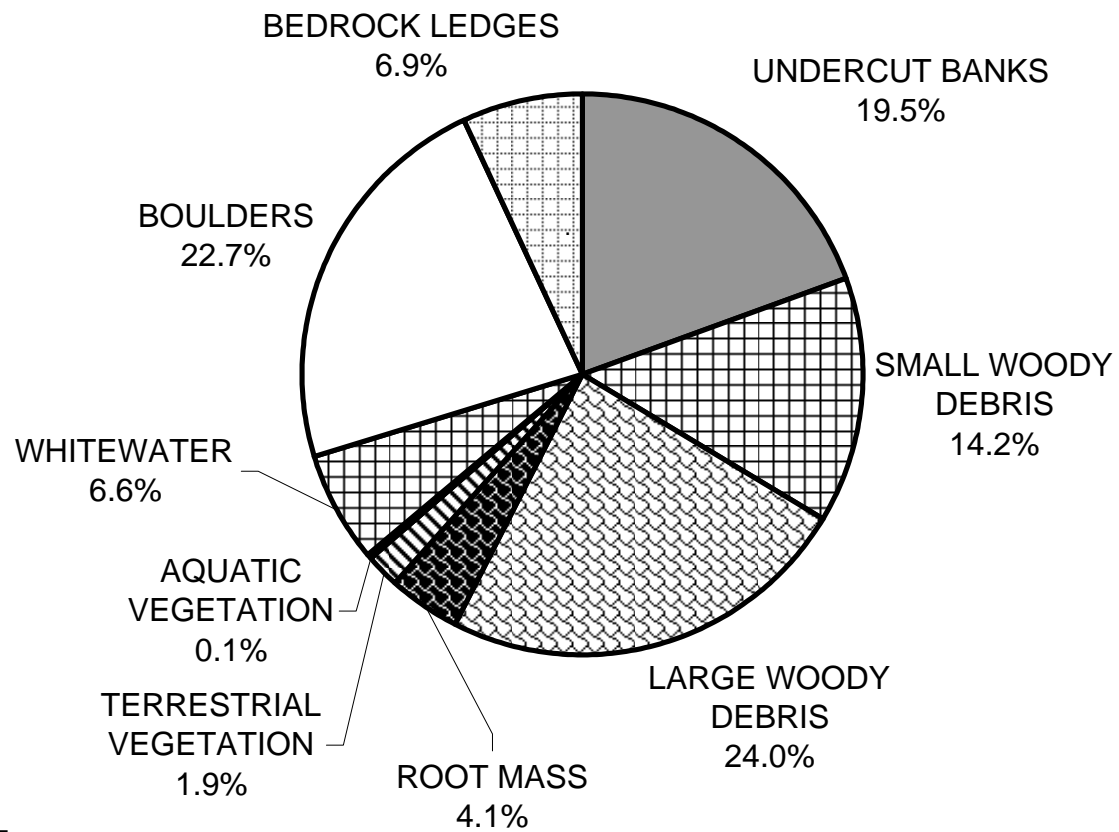
GRAPH 7

Table 5 summarizes mean percent cover by habitat type. Boulders are the dominant cover type in Chamberlain Creek. Graph 7 describes the pool cover in Chamberlain Creek. Large woody debris is the dominant pool cover type followed by boulders.

The mean shelter rating for pools is 20. The shelter rating in the flatwater habitats is 8. A pool shelter rating of approximately 100 is desirable. The amount of cover that now exists is being provided primarily by boulders in Chamberlain Creek. Large woody debris is the dominant cover type in pools followed by boulders. Log and root wad cover structures in the pool and flatwater habitats would enhance both summer and winter salmonid habitat. Log cover structures provide rearing fry with protection from predation, rest from water velocity, and also divide territorial units to reduce density related competition.

CHAMBERLAIN CREEK 2011 MEAN PERCENT COVER TYPES IN POOLS

- 4) Increase woody cover in the pools and flatwater habitat units. Most of the existing cover in the pools is from large woody debris. Adding high quality complexity with woody cover in the pools is desirable.

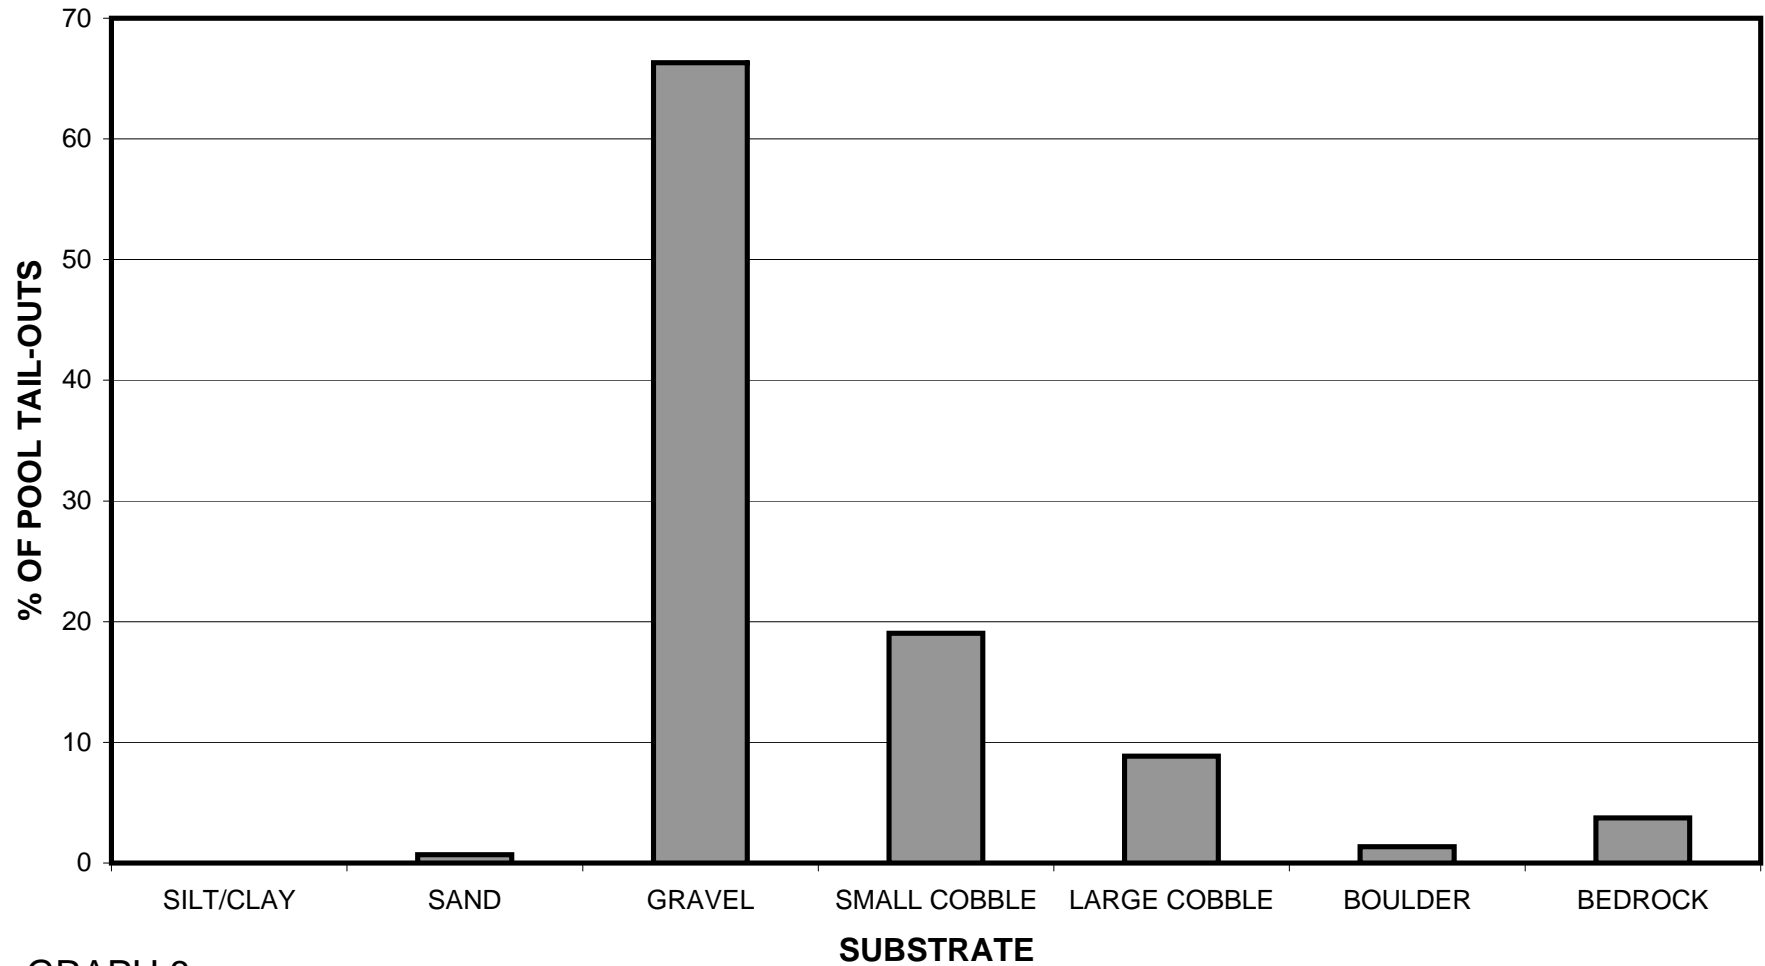
GRAPH 8

Table 6 summarizes the dominant substrate by habitat type. Graph 8 depicts the dominant substrate observed in pool tail-outs. Gravel was the dominant substrate observed in 66% of the pool tail-outs. Small cobble was the next most frequently observed dominant substrate type and occurred in 19% of the pool tail-outs.

Two hundred fifty-one of the 294 pool tail-outs measured had gravel or small cobble as the dominant substrate. This is generally considered good for spawning salmonids.

SUBSTRATE COMPOSITION IN POOL TAIL-OUTS

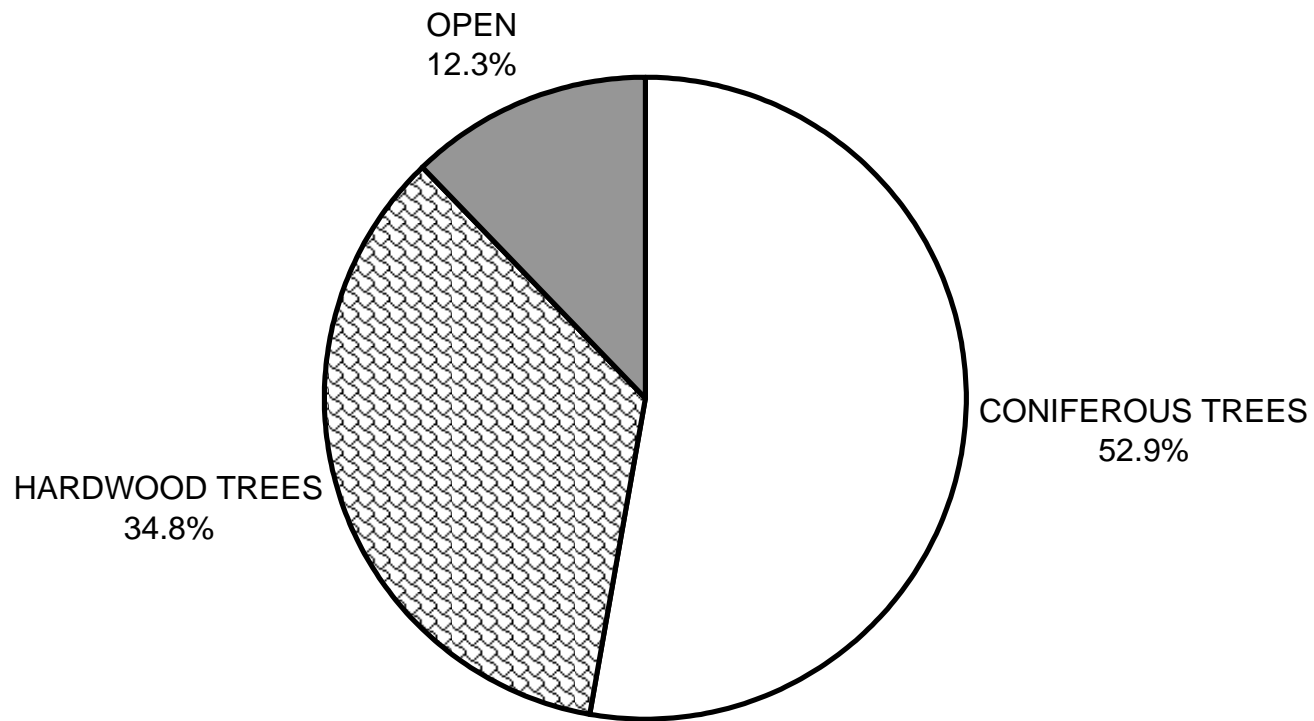
GRAPH 9

The mean percent canopy density for the surveyed length of Chamberlain Creek was 88%. Twelve percent of the canopy was open. Of the canopy present, the mean percentages of hardwood and coniferous trees were 40% and 60%, respectively. Graph 9 describes the mean percent canopy in Chamberlain Creek.

The mean percent canopy density for the stream was 88%. Reach 1 had a canopy density of 81%, Reach 2 had a canopy density of 94%, and Reach 3 had a canopy density of 95%. In general, revegetation projects are considered when canopy density is less than 80%.

CHAMBERLAIN CREEK 2011 MEAN PERCENT CANOPY

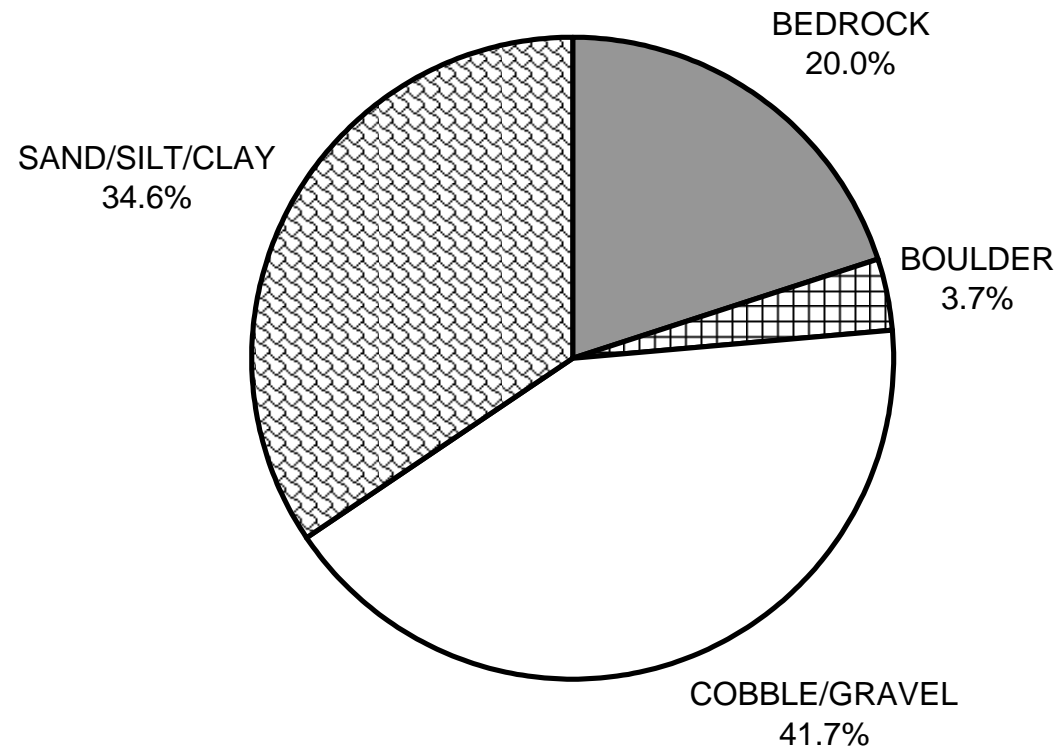
GRAPH 10

For the stream reach surveyed, the mean percent right bank vegetated was 97%. The mean percent left bank vegetated was 97%. The dominant elements composing the structure of the stream banks consisted of 42% cobble/gravel, 35% sand/silt/clay, 20% bedrock, and 4% boulder (Graph 10). Coniferous trees were the dominant vegetation type observed in 47% of the units surveyed. Additionally, 30% of the units surveyed had deciduous as the dominant vegetation type, and 14% had brush as the dominant vegetation type (Graph 11).

**CHAMBERLAIN CREEK 2011
DOMINANT BANK COMPOSITION IN SURVEY REACH**

The percentage of right and left bank covered with vegetation was 97% and 97%, respectively. In areas of stream bank erosion or where bank vegetation is sparse, planting endemic species of coniferous and hardwood trees, in conjunction with bank stabilization, is recommended.

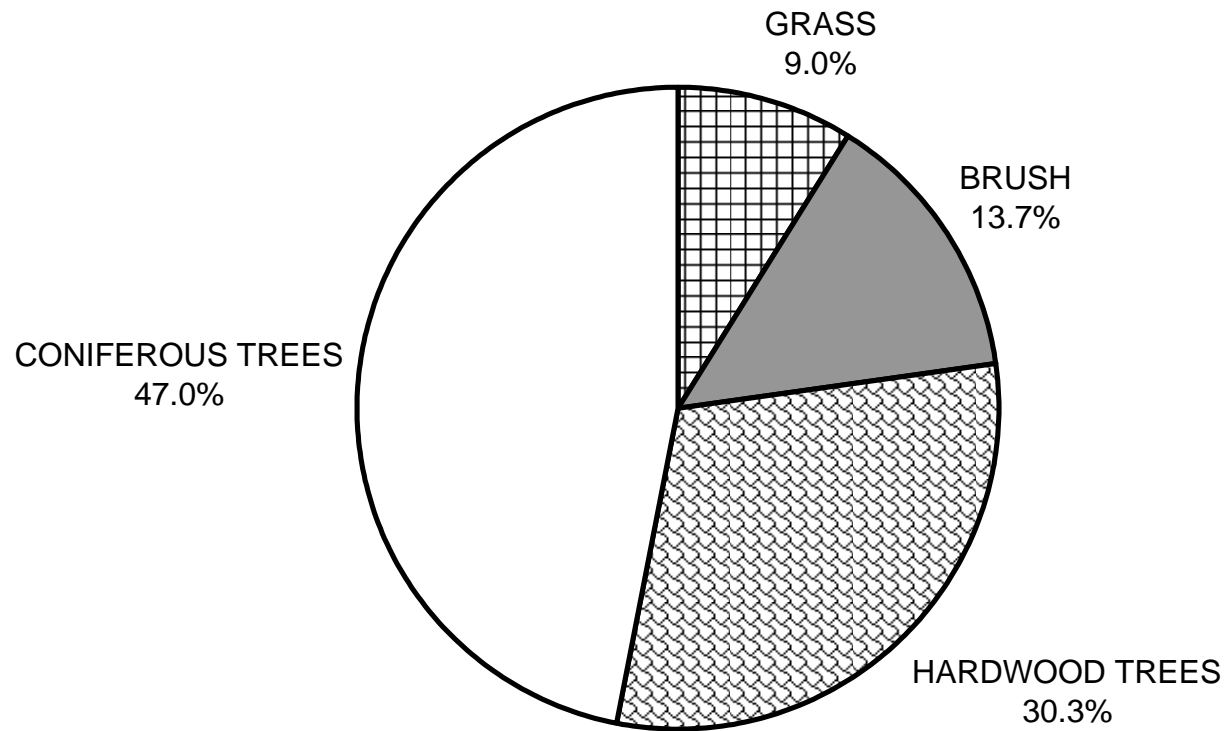
GRAPH 11

**CHAMBERLAIN CREEK 2011
DOMINANT BANK VEGETATION IN SURVEY REACH**
