# STREAM INVENTORY REPORT

## East Branch North Fork Big River

A stream inventory was conducted from June 7 to June 22, 2011 on East Branch North Fork Big River. The survey began at the confluence with North Fork Big River and extended upstream 7.8 miles. A stream inventory and report was also completed for one tributary to East Branch North Fork Big River.

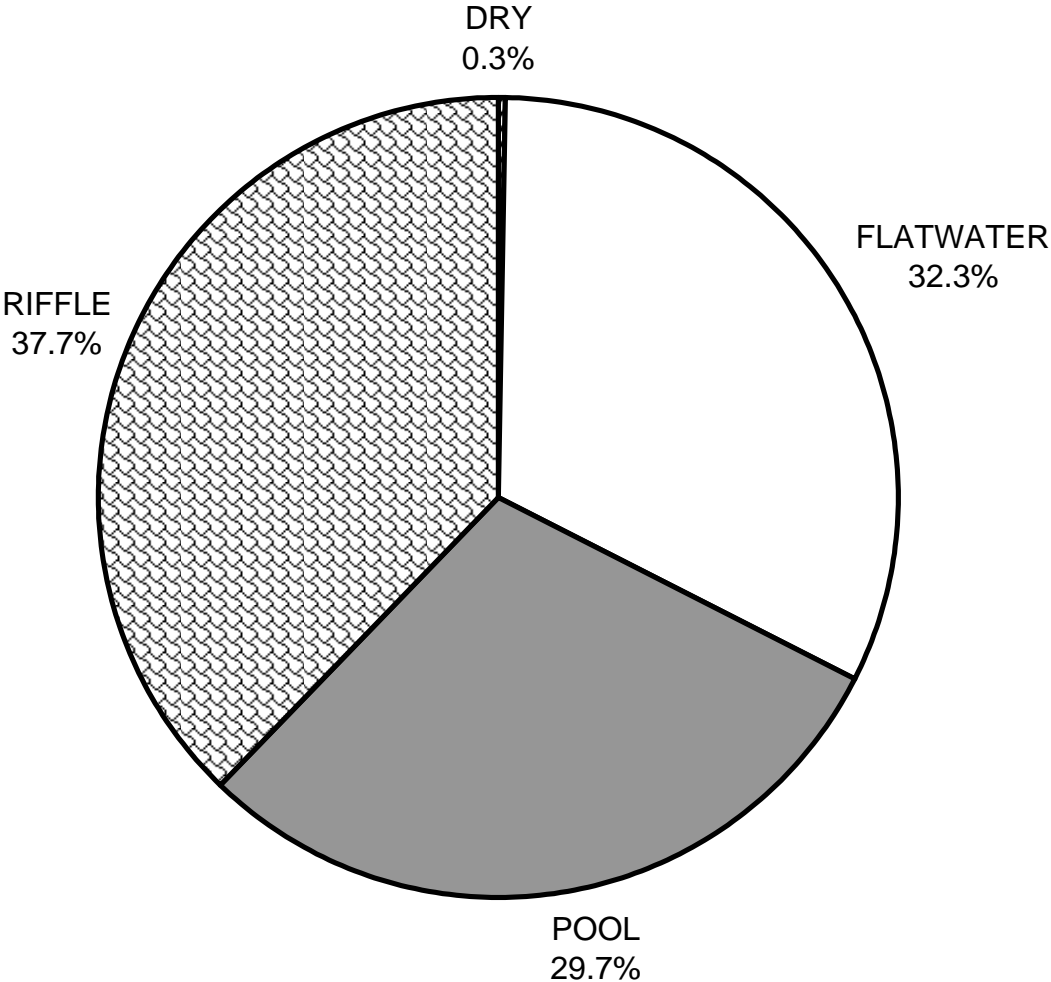
GRAPH 1

Table 1 summarizes the Level II riffle, flatwater, and pool habitat types. Based on frequency of occurrence there were 38% riffle units, 32% flatwater units, and 30% pool units (Graph 1). Based on total length of Level II habitat types there were 42% flatwater units, 34% riffle units, 23% pool units, and 1% dry units (Graph 2).

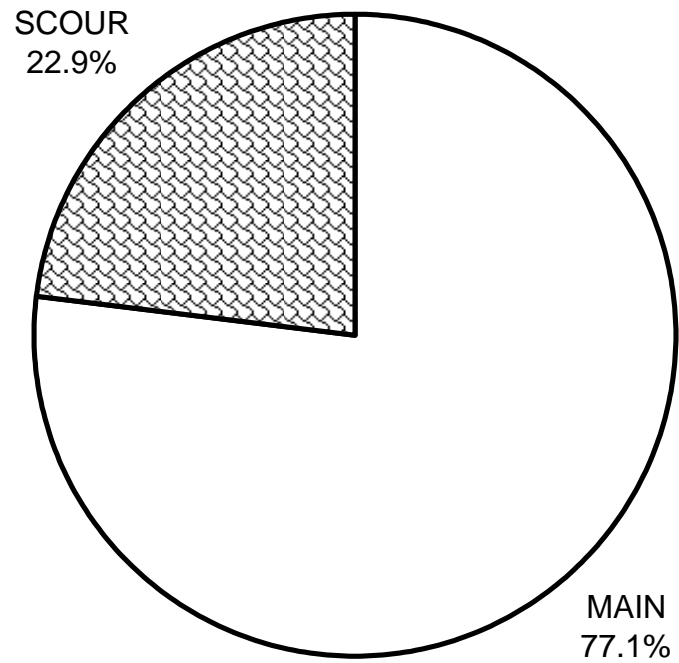
GRAPH 4

A total of 266 pools were identified (Table 3). Main channel pools were the most frequently encountered at 77% (Graph 4), and comprised 79% of the total length of all pools (Table 3).

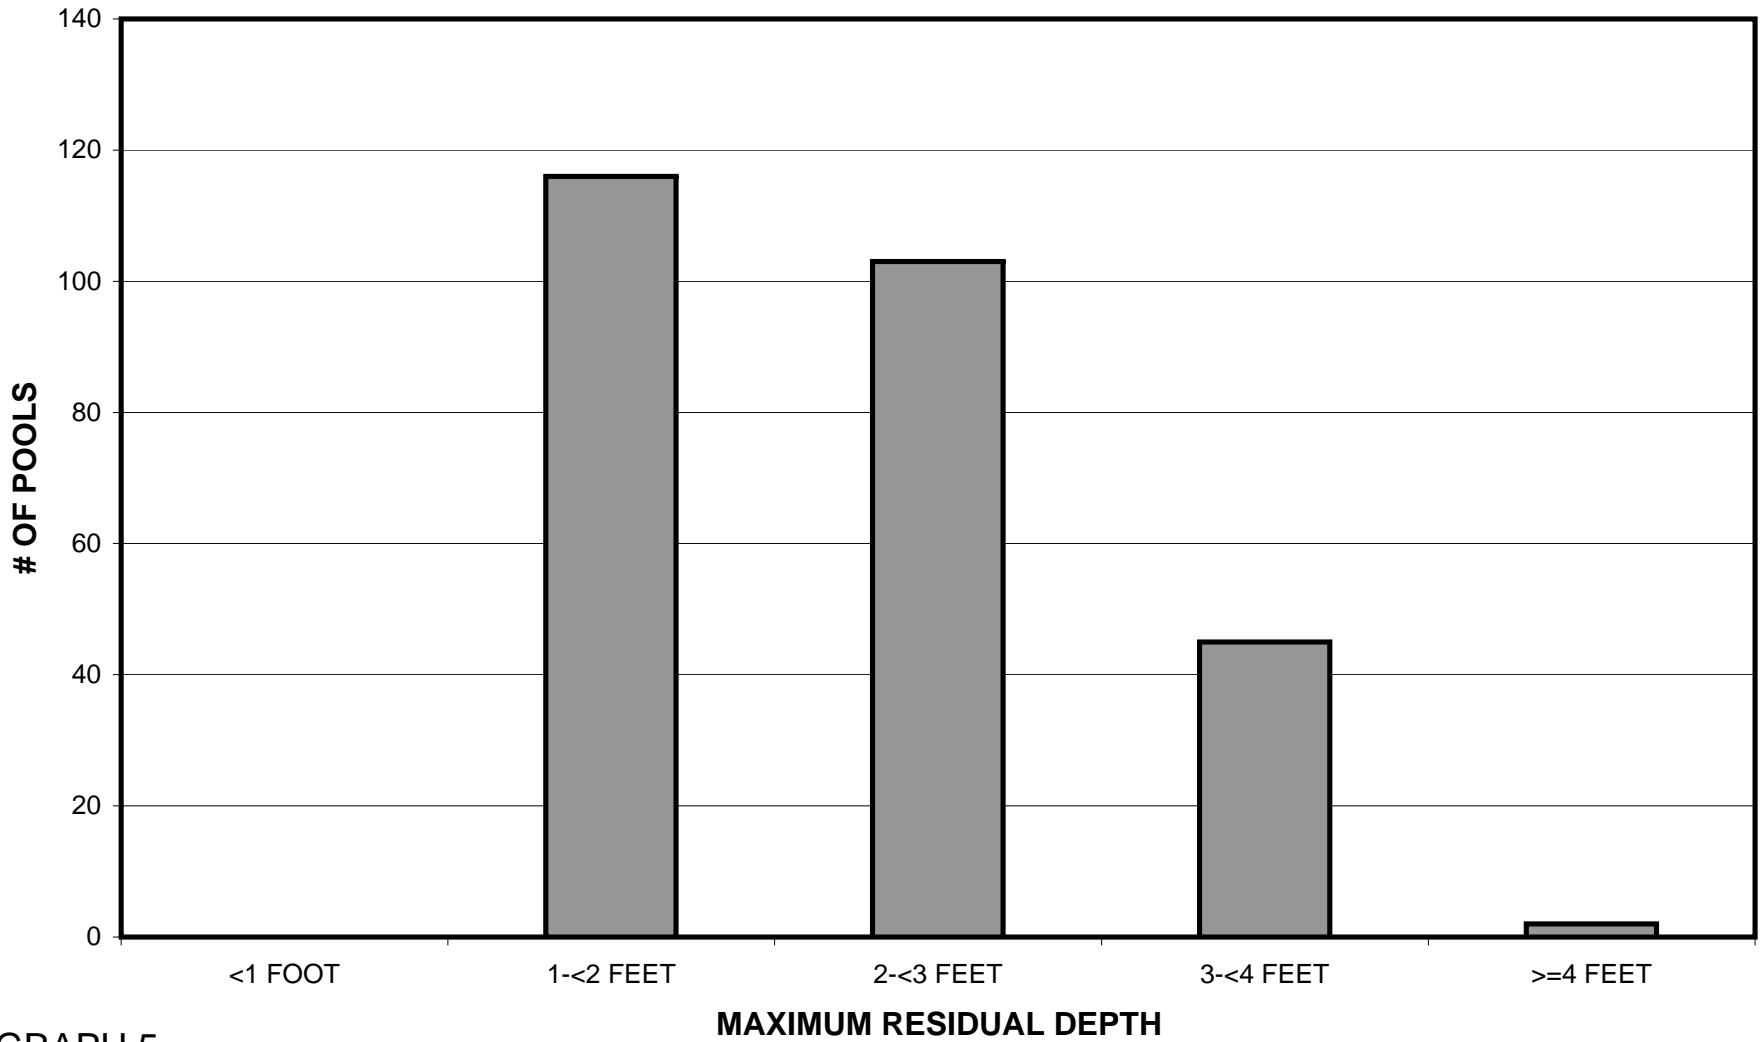
GRAPH 5

Table 4 is a summary of maximum residual pool depths by pool habitat types. Pool quality for salmonids increases with depth. Forty-seven of the 266 pools (18%) had a residual depth of three feet or greater (Graph 5).

Flatwater habitat types comprised 42% of the total length of this survey, riffles 34%, and pools 23%. Forty-seven of the 266 (18%) pools had a maximum residual depth greater than 3 feet. In general, pool enhancement projects are considered when primary pools comprise less than 40% of the length of total stream habitat. In third and fourth order streams, a primary pool is defined to have a maximum residual depth of at least three feet, occupy at least half the width of the low flow channel, and be as long as the low flow channel width. Installing structures that will increase or deepen pool habitat is recommended.

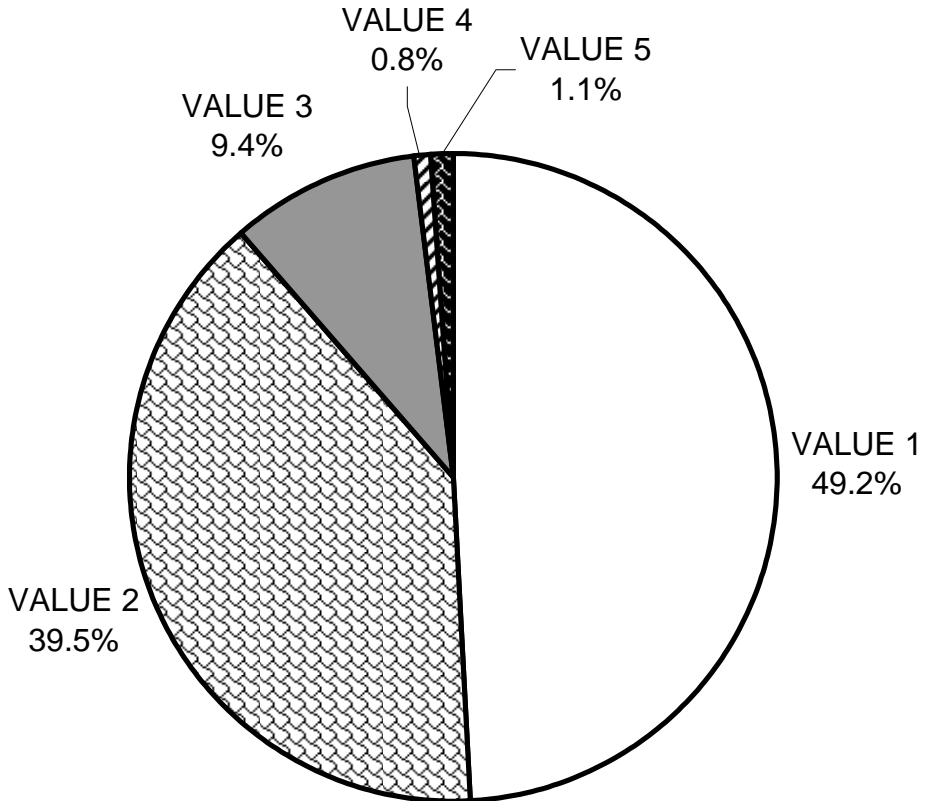
GRAPH 6

The depth of cobble embeddedness was estimated at pool tail-outs. Of the 266 pool tail-outs measured, 131 had a value of 1 (49.2%); 105 had a value of 2 (39.5%); 25 had a value of 3 (9.4%); 2 had a value of 4 (0.8%); 3 had a value of 5 (1.1%) (Graph 6). On this scale, a value of 1 indicates the highest quality of spawning substrate. Additionally, a value of 5 was assigned to tail-outs deemed not suitable for spawning due to inappropriate substrate such as bedrock, log sills, boulders, or other considerations.

Two hundred thirty-six of the 266 pool tail-outs measured had embeddedness ratings of 1 or 2. Twenty-seven of the pool tail-outs had embeddedness ratings of 3 or 4. Three of the pool tail-outs had a rating of 5, which is considered unsuitable for spawning. Cobble embeddedness measured to be 25% or less, a rating of 1, is considered to indicate good quality spawning substrate for salmon and steelhead.

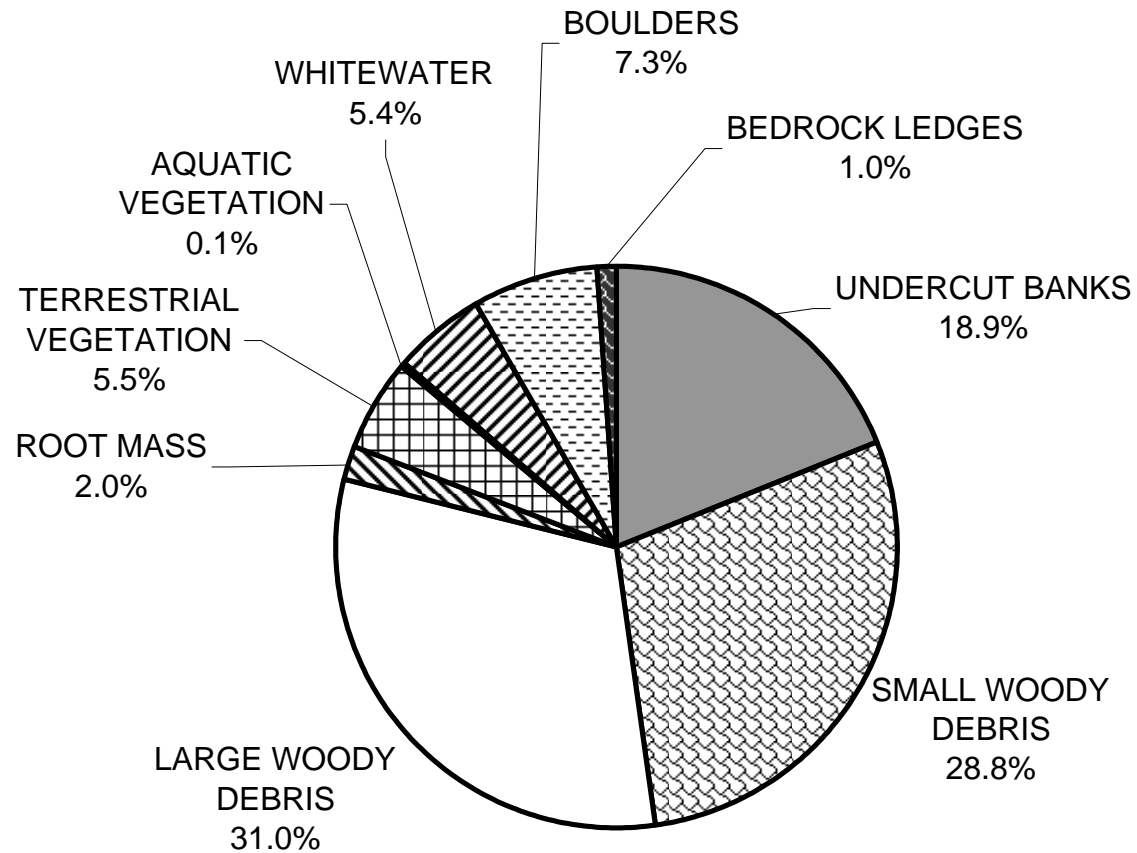
GRAPH 7

Table 5 summarizes mean percent cover by habitat type. Small woody debris is the dominant cover type in East Branch North Fork Big River. Graph 7 describes the pool cover in East Branch North Fork Big River. Large woody debris is the dominant pool cover type followed by small woody debris.

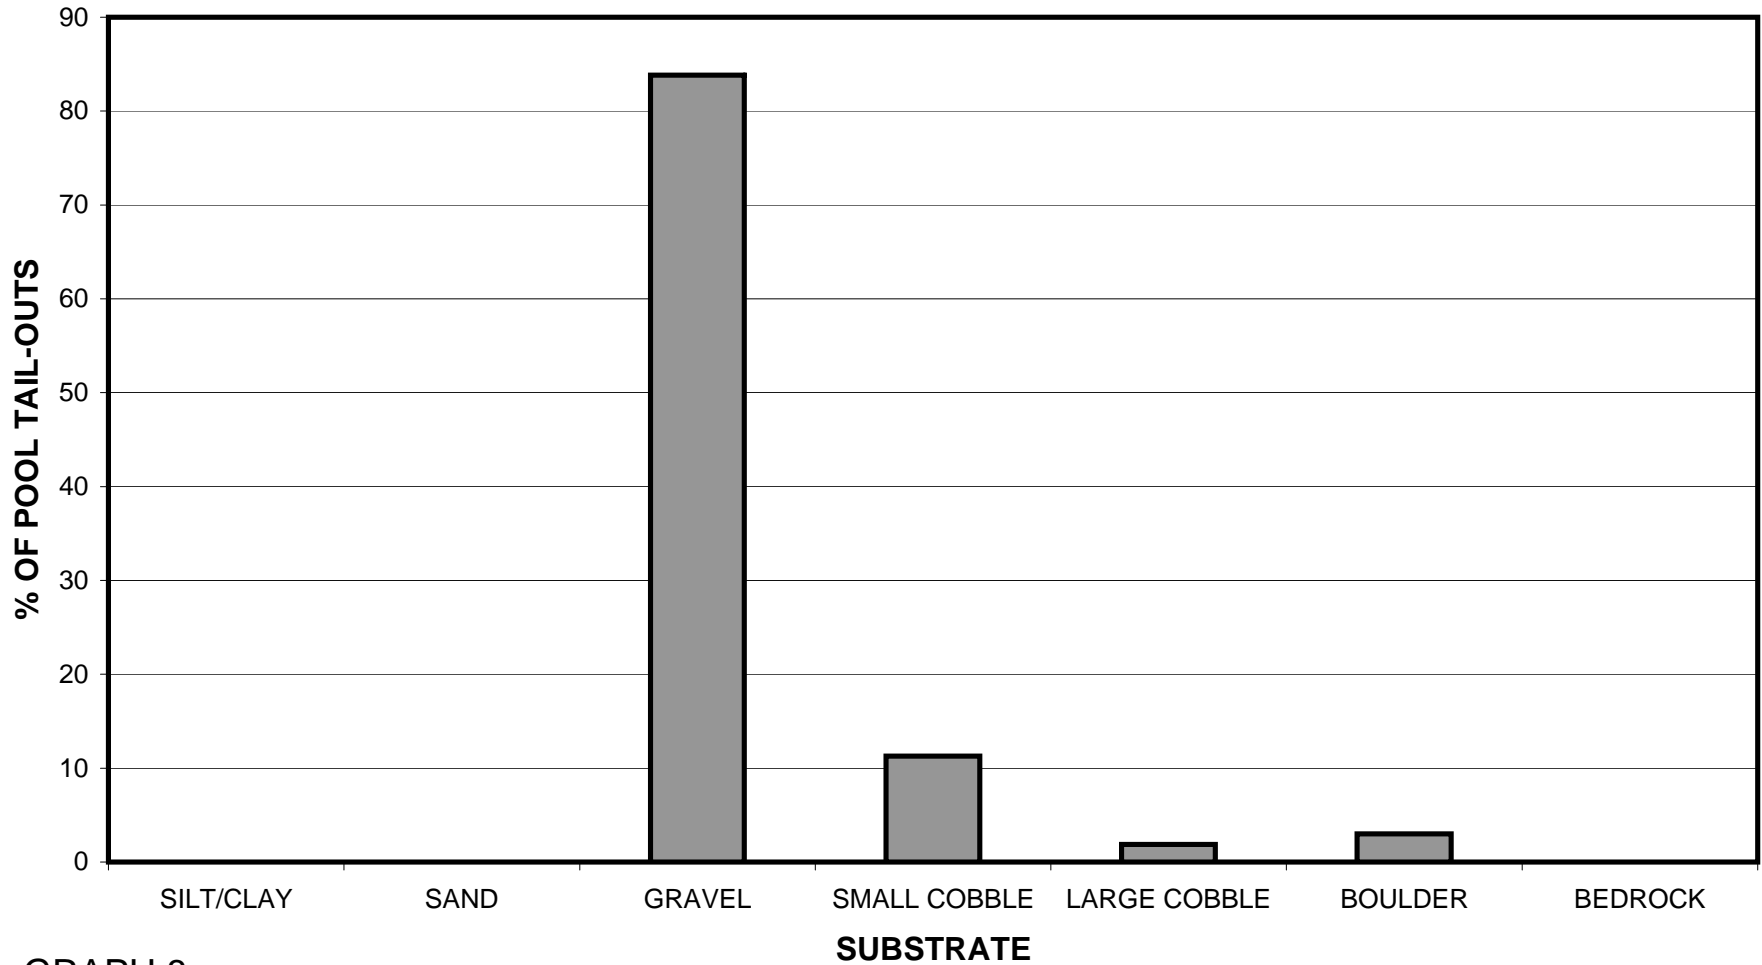
GRAPH 8

Table 6 summarizes the dominant substrate by habitat type. Graph 8 depicts the dominant substrate observed in pool tail-outs. Gravel was the dominant substrate observed in 84% of the pool tail-outs. Small cobble was the next most frequently observed dominant substrate type and occurred in 11% of the pool tail-outs.

Two hundred fifty-three of the 266 pool tail-outs measured had gravel or small cobble as the dominant substrate. This is generally considered good for spawning salmonids.

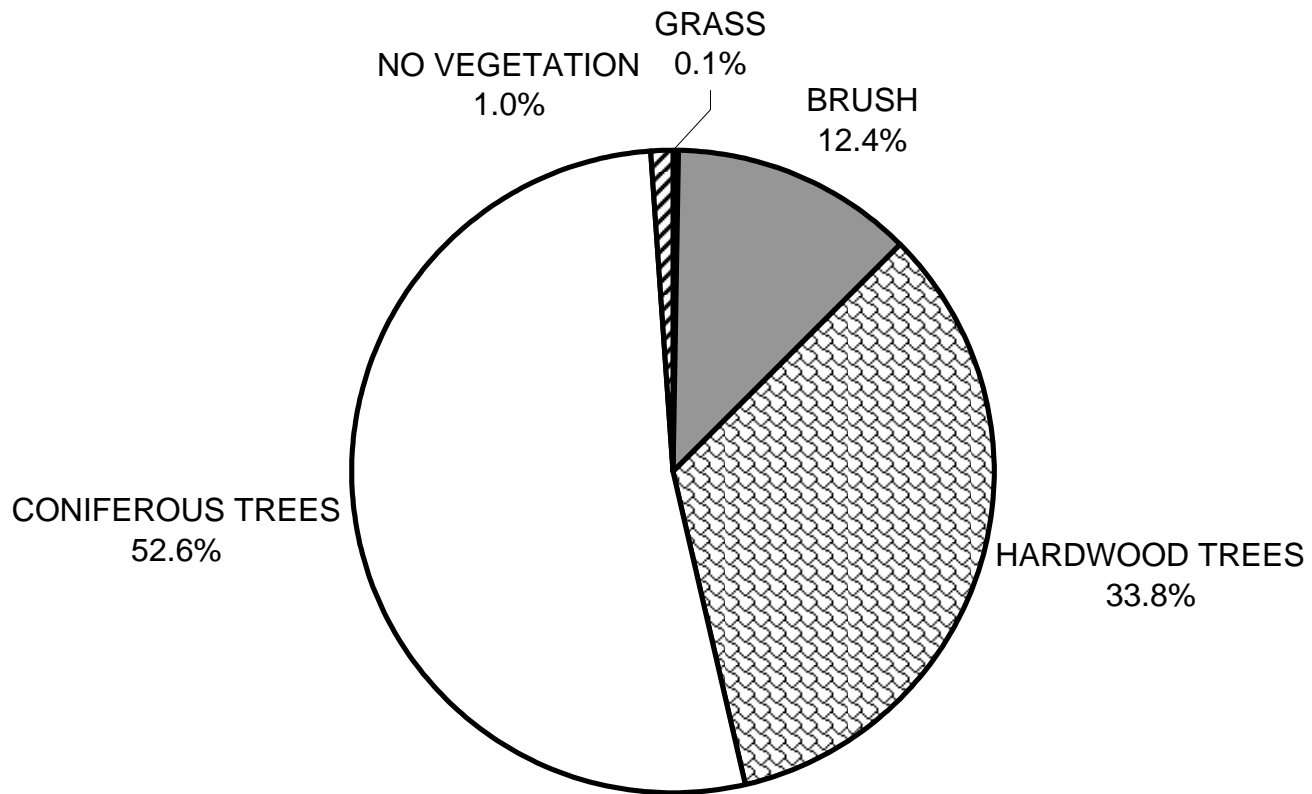
GRAPH 11

For the stream reach surveyed, the mean percent right bank vegetated was 97%. The mean percent left bank vegetated was 95%. The dominant elements composing the structure of the stream banks consisted of 44% cobble/gravel, 42% sand/silt/clay, 11% bedrock, and 3% boulder (Graph 10). Coniferous trees were the dominant vegetation type observed in 53% of the units surveyed. Additionally, 34% of the units surveyed had deciduous trees as the dominant vegetation type, and 12% had brush as the dominant vegetation type (Graph 11).

The percentage of right and left bank covered with vegetation was 97% and 95%, respectively. In areas of stream bank erosion or where bank vegetation is sparse, planting endemic species of coniferous and hardwood trees, in conjunction with bank stabilization, is recommended.
