STREAM INVENTORY REPORT

East Branch North Fork Big River

A stream inventory was conducted from June 7 to June 22, 2011 on East Branch North Fork Big River. The survey began at the confluence with North Fork Big River and extended upstream 7.8 miles. A stream inventory and report was also completed for one tributary to East Branch North Fork Big River.

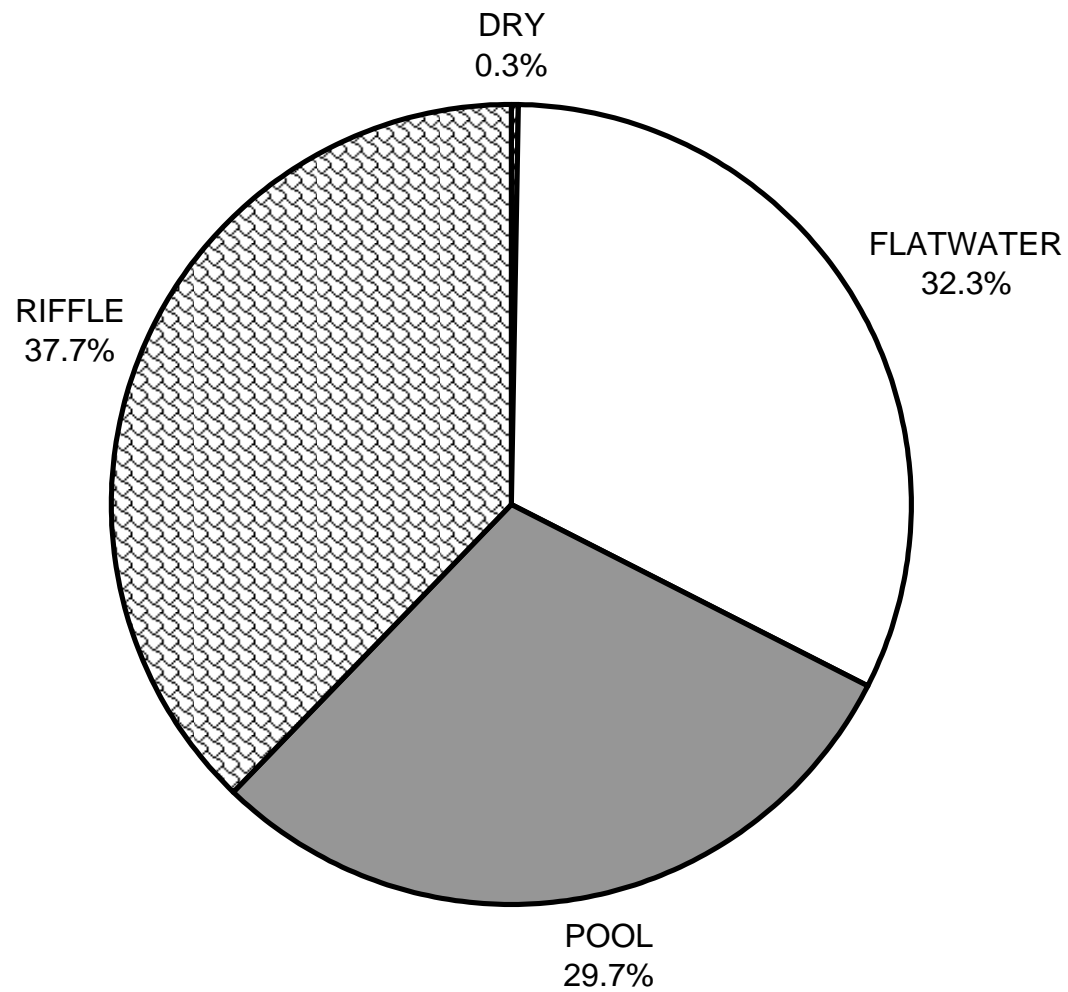
GRAPH 1

Table 1 summarizes the Level II riffle, flatwater, and pool habitat types. Based on frequency of occurrence there were 38% riffle units, 32% flatwater units, and 30% pool units (Graph 1). Based on total length of Level II habitat types there were 42% flatwater units, 34% riffle units, 23% pool units, and 1% dry units (Graph 2).

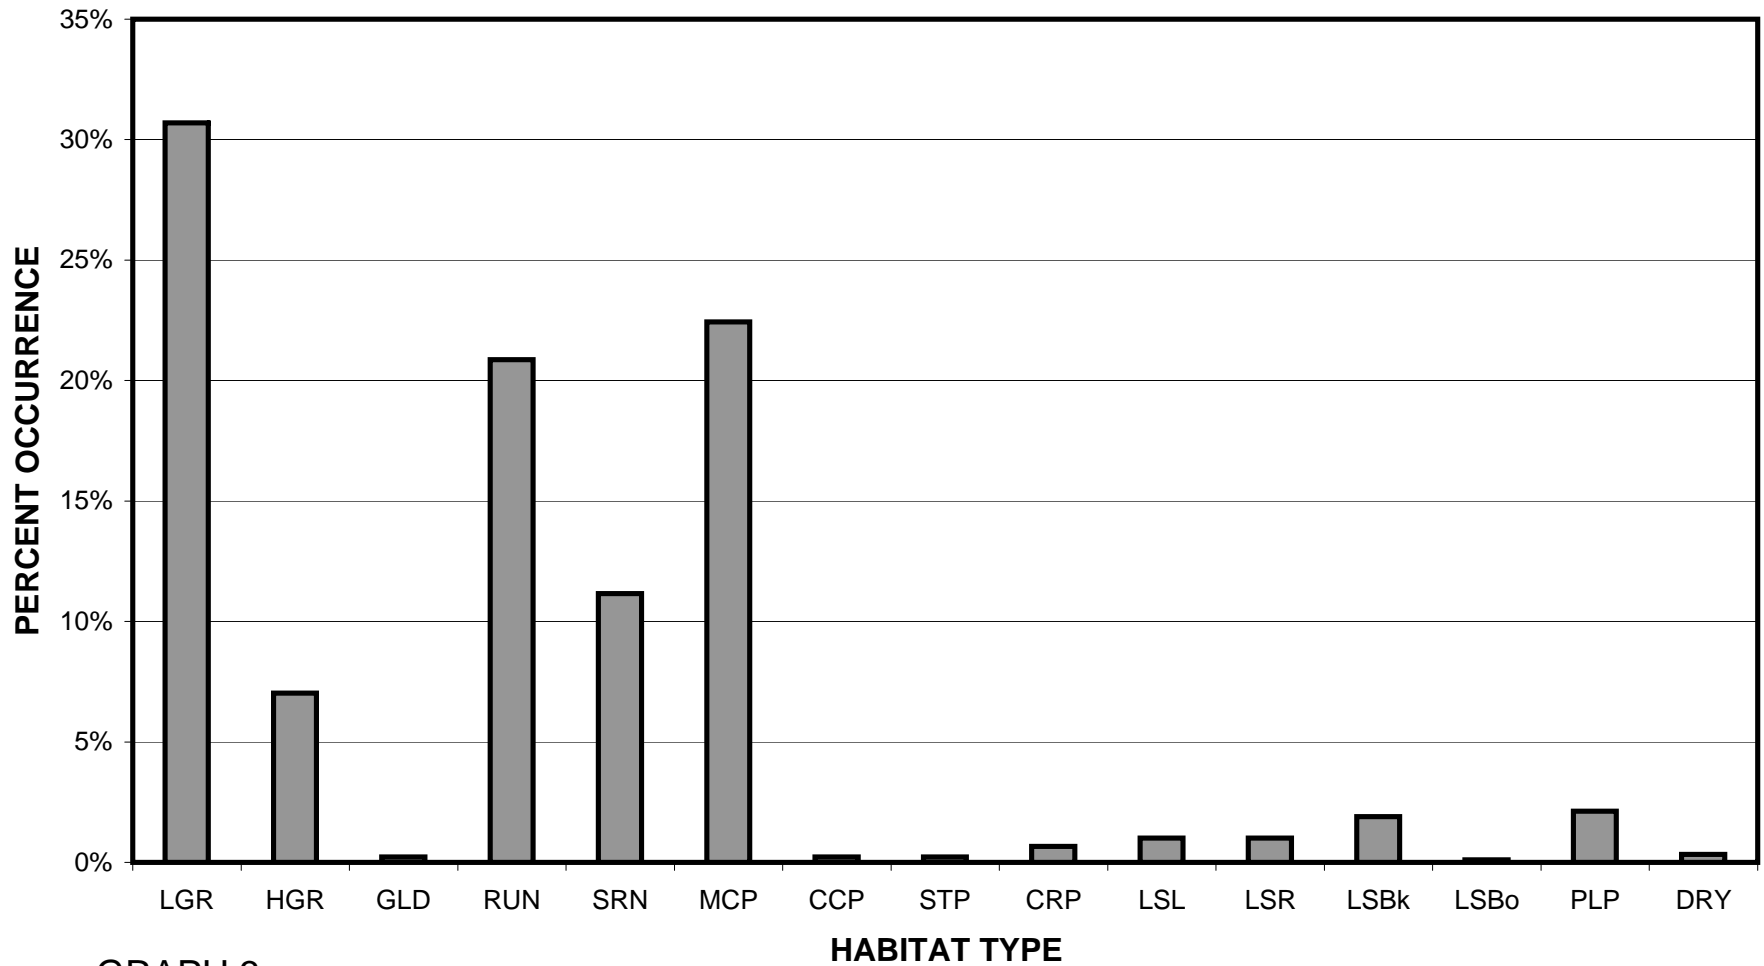
GRAPH 3

Fifteen Level IV habitat types were identified (Table 2). The most frequent habitat types by percent occurrence were low gradient riffle units, 31%; mid-channel pool units, 22%; and run units 21% (Graph 3). Based on percent total length, low gradient riffle units made up 28%, step run units 24%, run units 18%, and mid-channel pool units 18%.

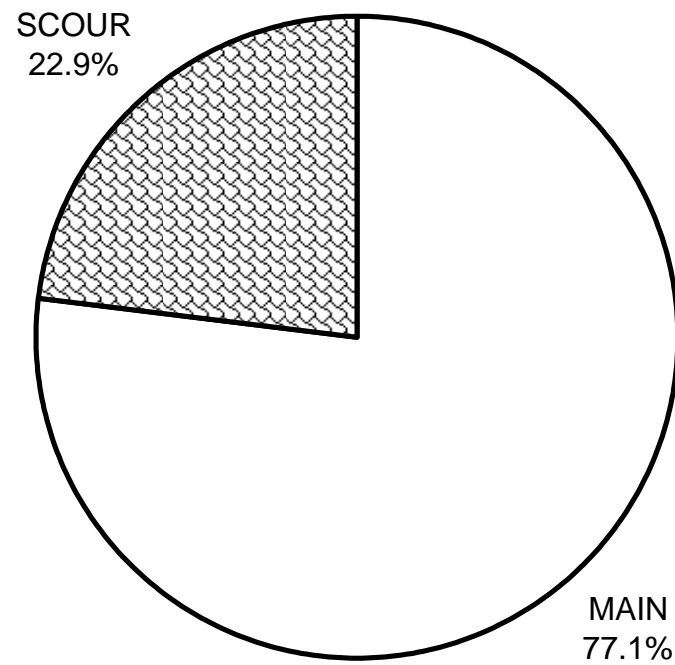
GRAPH 4

A total of 266 pools were identified (Table 3). Main channel pools were the most frequently encountered at 77% (Graph 4), and comprised 79% of the total length of all pools (Table 3).

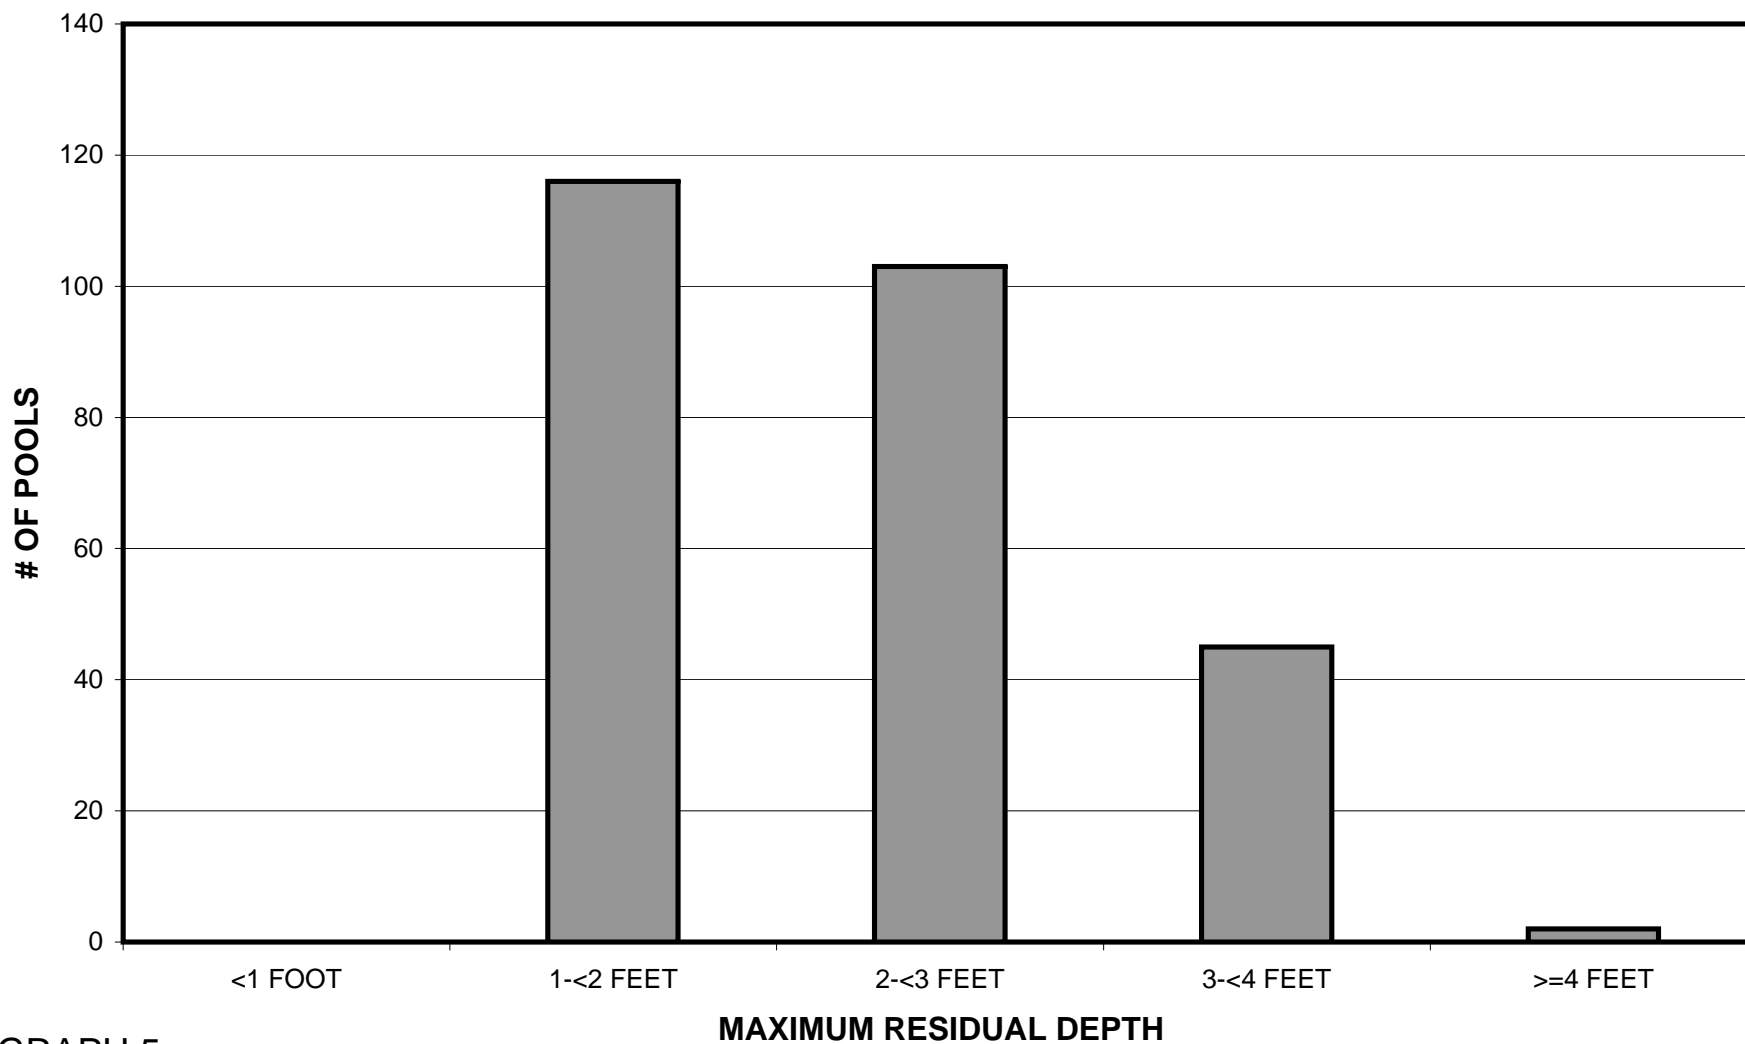
GRAPH 5

Table 4 is a summary of maximum residual pool depths by pool habitat types. Pool quality for salmonids increases with depth. Forty-seven of the 266 pools (18%) had a residual depth of three feet or greater (Graph 5).

Flatwater habitat types comprised 42% of the total length of this survey, riffles 34%, and pools 23%. Forty-seven of the 266 (18%) pools had a maximum residual depth greater than 3 feet. In general, pool enhancement projects are considered when primary pools comprise less than 40% of the length of total stream habitat. In third and fourth order streams, a primary pool is defined to have a maximum residual depth of at least three feet, occupy at least half the width of the low flow channel, and be as long as the low flow channel width. Installing structures that will increase or deepen pool habitat is recommended.

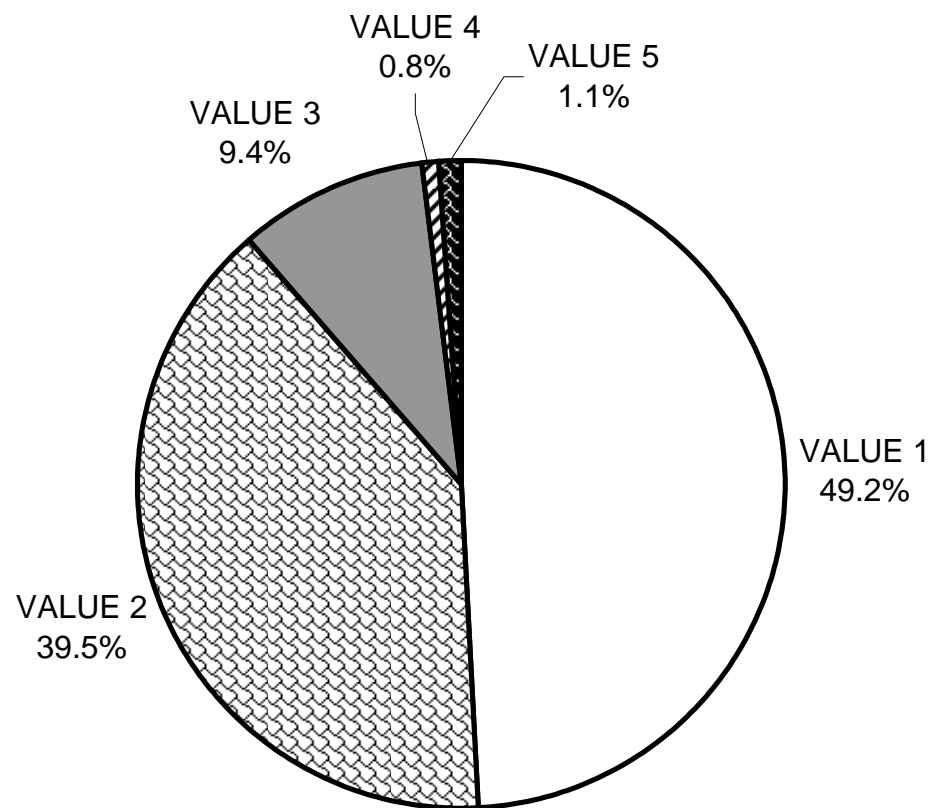
GRAPH 6

The depth of cobble embeddedness was estimated at pool tail-outs. Of the 266 pool tail-outs measured, 131 had a value of 1 (49.2%); 105 had a value of 2 (39.5%); 25 had a value of 3 (9.4%); 2 had a value of 4 (0.8%); 3 had a value of 5 (1.1%) (Graph 6). On this scale, a value of 1 indicates the highest quality of spawning substrate. Additionally, a value of 5 was assigned to tail-outs deemed not suitable for spawning due to inappropriate substrate such as bedrock, log sills, boulders, or other considerations.

Two hundred thirty-six of the 266 pool tail-outs measured had embeddedness ratings of 1 or 2. Twenty-seven of the pool tail-outs had embeddedness ratings of 3 or 4. Three of the pool tail-outs had a rating of 5, which is considered unsuitable for spawning. Cobble embeddedness measured to be 25% or less, a rating of 1, is considered to indicate good quality spawning substrate for salmon and steelhead.

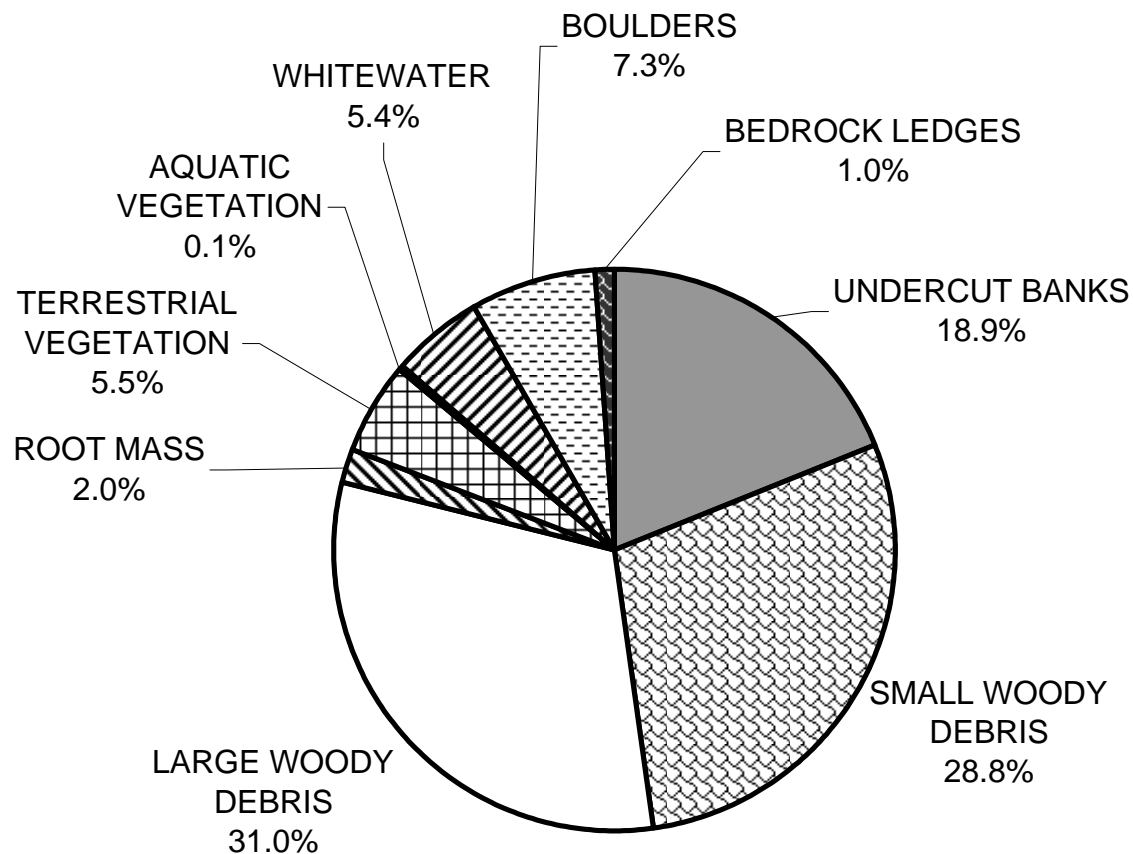
GRAPH 7

Table 5 summarizes mean percent cover by habitat type. Small woody debris is the dominant cover type in East Branch North Fork Big River. Graph 7 describes the pool cover in East Branch North Fork Big River. Large woody debris is the dominant pool cover type followed by small woody debris.

The mean shelter rating for pools is 14. The shelter rating in the flatwater habitats is 4. A pool shelter rating of approximately 100 is desirable. The amount of cover that now exists is being provided primarily by small woody debris in East Branch North Fork Big River. Large woody debris is the dominant cover type in pools followed by small woody debris. Log and root wad cover structures in the pool and flatwater habitats would enhance both summer and winter salmonid habitat. Log cover structures provide rearing fry with protection from predation, rest from water velocity, and also divide territorial units to reduce density related competition.

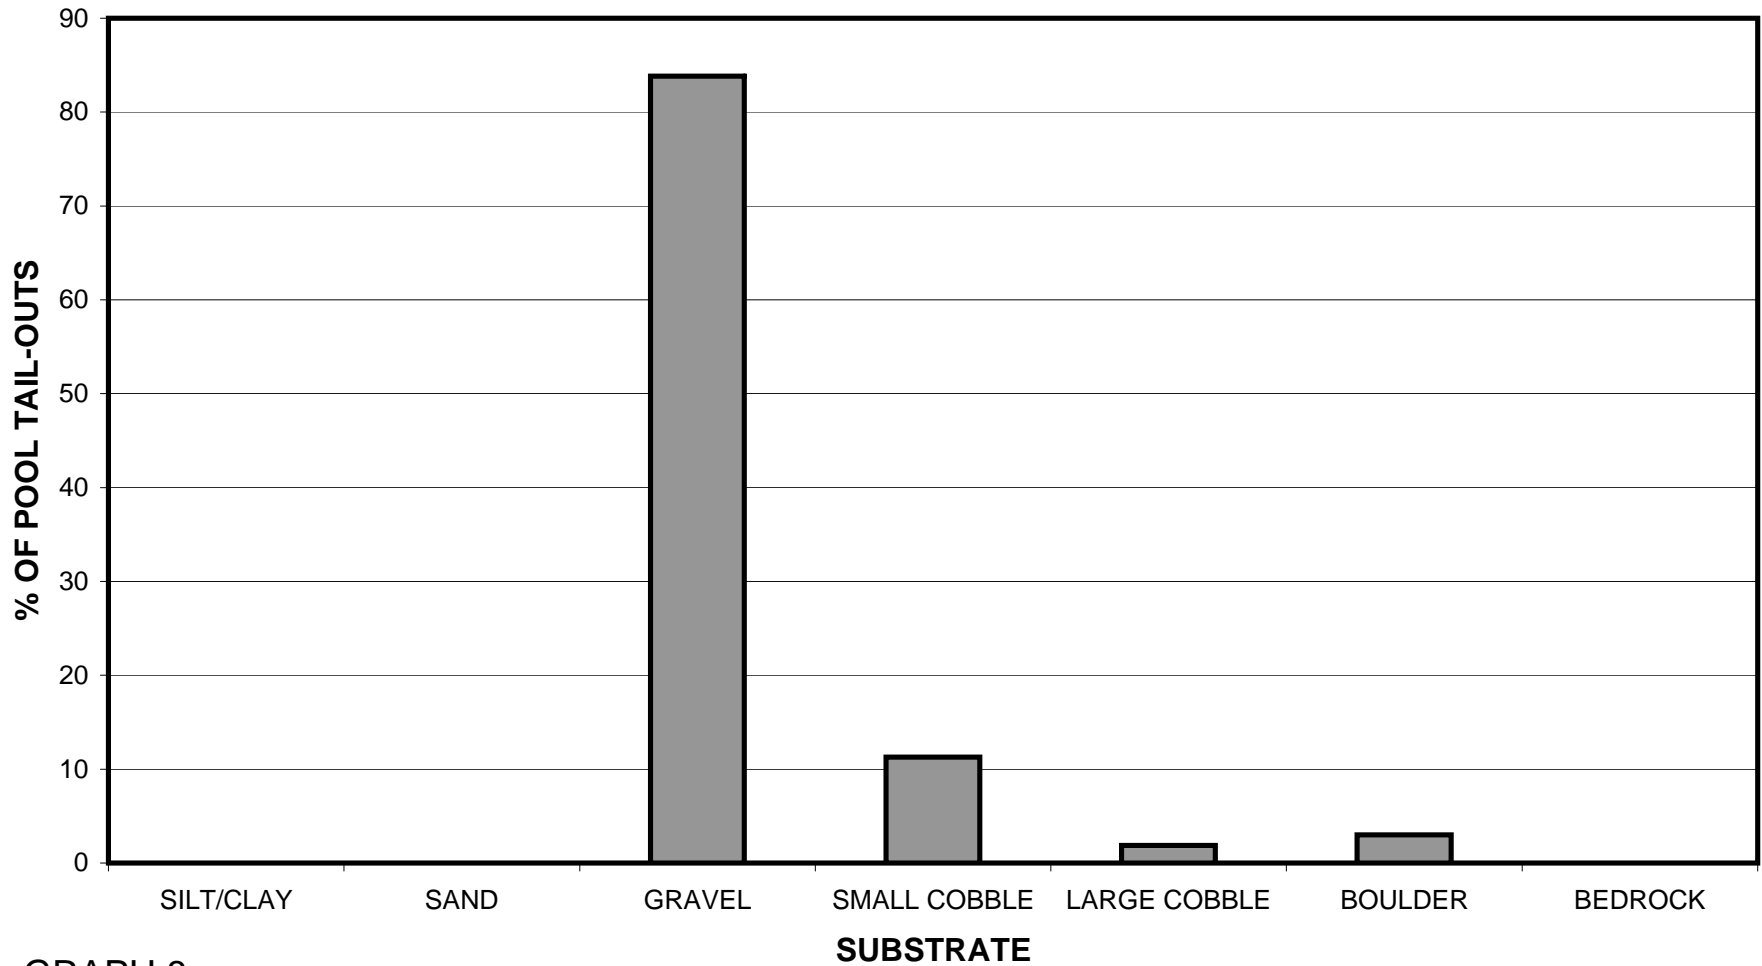
GRAPH 8

Table 6 summarizes the dominant substrate by habitat type. Graph 8 depicts the dominant substrate observed in pool tail-outs. Gravel was the dominant substrate observed in 84% of the pool tail-outs. Small cobble was the next most frequently observed dominant substrate type and occurred in 11% of the pool tail-outs.

Two hundred fifty-three of the 266 pool tail-outs measured had gravel or small cobble as the dominant substrate. This is generally considered good for spawning salmonids.

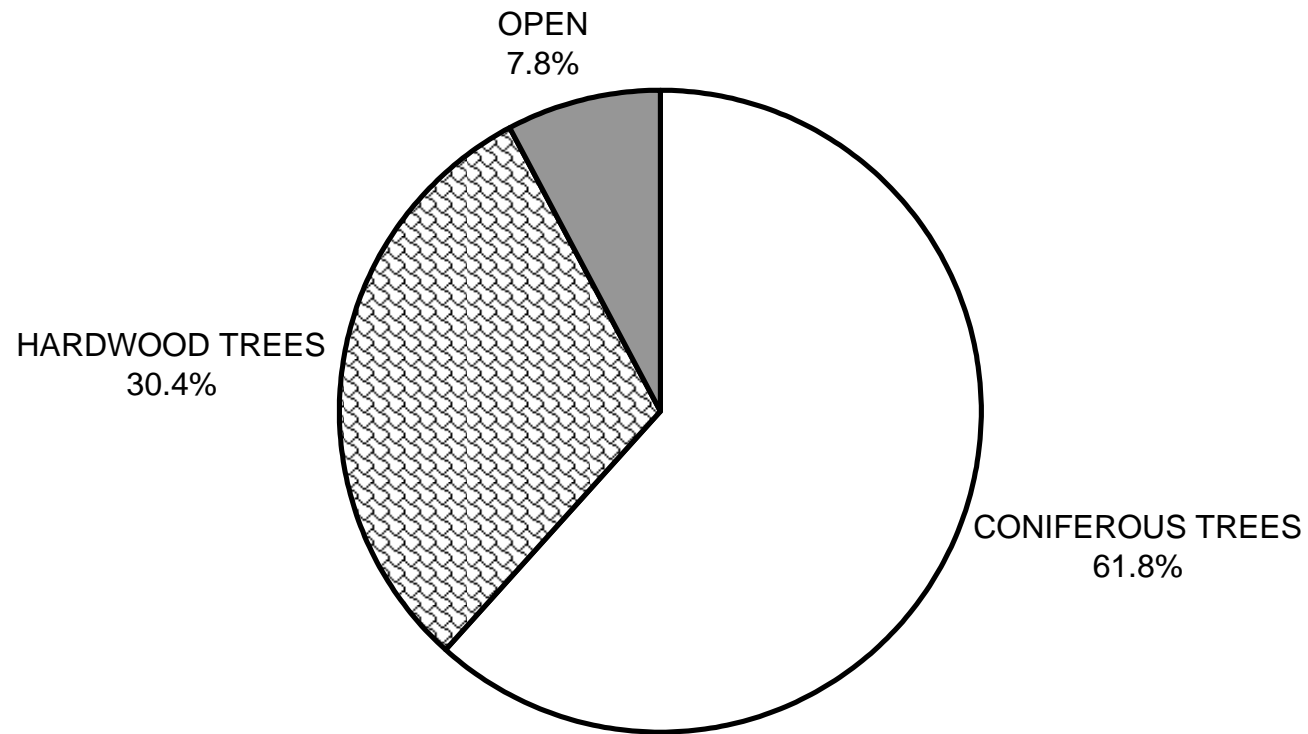
GRAPH 9

The mean percent canopy density for the surveyed length of East Branch North Fork Big River was 92%. Eight percent of the canopy was open. Of the canopy present, the mean percentages of hardwood and coniferous trees were 33% and 67%, respectively. Graph 9 describes the mean percent canopy in East Branch North Fork Big River.

The mean percent canopy density for the stream was 92%. Reach 1 had a canopy density of 92%, Reach 2 had a canopy density of 88%, Reach 3 had a canopy density of 92%, and Reach 4 had a canopy density of 95%. In general, revegetation projects are considered when canopy density is less than 80%.

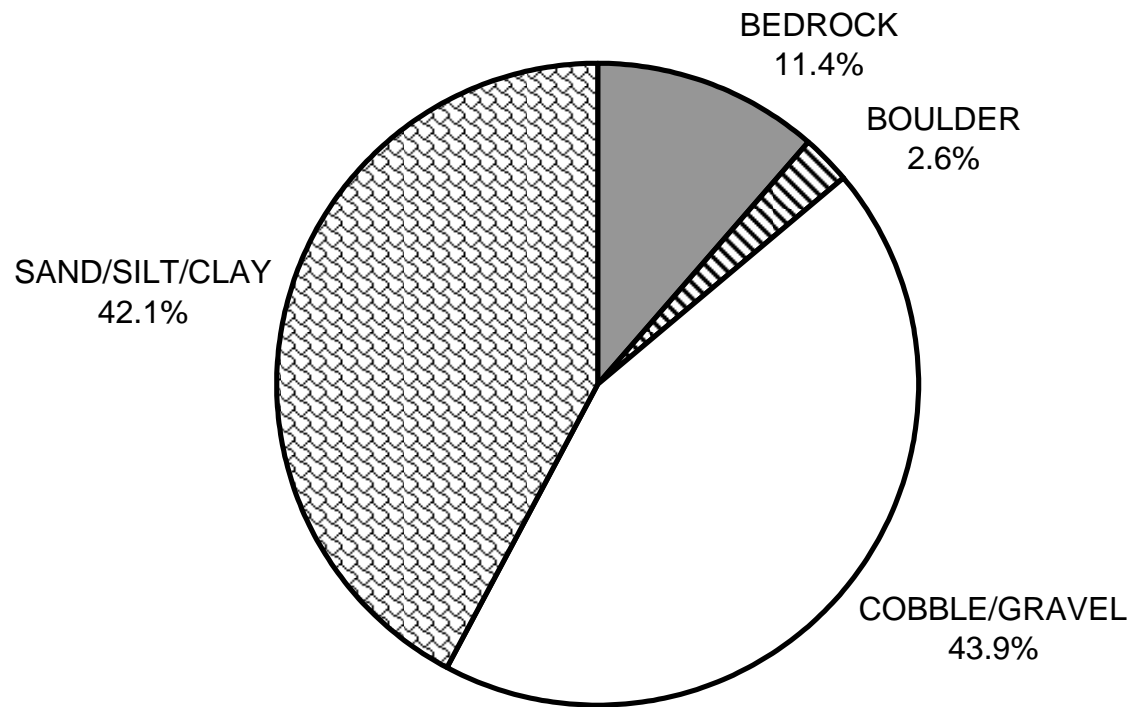
GRAPH 10

For the stream reach surveyed, the mean percent right bank vegetated was 97%. The mean percent left bank vegetated was 95%. The dominant elements composing the structure of the stream banks consisted of 44% cobble/gravel, 42% sand/silt/clay, 11% bedrock, and 3% boulder (Graph 10). Coniferous trees were the dominant vegetation type observed in 53% of the units surveyed. Additionally, 34% of the units surveyed had deciduous trees as the dominant vegetation type, and 12% had brush as the dominant vegetation type (Graph 11).

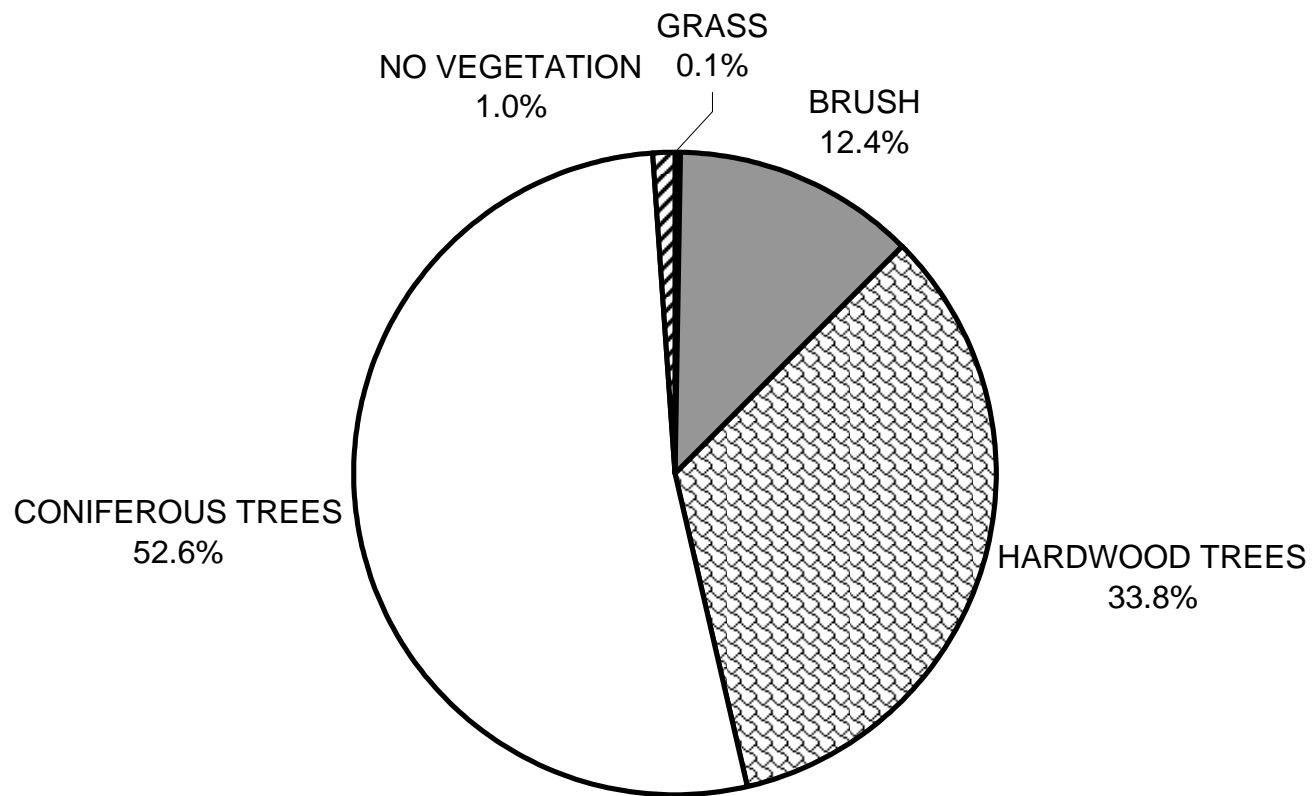
GRAPH 11

The percentage of right and left bank covered with vegetation was 97% and 95%, respectively. In areas of stream bank erosion or where bank vegetation is sparse, planting endemic species of coniferous and hardwood trees, in conjunction with bank stabilization, is recommended.
