# **STREAM INVENTORY REPORT**

## **Left Bank Tributary to Martin Creek**

A stream inventory was conducted beginning July 18 and ending July 23, 2002 on Left Bank Tributary to Martin Creek. The survey began at the confluence with Martin Creek and extended upstream 0.56 miles.

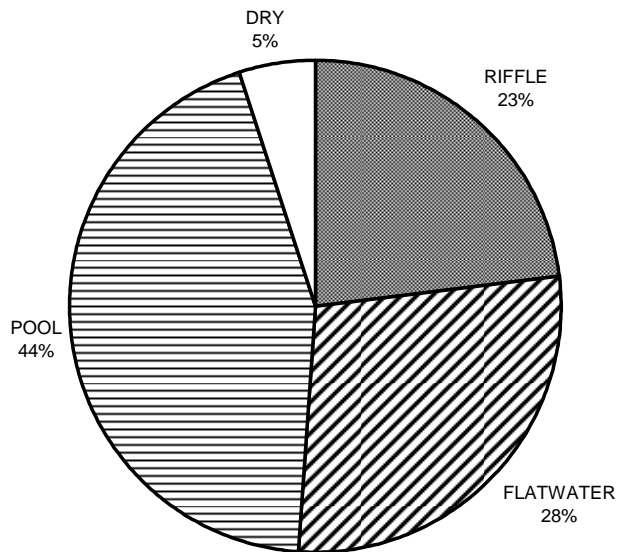
GRAPH 1

Table 1 summarizes the Level II riffle, flatwater, and pool habitat types. Based on frequency of occurrence there were 44% pool units, 28% flatwater units, 23% riffle units, and 5% dry units (Graph 1). Based on total length of Level II habitat types there were 47% flatwater units, 24% riffle units, 19% pool units, and 10% dry units (Graph 2).

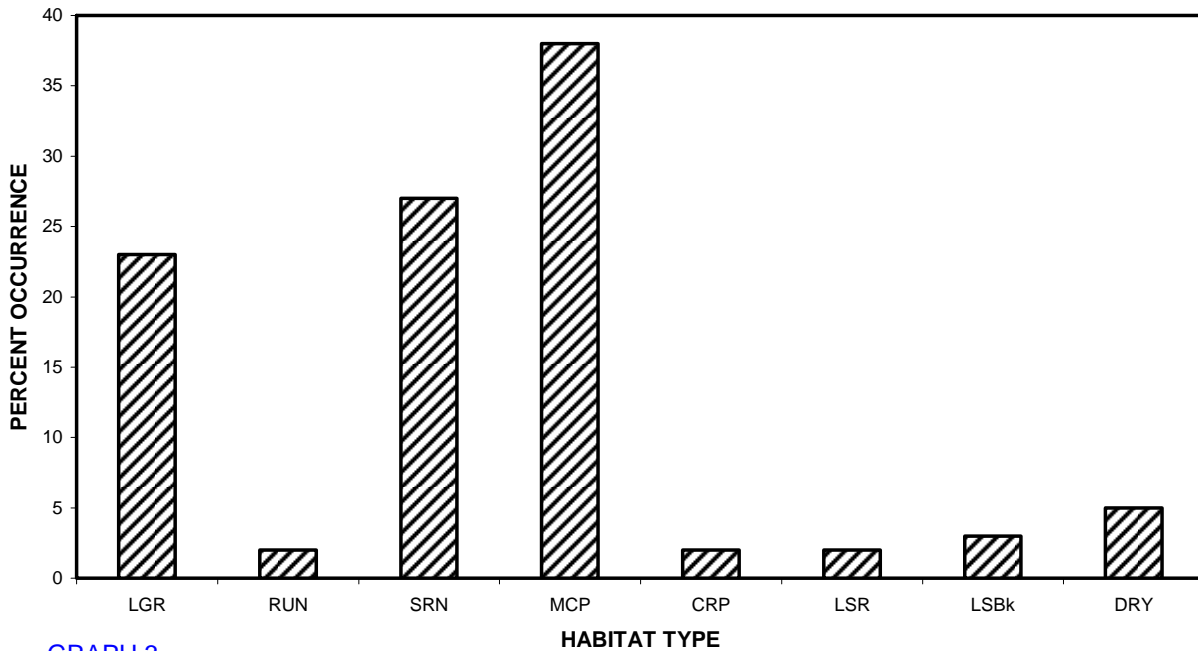
GRAPH 3

Eight Level IV habitat types were identified (Table 2). The most frequent habitat types by percent occurrence were mid-channel pools, 38%; step runs, 27%; and low gradient riffles, 23% (Graph 3). Based on percent total length, step runs made up 45%, low gradient riffles 24%, mid channel pools 15%, and dry 10%.

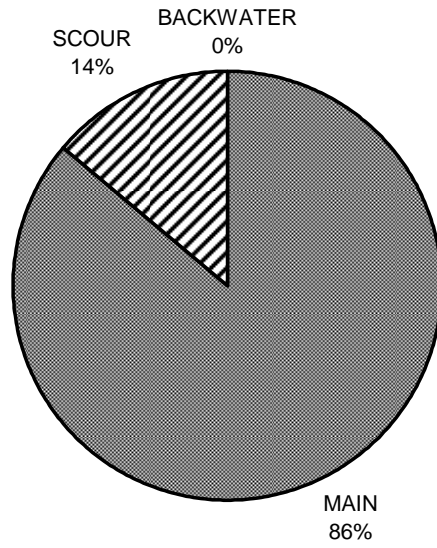
GRAPH 4

A total of 28 pools were identified (Table 3). Main channel pools were the most frequently encountered, at 86%, and comprised 78% of the total length of all pools (Graph 4).

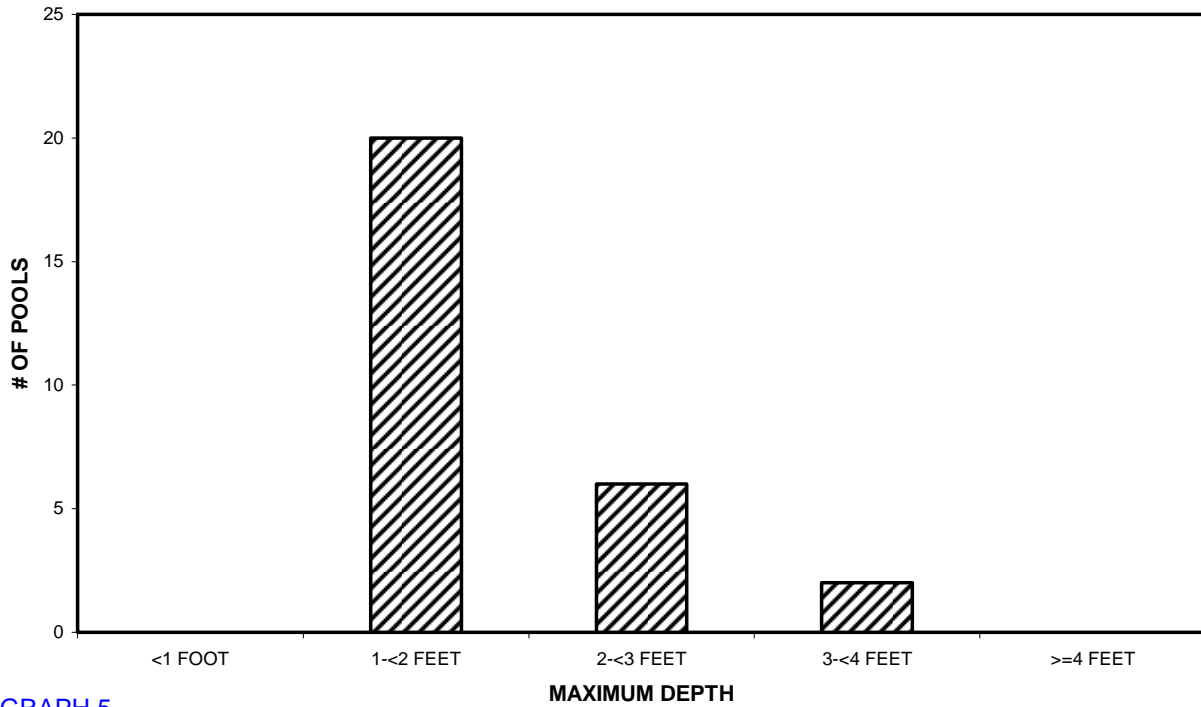
GRAPH 5

Table 4 is a summary of maximum pool depths by pool habitat types. Pool quality for salmonids increases with depth. Eight of the 28 pools (29%) had a depth of two feet or greater (Graph 5).

Flatwater habitat types comprised 47% of the total length of this survey, riffles 24%, pools 19%, and dry 10%. The pools are relatively shallow, with 8 of the 28 (29%) pools having a maximum depth greater than 2 feet. In general, pool enhancement projects are considered when primary pools comprise less than 40% of the length of total stream habitat. In first and second order streams, a primary pool is defined to have a maximum depth of at least two feet, occupy at least half the width of the low flow channel, and be as long as the low flow channel width. Installing structures that will increase or deepen pool habitat is recommended for locations where their installation will not be threatened by high stream energy, or where their installation will not conflict with the modification of the numerous log debris accumulations (LDA's) in the stream.

- 3) Where feasible, design and engineer pool enhancement structures to increase the number of pools. This must be done where the banks are stable or in conjunction with stream bank armor to prevent erosion.

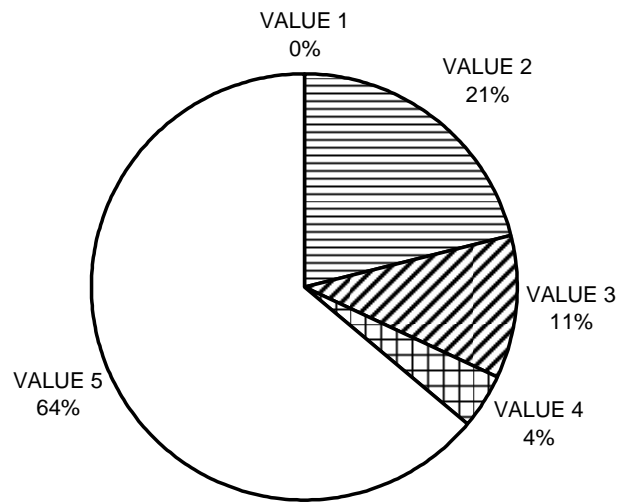
GRAPH 6

The depth of cobble embeddedness was estimated at pool tail-outs. Of the 28 pool tail-outs measured, 0 had a value of 1 (0%); 6 had a value of 2 (21%); 3 had a value of 3 (11%); 1 had a value of 4 (4%); and 18 had a value of 5 (64%) (Graph 6). On this scale, a value of 1 indicates the highest quality of spawning substrate.

Six of the 28 pool tail-outs measured had embeddedness ratings of 1 or 2. Four of the pool tail-outs had embeddedness ratings of 3 or 4. Eighteen of the pool tail-outs had a rating of 5, which is considered unsuitable for spawning. Cobble embeddedness measured to be 25% or less, a rating of 1, is considered to indicate good quality spawning substrate for salmon and steelhead. Sediment sources in Left Bank Tributary to Martin Creek should be mapped and rated according to their potential sediment yields, and control measures should be taken.

- 5) Inventory and map sources of stream bank erosion and prioritize them according to present and potential sediment yield. Identified sites should then be treated to reduce the amount of fine sediments entering the stream.

- 6) Active and potential sediment sources need to be identified, mapped, and treated according to their potential for sediment yield to the stream and its tributaries.

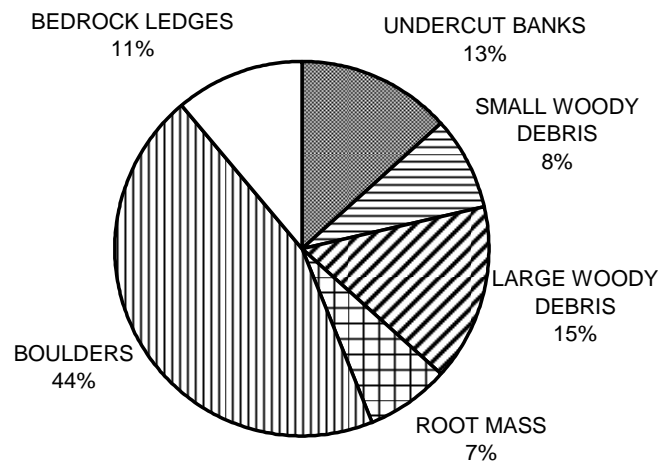
GRAPH 7

Table 5 summarizes mean percent cover by habitat type. Boulders are the dominant cover types in Left Bank Tributary to Martin Creek. Graph 7 describes the pool cover in Left Bank Tributary to Martin Creek. Boulders are the dominant pool cover type followed by large woody debris.

The mean shelter rating for pools was 25. The shelter rating in the flatwater habitats was 29. A pool shelter rating of approximately 100 is desirable. The amount of cover that now exists is being provided primarily by boulders in all habitat types. Additionally, large woody debris contributes a small amount. Log and root wad cover structures in the pool and flatwater habitats would enhance both summer and winter salmonid habitat. Log cover structure provides rearing fry with protection from predation, rest from water velocity, and also divides territorial units to reduce density related competition.

- 4) Increase woody cover in the pools and flatwater habitat units. Most of the existing cover is from boulders. Adding high quality complexity with log and root wad cover is desirable.

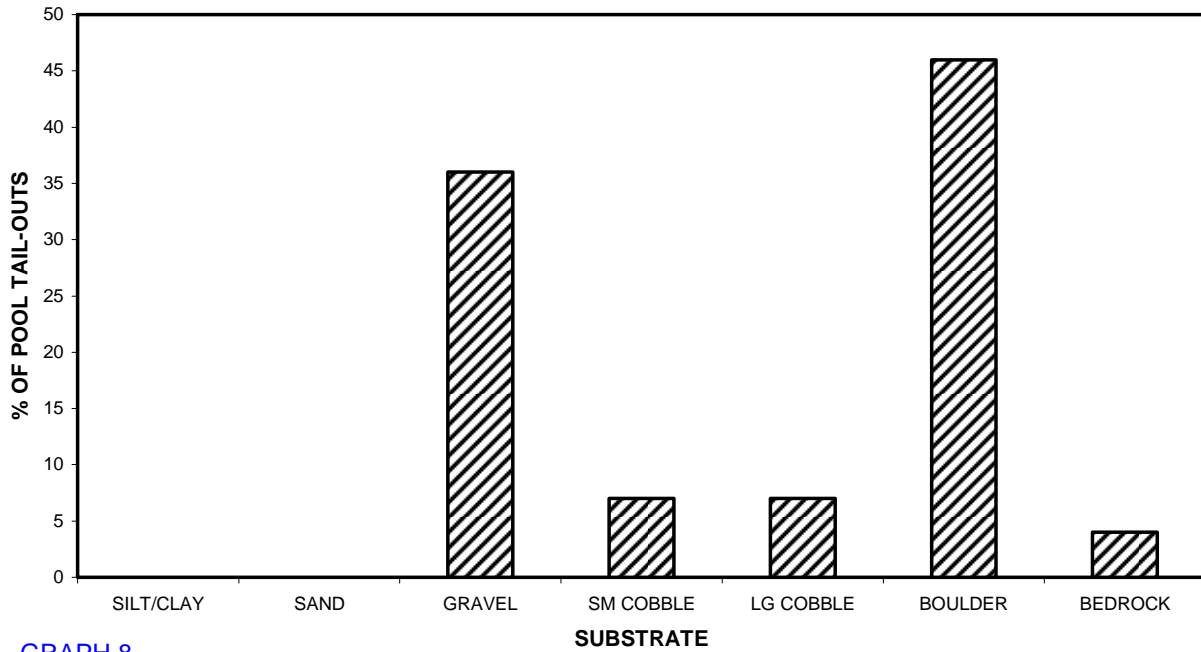
GRAPH 8

Table 6 summarizes the dominant substrate by habitat type. Graph 8 depicts the dominant substrate observed in pool tail-outs. Boulders were the dominant substrate observed in 46% of pool tail-outs while gravel was the next most frequently observed substrate type, at 36%.

Twenty-four of the 28 pool tail-outs measured had sand/silt/clay, large cobble, boulders or bedrock as the dominant substrate. This is generally considered unsuitable for spawning salmonids.

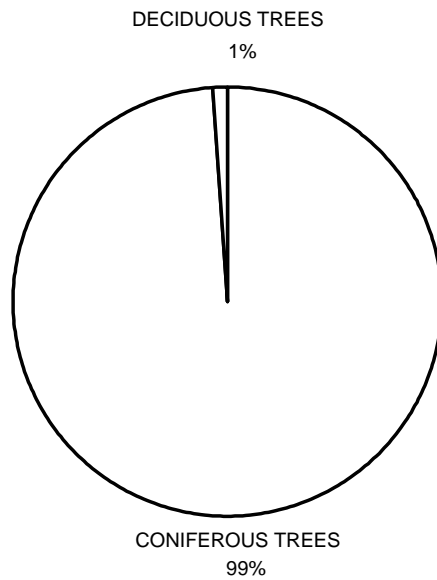
GRAPH 9

The mean percent canopy density for the surveyed length of Left Bank Tributary to Martin Creek was 90%. The mean percentages of deciduous and coniferous trees were 1% and 99%, respectively. Graph 9 describes the mean percent canopy in Left Bank Tributary to Martin Creek.

The mean percent canopy density for the stream was 90%. In general, revegetation projects are considered when canopy density is less than 80%.

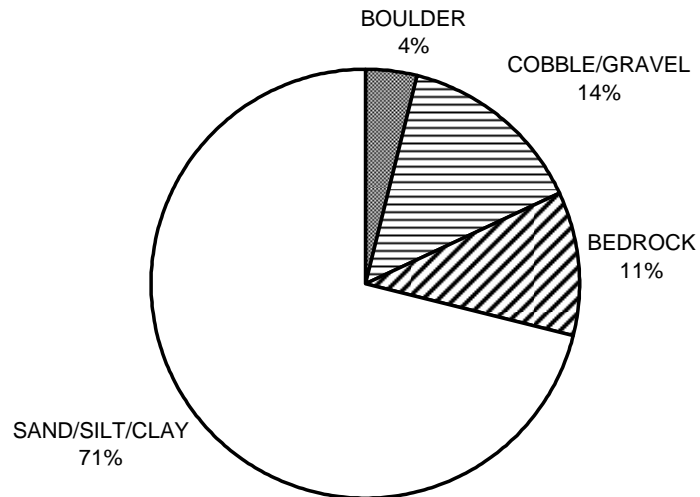
GRAPH 10

For the stream reach surveyed, the mean percent right bank vegetated was 58%. The mean percent left bank vegetated was 65%. The dominant elements composing the structure of the stream banks consisted of 71% sand/silt/clay, 14% cobble/gravel, 11% bedrock, and 4% boulder (Graph 10). Coniferous trees were the dominant vegetation type observed in 86% of the units surveyed. Additionally, 14% of the units surveyed had brush as the dominant vegetation type (Graph 11).

The percentage of right and left bank covered with vegetation was moderate at 58% and 65%, respectively. In areas of stream bank erosion or where bank vegetation is not at acceptable levels, planting endemic species of coniferous and deciduous trees, in conjunction with bank stabilization, is recommended.
